***LIMITED
LEAD INSPECTION***

**South Texas Veterans Health Care System
Audie L. Murphy Memorial VA Hospital
M003
7400 Merton Minter
San Antonio, Texas 78229**

LIMITED LEAD INSPECTION
South Texas Veterans Health Care System
Audie L. Murphy Memorial VA Hospital
M003
7400 Merton Minter
San Antonio, Texas 78229

M003 – Pump House
11 September 2013

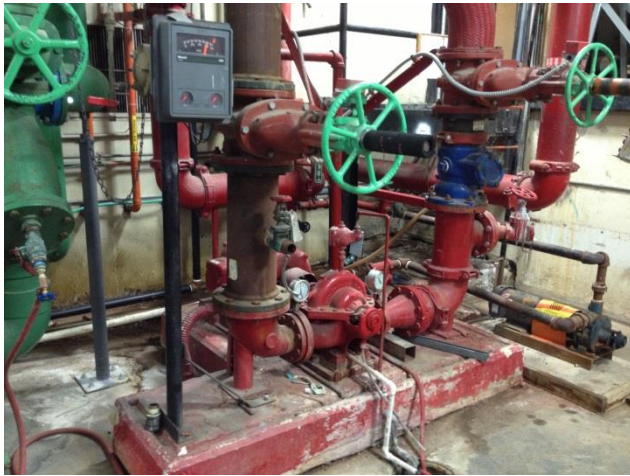
4.2.1. Red painted surfaces

1. Red concrete base – 0.13 mg/cm^2

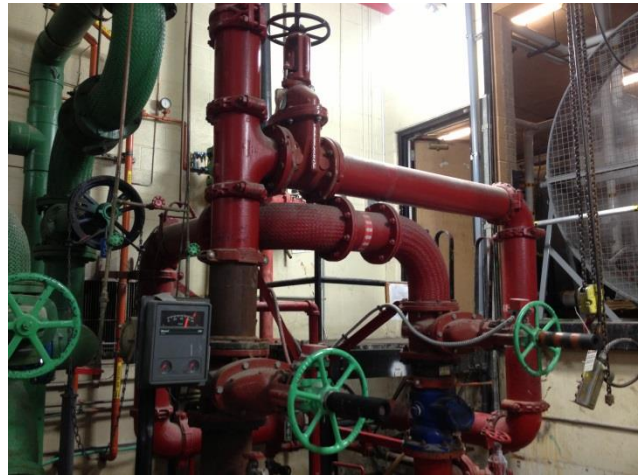
2. Red handles and piping – 0.5 mg/cm^2

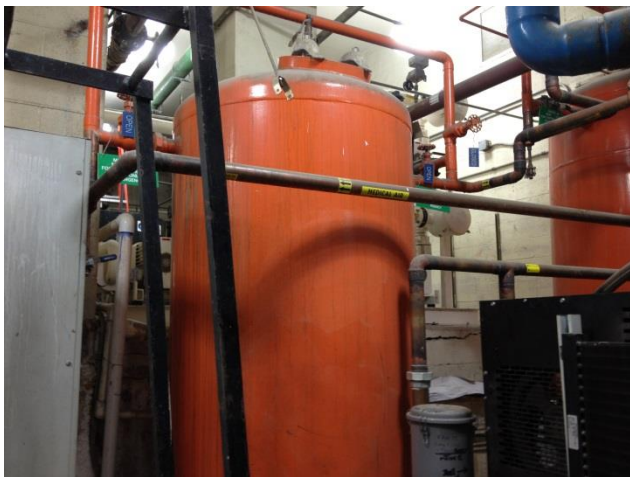
4.2.2. Orange painted surfaces

3. Orange tank and piping – 1.5 mg/cm^2

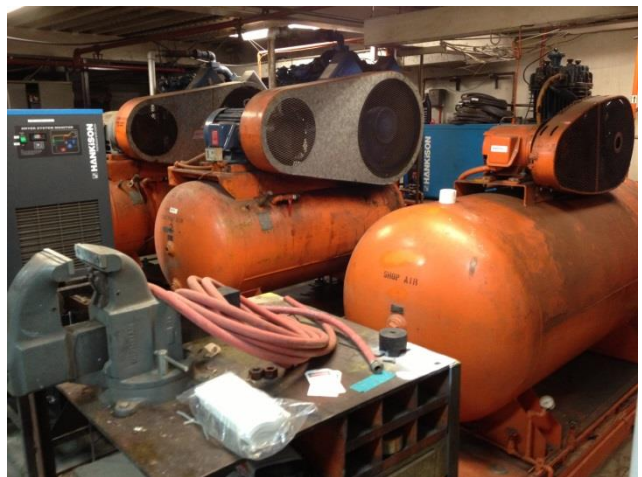
4. Orange cylinders and appurtenances –
 0.18 mg/cm^2
