# **ASBESTOS CONTAINING BUILDING MATERIAL REPORT BUILDING 1**

**Bay Pines VA Medical Center  
10000 Bay Pines Boulevard  
Bay Pines, Florida**

Project No. 2009011.002

November 9, 2009

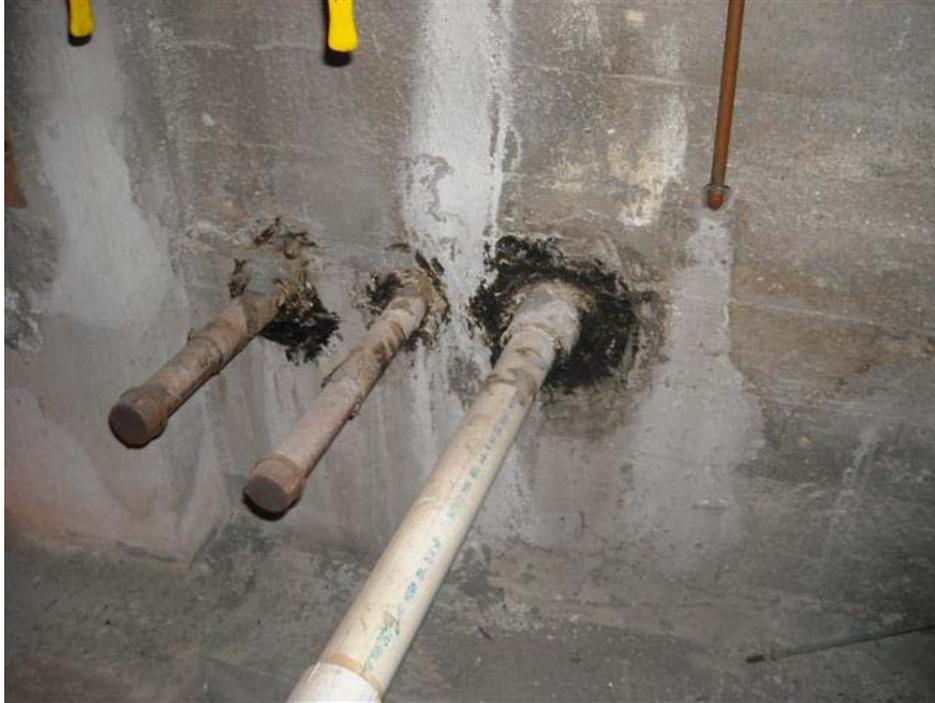
**Building 1**  
**Sample 13 - Black Fire Stop**

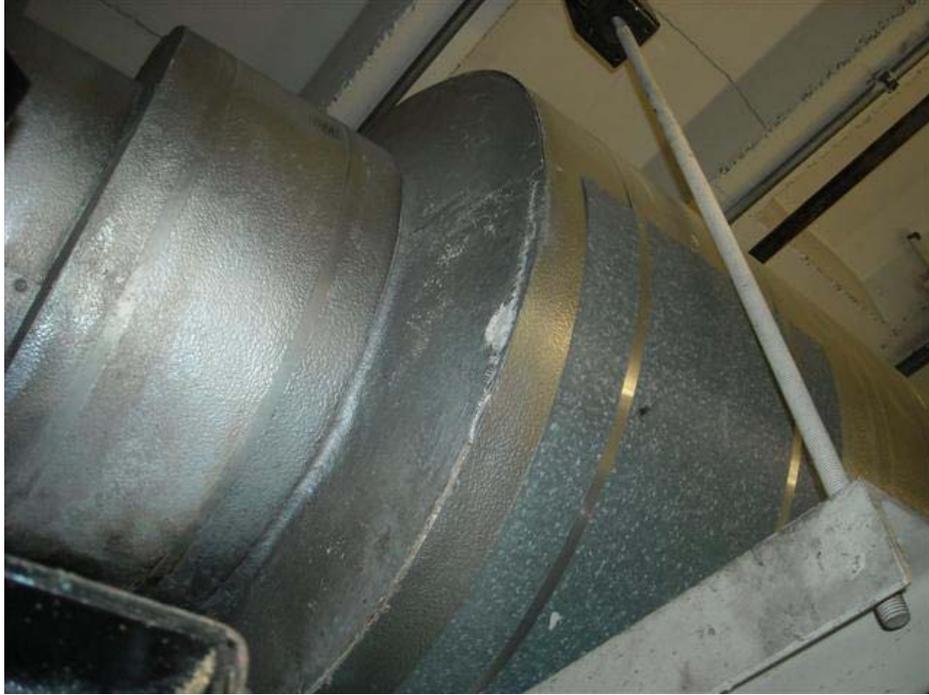
**Building 1**  
**Sample 58 - Generator Insulation Wrap**

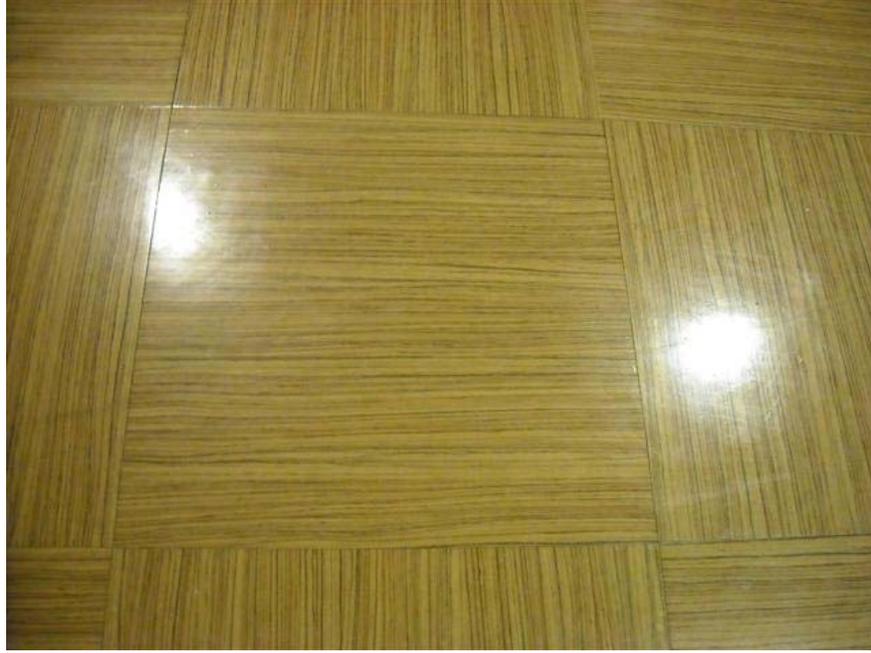
**Building 1**  
**Sample 64 - 18"x18" Wood Pattern FT Mastic**

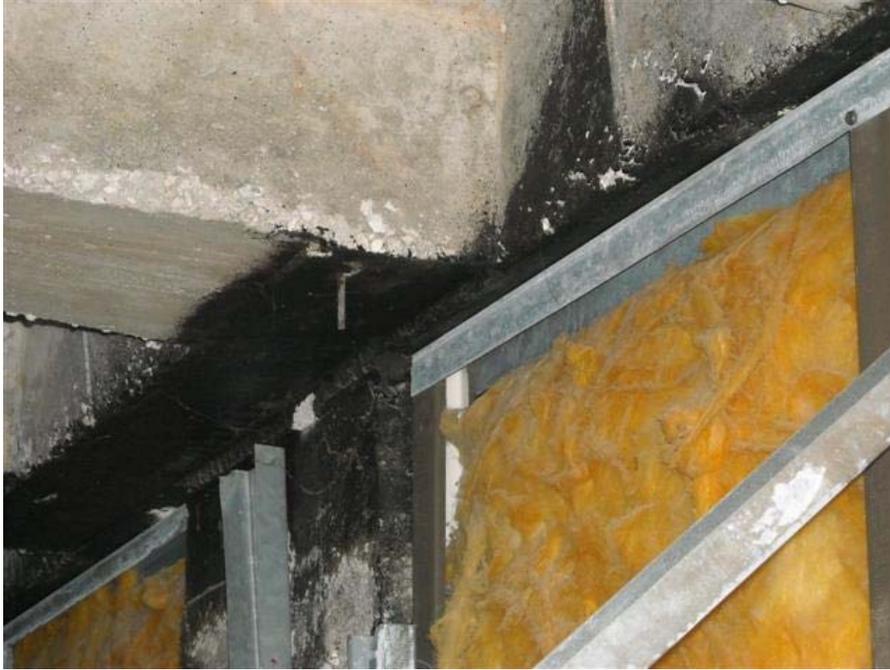
**Building 1**  
**Sample 76 - Black Waterproofing – Exterior Walls**

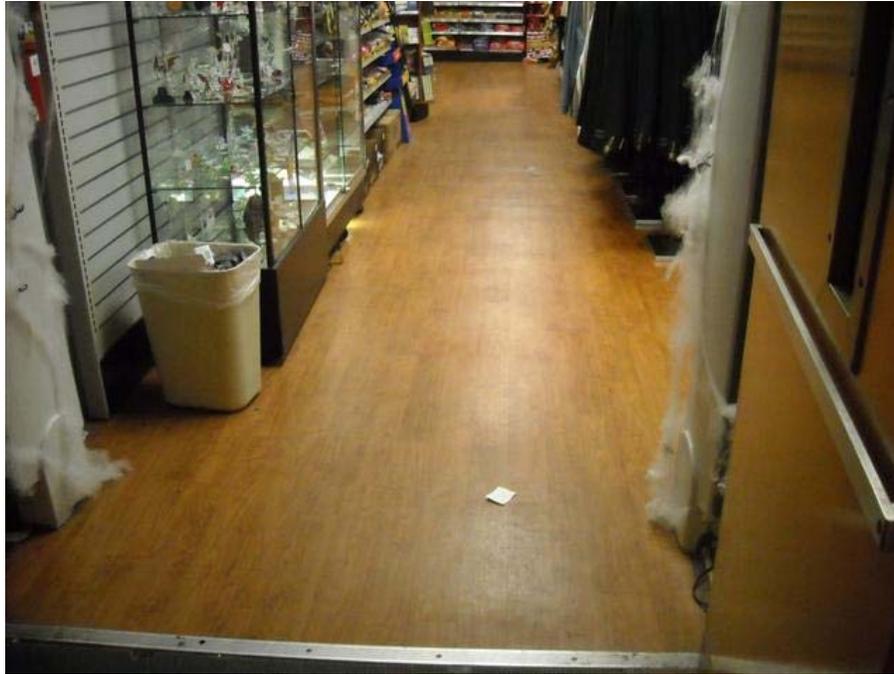
**Building 1**  
**Sample 82 – Wood Grain Linoleum Mastic**

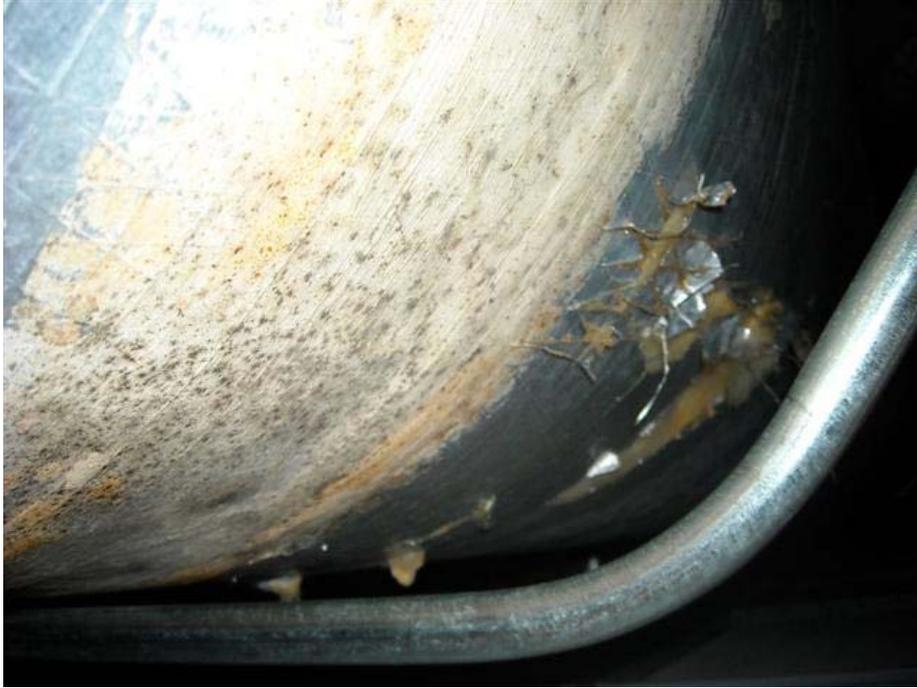
**Building 1**  
**Sample 123 – Off-White Duct Wrap**

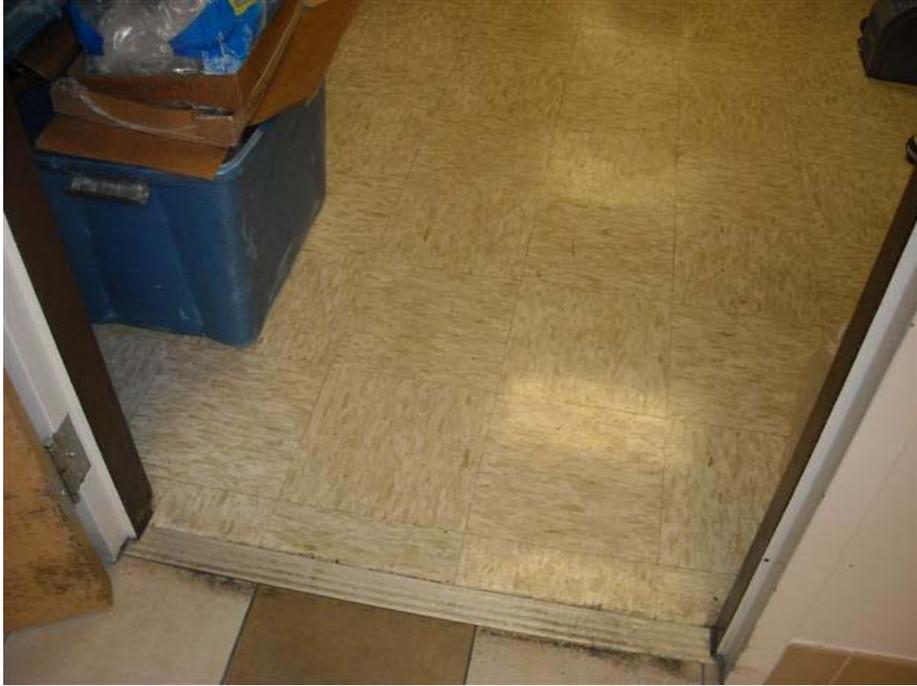
**Building 1**  
**Sample 150 – 12” Gray FT Mastic**

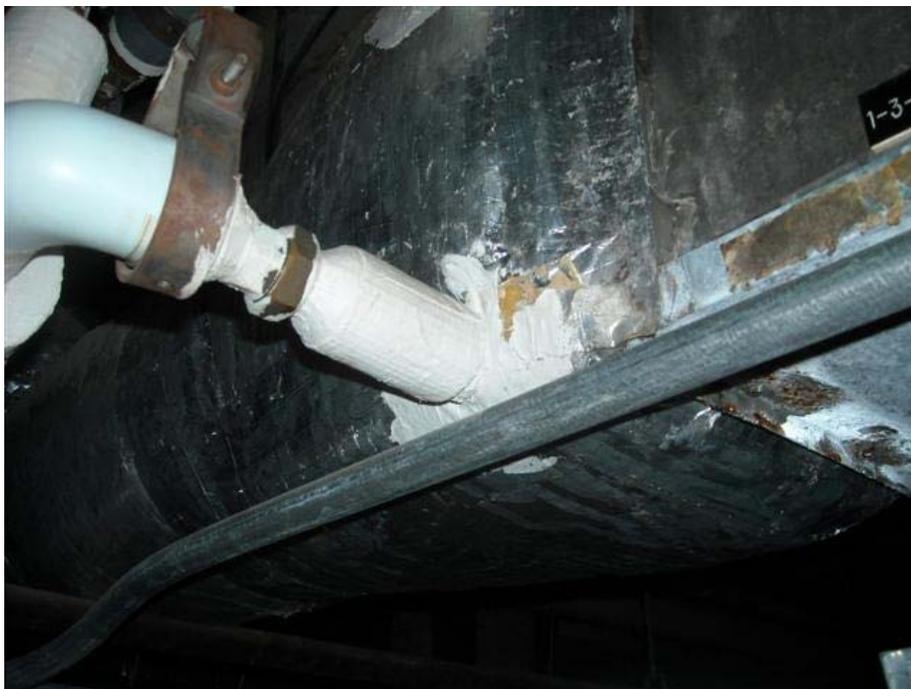
**Building 1**  
**Sample 165 – White Duct Mastic**
