ASBESTOS INSPECTION REPORT

Subject Property: Orlando V A Healthcare Center-Building No. 502 Boiler & Generator Plant

Property Location: 5201 Raymond Street – Orlando, Florida 32803

Project Number: A-0640-07

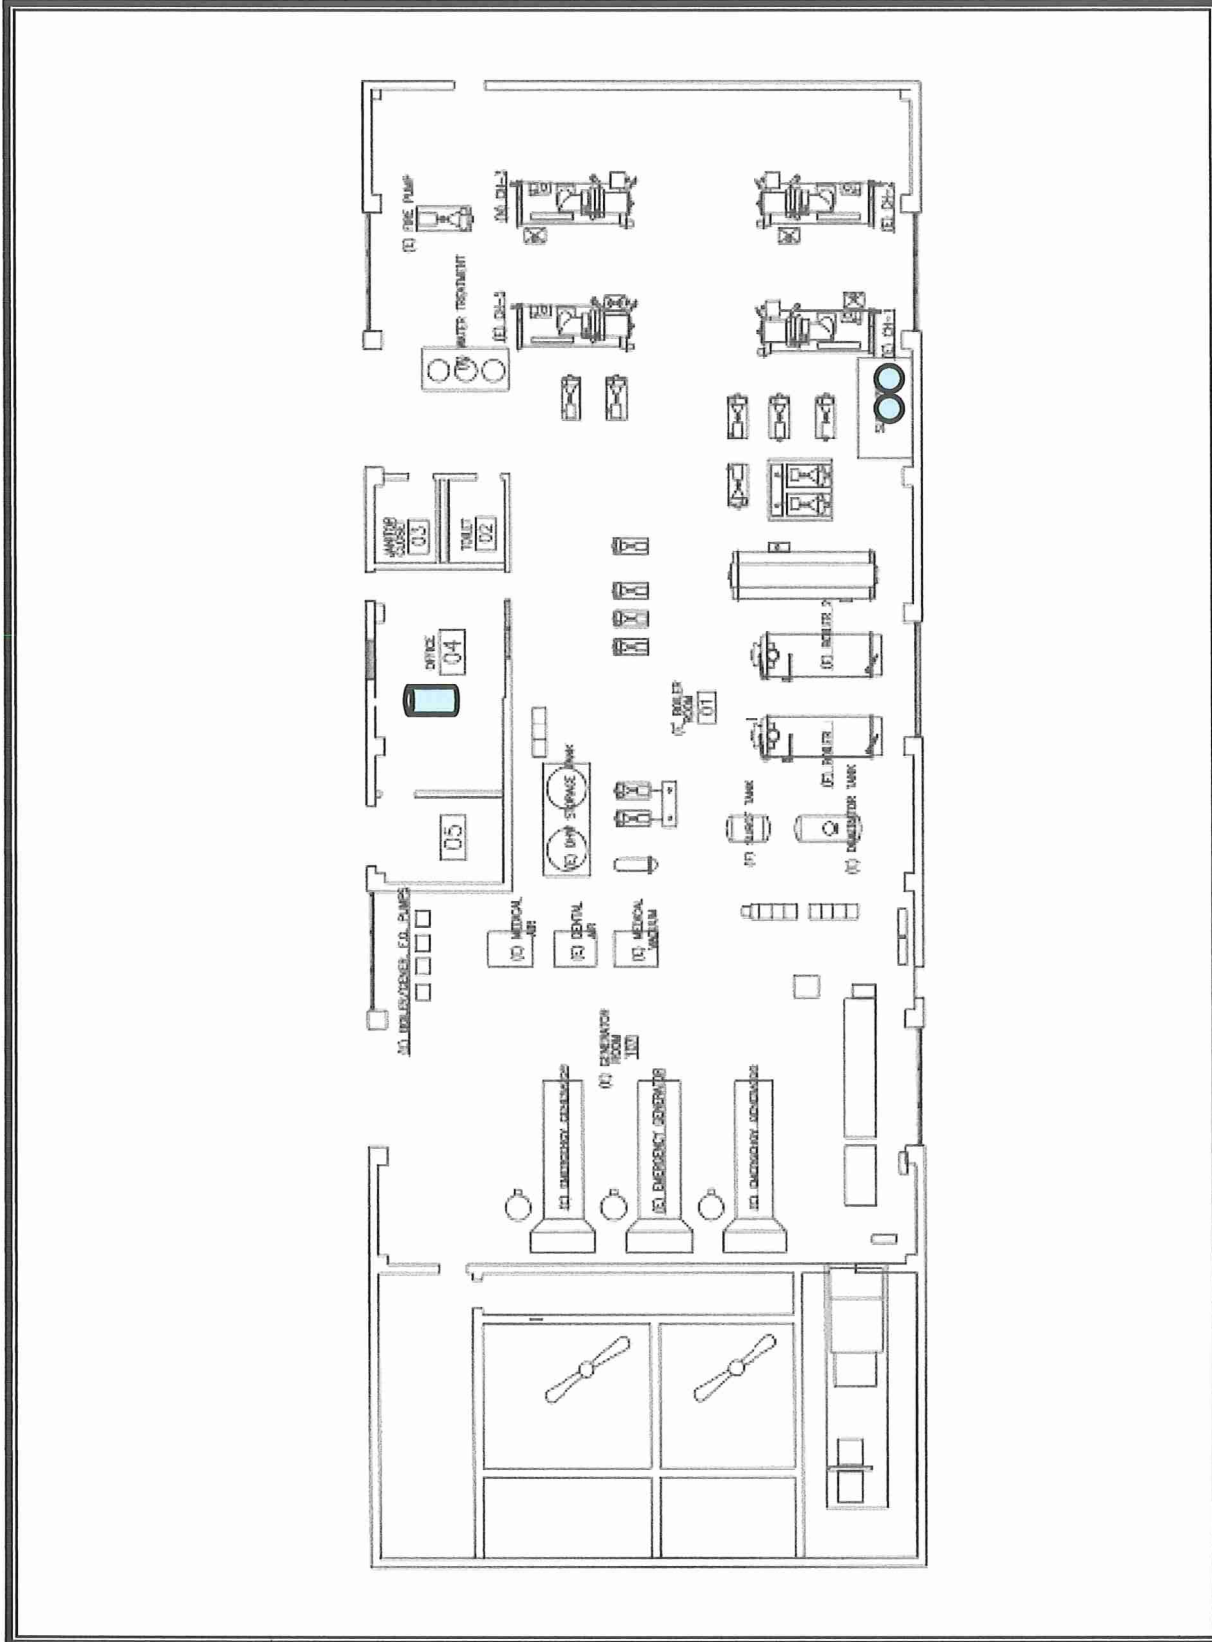
Orlando VA Healthcare Center
 Building 502
 Location of ACM
 Project Number A-0640-07

Sample#	Sample Description / Location	Approximate Quantities	ACM	Asbestos Content
502-25, 26 & 27	Equalizer Tank Insulation Mastic (White) / Above Office	150 sq. ft.	Category I	10% Mastic Only
500-132	Pipe Insulation Mastic (White) / Utility Tunnel - Building #500 Chill Water Supply and Return Piping	660 sq. ft. (Joints)	Category I	10% Mastic Only

Location of ACM Pipe Mastic Joints
 On-chill water supply and return and
 Expansion Tank

It is our recommendation that the ACM identified in this survey be removed by a Florida licensed asbestos abatement contractor prior to renovation or demolition activities that may potentially impact or disturb these materials.
