Asbestos Containing Materials Survey Point Count Analysis Report

Tripler Army Medical Facility E-Wing Exterior Surface Repair Project

January 24, 2013

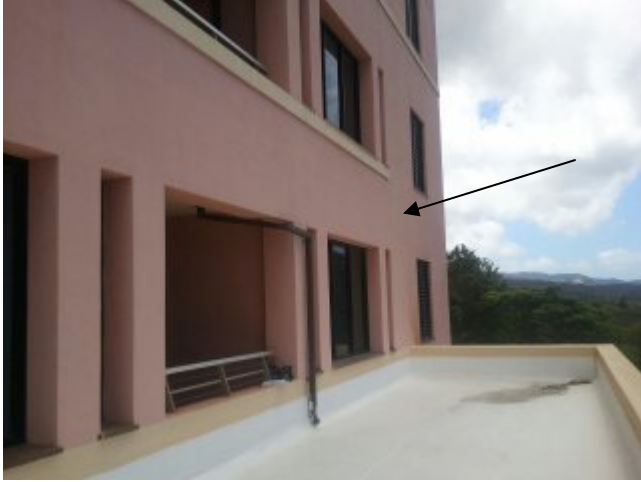
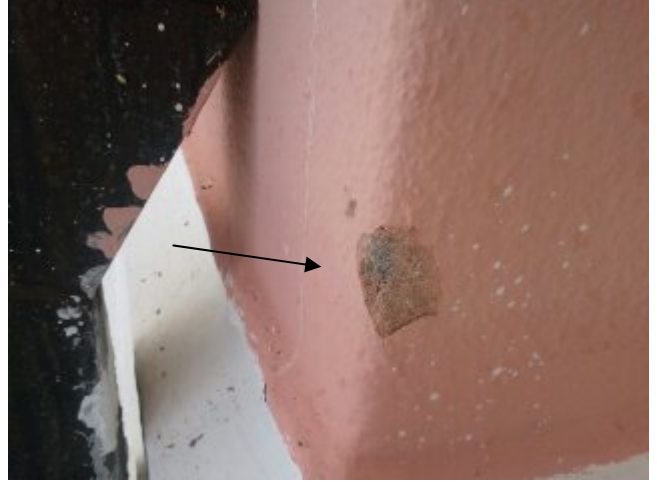
Based on the PLM point count analytical results the plaster material is not classified as a regulated asbestos containing material (RACM) as defined by EPA and HDOH. This determination enables the disturbance of this material to be conducted without establishing a negative pressure containment for areas where the exterior plaster material will be disturbed during renovations.

Exterior Wall Plaster

Disturbance/abatement of materials containing less than 1% asbestos must be conducted in compliance with OSHA 29 CFR 1926.1101 including but not limited to the following.

- Trained Workers
- Medical Clearance
- Respirator Fit Test
- Personnel Protective Equipment
- Exposure Monitoring
- Wet Removal Methods
- Prompt Clean Up
