# **Asbestos Containing Materials Survey**

## **Tripler Army Medical Facility E-Wing Exterior Surface Repair Project**

**June 11, 2012**

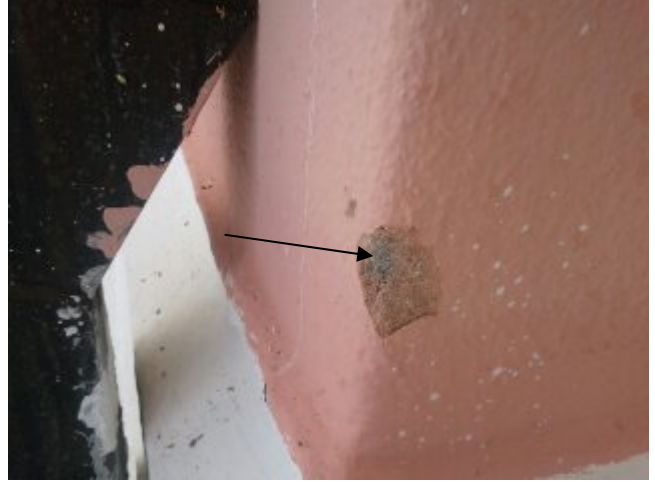
<b>Asbestos Containing Materials</b>	<b>Results</b>	<b>Estimated Quantities</b>
Plaster – Friable Condition – Fair Exterior Walls <i>See Section 2 for Photo ID of Material</i>	< 1% Chrysotile Asbestos	All Exterior Wall Surfaces Excluding Cementitious/Plaster Awnings

The potentially friable asbestos containing plaster is located under the exterior paint and skim coat layers on the exterior walls of the E Wing building. Removal and/or disturbance of this material are defined by EPA as Category II ACM that may become friable during exterior wall repair and surface preparation.

Exterior Wall – RACM - Cementitious Plaster

Note: Without additional PLM point count analysis to verify the asbestos concentrations at < 1% the wall repair and surface preparation must be conducted within a negative pressure containment.
