**ASBESTOS SURVEY REPORT**

**VA Medical Center  
Bedford, MA**

ACM Sampling Report  
MCE-1672

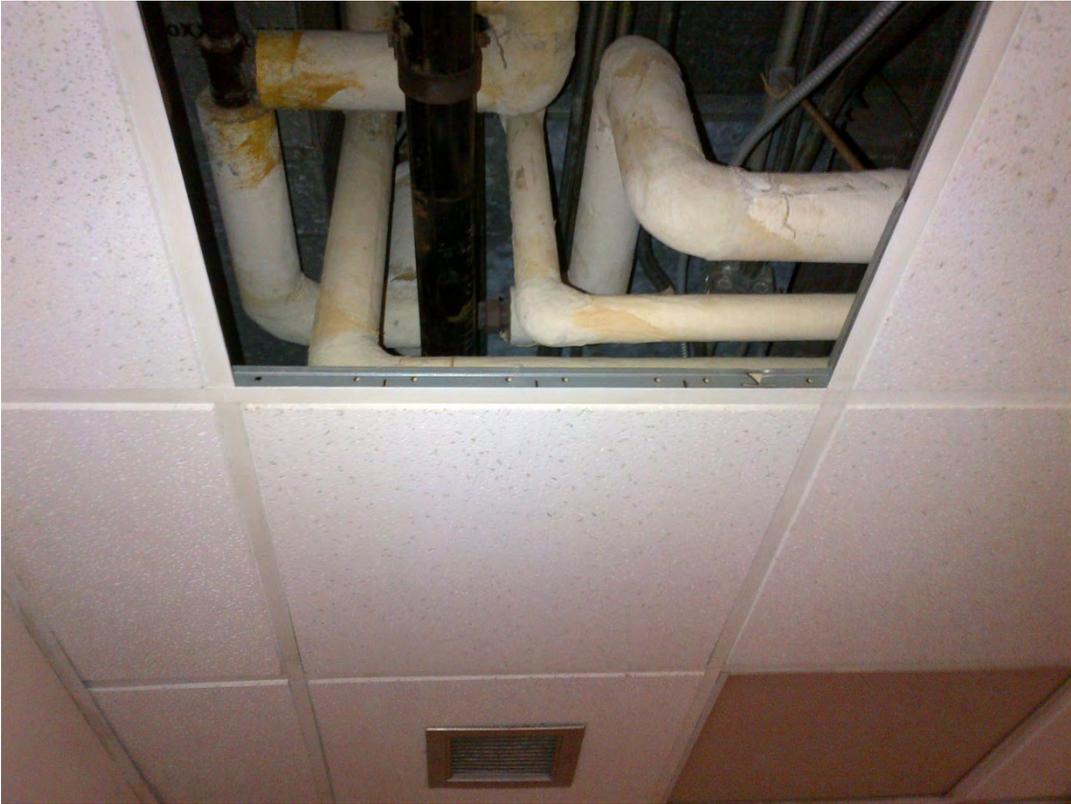
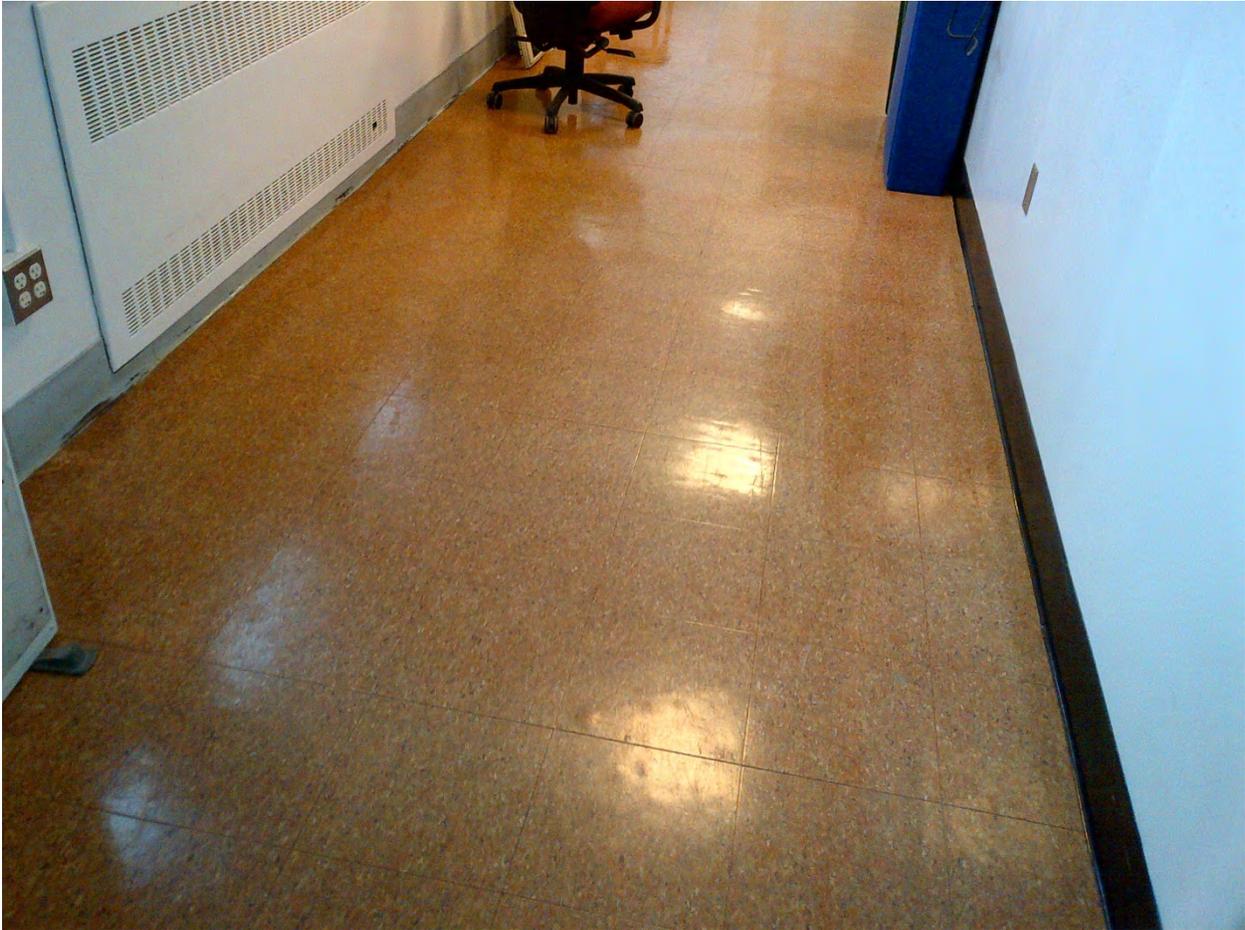
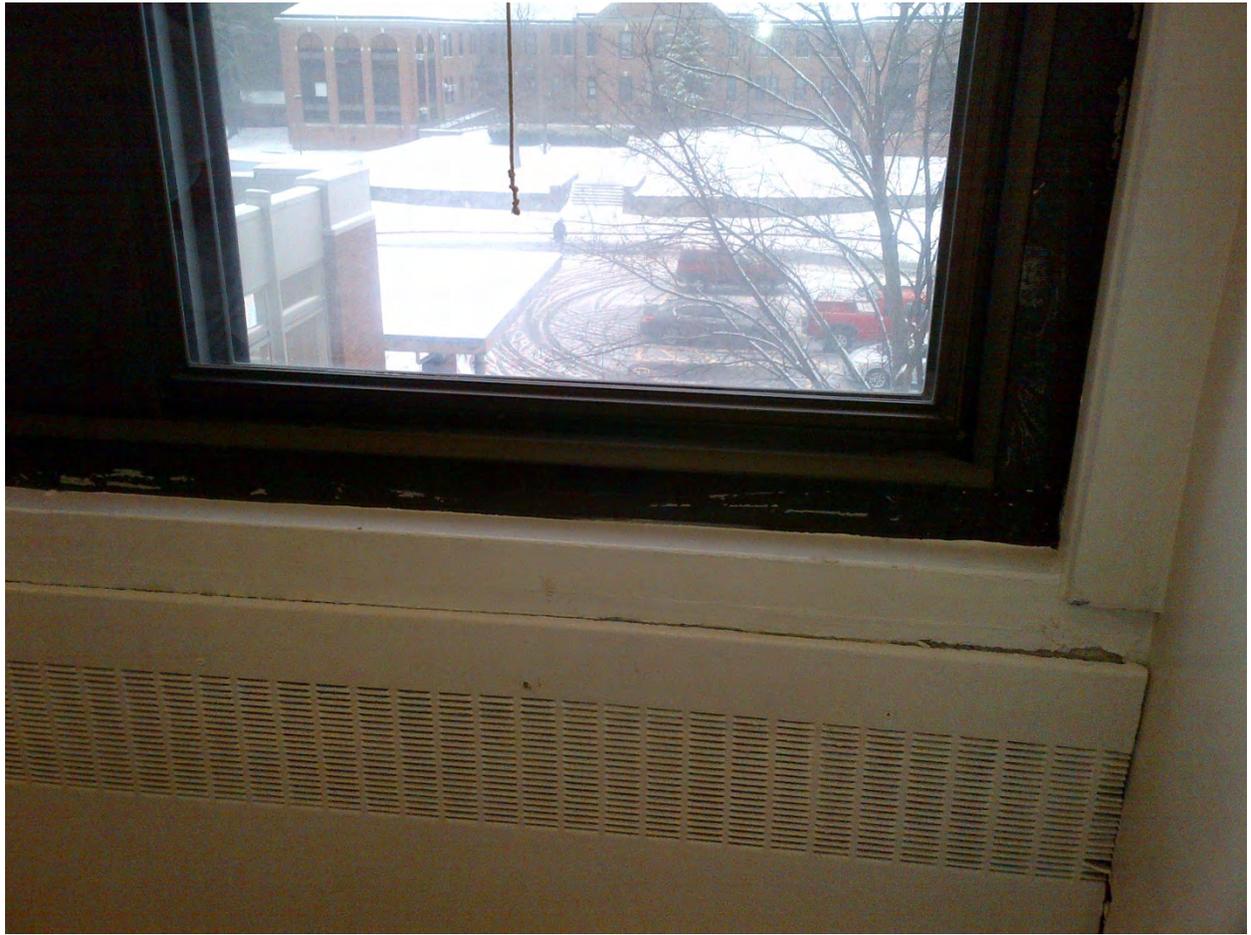
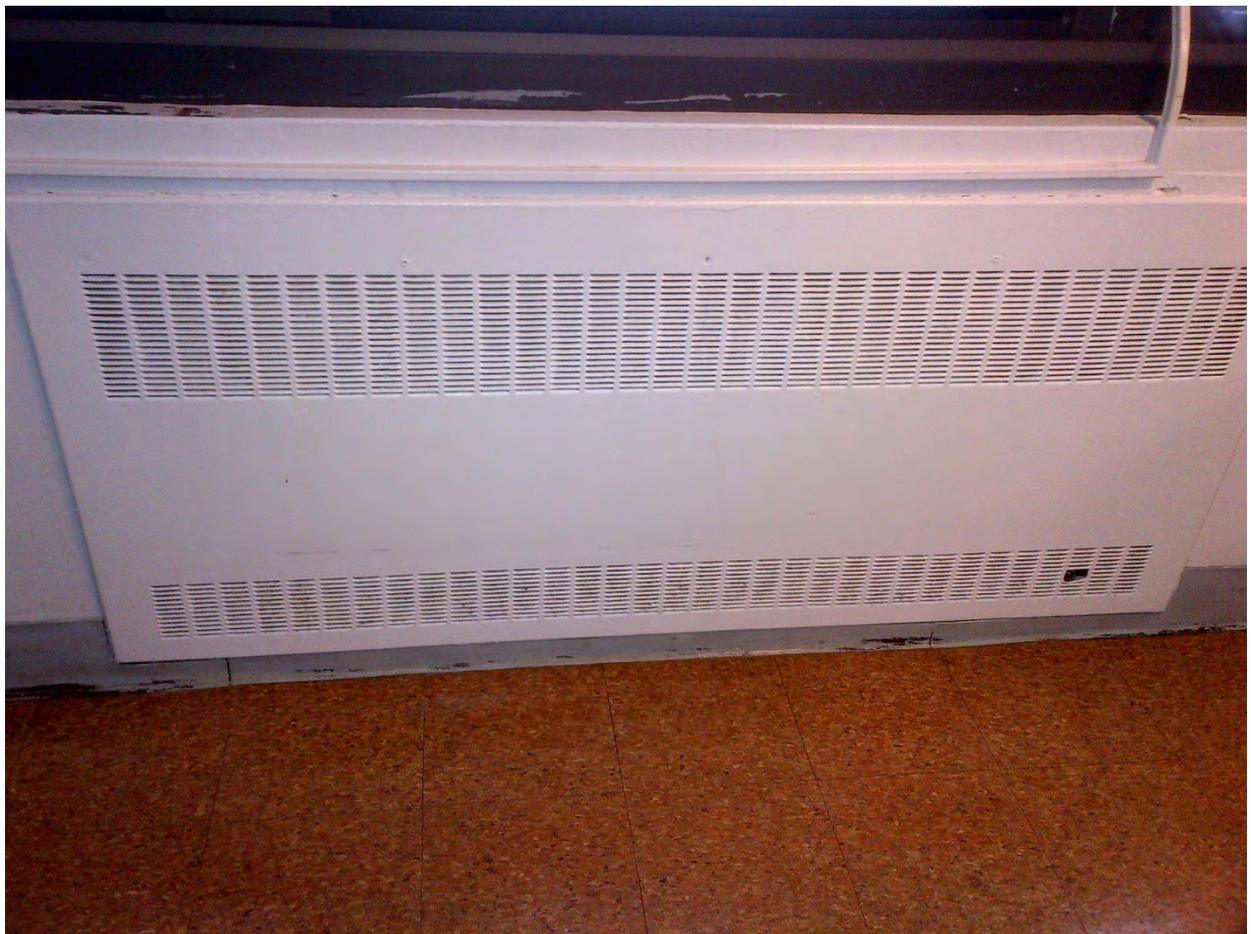
Sample No.	Description	Result	Location	Quantity
1	Debris above ceiling	ND		
2	Ceiling Tile	ND		
3	Wall Board –above ceiling	ND		
4	Floor tile – orange <b>Mastic – black</b>	ND ACM	Rm303, Rm310A entry and locker Rm, & Rm310B	<b>396 ft<sup>2</sup> total</b> <i>(80 ft<sup>2</sup> covered in carpet Rm3030)</i>
5	Cove base –grey	ND		
6	Cove base – black	ND		
7	Pipe wrap	ND		
8	<b>Window caulking</b>	ACM	Throughout space	<b>18 LF per window</b> 18 windows
9	Glue on ceramic tile	ND		
10	Floor tile – white	ND		
11	Hard ceiling	ND		
12	<b>Wall board behind radiator</b>	ACM	Throughout space	<b>Approx. 20 ft<sup>2</sup> /radiator</b> 7 radiators
13	Debris above ceiling	ND		
14	Pipe insulation	ND		See note below on elbows
15	Joint compound – autoclaves	ND		
16	Ceiling above autoclaves	ND		
17	Wall tile glue	ND		
18	Mastic on ductwork	ND		
19	Cove base – brown	ND		
20	Debris above ceiling	ND		
NA	<b>Pipe elbows – 2” &amp; 4”</b>	Visual	Throughout ceilings	<b>87 - 2” elbows</b> <b>2 - 4” elbows</b>

NA	<b>Pipe elbows – 2”</b>	Visual	Under Autoclaves	<b>11 - 2” elbows</b>
<p>Asbestos wrapped piping connections (elbows and “T”s) were observed throughout the ceiling. This material was not sampled as visual inspection revealed that the material is classic ACM. The pipe insulation on the straight runs of pipe was sampled and confirmed to be non-ACM.</p>				
NA	<b>Red Linoleum</b>	ACM	Rm 337	<b>588 ft<sup>2</sup> total</b>

The ACM must be abated prior to any renovations being done that would disturb the materials.
