Subject: Additional Asbestos Sampling – HP Steam Line at B147 & Tunnel
Project: Install Steam Line Bypass B147 to B121
VA Project No. 552-15-210
Dayton VA Medical Center
4100 West Third Street
Dayton, Montgomery County, Ohio
Terracon Project No. N1137167

SUSPECT ACM - BULK MATERIAL SAMPLE LOG

CERTIFICATE OF ANALYSIS

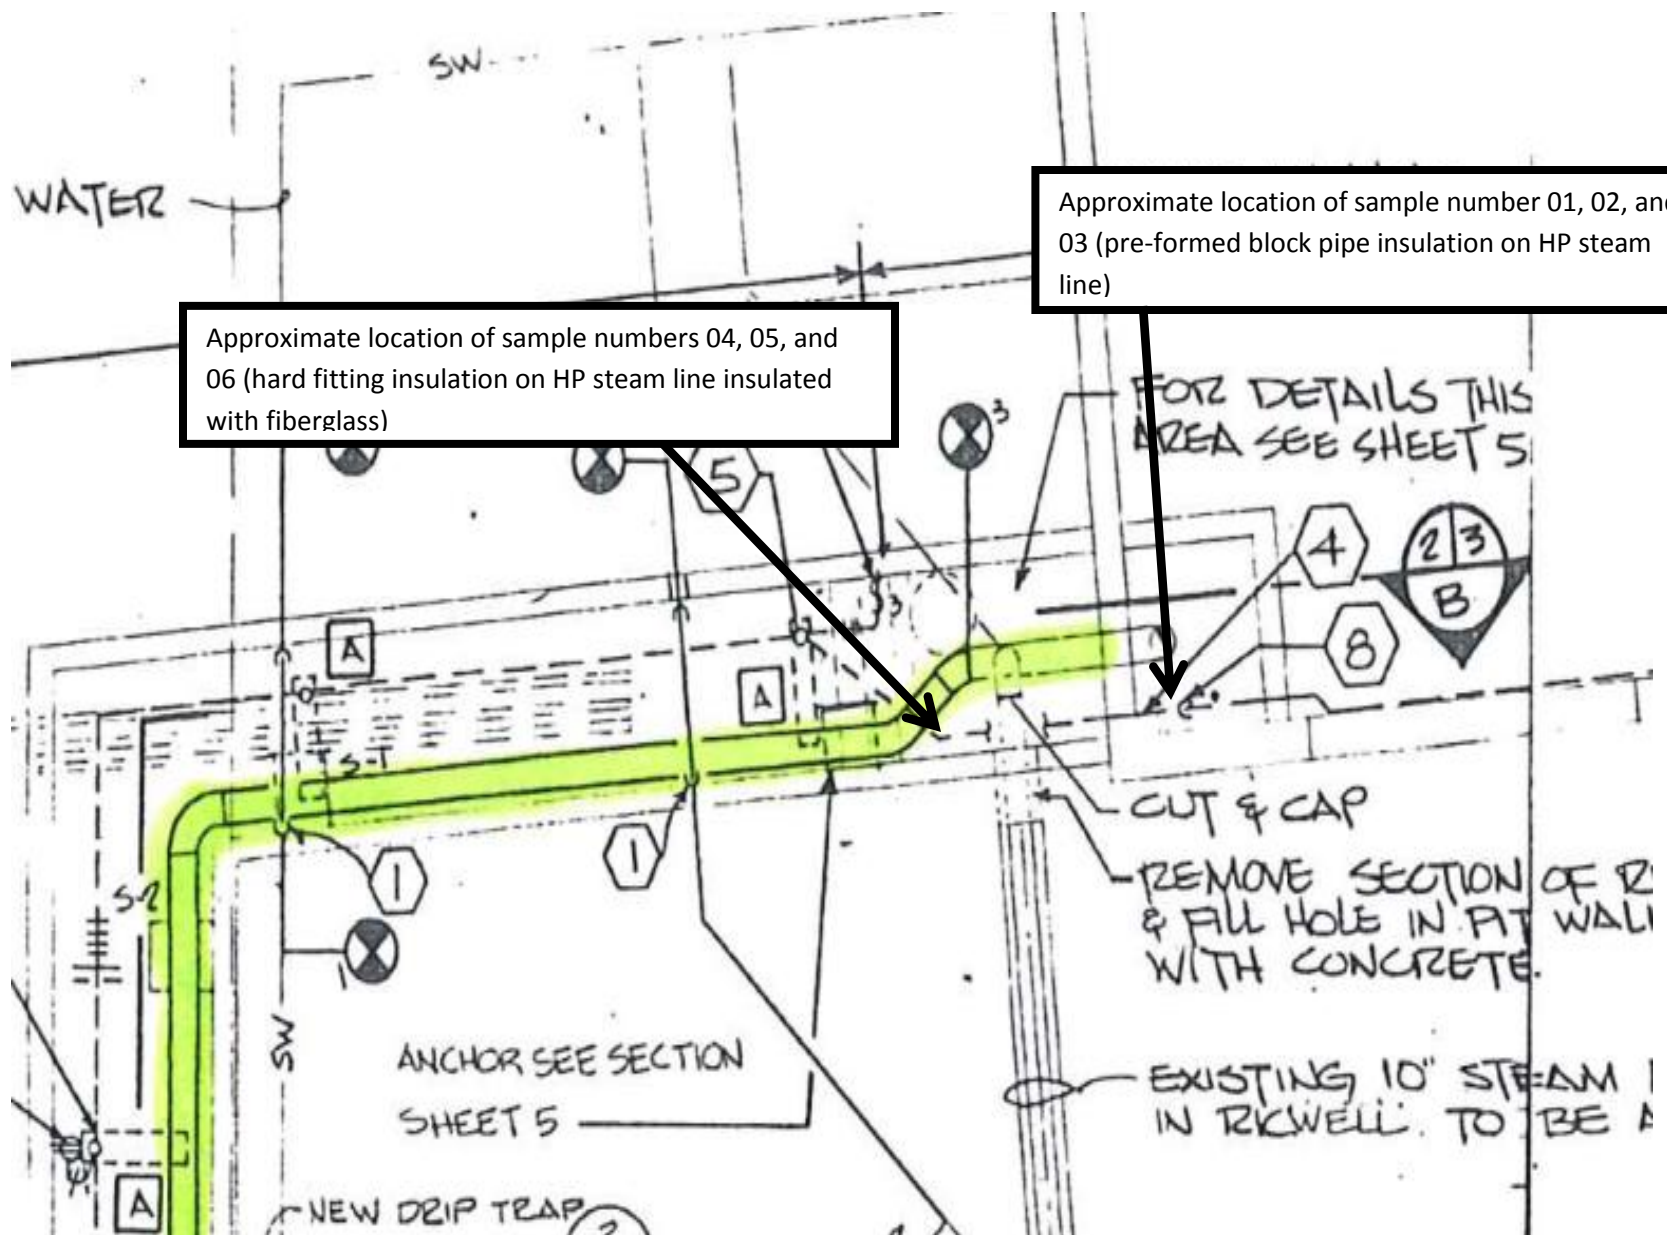
Approximate location of additional samples collected from a high pressure steam line (March 26, 2014)
