Drawing Title	
ASBESTOS LOCATION PLAN	
Approved Project Director	
-	
-	
-

Project Title		Project Number	
STRATTON VAMC 3RD FLOOR B WING AND CORE CONSOLIDATED LABS RENOVATION		528A8-10-801	
Location		Building Number	
STRATTON VA MEDICAL CENTER NY		BLDG. 1	
Date		Drawing Number	
04/04/2014		AB-01	
Checked	Drawn	Dwg. 2 of 54	
CMD	MM/LKB

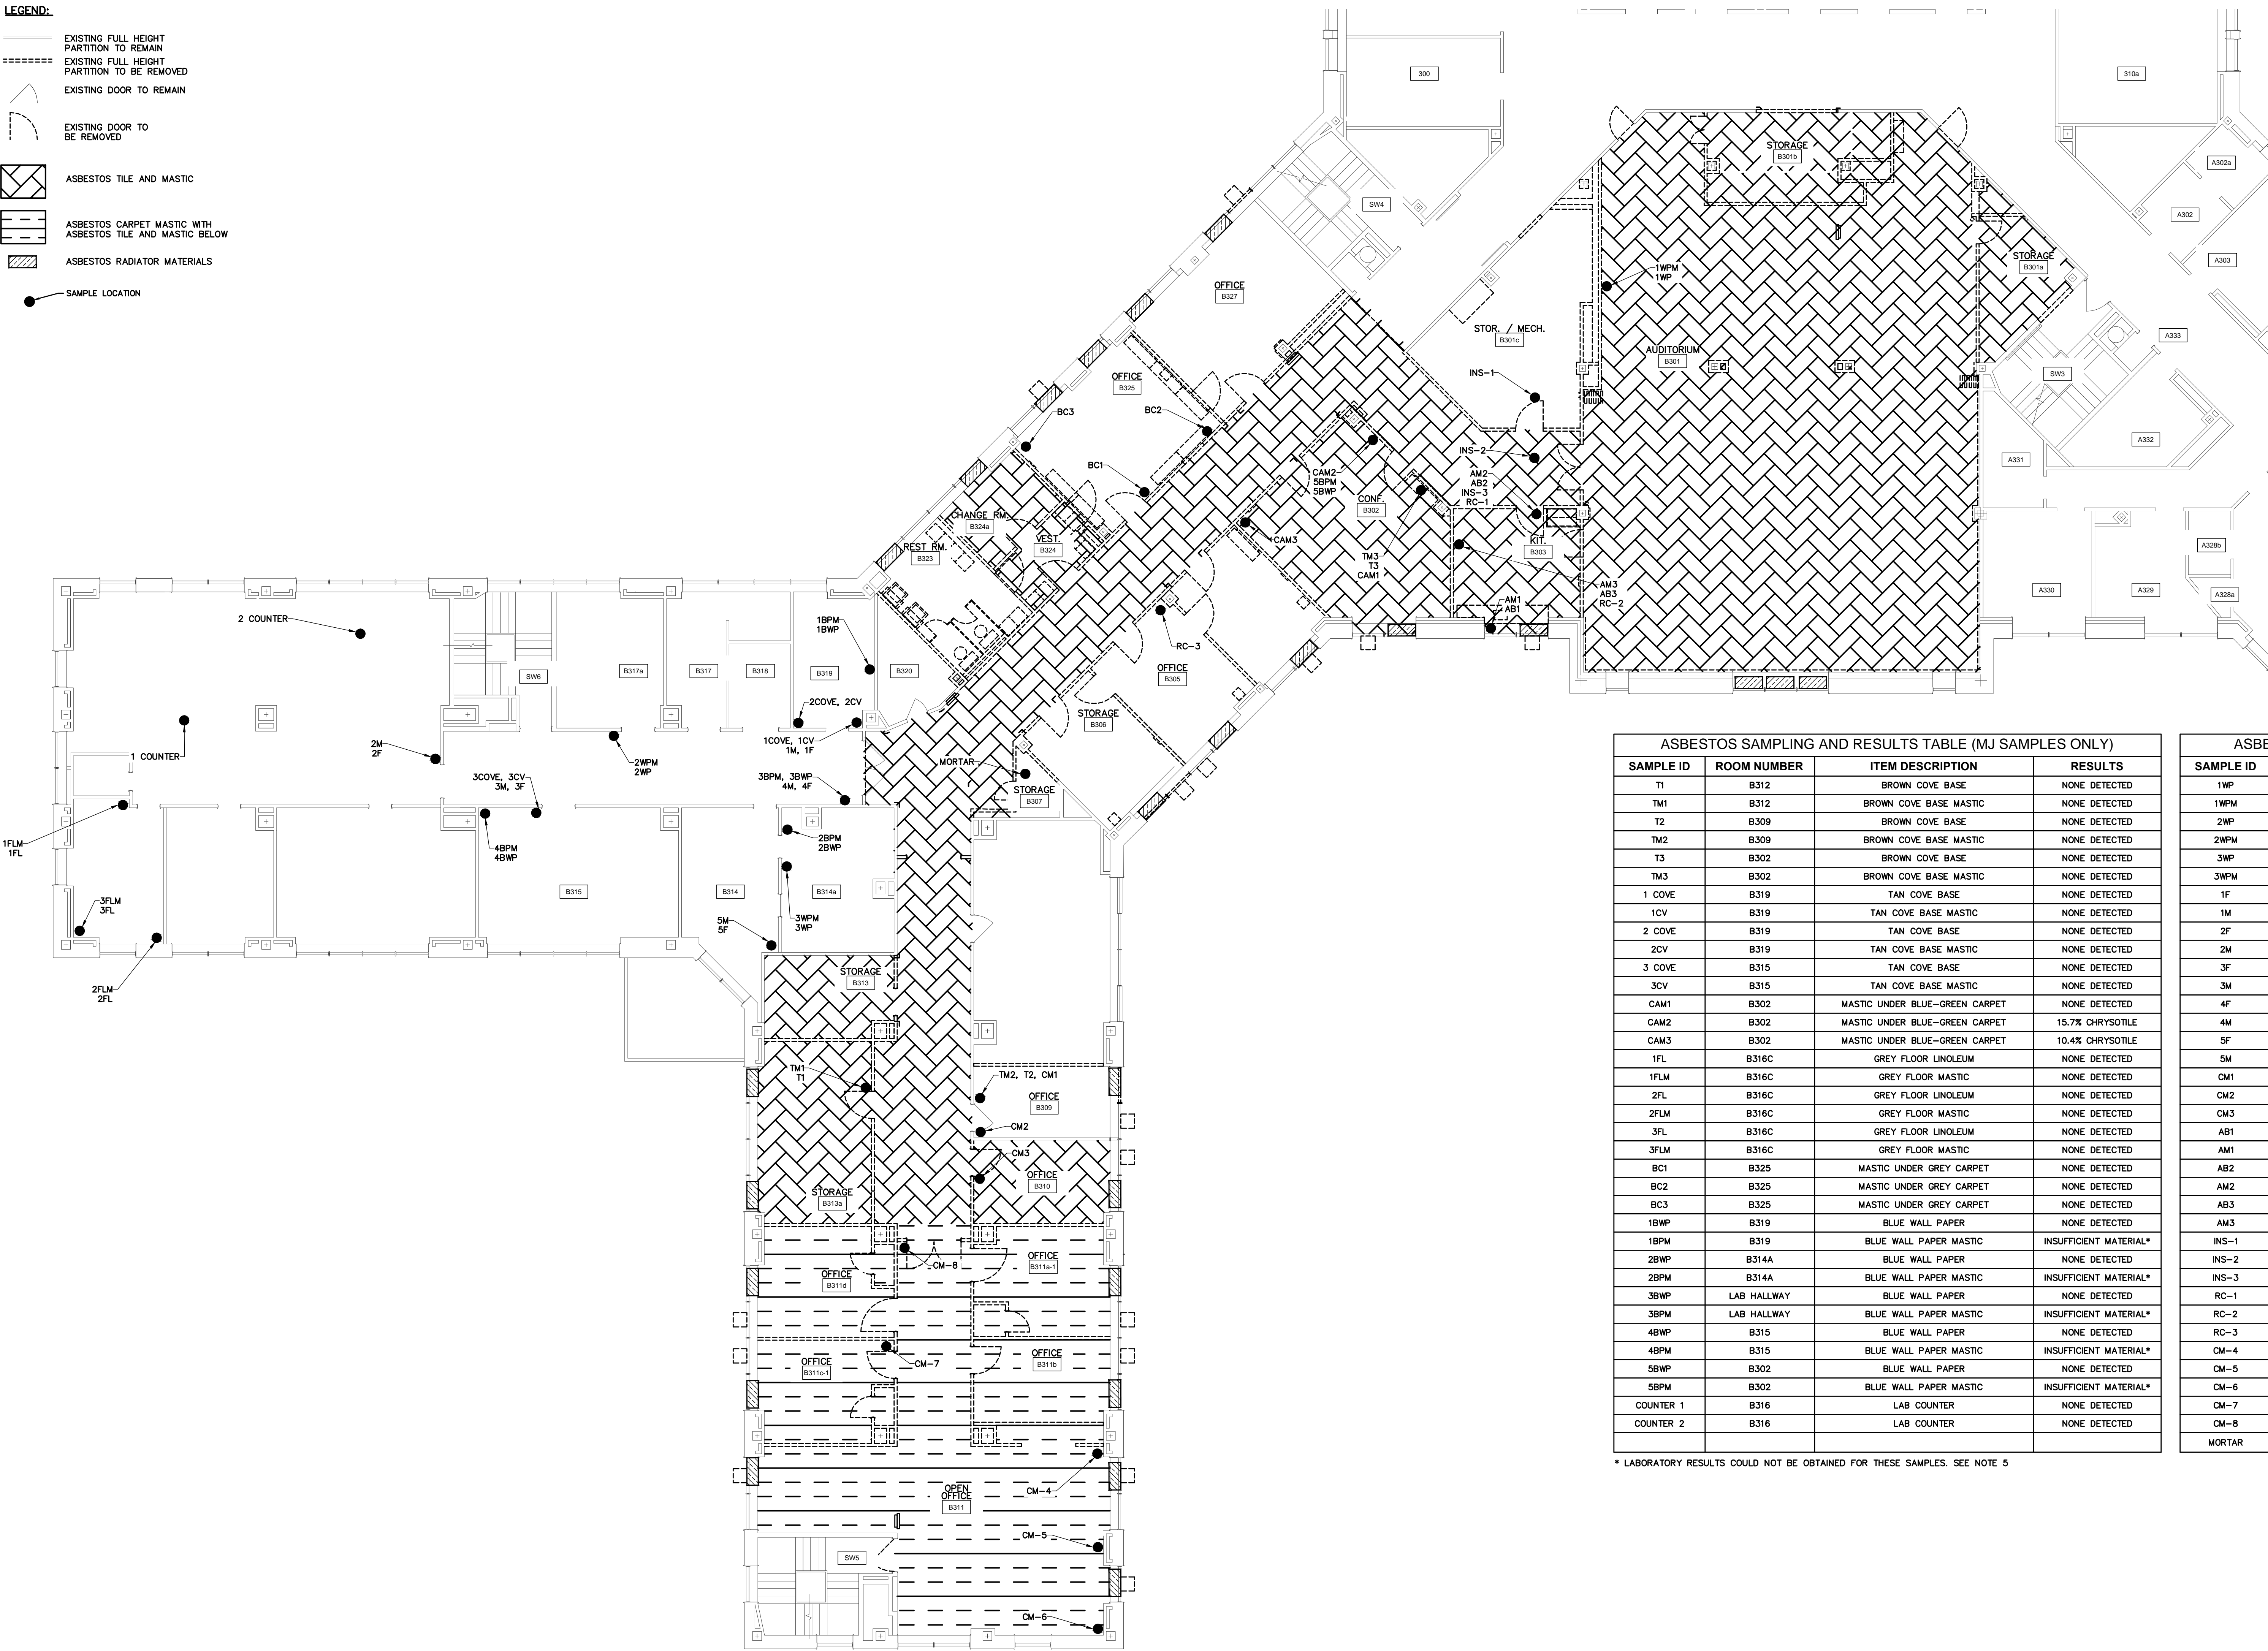
**1 ASBESTOS LOCATION PLAN**  
SCALE: 1/8" = 1'-0"

- ASBESTOS LOCATION NOTES:**
- ASBESTOS LOCATIONS ARE BASED ON ASBESTOS INSPECTIONS CONDUCTED IN OCTOBER 2010, SEPTEMBER AND OCTOBER 2012, AND MAY 2013. ASBESTOS LOCATIONS AND AREAS IDENTIFIED ON THIS PLAN ARE APPROXIMATE.

- SEVERAL SAMPLES THAT WERE SENT IN FOR TESTING WERE UNABLE TO BE PROCESSED DUE TO INSUFFICIENT MATERIAL. SEPARATION OF THE WALL PAPER AND RELATED MASTIC WAS NOT POSSIBLE, AND THE TWO MATERIALS WERE TREATED AS A UNIFORM SUBSTANCE. FLOOR TILE MASTIC FOR ROOM B303 WAS NOT RE-TESTED DUE TO THE POSITIVE RESULTS OF THE FLOOR TILES AND ADJACENT MASTIC SAMPLES, AND POSITIVE RESULTS IN THE PREVIOUS ASBESTOS REPORT. THE MASTIC UNDER THE FLOOR TILES IN ROOM B303 IS CONSIDERED TO BE ACM.

- NON-FIBERGLASS INSULATION WITHIN WALL CHASES
    - NON-FIBERGLASS INSULATION ON HEATING PIPES
    - REMOVE ACM ARCCELL PANELS LOCATED BEHIND RADIATORS DURING ASBESTOS ABATEMENT. COORDINATE WITH MECHANICAL REMOVALS.

- REMOVE NON FIBERGLASS INSULATION WITHIN WALL CHASES AND ON HEATING PIPING AS REQUIRED FOR INSTALLATION OF NEW WORK. COORDINATE WITH PLUMBING AND MECHANICAL REMOVALS AND NEW WORK. ACM ENCOUNTERED DURING CONSTRUCTION OR DEMOLITION EFFORTS, OTHER THAN THAT LISTED ABOVE, WORK SHALL BE HALTED AND REMOVAL OR REMEDIATION EFFORTS DISCUSSED WITH THE VA COR.
