**CONSOLIDATED LABS RENOVATION
ASBESTOS INSPECTION REPORT**
STRATTON VETERANS AFFAIRS MEDICAL CENTER
THIRD FLOOR, B-WING AND CORE
ALBANY, NY

June 2013

Drawing Title	
ASBESTOS LOCATION PLAN	
Approved: Project Director	
-	
-	
-

Drawing Number
AB-01

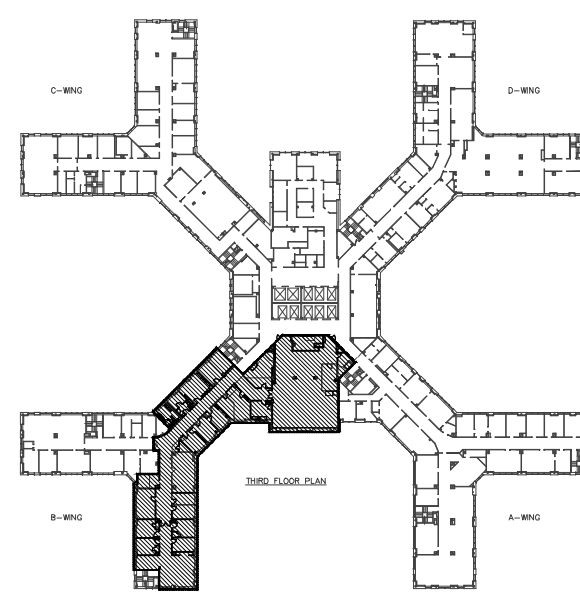
ASBESTOS SAMPLING AND RESULTS TABLE (MJ SAMPLES ONLY)			
SAMPLE ID	ROOM NUMBER	ITEM DESCRIPTION	RESULTS
1WP	AUDITORIUM	TAN WALL PAPER	NONE DETECTED
1WPM	AUDITORIUM	TAN WALL PAPER MASTIC	INSUFFICIENT MATERIAL
2WP	LAB HALLWAY	TAN WALL PAPER	NONE DETECTED
2WPM	LAB HALLWAY	TAN WALL PAPER MASTIC	INSUFFICIENT MATERIAL
3WP	B314A	TAN WALL PAPER	NONE DETECTED
3WPM	B314A	TAN WALL PAPER MASTIC	INSUFFICIENT MATERIAL
1F	B319	BLUE-GREEN FLOOR TILE	NONE DETECTED
1M	B319	MASTIC UNDER BLUE-GREEN FLOOR TILE	NONE DETECTED
2F	B316	BLUE-GREEN FLOOR TILE	NONE DETECTED
2M	B316	MASTIC UNDER BLUE-GREEN FLOOR TILE	NONE DETECTED
3F	B315	BLUE-GREEN FLOOR TILE	NONE DETECTED
3M	B315	MASTIC UNDER BLUE-GREEN FLOOR TILE	NONE DETECTED
4F	MICROBIOLOGY	BLUE-GREEN FLOOR TILE	NONE DETECTED
4M	MICROBIOLOGY	MASTIC UNDER BLUE-GREEN FLOOR TILE	NONE DETECTED
5F	B314	BLUE-GREEN FLOOR TILE	NONE DETECTED
5M	B314	MASTIC UNDER BLUE-GREEN FLOOR TILE	NONE DETECTED

CM1	B309	MASTIC UNDER CARPET	NONE DETECTED
CM2	B309	MASTIC UNDER CARPET	NONE DETECTED
CM3	B310	MASTIC UNDER CARPET	NONE DETECTED
AB1	B303	FLOOR TILE	19.5% CHRYSOTILE
AM1	B303	MASTIC UNDER FLOOR TILE	INSUFFICIENT MATERIAL
AB2	B303	FLOOR TILE	POSITIVE STOP
AM2	B303	MASTIC UNDER FLOOR TILE	INSUFFICIENT MATERIAL
AB3	B303	FLOOR TILE	POSITIVE STOP
AM3	B303	MASTIC UNDER FLOOR TILE	POSITIVE STOP
INS-1	B301 – CEILING	PIPE INSULATION	NONE DETECTED
INS-2	B301 – HALL CEILING	PIPE INSULATION	NONE DETECTED
INS-3	B303 – CEILING	PIPE INSULATION	NONE DETECTED
RC-1	B303 – CEILING	CEILING MORTAR COMPOUND	NONE DETECTED
RC-2	B303 – CEILING	CEILING MORTAR COMPOUND	NONE DETECTED
RC-3	B305 – CEILING	CEILING MORTAR COMPOUND	NONE DETECTED
CM-4	B311	CARPET MASTIC	1.3% CHRYSOTILE
CM-5	B311	CARPET MASTIC	NONE DETECTED
CM-6	B311	CARPET MASTIC	1.2% CHRYSOTILE
CM-7	B311	CARPET MASTIC	POSITIVE STOP
CM-8	B311	CARPET MASTIC	POSITIVE STOP
MORTAR	B307	TILE GROUT/MORTAR	NONE DETECTED

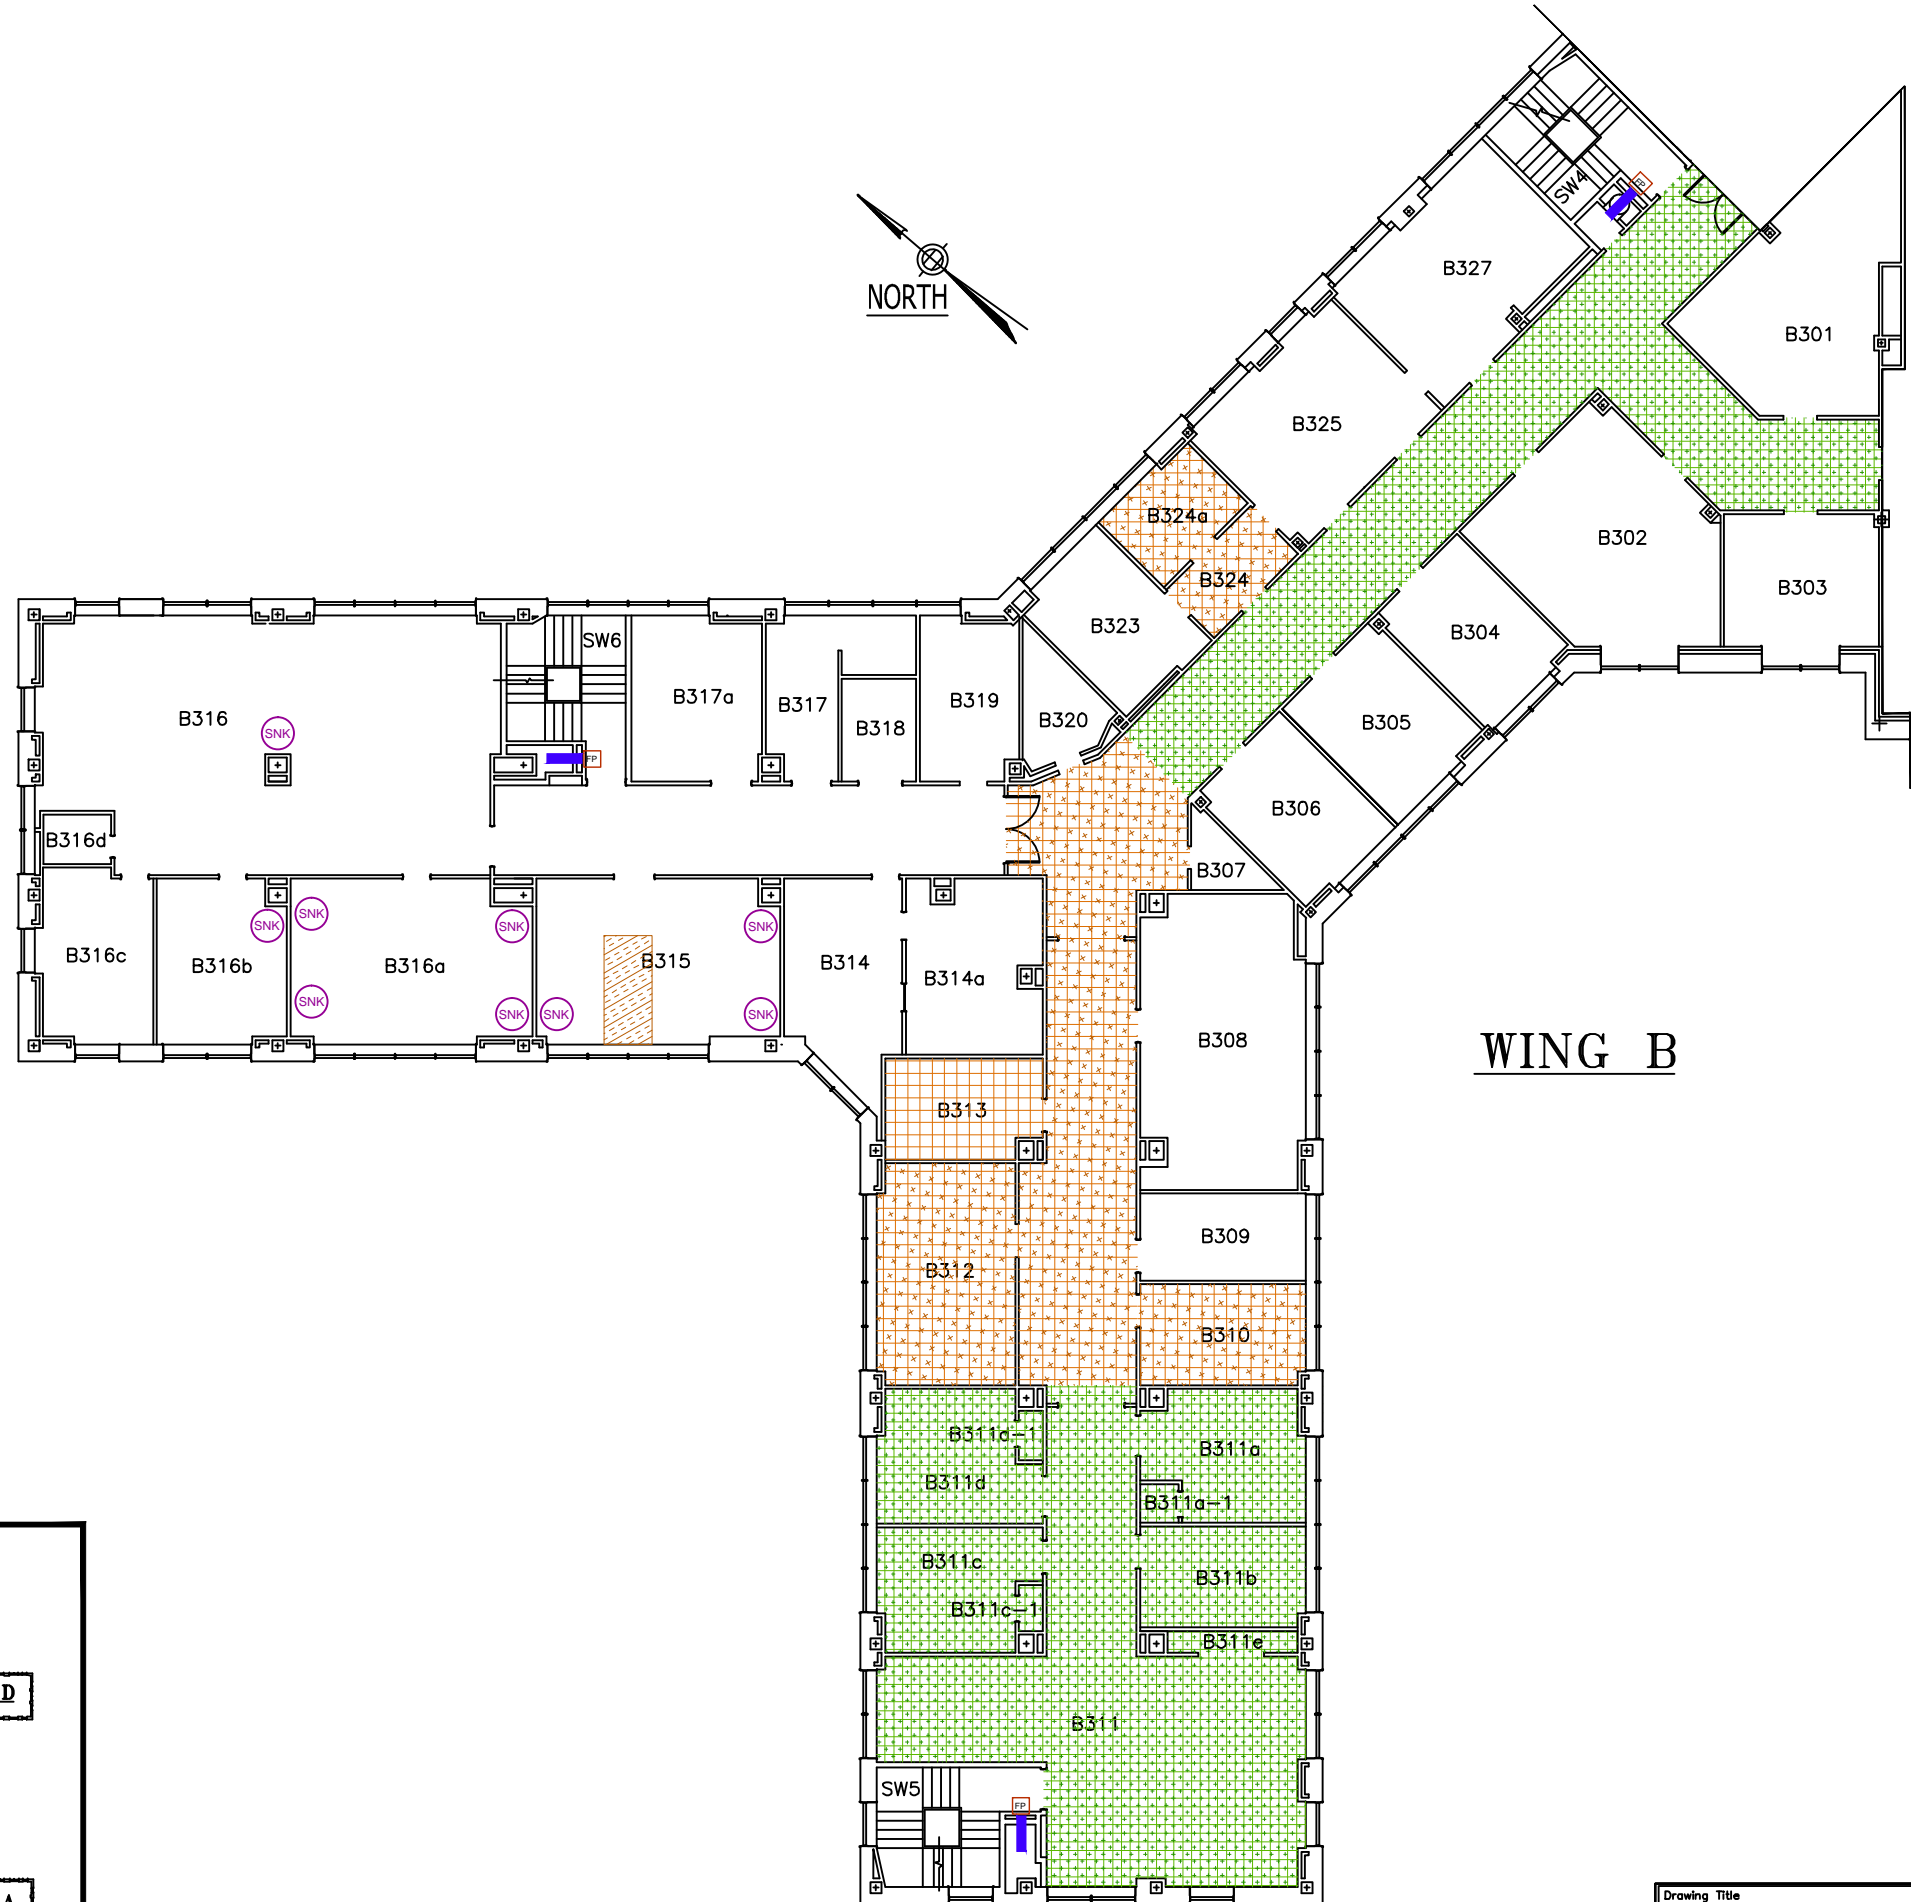
ASBESTOS SURVEY SUMMARY PLAN

- REPRESENTATIVE SAMPLES WERE COLLECTED FROM EXPOSED WALLS AND IN ACCORDANCE WITH THE SCOPE OF THIS WORK. THE BLACK DAMP PROOFING SAMPLES COLLECTED, WERE FOUND TO BE ACM. BECAUSE OF RENOVATIONS AND CHANGES DURING THE LIFE OF THE BUILDING AND THE DIFFICULTY IN DETERMINING THE HOMOGENEITY OF BLACK DAMP PROOFING, IT IS RECOMMENDED THAT ALL BLACK DAMP PROOFING BE ASSUMED ACM OR MORE EXTENSIVE SAMPLING AND ANALYSIS BE CONDUCTED PRIOR TO DISTURBANCE.

- DURING THE COURSE OF THE ACM SURVEY, AIRCELL PIPE INSULATION WAS OBSERVED BENEATH TWO STEAM RADIATORS THAT HAD BEEN OPENED FOR REPAIRS. THE PIPING WAS OBSERVED BENEATH THE FLOOR ALONG PERIMETER WALLS. IT IS RECOMMENDED THAT IT BE ASSUMED PRESENT BENEATH ALL STEAM RADIATORS OR MORE EXTENSIVE SAMPLING AND ANALYSIS BE CONDUCTED PRIOR TO DISTURBANCE.

- IF ORIGINAL FIRE-RATED DOORS ARE PRESENT, THEY SHOULD BE ASSUMED ACM OR MORE EXTENSIVE SAMPLING AND ANALYSIS BE CONDUCTED PRIOR TO DISTURBANCE.
 - DURING THE COURSE OF THE ACM SURVEY, UNREMIEDIATED ACM PIPING WAS OBSERVED IN WALL PENETRATIONS THROUGHT THE SITE. THE PRESENCE OF UNREMIEDIATED ACM PIPING SHOULD BE ASSUMED IN ALL WALL PENETRATIONS OR MORE EXTENSIVE SAMPLING AND ANALYSIS BE CONDUCTED PRIOR TO DISTURBANCE.

HATCHED AREAS INDICATE POSITIVE DETECTION OR PRESUMED PRESENCE OF ASBESTOS CONTAINING BUILDING COMPONENTS
