**Veterans Administration
2121 N. Avenue
Grand Junction, CO 81501
RE: Boiler House
100,000 Gallon E.W.T.
May 17, 2013
Doyle Payne,
Assistant Chief Engineering Service
(970) 242-0731 ext. 2099
Job No. 313195**

Veterans Administration
RE: Boiler House
100,000 Gallon E.W.T.

ELEVATED TANK INSPECTION REPORT

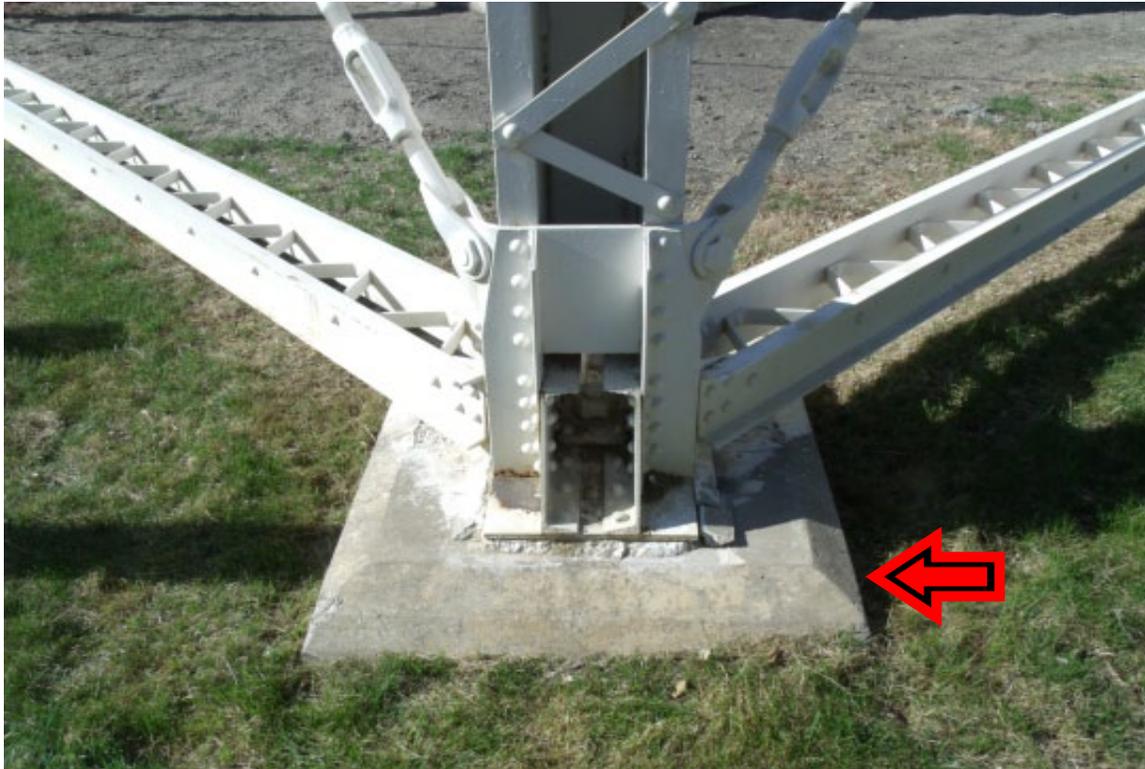
Photo shows the condition of the foundations. We recommend removing all dirt, debris and loose gravel from the foundation, repairing any cracks and spalling in the concrete with a commercial non-shrinking grout and sealing the foundation with a sealant.

We also recommend the tank be electrically grounded for lightning protection as required by [OSH Act 29 CFR 1926, Subpart K](#).

2. Repair any cracks and spalling in the concrete with a commercial non-shrinking grout and seal the foundations with a sealant

Electrically ground the tank for lightning protection
3. Clean the area around the anchor bolts, then weld around the circumference of the bolt-to-nut and nut-to-base plate connections to reinforce

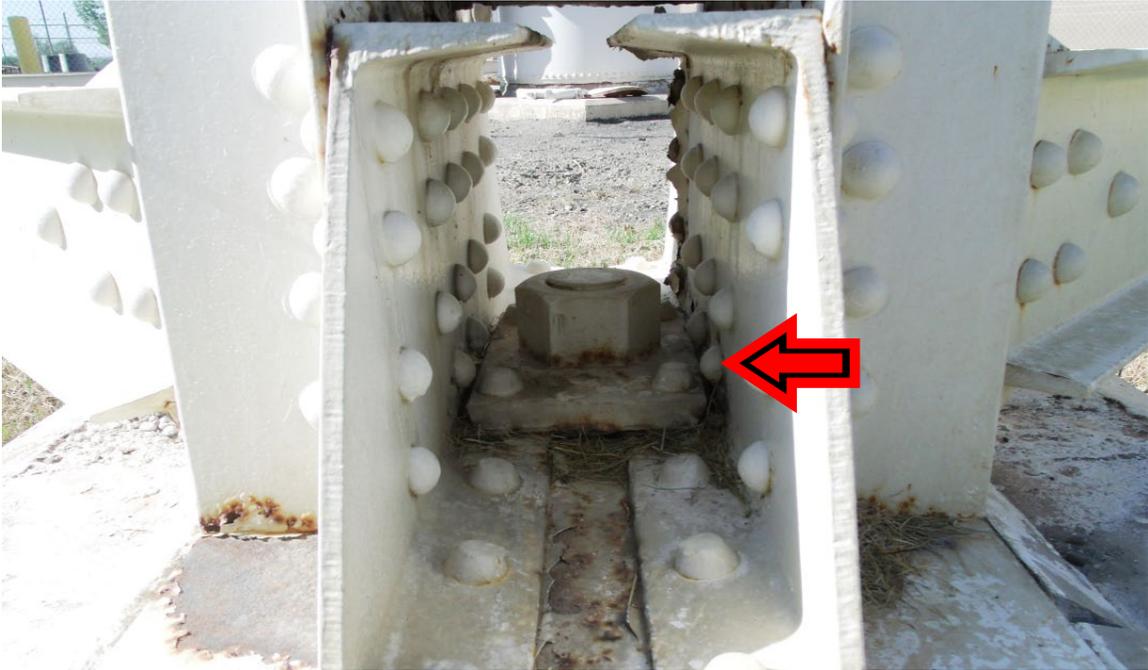
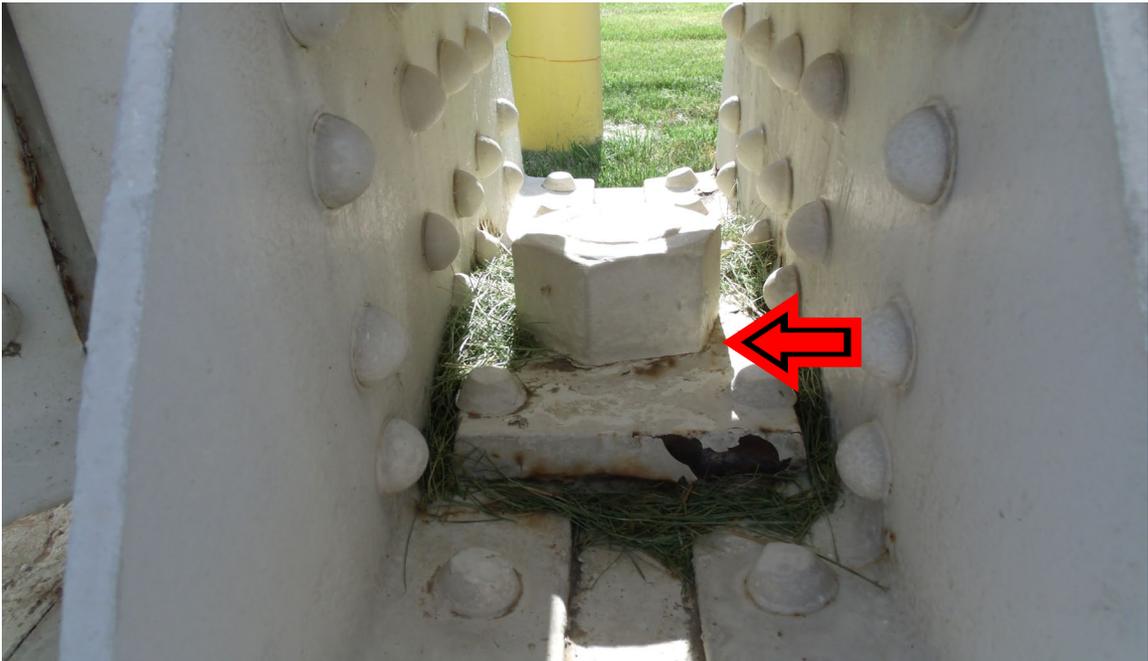
Photos show the condition of the anchor bolts. The structural integrity of the anchor bolts should be maintained to withstand 100 m.p.h. winds blowing from any direction as required by [AWWA D100-11; 3.8: Foundation bolts](#). We recommend cleaning the area around the anchor bolts, then welding around the circumference of the bolt-to-nut and nut-to-base plate connections to reinforce.

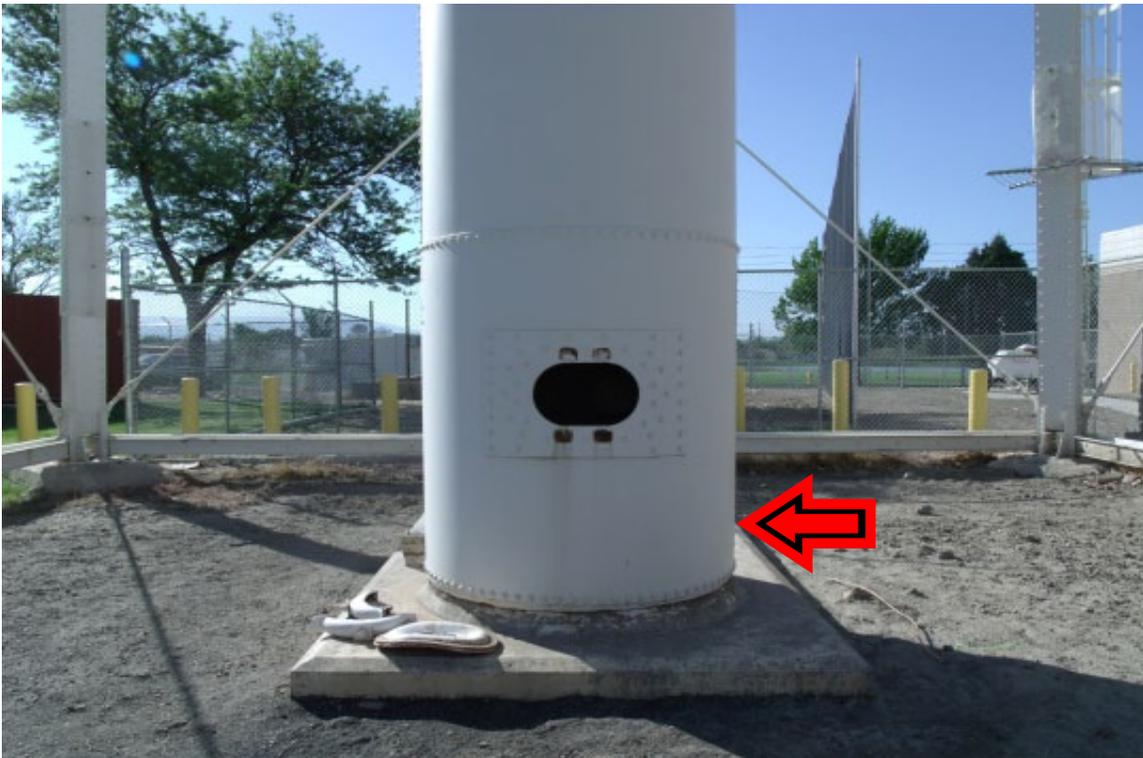
Photo shows the base of the riser pipe. Currently there is no riser drain valve. A drain valve performs two functions it allows the tank to be drained and it is used as a blowout to remove silt and scale from the lower portion of the tank. We recommend installing a frost proof drain valve, complete with locking device to prevent unauthorized draining of the tank and a splash pad to direct water away from the foundation.

4. Install a frost proof drain valve, complete with a locking device and a splash pad
5. Remove the name plate, clean the face of the plate, clean and repaint the area behind the plate, and remount it

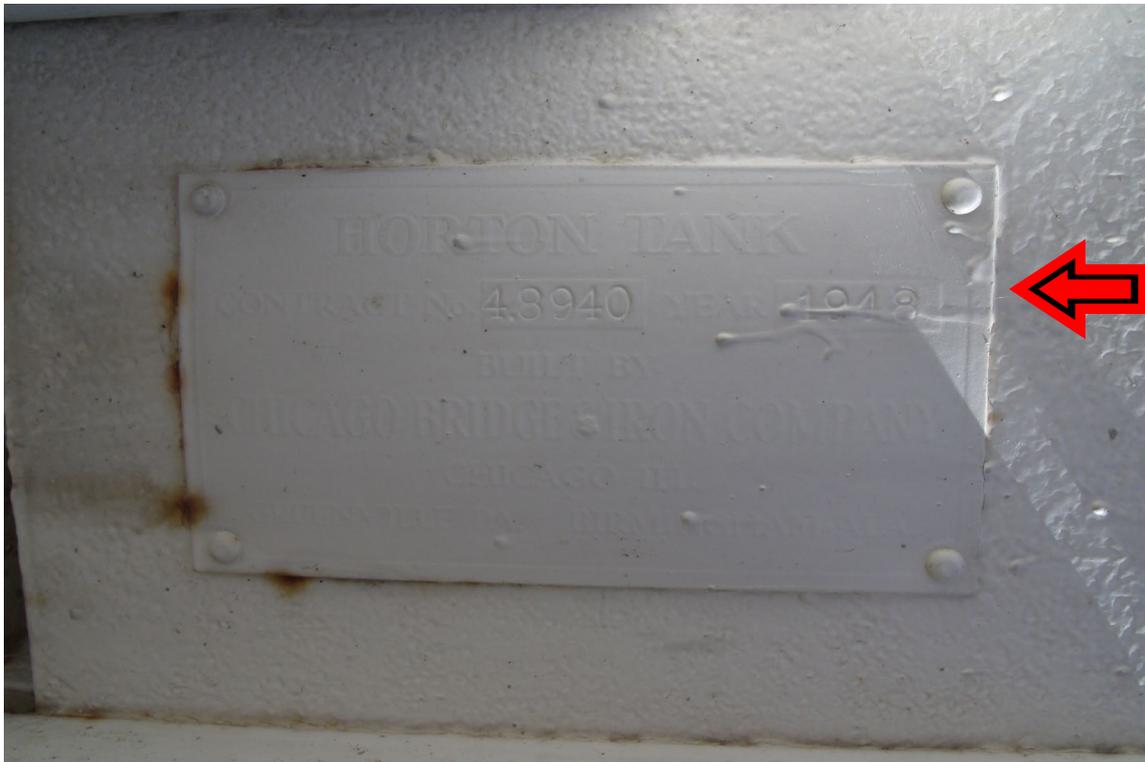
Photo shows the tank name plate. We recommend removing the name plate, cleaning the face of the plate, cleaning and repainting the area behind the plate, and remounting it.

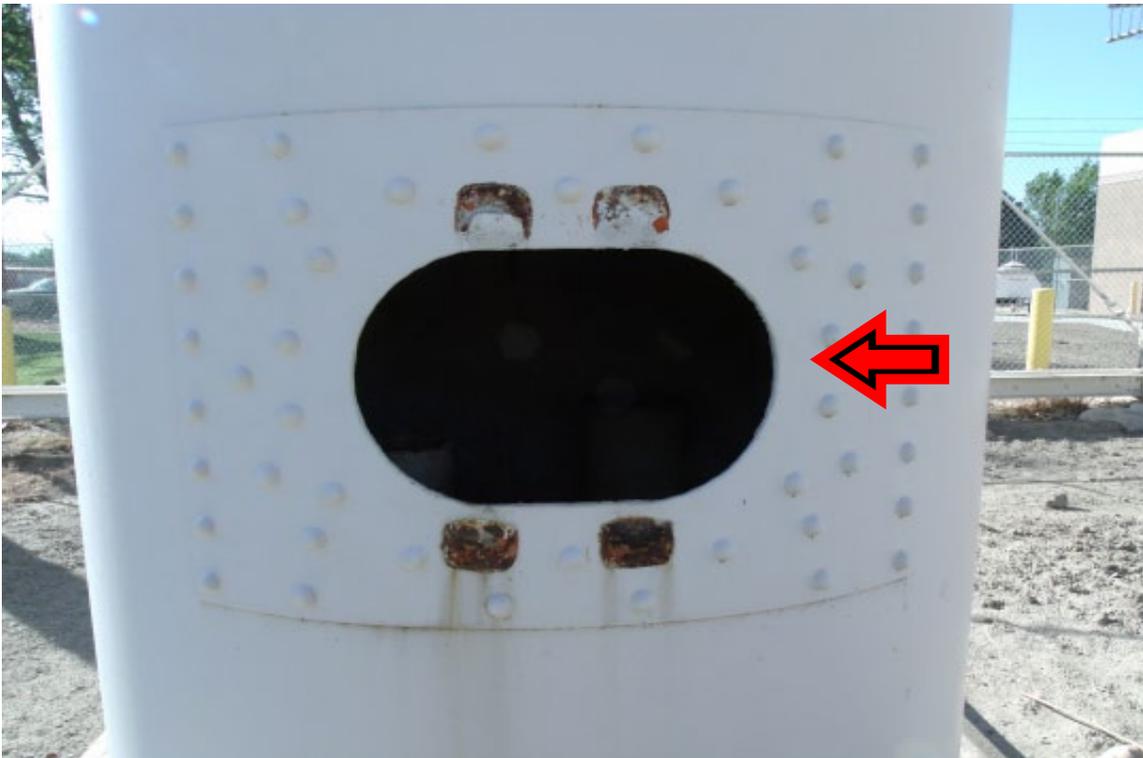
Photo shows the condition of the riser manway. This manway would restrict entry in an emergency. We recommend replacing the existing riser manway with an **AWWA D100-11: 5.4.4** approved 24" manway, complete with a davit arm, a **Confined Space Entry** sign and maintenance free galvanized steel bolts.

6. Replace the existing riser manway with an, approved 24" manway, complete with a davit arm, a **Confined Space Entry** sign and maintenance free galvanized steel bolts

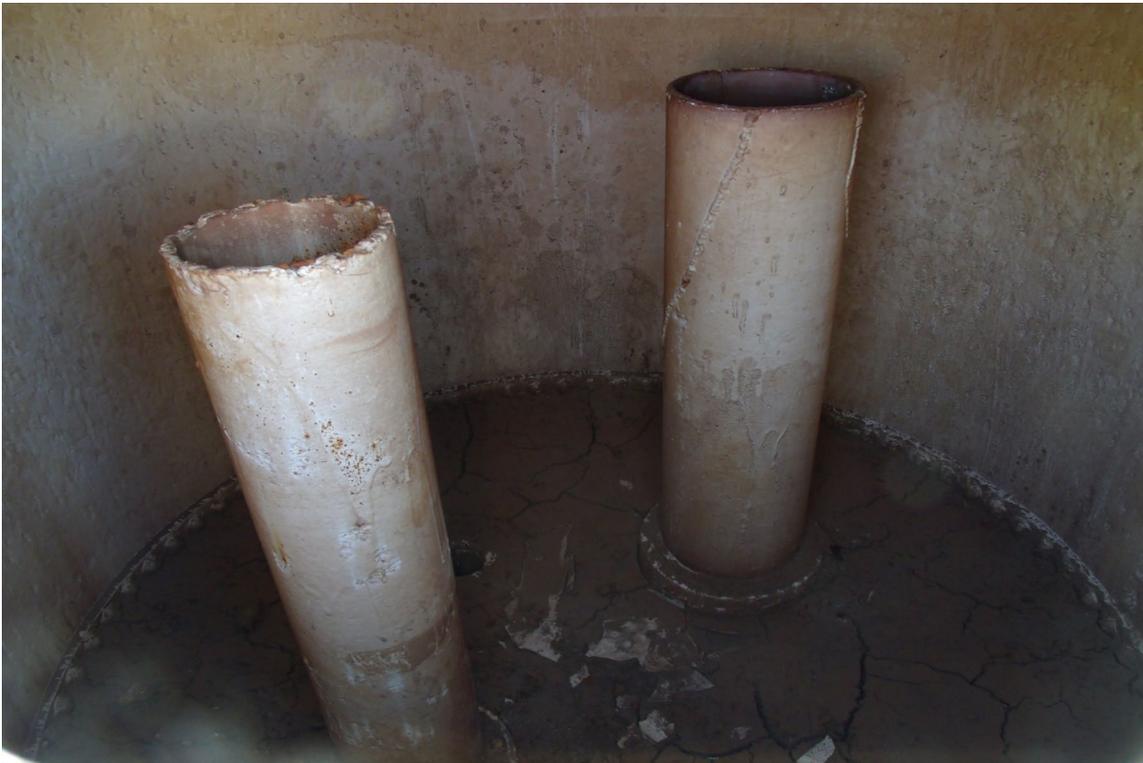
Photo shows the inlet and outlet pipes in the base of the riser pipe. We recommend installing a protective plate over the outlet pipe, supported over the pipe by three 1/2" x 1" standoffs 12" long. This will prevent silt from falling into the pipe from the tank bowl.

7. Install a protective plate over the outlet pipe located in the riser
8. Extend the overflow down the exterior to grade, complete with stand-offs every 12' on center, install an elbow, a flapper valve with a screen and a splash pad

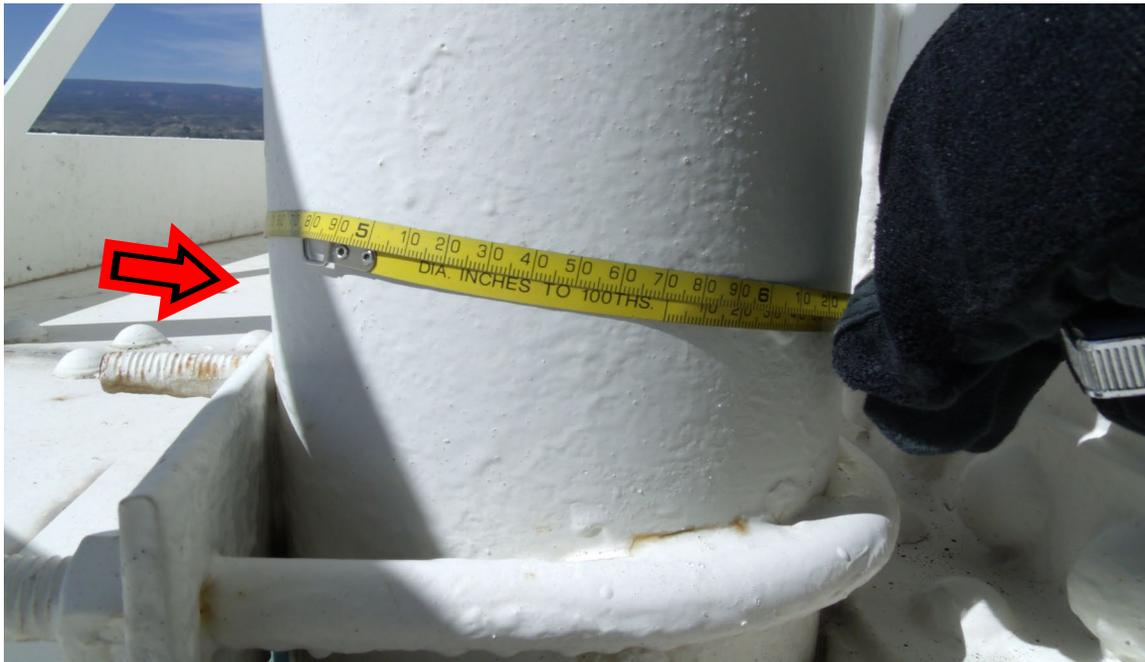
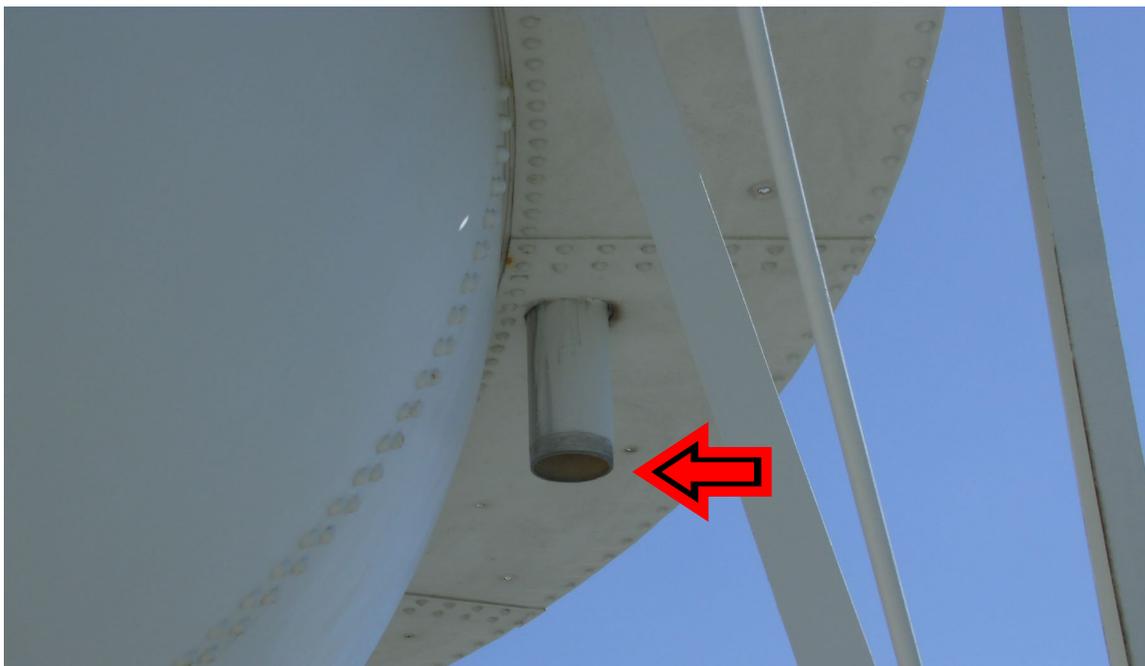
Photos show the condition of the stub overflow pipe which exits beneath the catwalk. The overflow pipe is not equipped with a flapper valve and screen. We recommend extending the overflow down the exterior to grade with 6" pipe, complete with standoffs every 12' on center, installing an elbow at the base fitted with a flapper valve and screen to prevent the ingress of contaminants into the water supply and a splash pad to direct water away from the foundations.

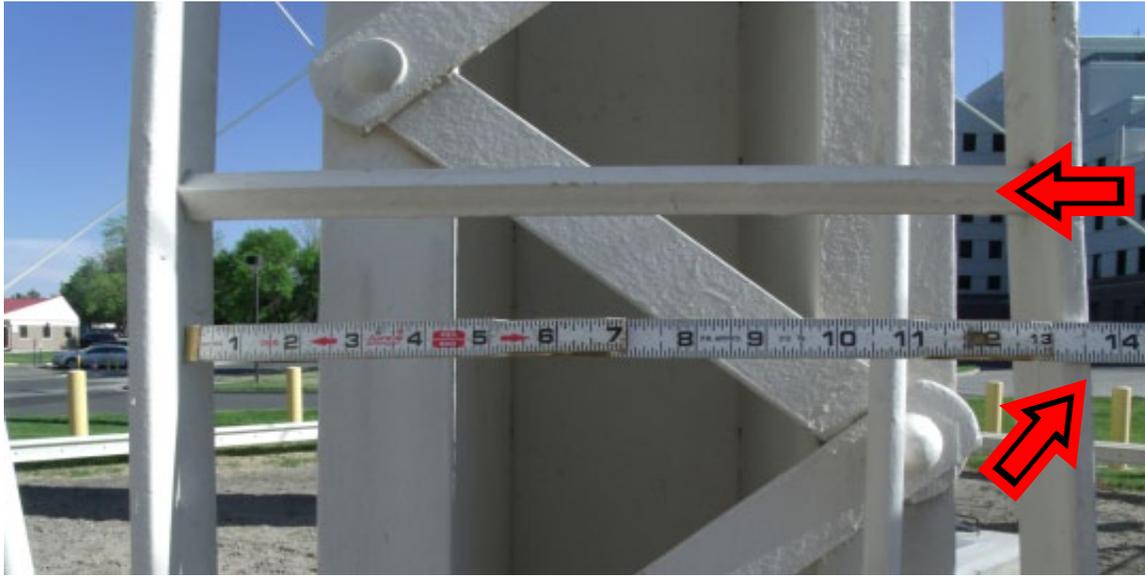
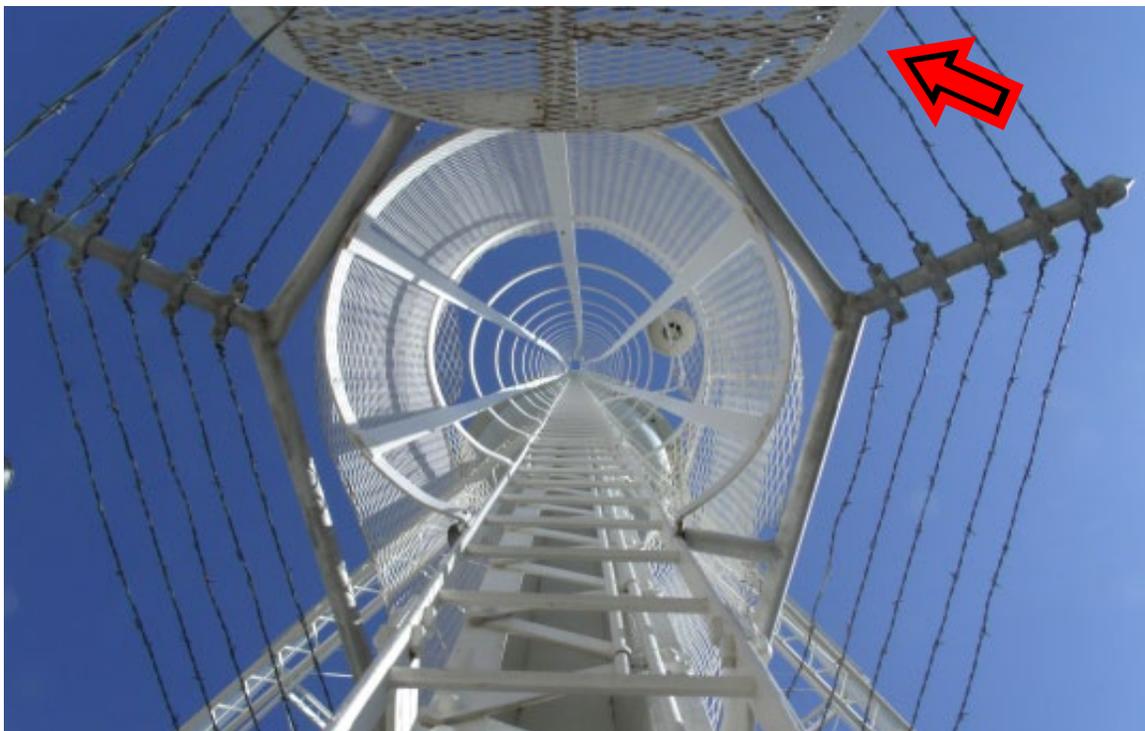
Photos show the tower access ladder is equipped with anti-skid rungs but is 13" wide. **OSHA 19.27 Ladders** states; "Minimum clear distance between the sides of individual rung/step ladders and between the side rails of other fixed ladders must be 16 inches (41 cm)." We recommend installing an approved tower access ladder complete with standoffs every 12' on center, a cable type ladder safety device, a new lockable ladder guard to prevent unauthorized access and posting a **Fall Protection Required** sign.

9. Install an approved, anti-skid rung equipped, tower access ladder complete with stand-offs every 12' on center
Install a cable type ladder safety climb device
Install an aluminum lockable ladder guard to prevent unauthorized access
Post a **Fall Protection Required** sign

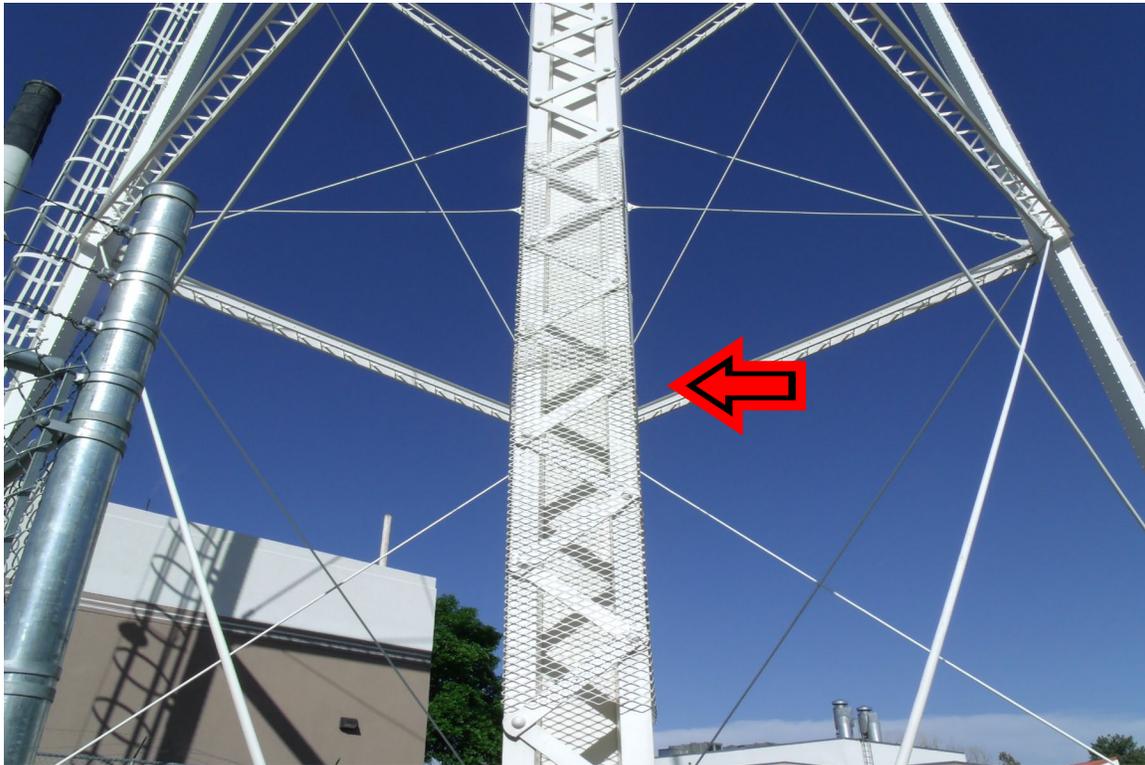
Photo shows the lattice leg climbing guards which appear to be in good condition.

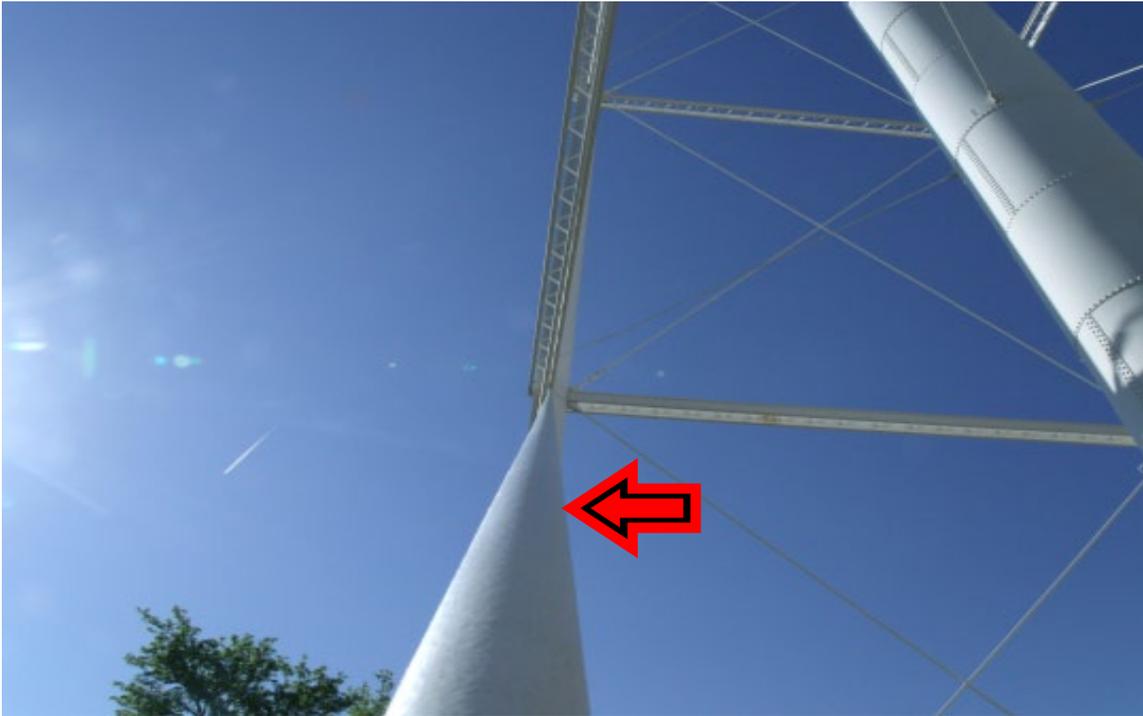
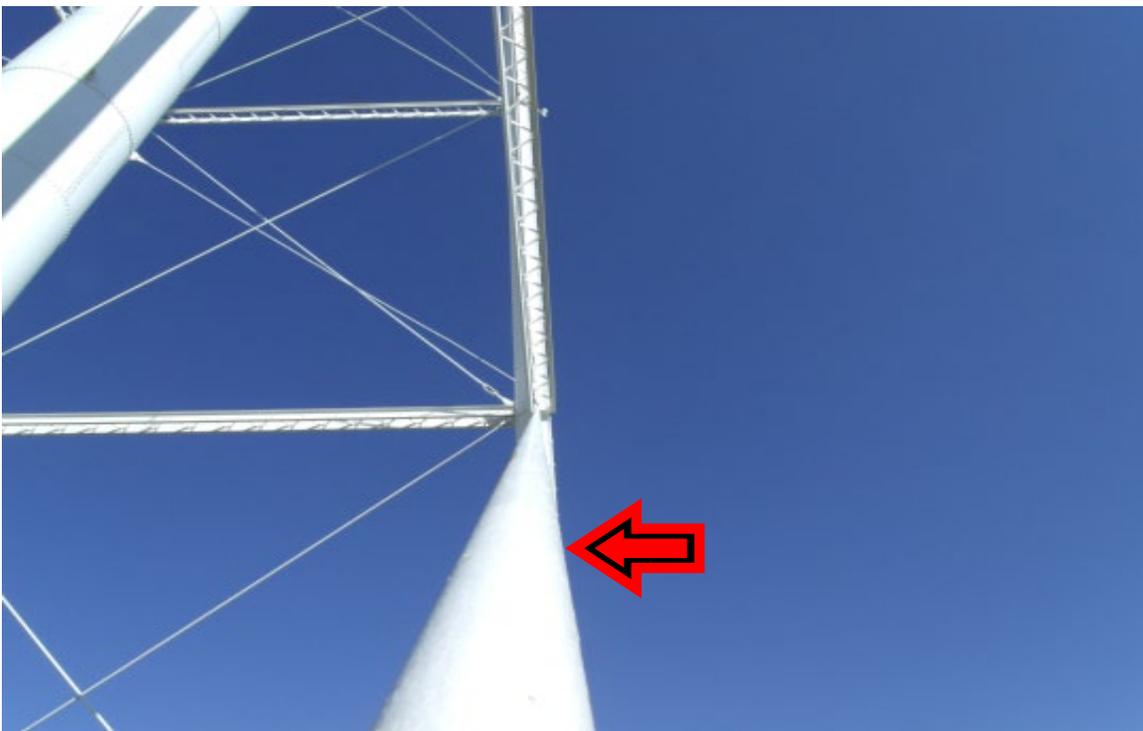
Photos show the condition of the windage rods. The windage rods are in tune and appear to be properly adjusted.

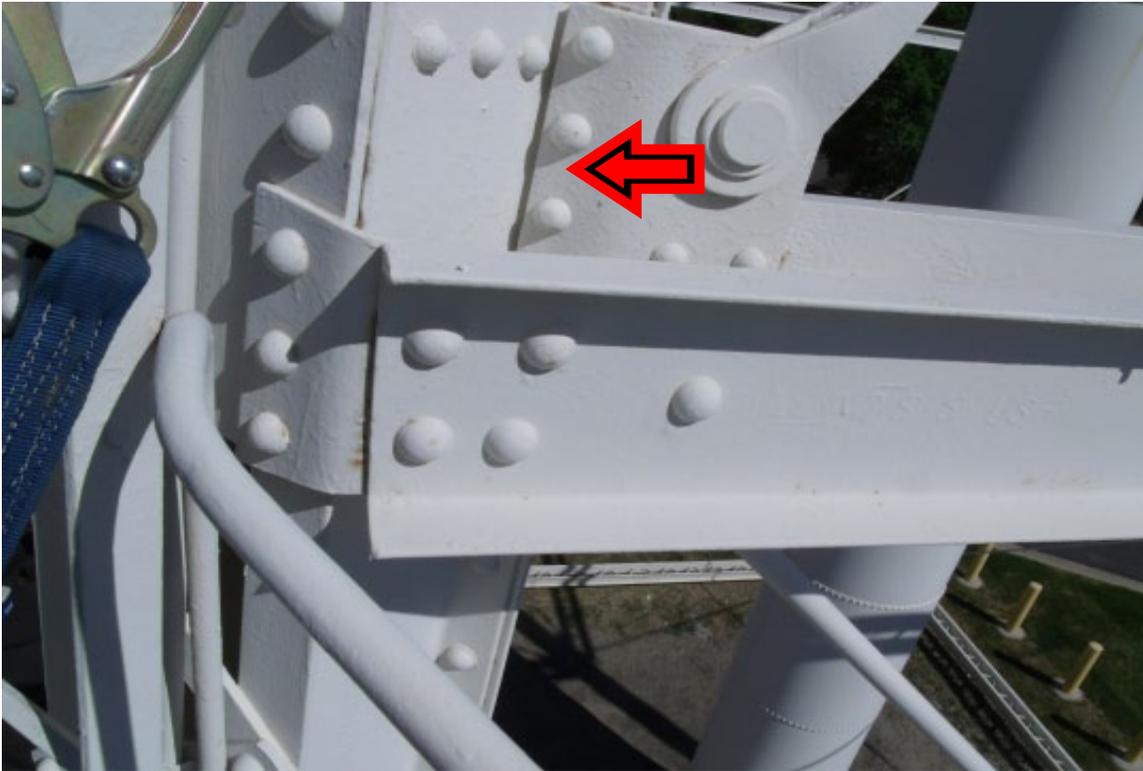
Photo shows the strut end connections, which appear to be in good condition.

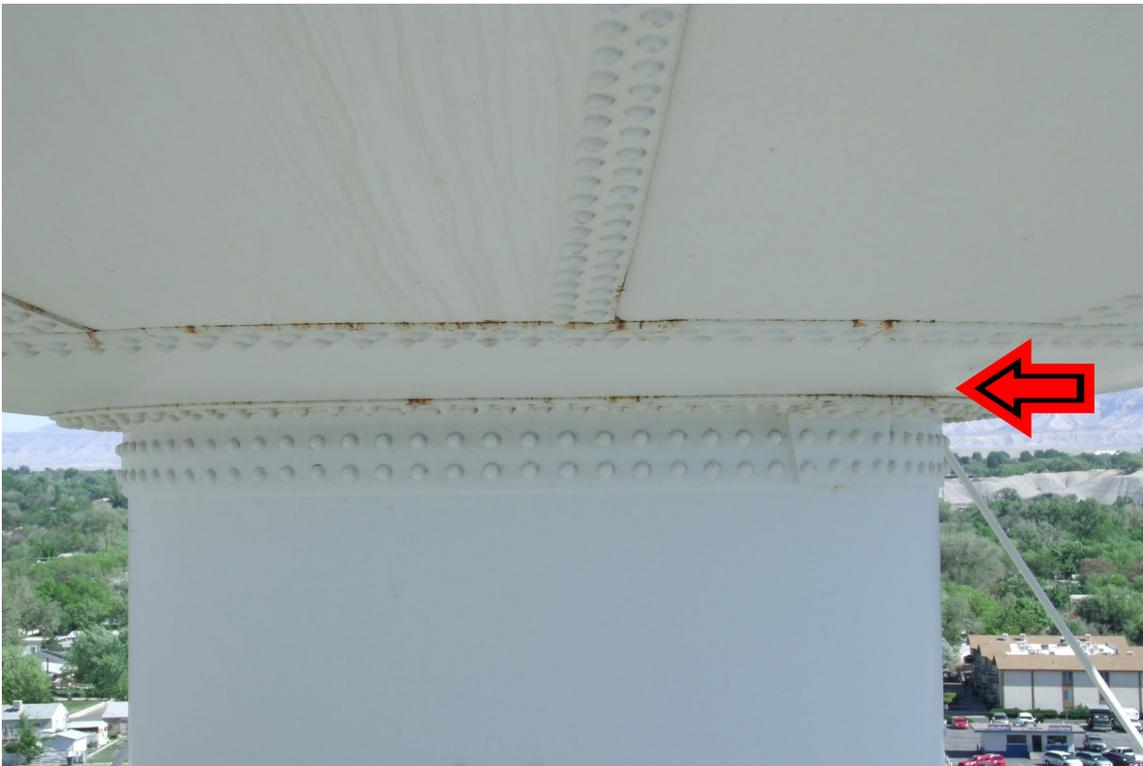
Photo shows the riser pipe and bowl connection which appears to be in good condition.

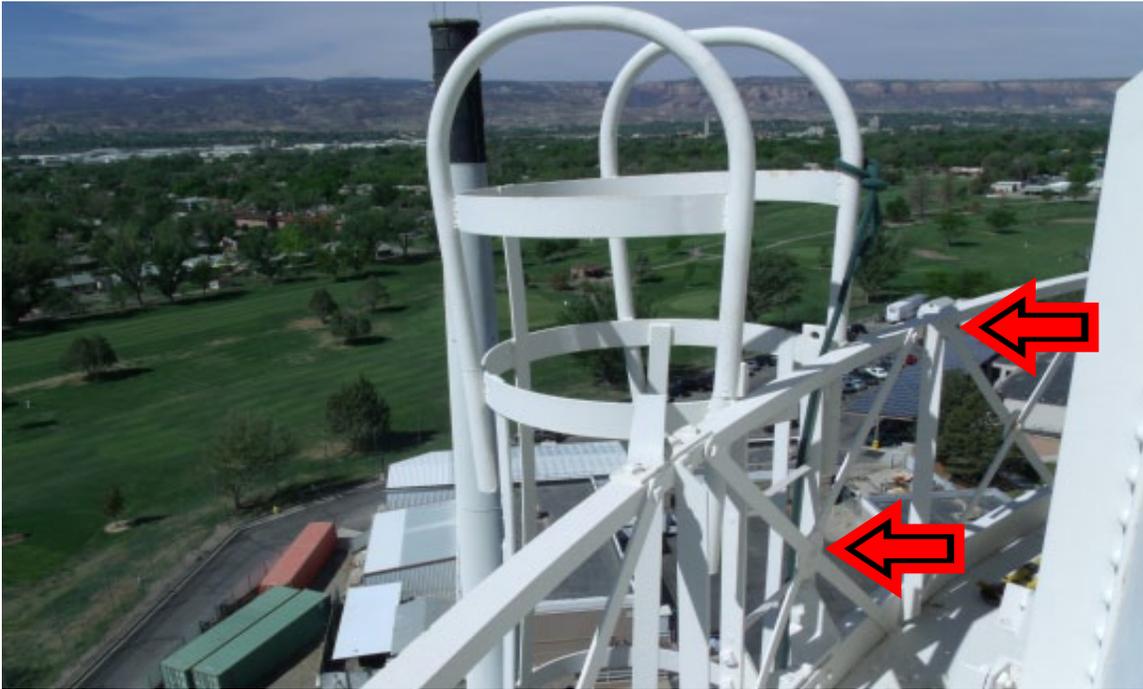
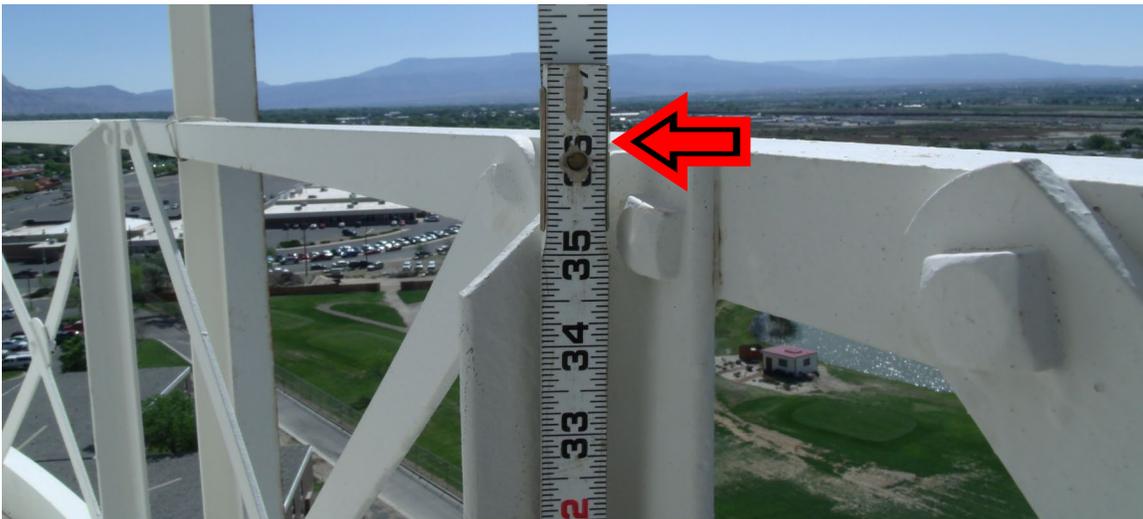
Photos show the condition of the existing handrail system. The handrail is only 36" high, not equipped with an intermediate rail and not in compliance with **OSHA 29 CFR 1910.23(e)(1)**. We recommend raising the existing handrail system to the required 42", installing an intermediate rail, cutting out a section of the handrail at the junction of the tower access ladder and structural girder, the width of the tower access ladder + 4" on each side and installing the necessary bracing to keep railing at design strength, complete with a stainless steel chain gate at the opening in the handrail at the junction of the tower access ladder and structural girder.

14. Raise the existing handrail system to the required 42", install an intermediate rail, cut out a section of the handrail at the junction of the tower access ladder and catwalk, the width of the tower access ladder + 4" on each side, and install the necessary bracing to keep railing at design strength, complete with a stainless steel chain gate

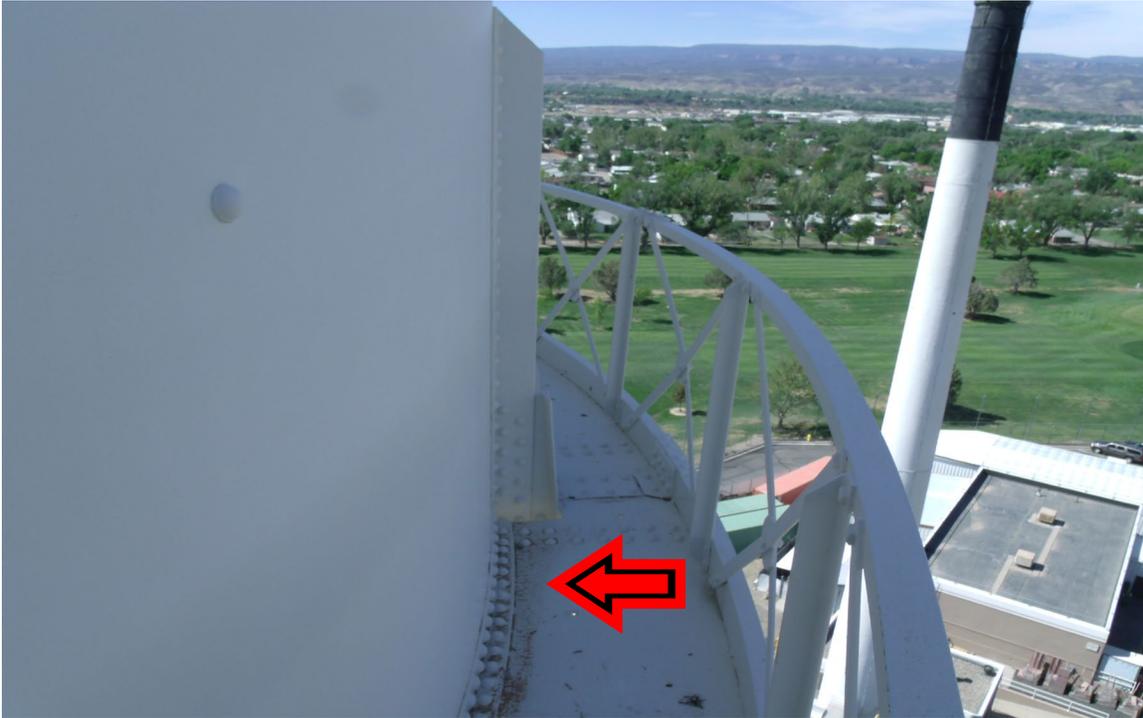
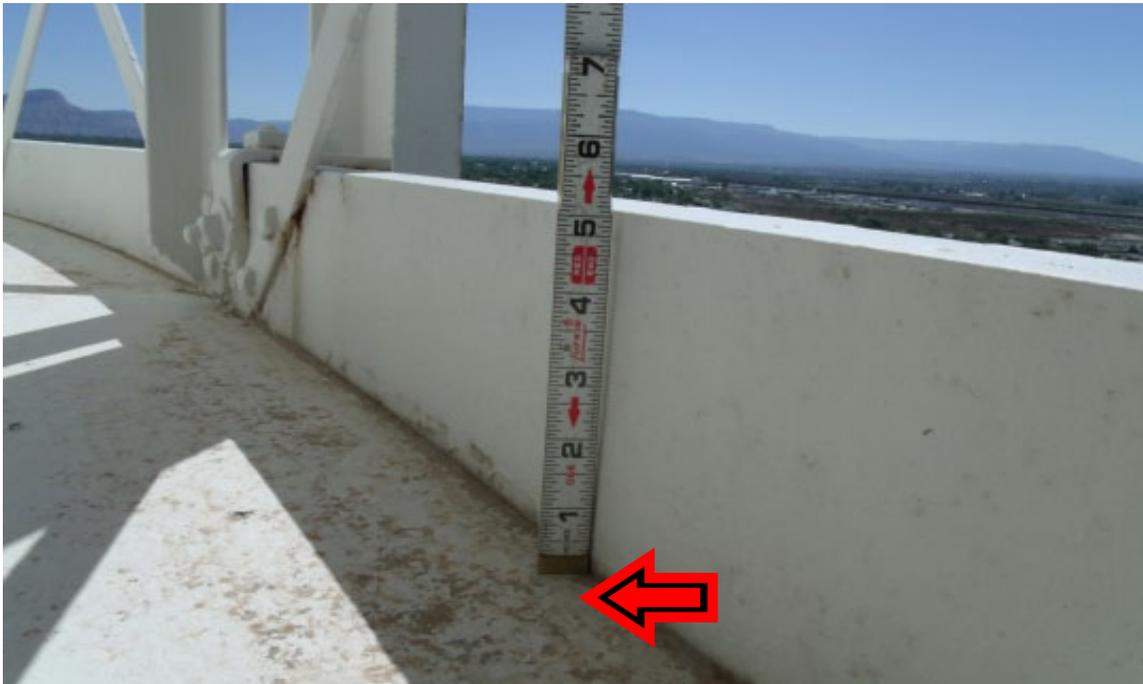
Photos show the condition of the balcony floor. The arrows are pointing to show where water is ponding, causing deterioration of the paint and steel. We recommend drilling additional weep holes in the balcony floor to prevent ponding of water.

15. Drill additional weep holes in balcony floor
16. Install a 30" shell manway
Install a 30" second shell manway 180° from primary shell manway
Post **Confined Space Entry** signs at shell manways
Install interior bowl ladders at shell manways
Install cable type ladder safety devices on interior bowl ladders

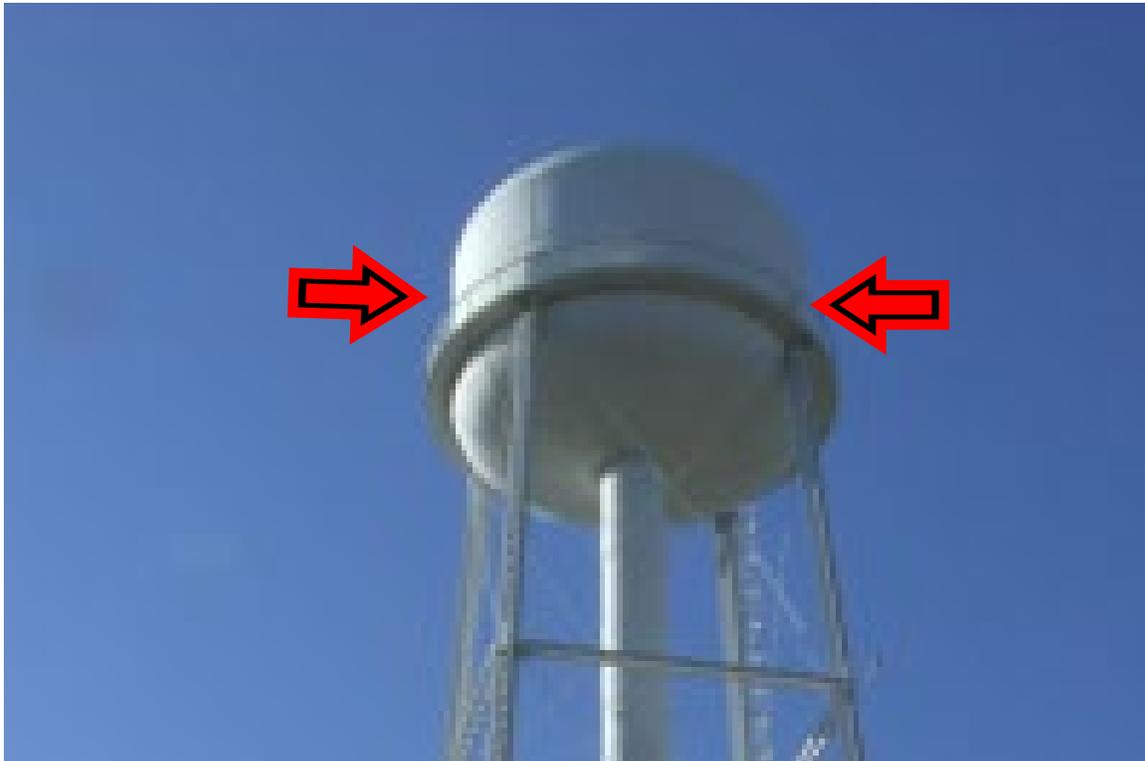
Photo shows the condition of the tank shell. Shell manways installed on this tank will be in compliance with **AWWA D100-11; 7.4.4** and **OSHA 1910.36**; General requirements.

We recommend :

- Install a 30" shell manway
- Install a 30" second shell manway 180° from primary shell manway
- Post **Confined Space Entry** signs at shell manways
- Install interior bowl ladders at shell manways
- Install cable type ladder safety devices on interior bowl ladders

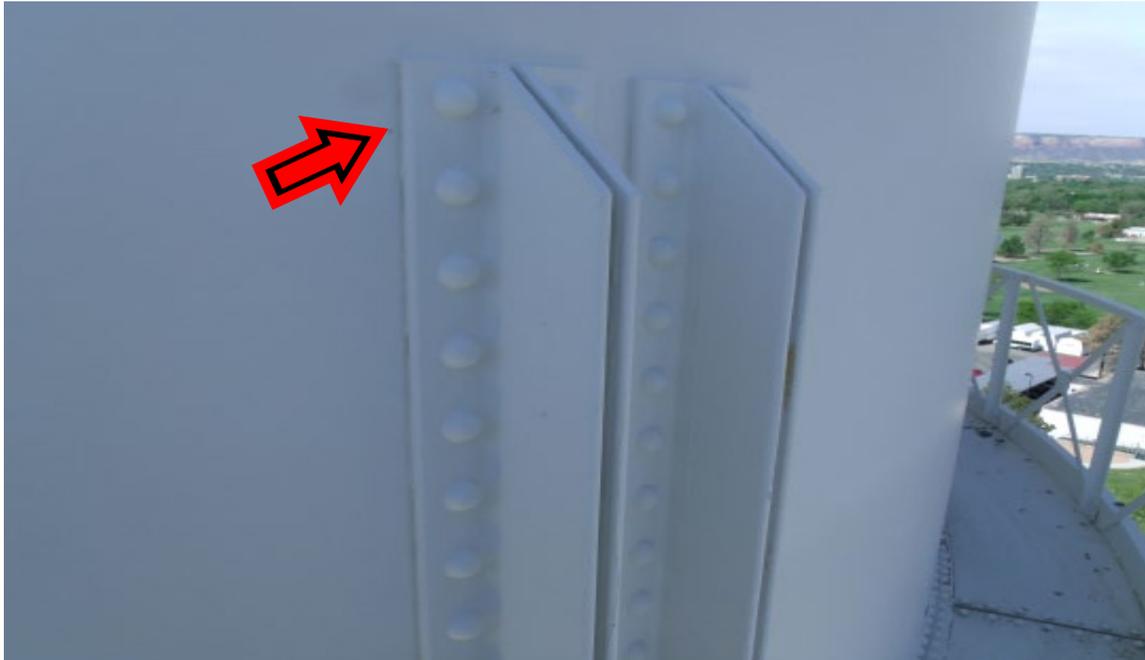
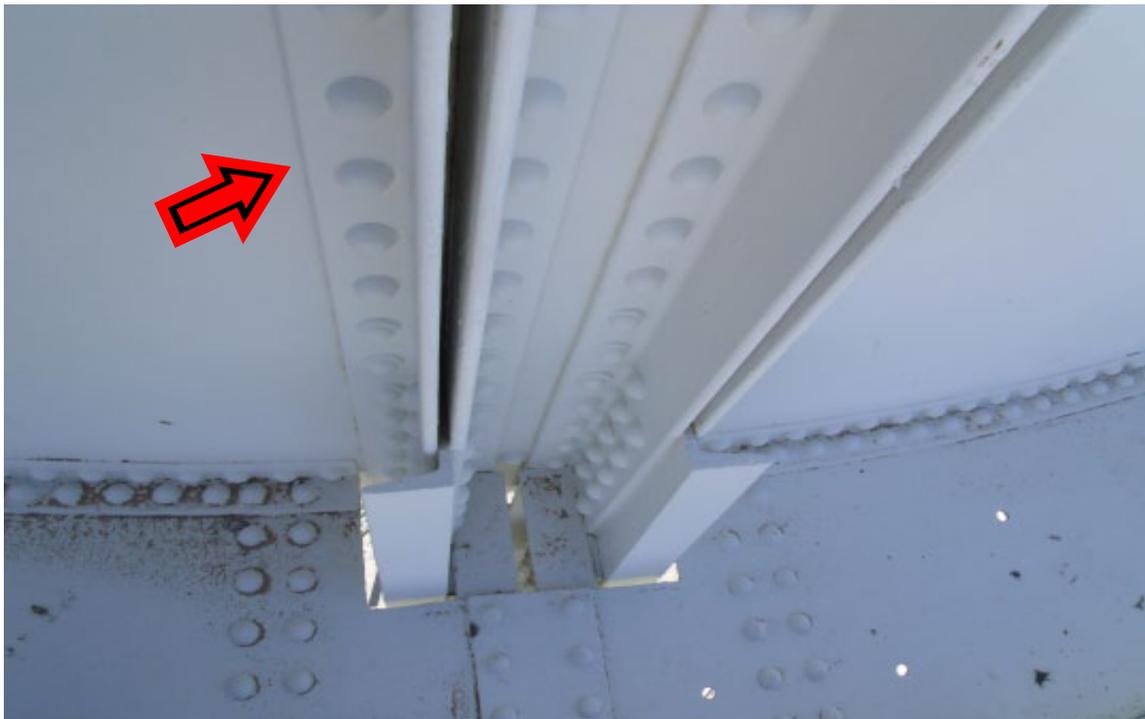
Photos show the condition of the posthead connections. The postheads secure the column legs to the tank shell and support the tank's live and dead load. We recommend welding the circumference of the posthead-to-shell connection for reinforcement.

17. Weld the circumference of the posthead-to-shell connections
18. Apply a commercial bird repellent on the tank to discourage birds from roosting in the treated area

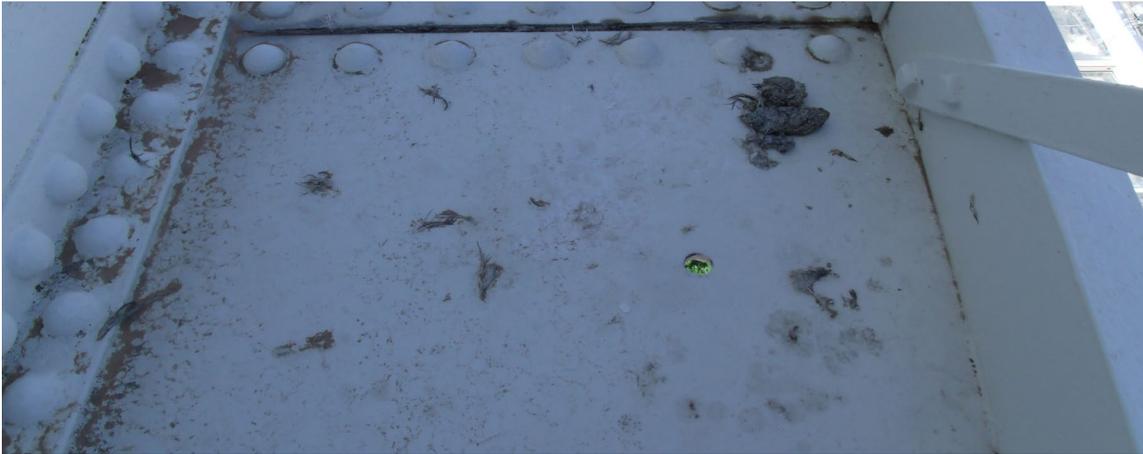
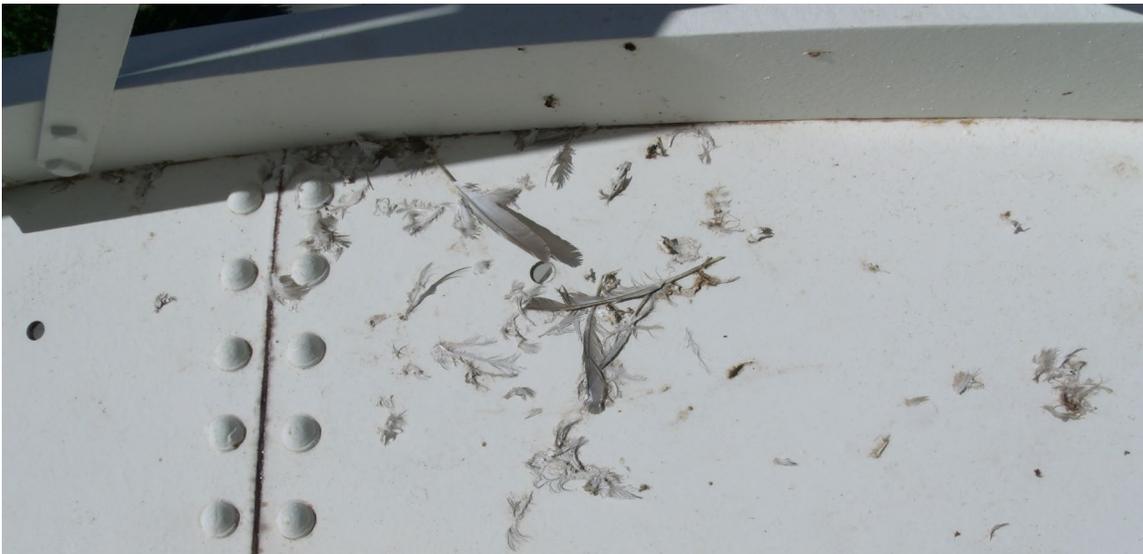
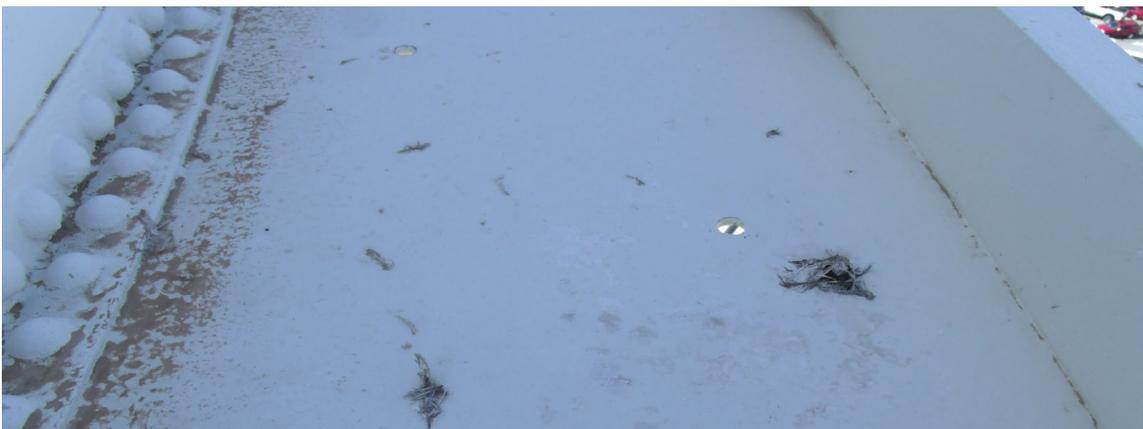
Photos show bird feathers on the tank catwalk. We recommend applying a commercial bird repellent on the tank to discourage birds from roosting in the treated area.
