**Veterans Administration
2121 N. Avenue
Grand Junction, CO 81501
RE: Boiler House
100,000 Gallon E.W.T.
May 17, 2013
Doyle Payne,
Assistant Chief Engineering Service
(970) 242-0731 ext. 2099
Job No. 313195**

Veterans Administration
RE: Boiler House
100,000 Gallon E.W.T.

ELEVATED TANK INSPECTION REPORT

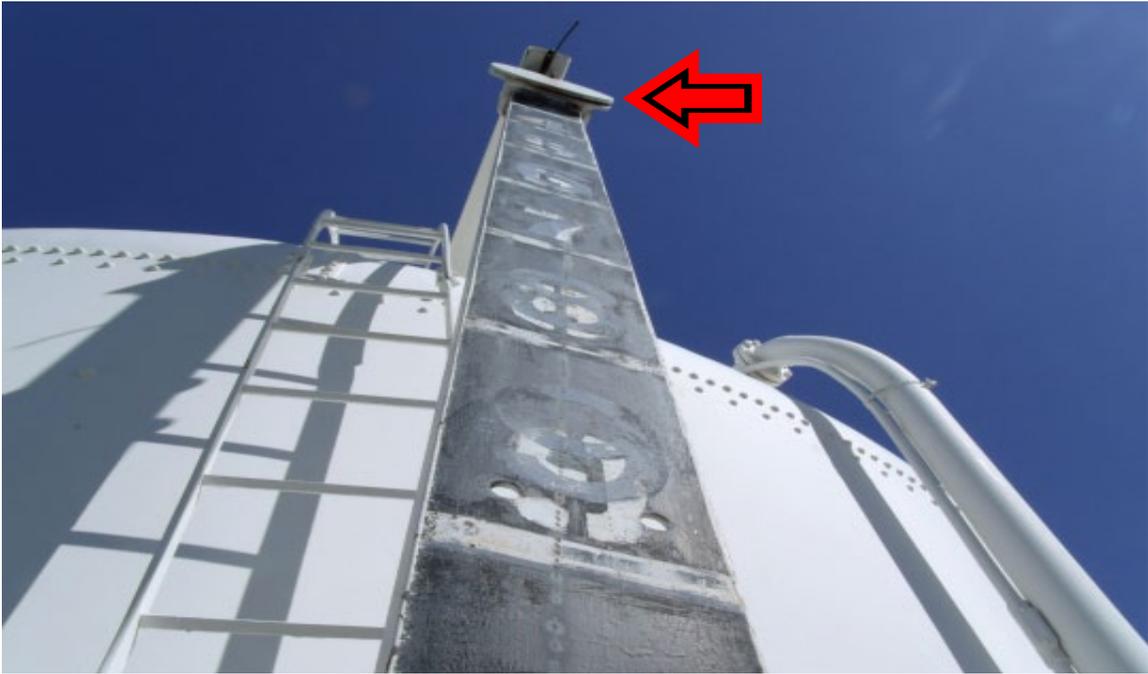
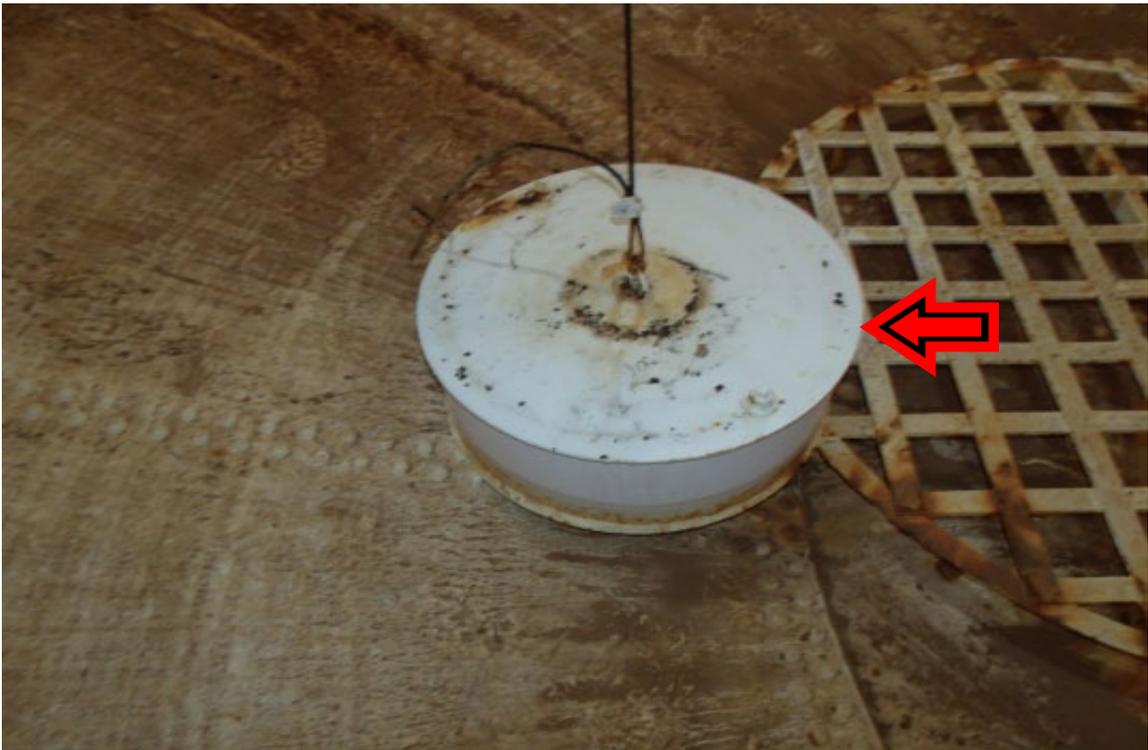
Photos show the condition of the liquid level indicator. We recommend cleaning and lubricating all moving parts on the liquid level indicator for preventative maintenance then adjust and calibrate the unit.

19. Clean and lubricate all moving parts on the liquid level indicator then adjust and calibrate the unit
20. Install an approved, anti-skid rung equipped, shell/roof access ladder complete with standoffs every 12' on center
Install a cable type ladder safety climb device

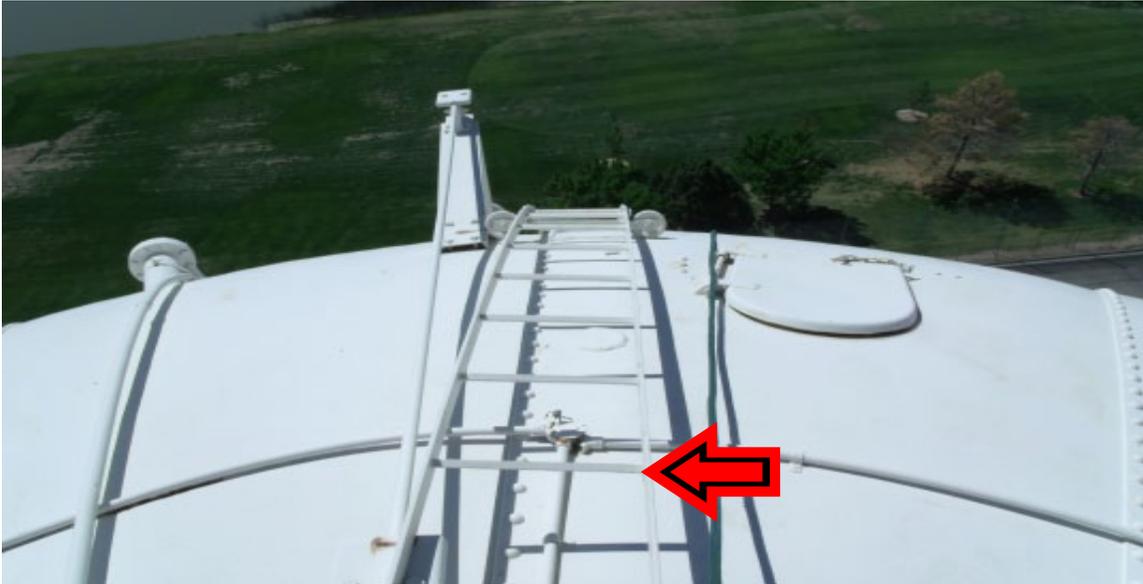
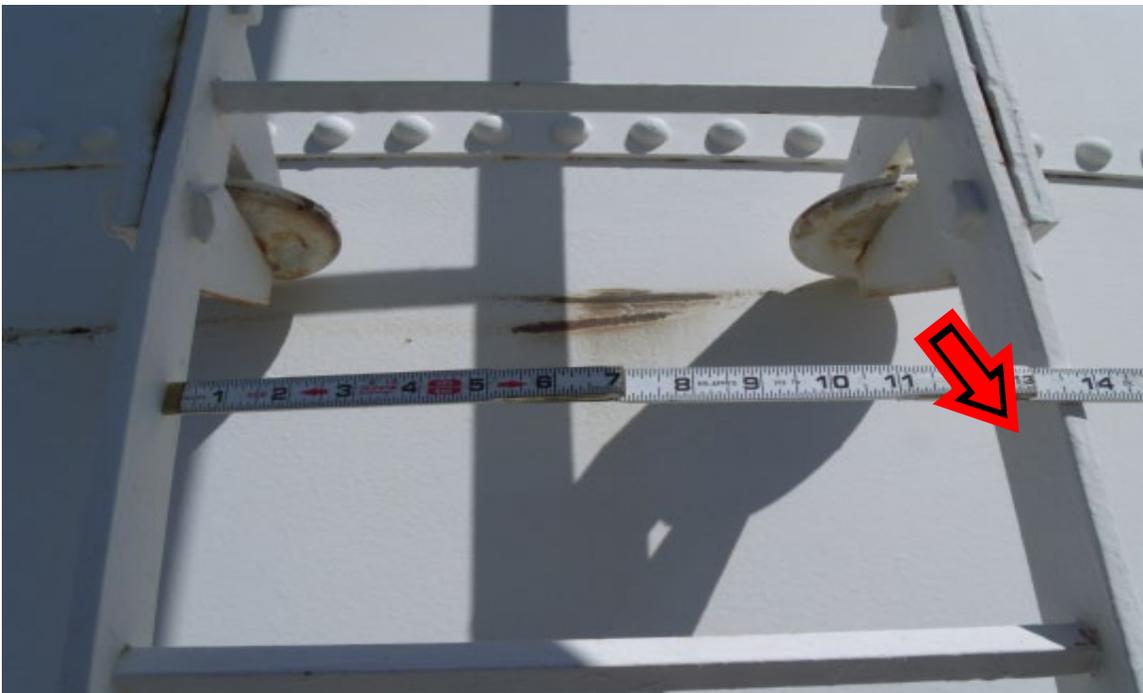
The photos show the shell/roof access ladder is equipped with anti-skid rungs but is only 13" wide, and is a roll-a-round type. **OSHA 19.27 Ladders** states; "Minimum clear distance between the sides of individual rung/step ladders and between the side rails of other fixed ladders must be 16 inches (41 cm)." We recommend installing an approved shell/roof ladder complete with standoffs every 12' on center and a cable type ladder safety device.

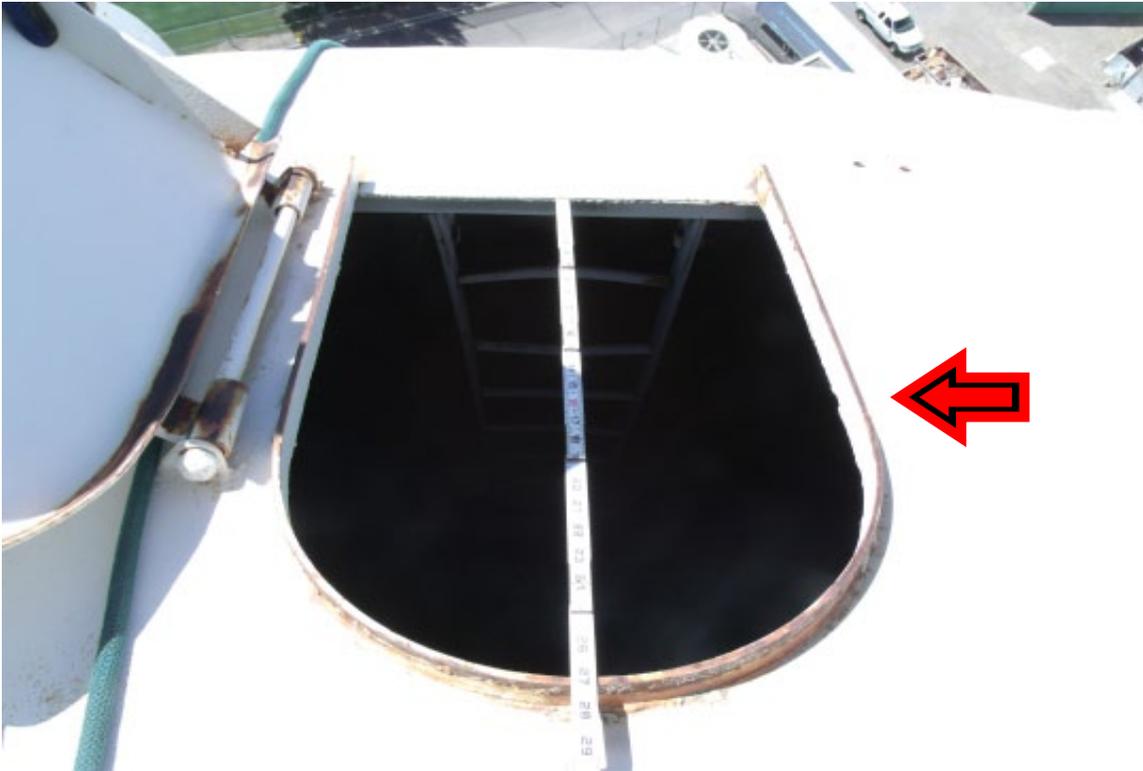
Photo shows the condition of the 27" x 19" roof manway. Roof openings on this tank require the following to be in compliance with [OSHA 29 CFR 1910.23\(a\)\(1\)](#) and [AWWA D100-11; 5.4.3.1 roof openings](#).

We recommend:

- Replace existing roof manway with a 30" manway with a 4" curb and a 2" overlap cover
- Post a **Confined Space Entry** sign on roof manway
- Install handrails around all roof openings

21. Replace existing roof manway with a 30" manway with a 4" curb and a 2" overlap cover
Post a **Confined Space Entry** sign on roof manway
Install handrails around all roof openings

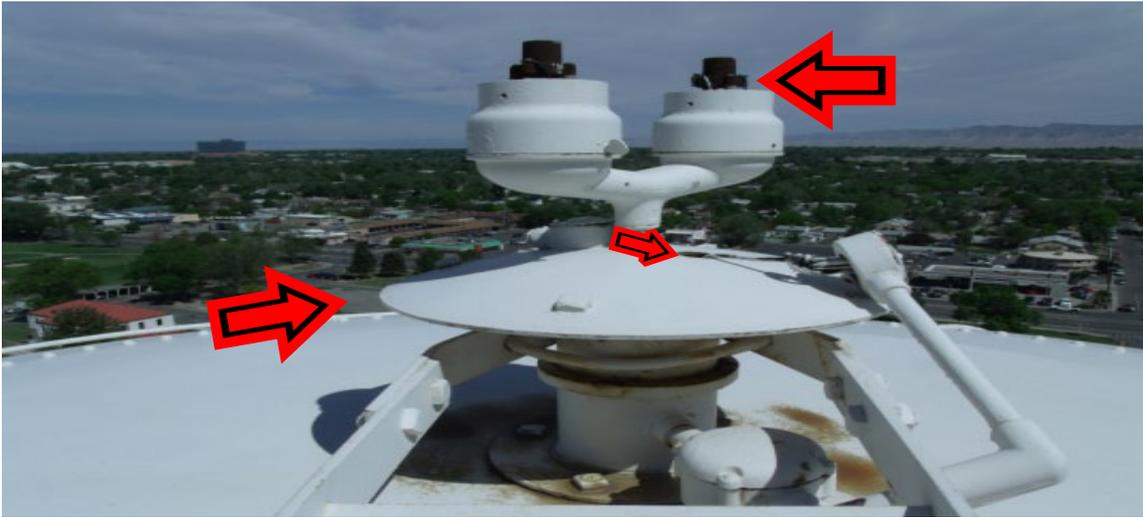
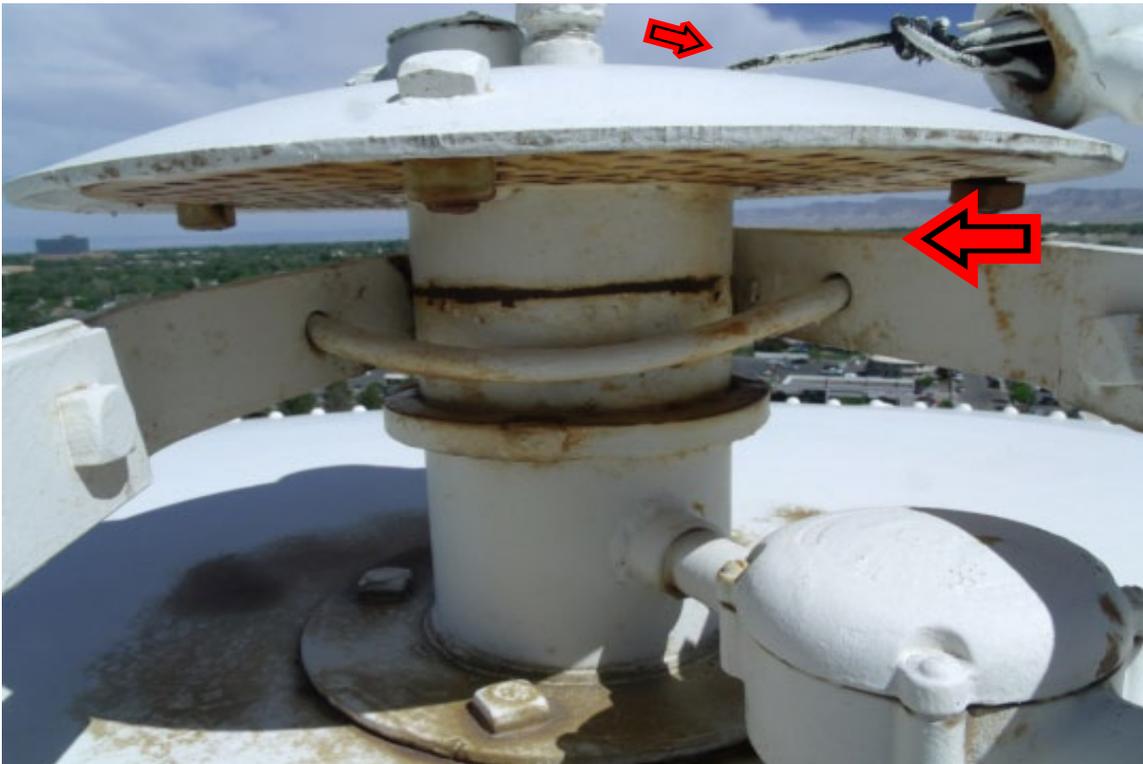
Photos show the condition of the existing roof vent. The vent is of an inadequate size and not compliant with [AWWA D-100; 5.5 vent](#). **An improperly vented tank may cause external pressure to act on the tank which can cause buckling even at low pressure differential.** We recommend replacing the existing roof vent with a vacuum/pressure, frost proof vent and screen.

We recommend repairing or removing the obstruction light system.

22. Replace the existing roof vent with a vacuum/pressure vent and screen
Repair or remove the obstruction light system
24. Install an approved, anti-skid rung equipped, interior access ladder complete with standoffs every 12' on center
Install a cable type ladder safety climb device

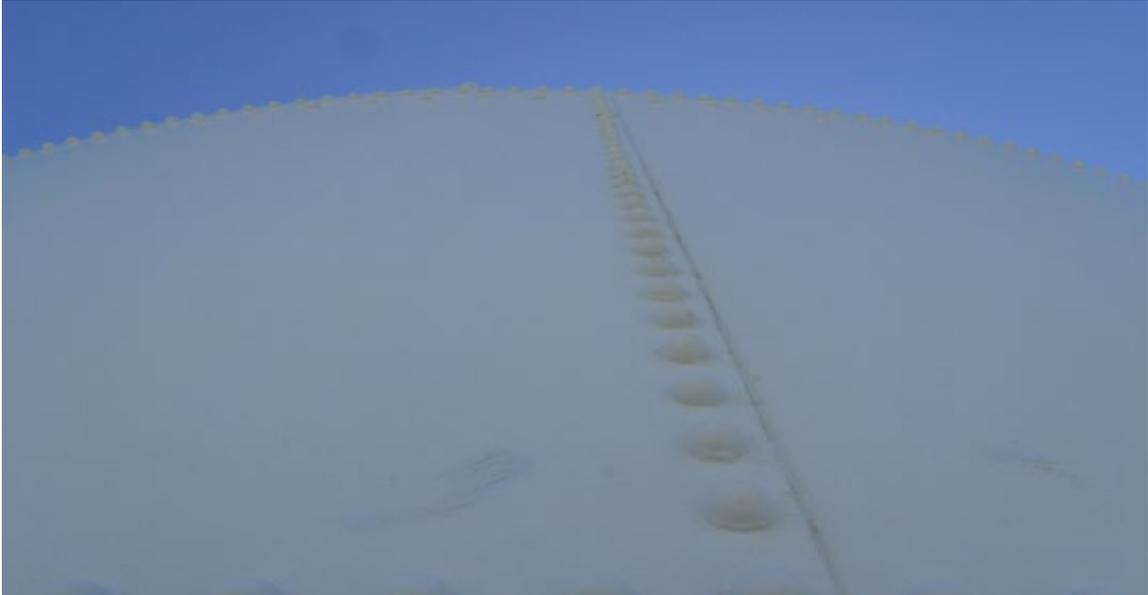
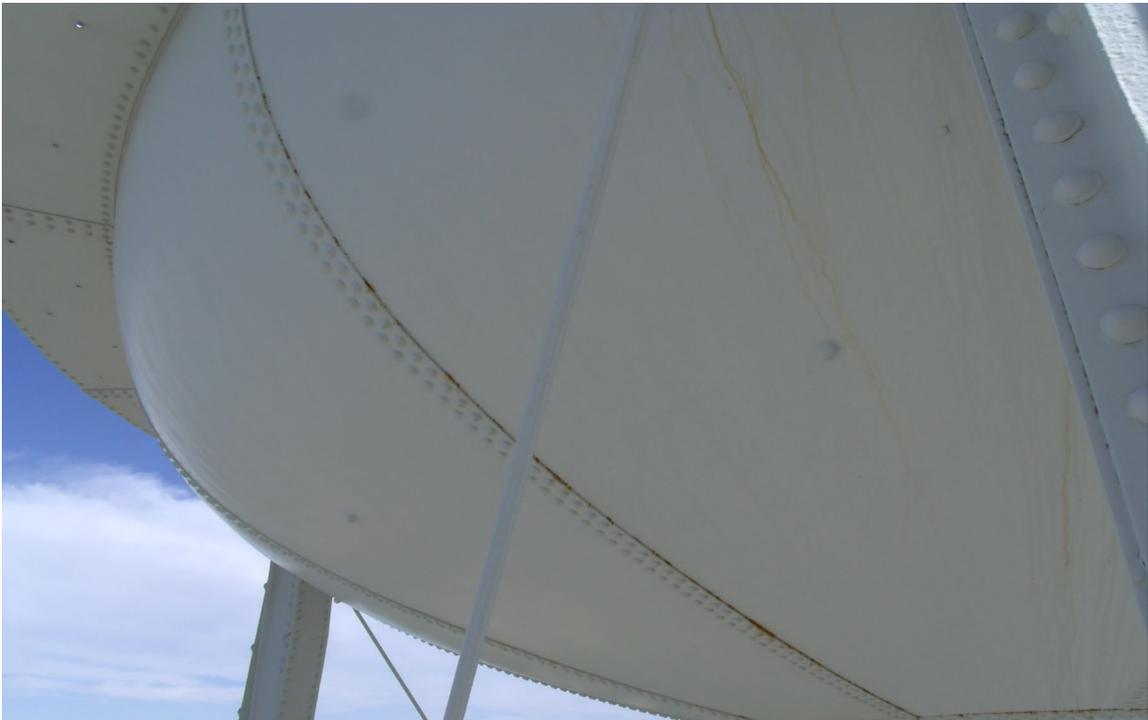
Photos show the tank exterior coating system which appears to be in good condition.

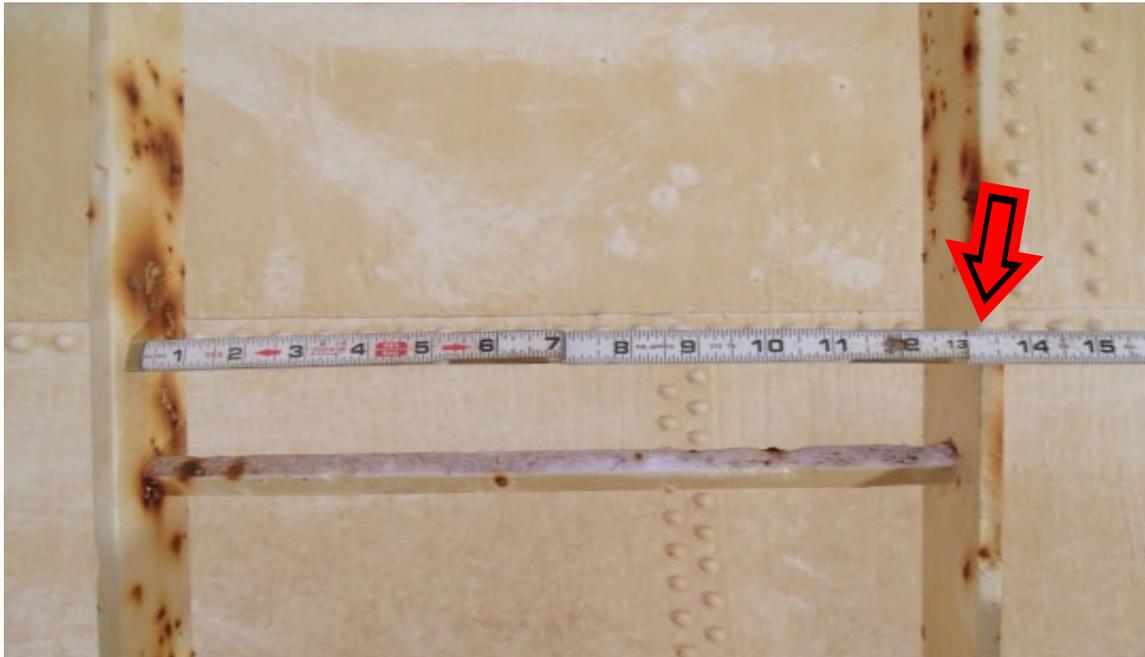
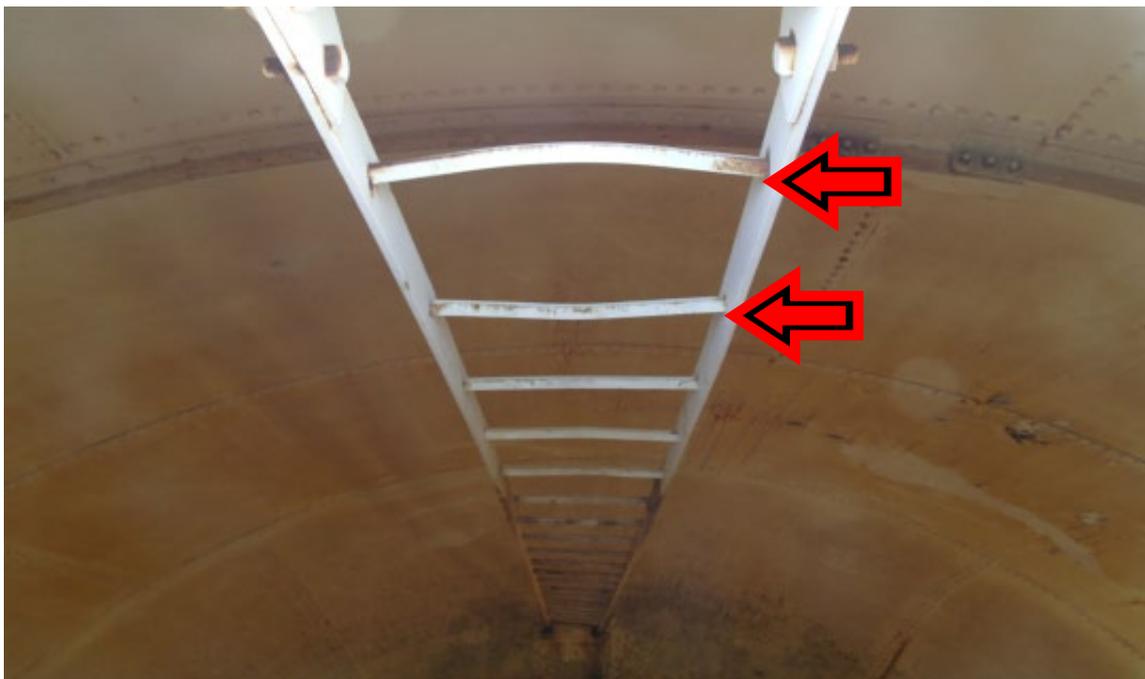
Photos show the interior access ladder is equipped with anti-skid rungs but is only 13" wide. (Also notice the bent rungs) [OSHA 19.27 Ladders](#) states; "Minimum clear distance between the sides of individual rung/step ladders and between the side rails of other fixed ladders must be 16 inches (41 cm)." We recommend installing an approved interior access ladder complete with standoffs every 12' on center and a cable type ladder safety device.

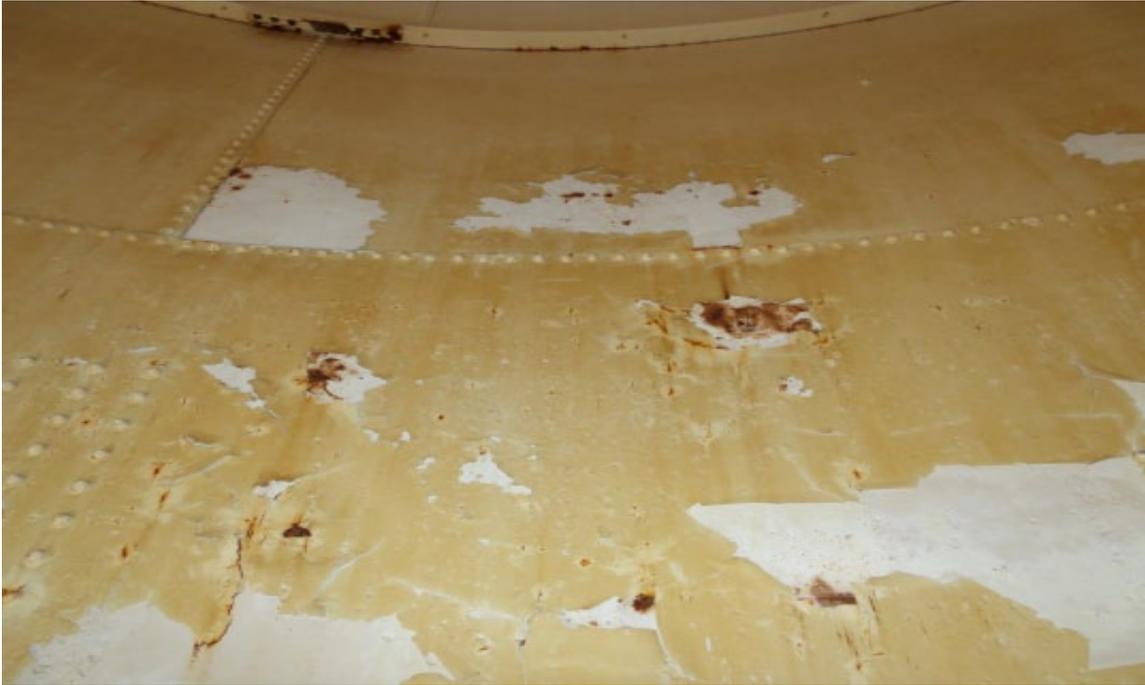
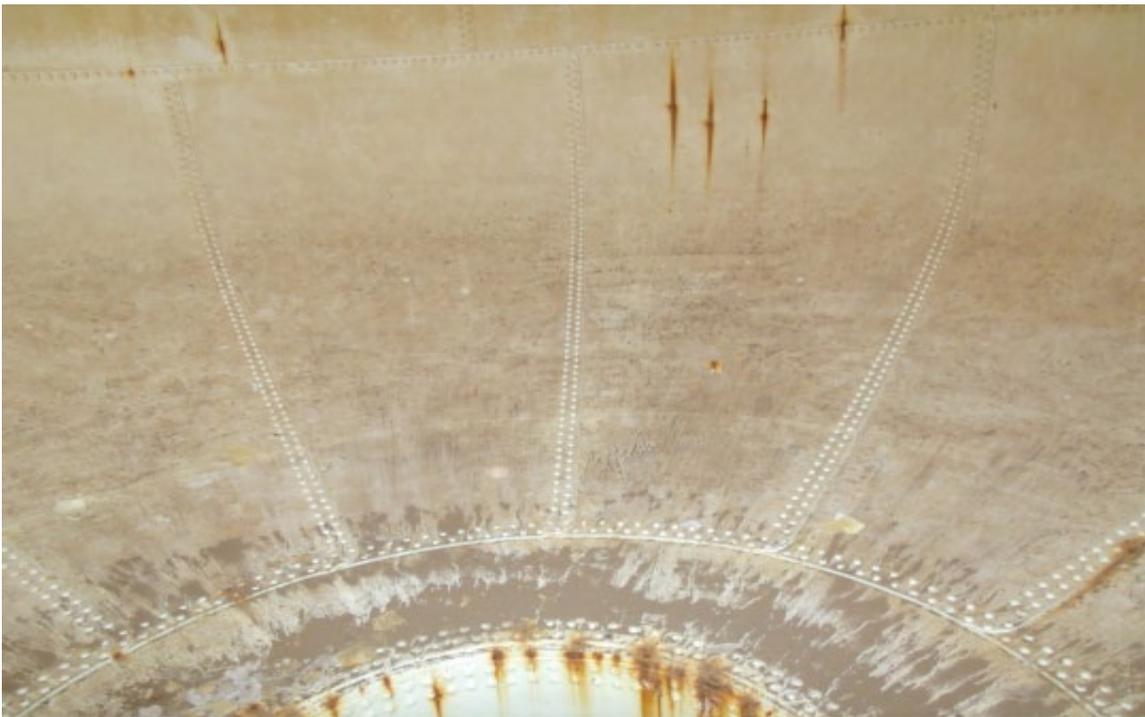
Photos show the tank interior after the clean out procedure.

We recommend installing a passive cathodic protection system on the interior of the tank.

25. Install a passive cathodic protection system on the interior of the tank

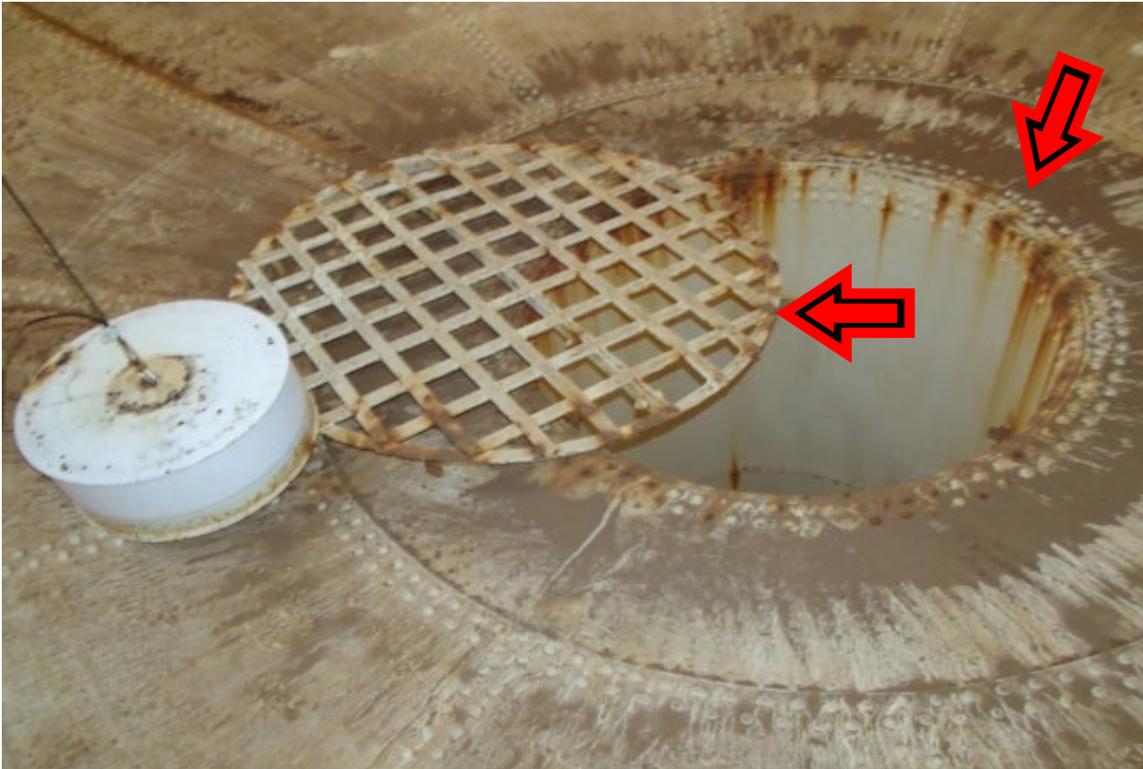
Photo shows the condition of the riser pipe opening. The riser opening is equipped with a safety grating in accordance with [AWWA D100-11;.5.1.1 Safety grill](#) and [OSHA 29 CFR 1910.23\(a\)\(1\)](#), which appears to be in good condition.

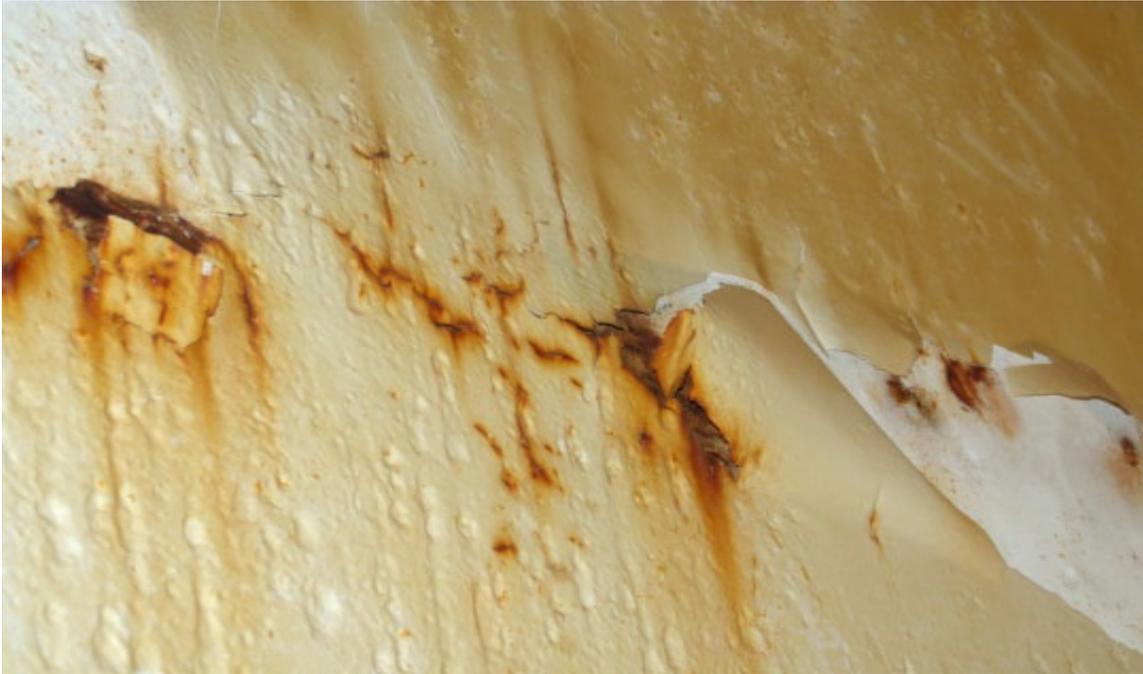
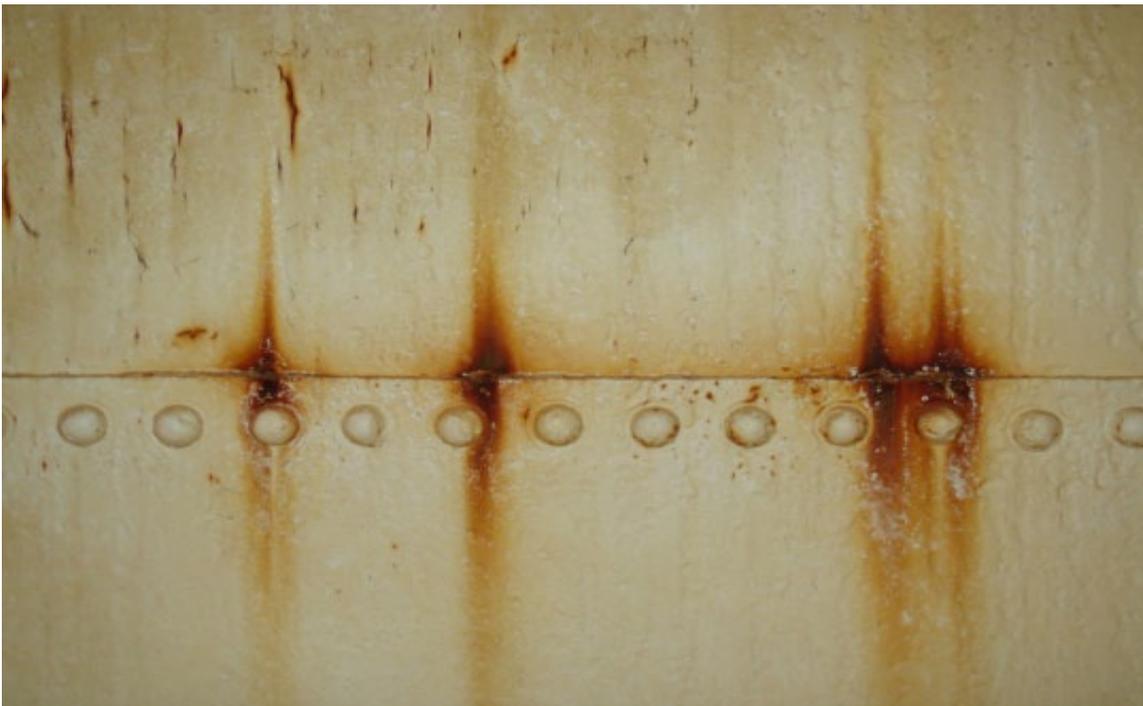
Photos show the condition of the interior liner. We recommend sandblasting the tank interior to an SSPC #10 (near white blast) condition, stripe coating all seams and welds, then applying an epoxy liner to achieve 8-10 mils of dry film thickness.

27. INTERIOR COATING SYSTEM: Sandblast all rusted and abraded areas of the tank interior to SSPC #10 (near white blast) condition, brushblast all remaining areas, stripe coat all seams and welds, then apply an epoxy liner to achieve 8-10 mils dry film thickness
