**Veterans Administration
2121 N. Avenue
Grand Junction, CO 81501
RE: Boiler House
100,000 Gallon E.W.T.
May 17, 2013
Doyle Payne,
Assistant Chief Engineering Service
(970) 242-0731 ext. 2099
Job No. 313195**

ELEVATED TANK INSPECTION REPORT

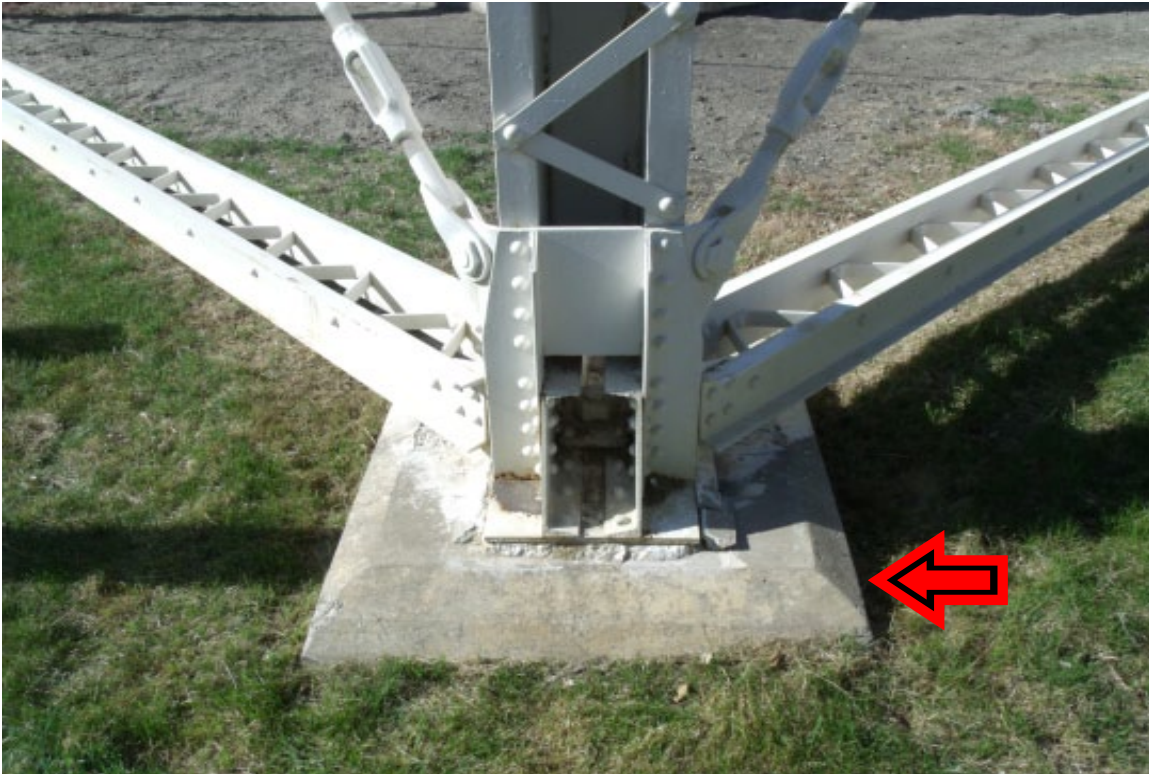
Photo shows the condition of the foundations. We recommend removing all dirt, debris and loose gravel from the foundation, repairing any cracks and spalling in the concrete with a commercial non-shrinking grout and sealing the foundation with a sealant.

We also recommend the tank be electrically grounded for lightning protection as required by [OSH Act 29 CFR 1926, Subpart K](#).

2. Repair any cracks and spalling in the concrete with a commercial non-shrinking grout and seal the foundations with a sealant

Electrically ground the tank for lightning protection
3. Clean the area around the anchor bolts, then weld around the circumference of the bolt-to-nut and nut-to-base plate connections to reinforce

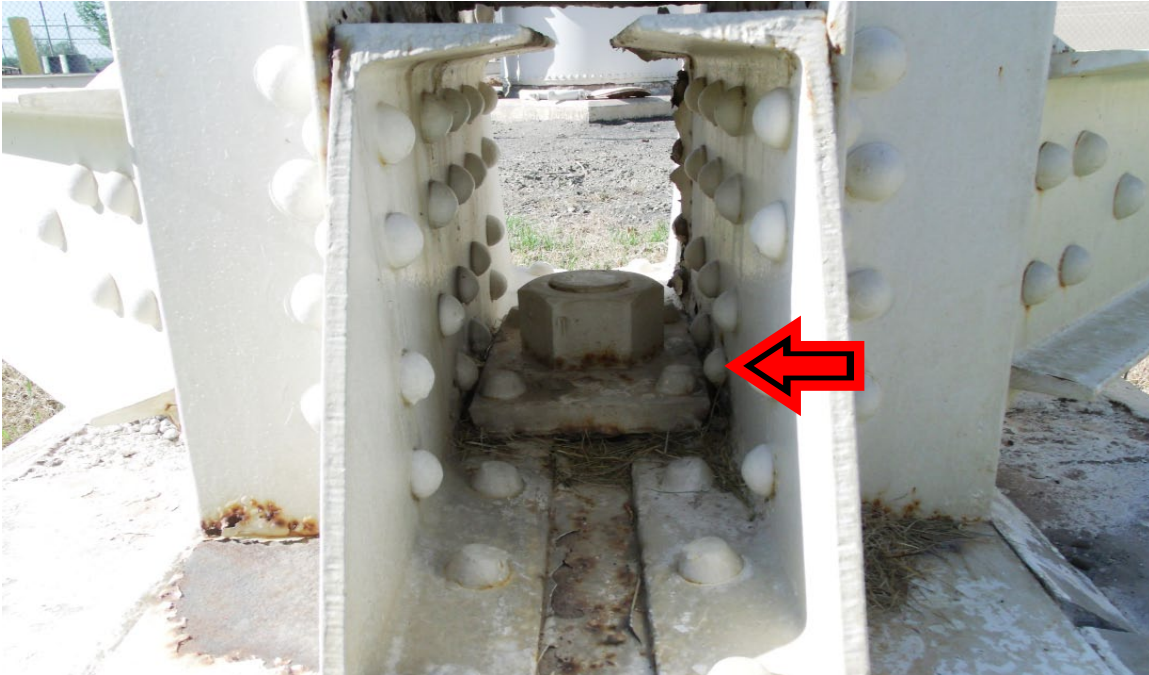
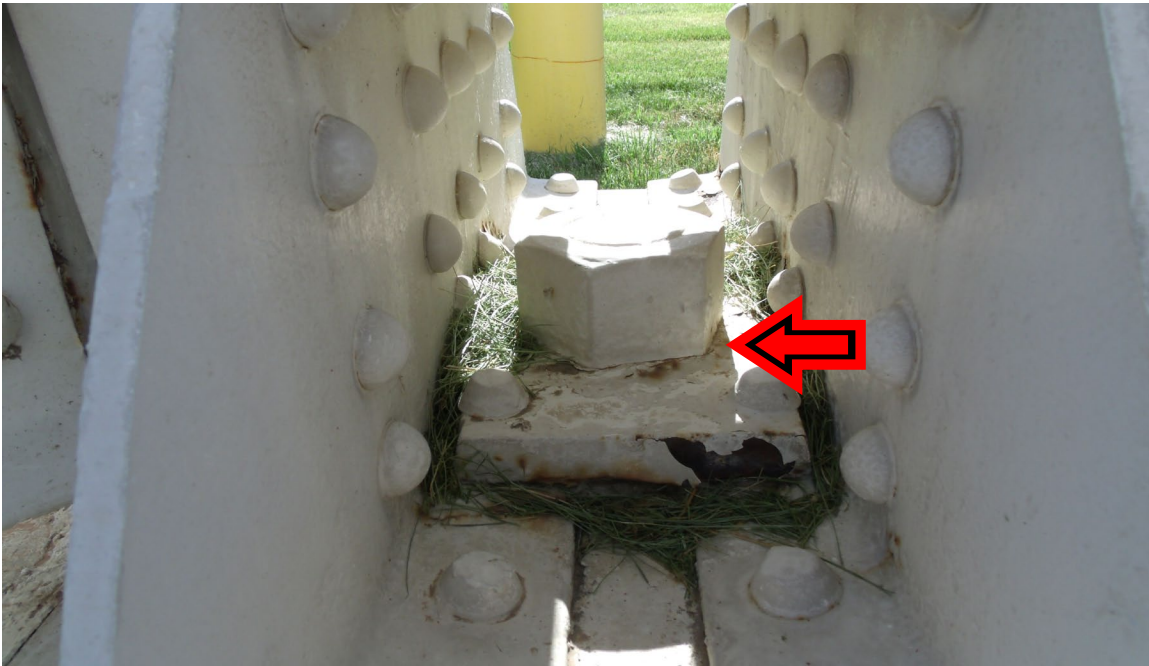
Photos show the condition of the anchor bolts. The structural integrity of the anchor bolts should be maintained to withstand 100 m.p.h. winds blowing from any direction as required by **AWWA D100-11; 3.8: Foundation bolts**. We recommend cleaning the area around the anchor bolts, then welding around the circumference of the bolt-to-nut and nut-to-base plate connections to reinforce.

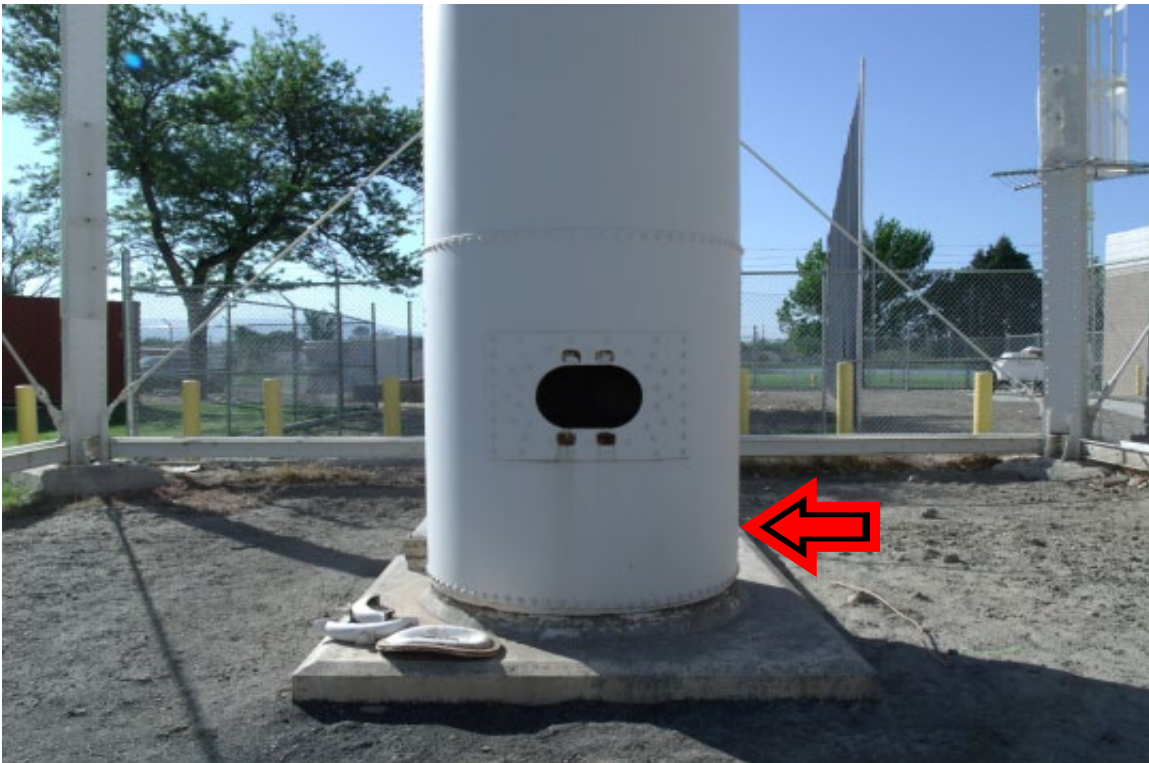
Photo shows the base of the riser pipe. Currently there is no riser drain valve. A drain valve performs two functions it allows the tank to be drained and it is used as a blowout to remove silt and scale from the lower portion of the tank. We recommend installing a frost proof drain valve, complete with locking device to prevent unauthorized draining of the tank and a splash pad to direct water away from the foundation.

4. Install a frost proof drain valve, complete with a locking device and a splash pad
5. Remove the name plate, clean the face of the plate, clean and repaint the area behind the plate, and remount it

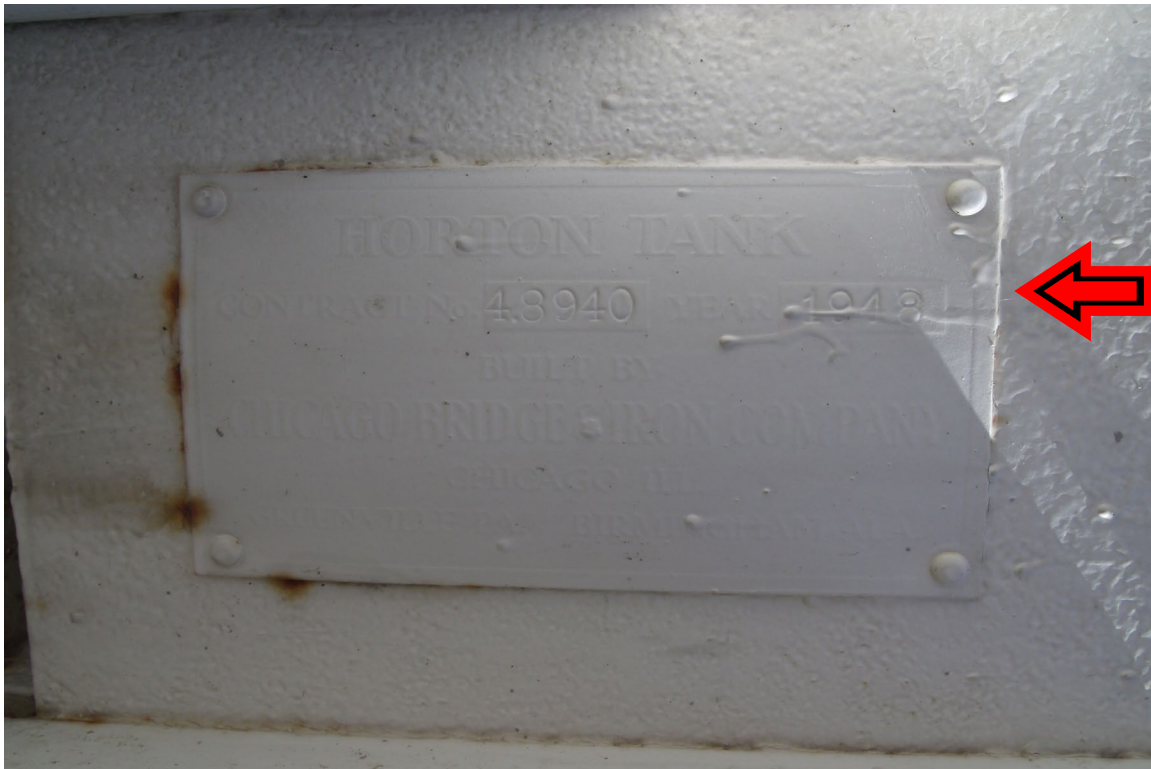
Photo shows the tank name plate. We recommend removing the name plate, cleaning the face of the plate, cleaning and repainting the area behind the plate, and remounting it.

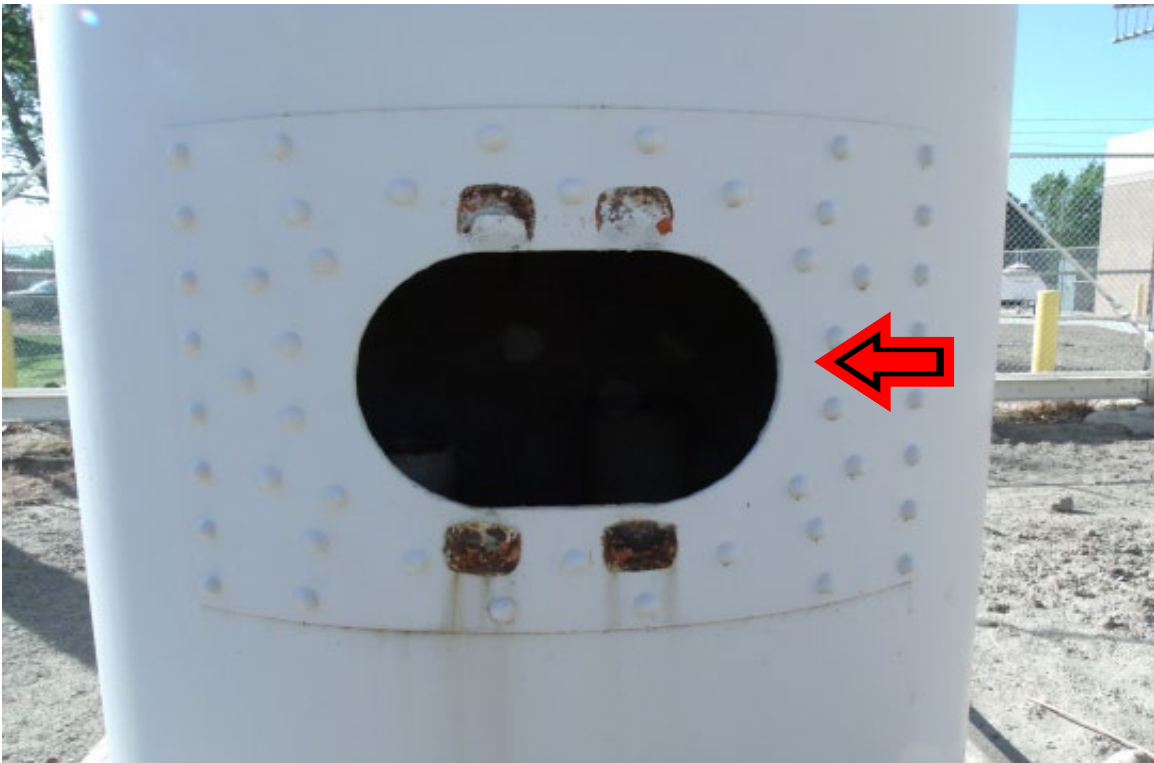
Photo shows the condition of the riser manway. This manway would restrict entry in an emergency. We recommend replacing the existing riser manway with an **AWWA D100-11: 5.4.4** approved 24" manway, complete with a davit arm, a **Confined Space Entry** sign and maintenance free galvanized steel bolts.

6. Replace the existing riser manway with an, approved 24" manway, complete with a davit arm, a **Confined Space Entry** sign and maintenance free galvanized steel bolts

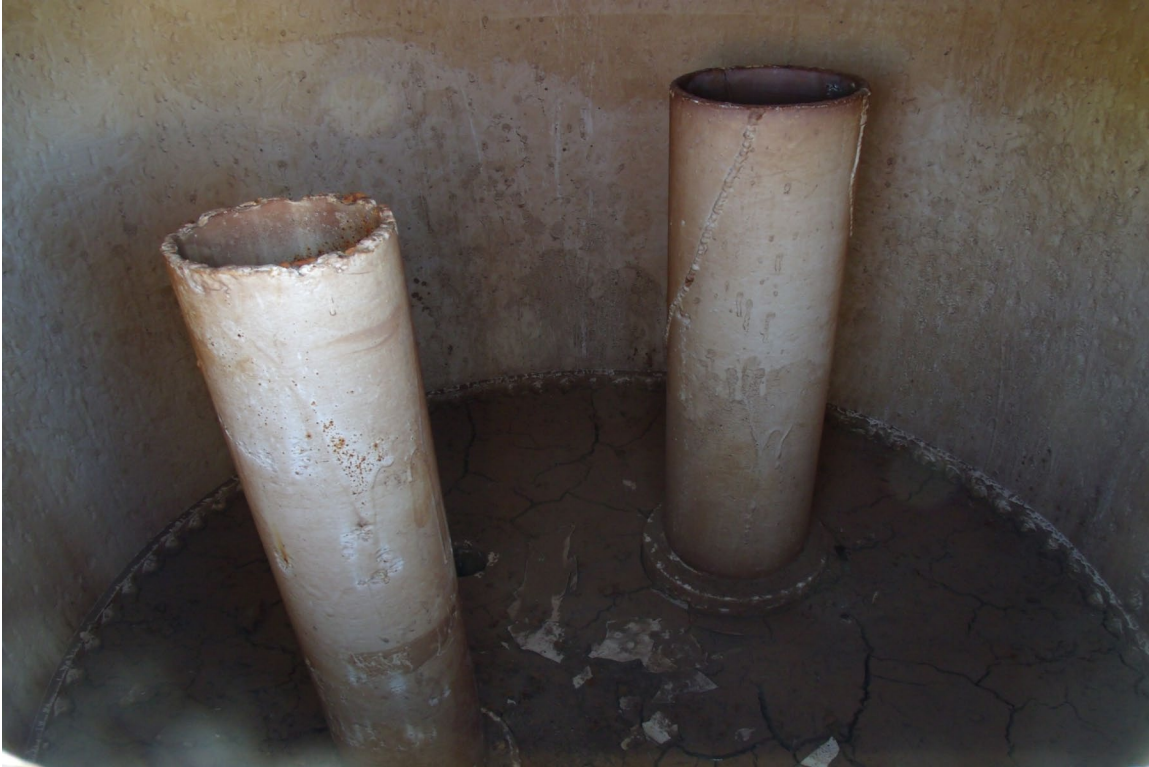
Photo shows the inlet and outlet pipes in the base of the riser pipe. We recommend installing a protective plate over the outlet pipe, supported over the pipe by three 1/2" x 1" standoffs 12" long. This will prevent silt from falling into the pipe from the tank bowl.

7. Install a protective plate over the outlet pipe located in the riser
8. Extend the overflow down the exterior to grade, complete with stand-offs every 12' on center, install an elbow, a flapper valve with a screen and a splash pad

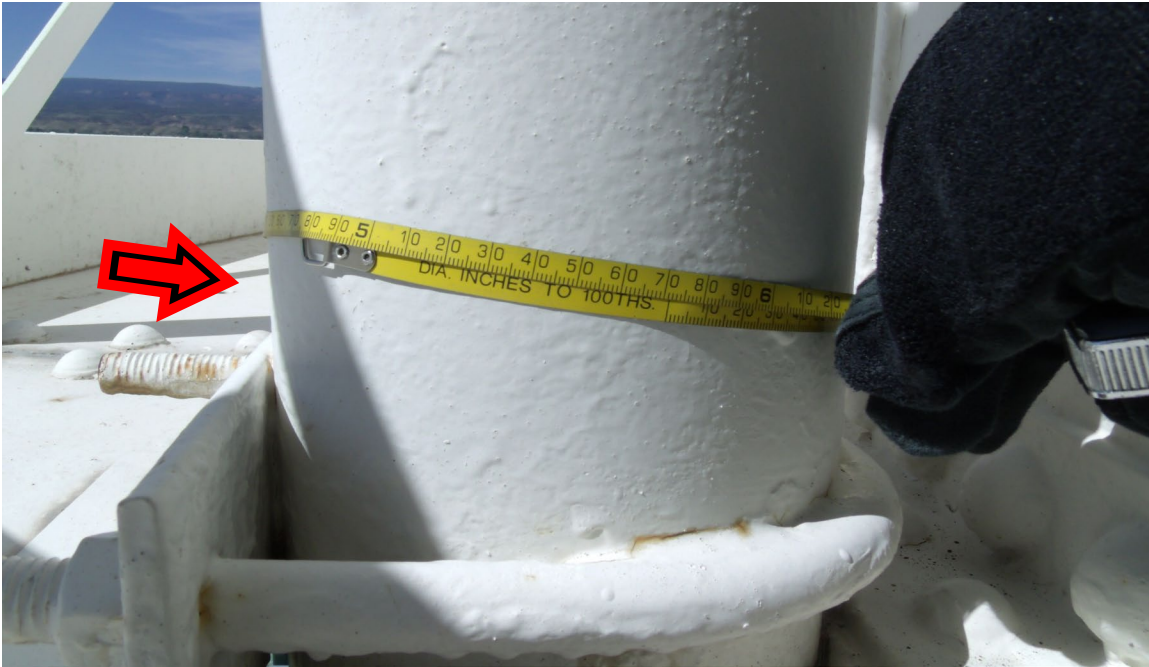
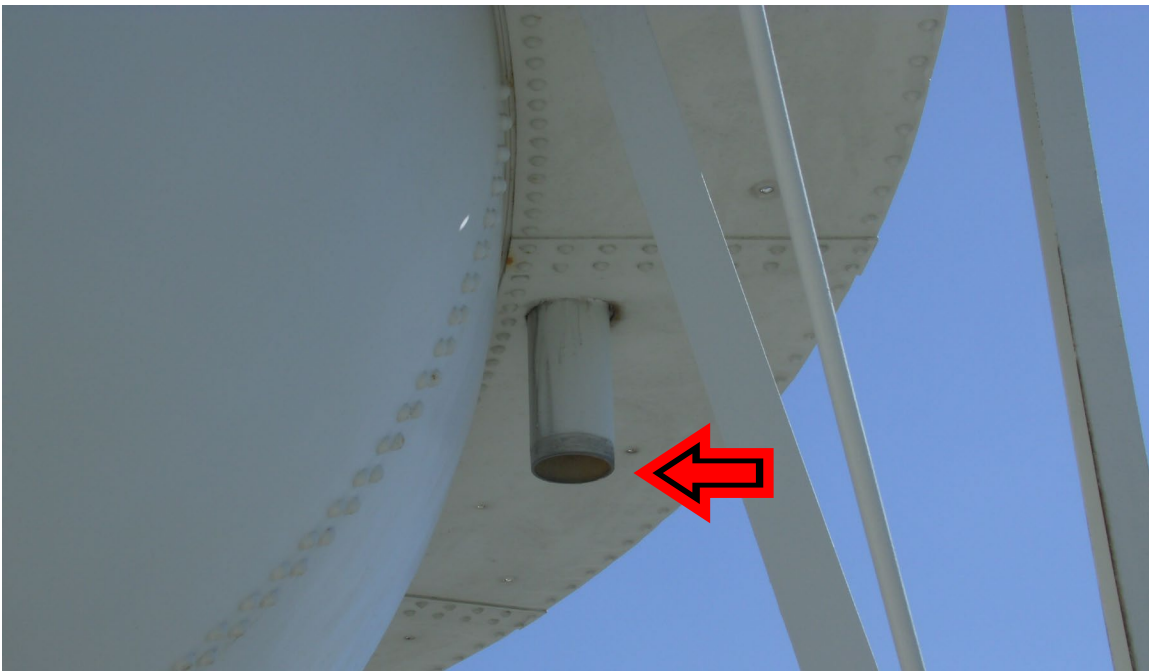
Photos show the condition of the stub overflow pipe which exits beneath the catwalk. The overflow pipe is not equipped with a flapper valve and screen. We recommend extending the overflow down the exterior to grade with 6" pipe, complete with standoffs every 12' on center, installing an elbow at the base fitted with a flapper valve and screen to prevent the ingress of contaminants into the water supply and a splash pad to direct water away from the foundations.

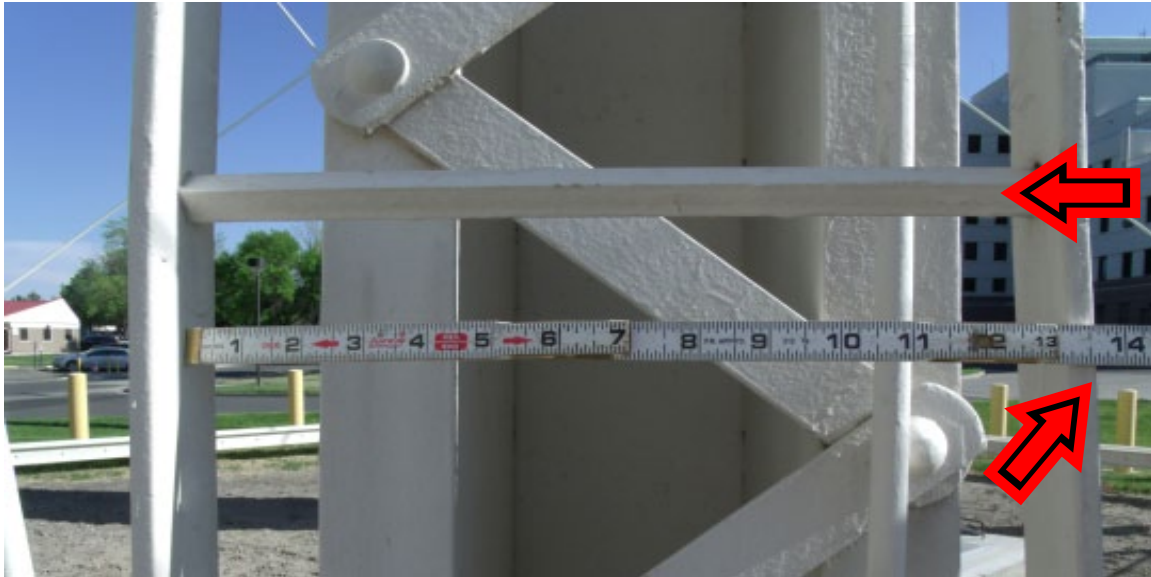
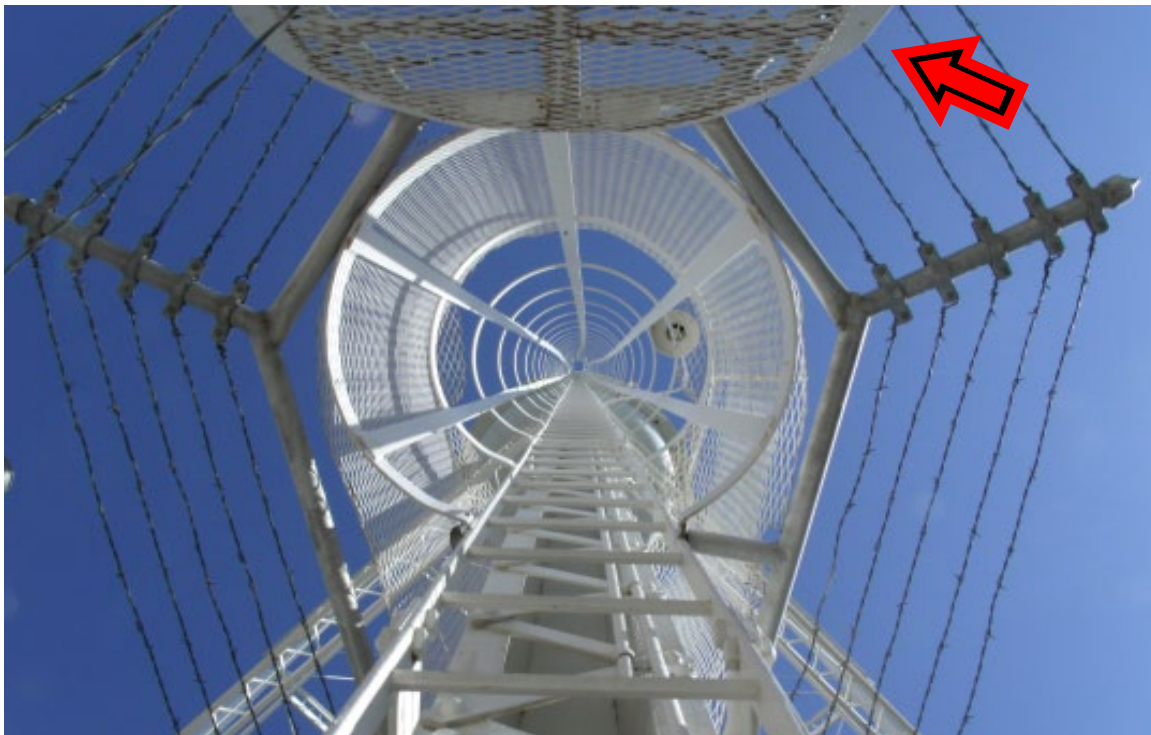
Photos show the tower access ladder is equipped with anti-skid rungs but is 13" wide. **OSHA 19.27 Ladders** states; "Minimum clear distance between the sides of individual rung/step ladders and between the side rails of other fixed ladders must be 16 inches (41 cm)." We recommend installing an approved tower access ladder complete with standoffs every 12' on center, a cable type ladder safety device, a new lockable ladder guard to prevent unauthorized access and posting a **Fall Protection Required** sign.

9. Install an approved, anti-skid rung equipped, tower access ladder complete with stand-offs every 12' on center
Install a cable type ladder safety climb device
Install an aluminum lockable ladder guard to prevent unauthorized access
Post a **Fall Protection Required** sign

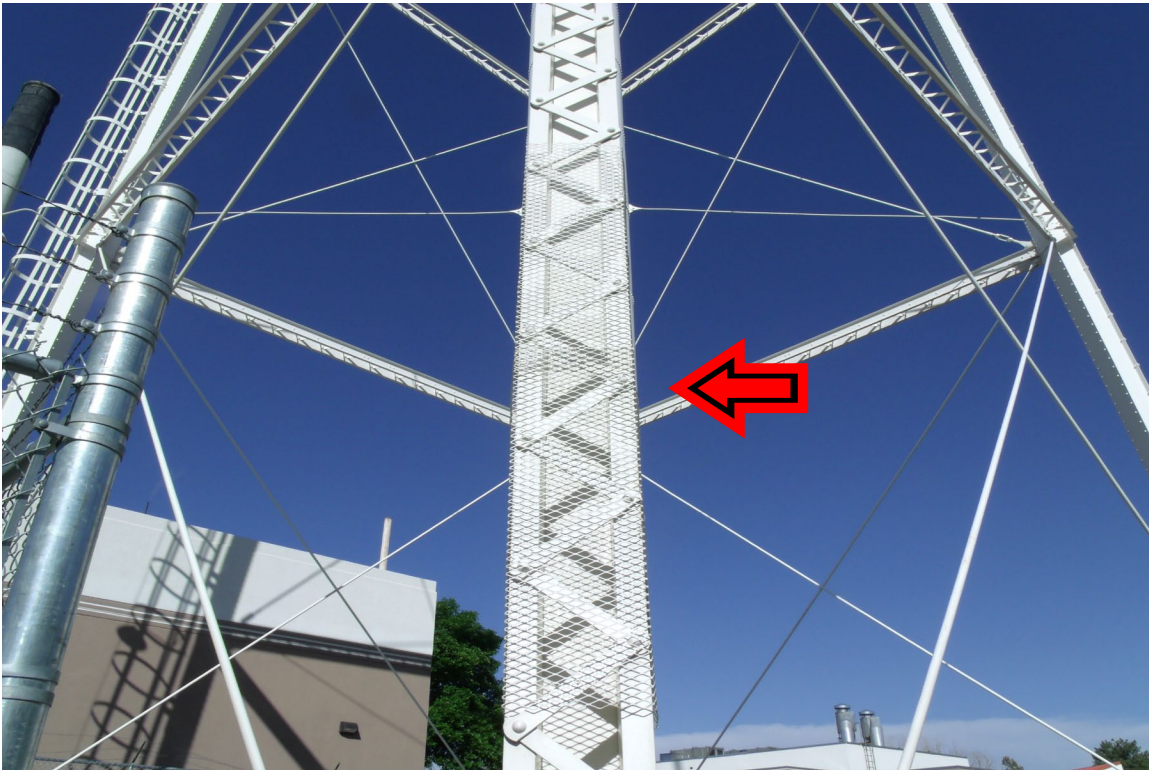
Photo shows the lattice leg climbing guards which appear to be in good condition.

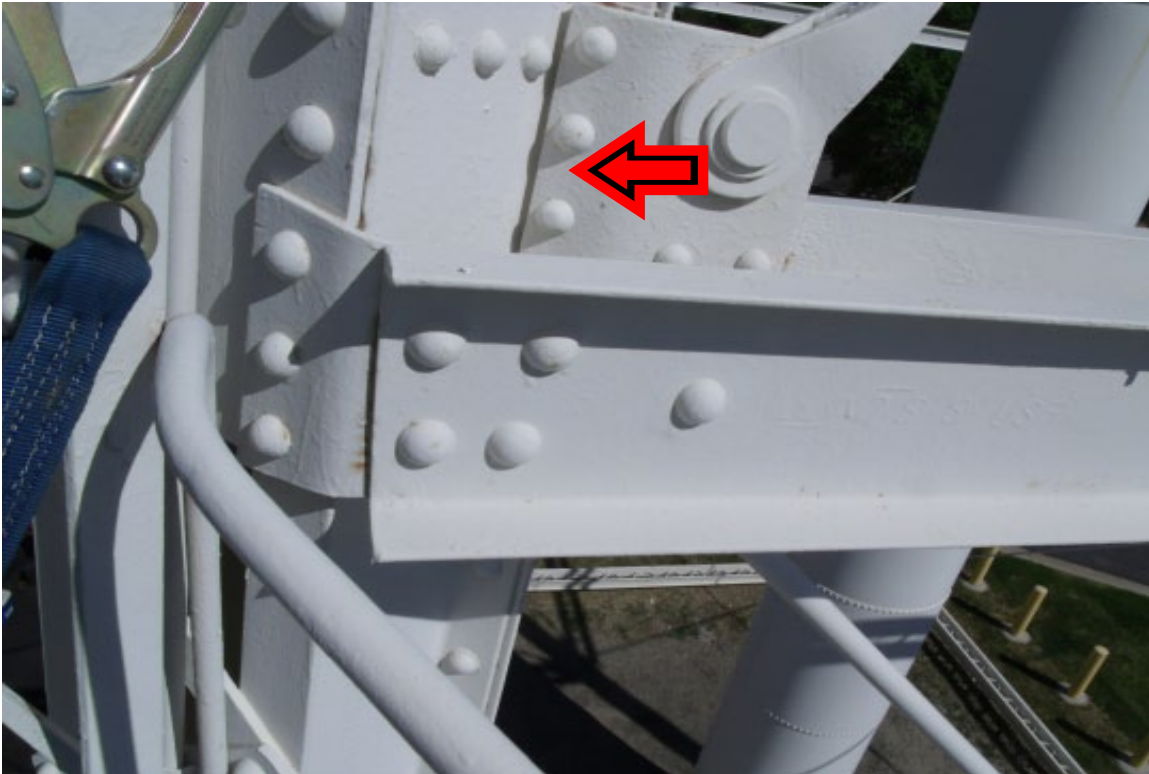
Photo shows the strut end connections, which appear to be in good condition.

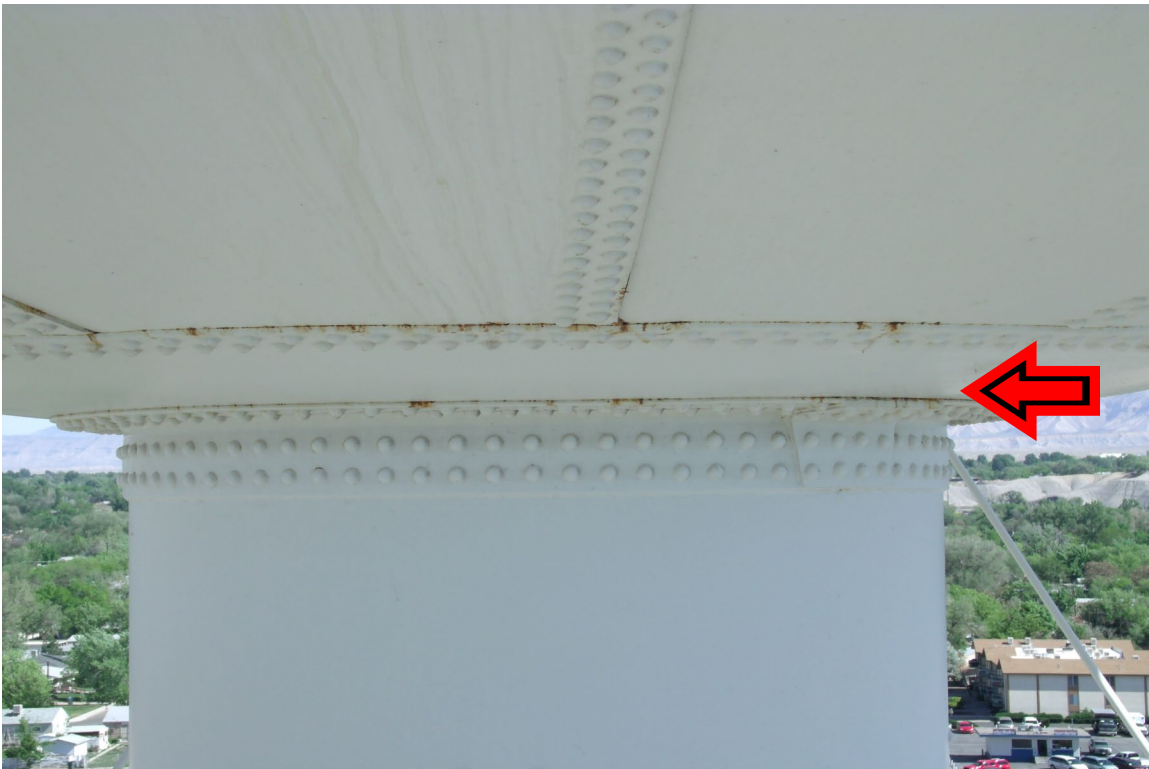
Photo shows the riser pipe and bowl connection which appears to be in good condition.

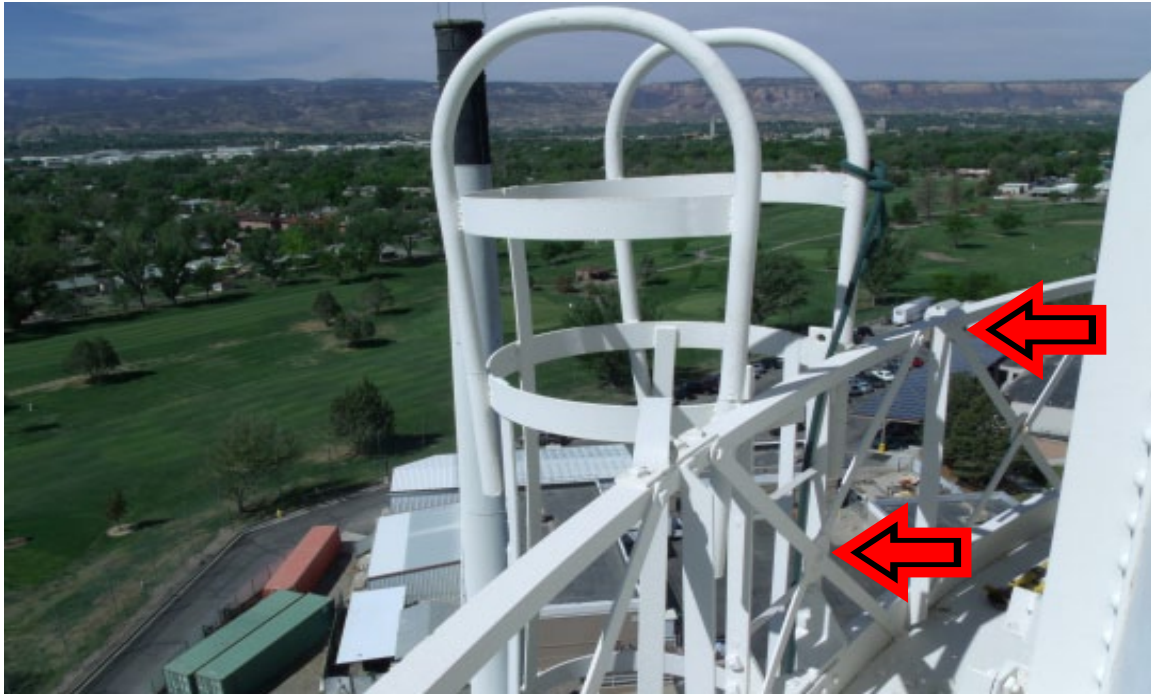
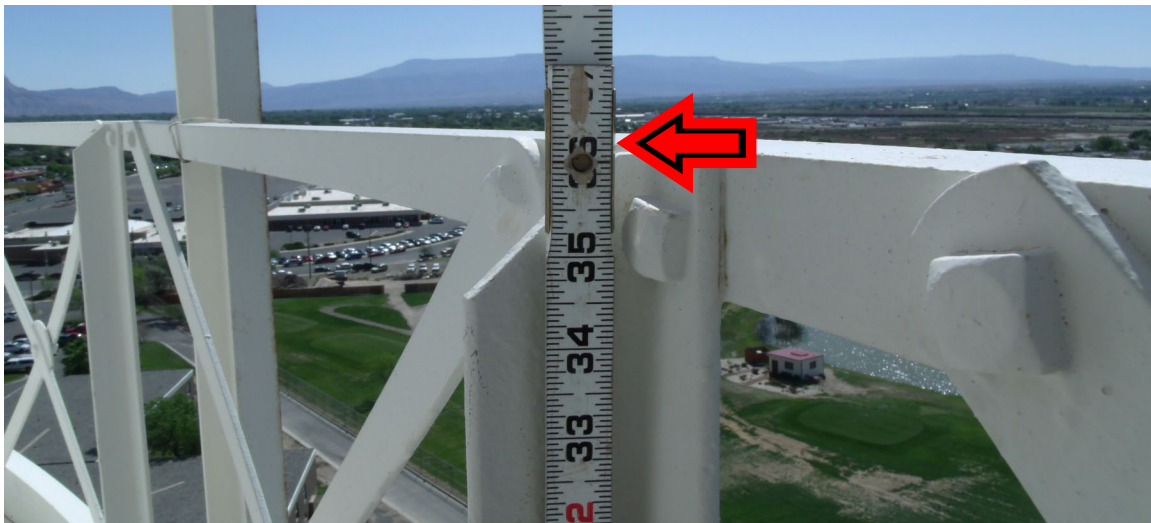
Photos show the condition of the existing handrail system. The handrail is only 36" high, not equipped with an intermediate rail and not in compliance with **OSHA 29 CFR 1910.23(e)(1)**. We recommend raising the existing handrail system to the required 42", installing an intermediate rail, cutting out a section of the handrail at the junction of the tower access ladder and structural girder, the width of the tower access ladder + 4" on each side and installing the necessary bracing to keep railing at design strength, complete with a stainless steel chain gate at the opening in the handrail at the junction of the tower access ladder and structural girder.

14. Raise the existing handrail system to the required 42", install an intermediate rail, cut out a section of the handrail at the junction of the tower access ladder and catwalk, the width of the tower access ladder + 4" on each side, and install the necessary bracing to keep railing at design strength, complete with a stainless steel chain gate

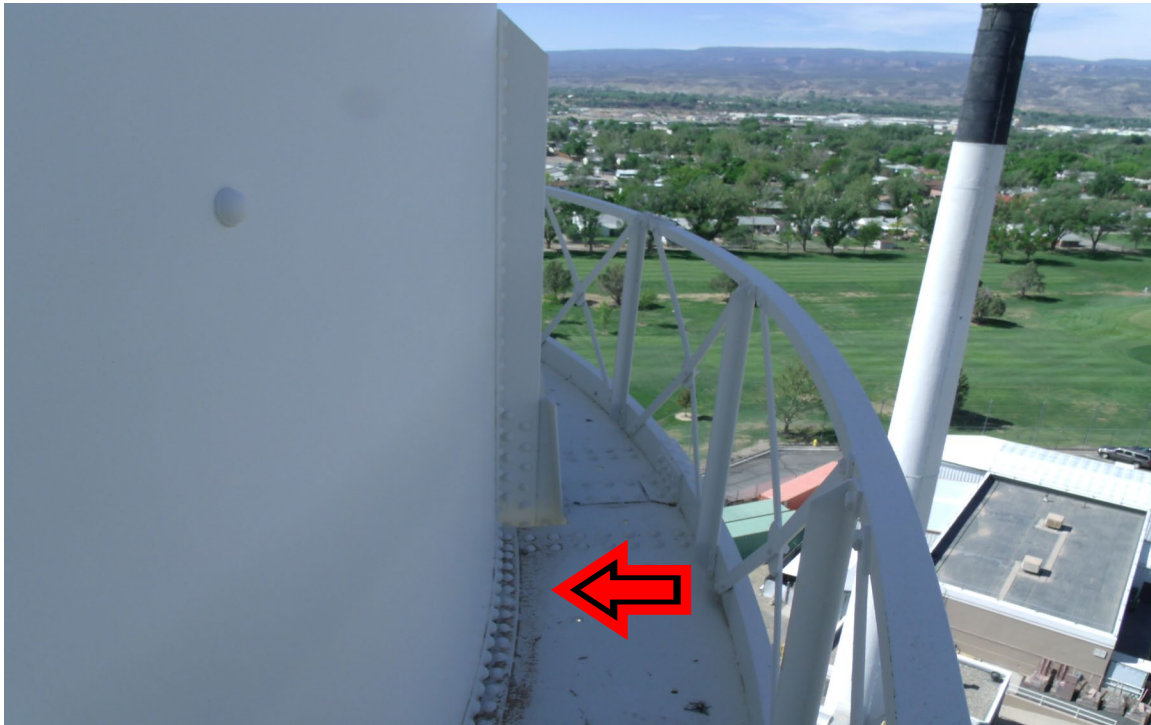
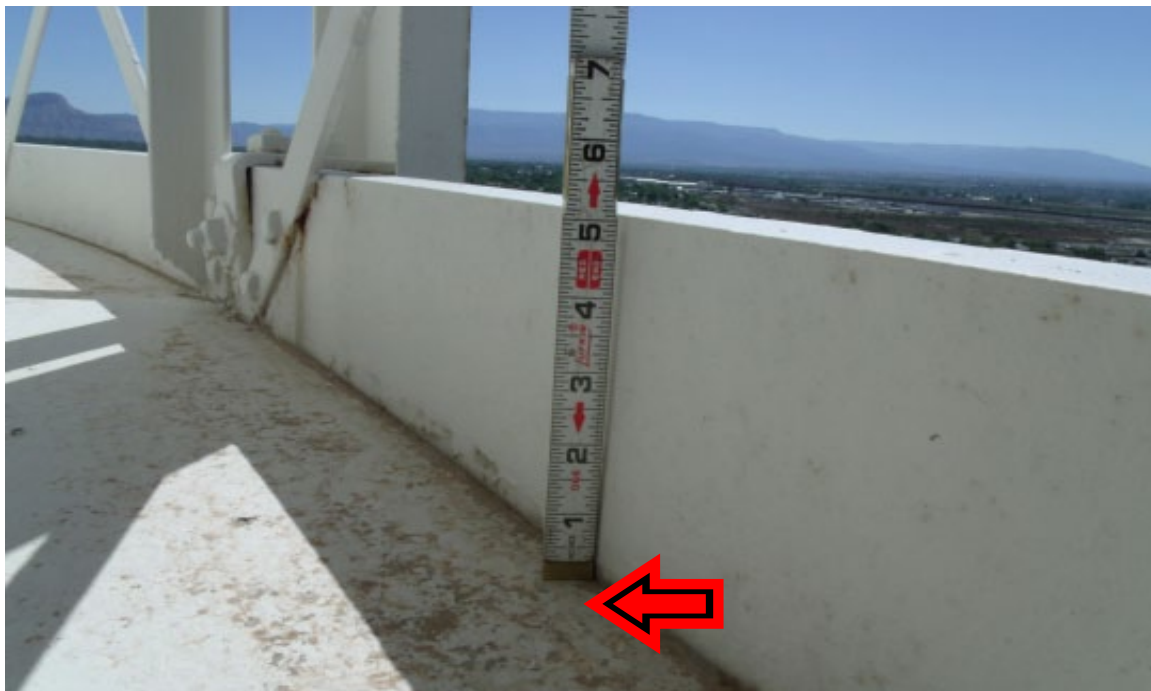
Photos show the condition of the balcony floor. The arrows are pointing to show where water is ponding, causing deterioration of the paint and steel. We recommend drilling additional weep holes in the balcony floor to prevent ponding of water.

15. Drill additional weep holes in balcony floor
16. Install a 30" shell manway
Install a 30" second shell manway 180° from primary shell manway
Post **Confined Space Entry** signs at shell manways
Install interior bowl ladders at shell manways
Install cable type ladder safety devices on interior bowl ladders

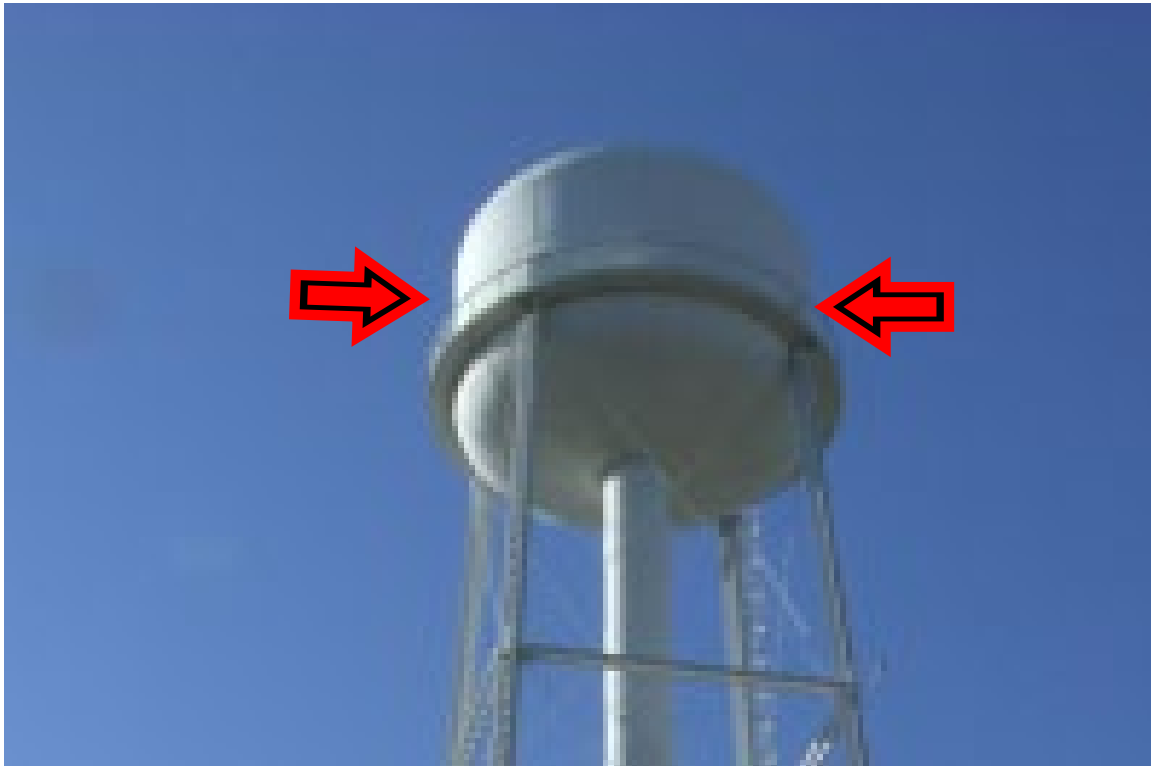
Photo shows the condition of the tank shell. Shell manways installed on this tank will be in compliance with **AWWA D100-11; 7.4.4** and **OSHA 1910.36**; General requirements.

We recommend :

- Install a 30" shell manway
- Install a 30" second shell manway 180° from primary shell manway
- Post **Confined Space Entry** signs at shell manways
- Install interior bowl ladders at shell manways
- Install cable type ladder safety devices on interior bowl ladders

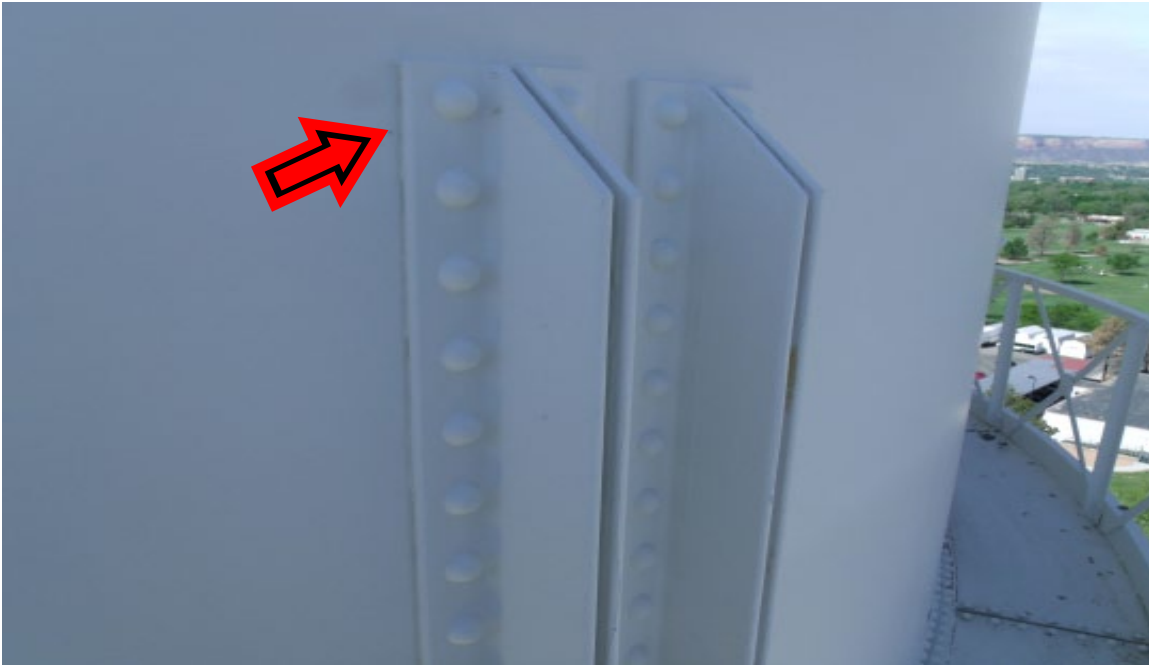
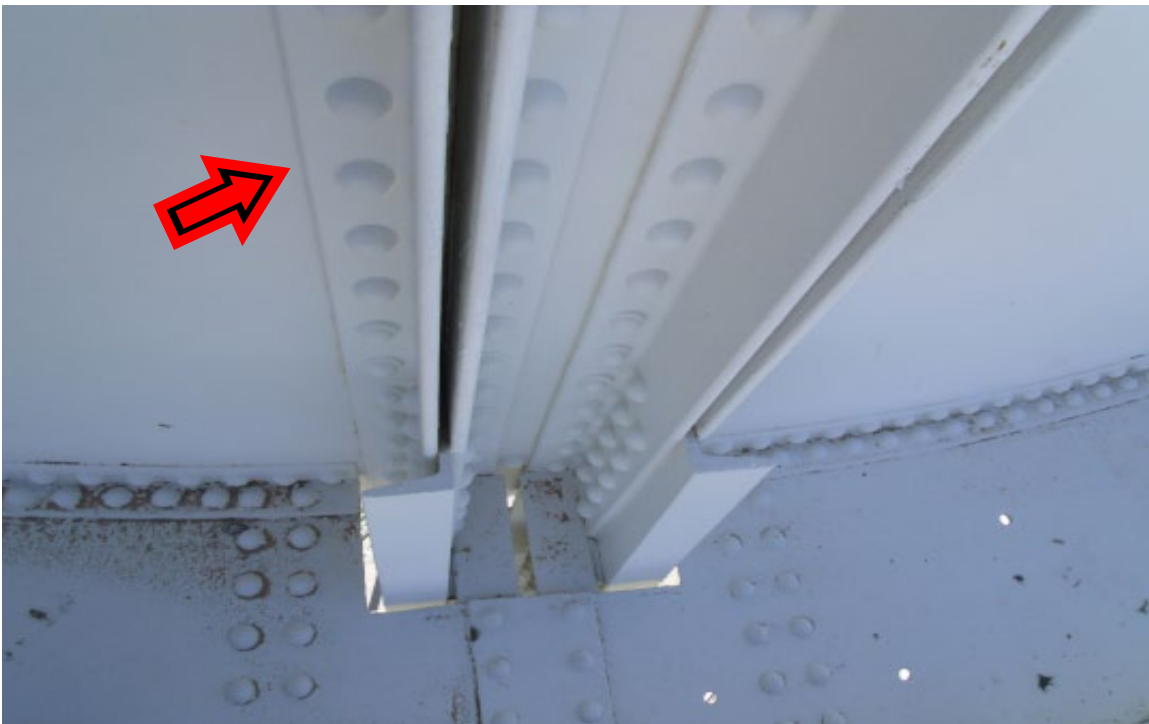
Photos show the condition of the posthead connections. The postheads secure the column legs to the tank shell and support the tank's live and dead load. We recommend welding the circumference of the posthead-to-shell connection for reinforcement.

17. Weld the circumference of the posthead-to-shell connections
18. Apply a commercial bird repellant on the tank to discourage birds from roosting in the treated area

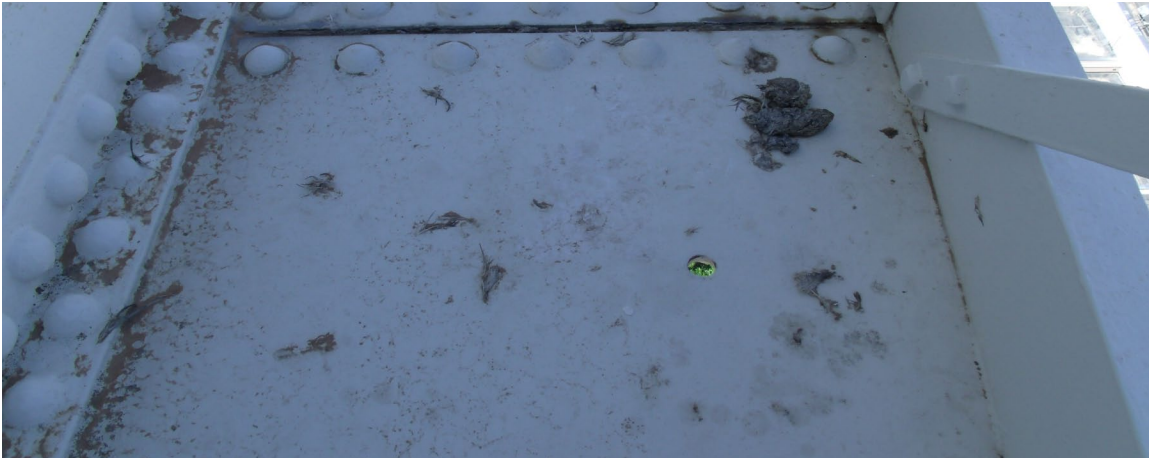
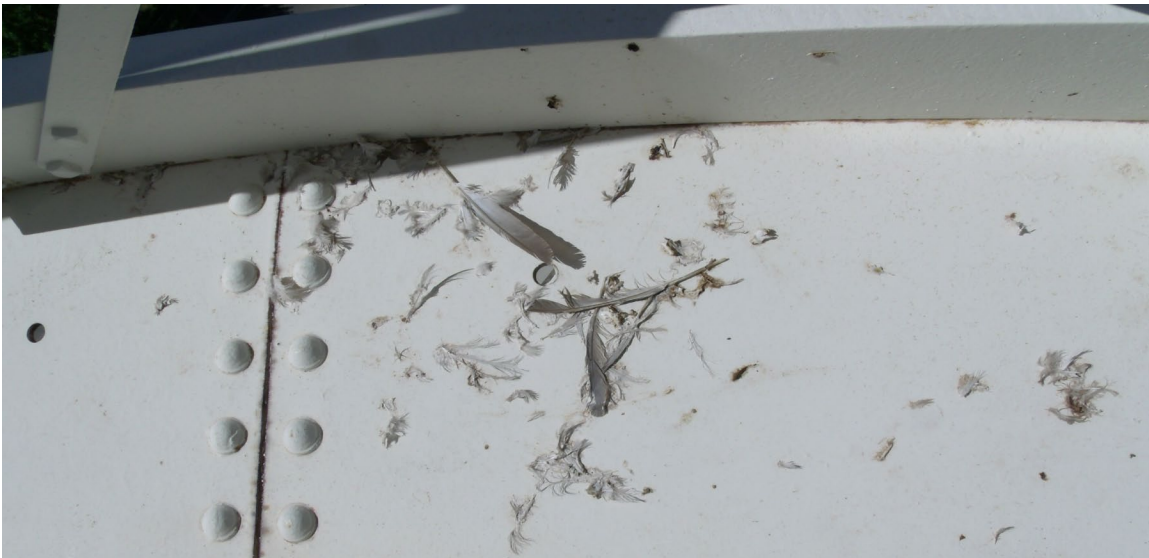
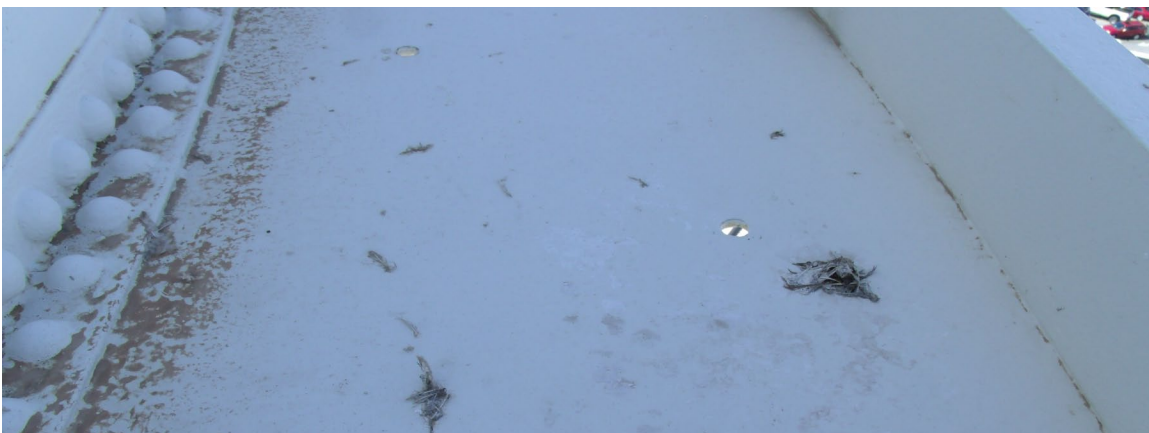
Photos show bird feathers on the tank catwalk. We recommend applying a commercial bird repellent on the tank to discourage birds from roosting in the treated area.

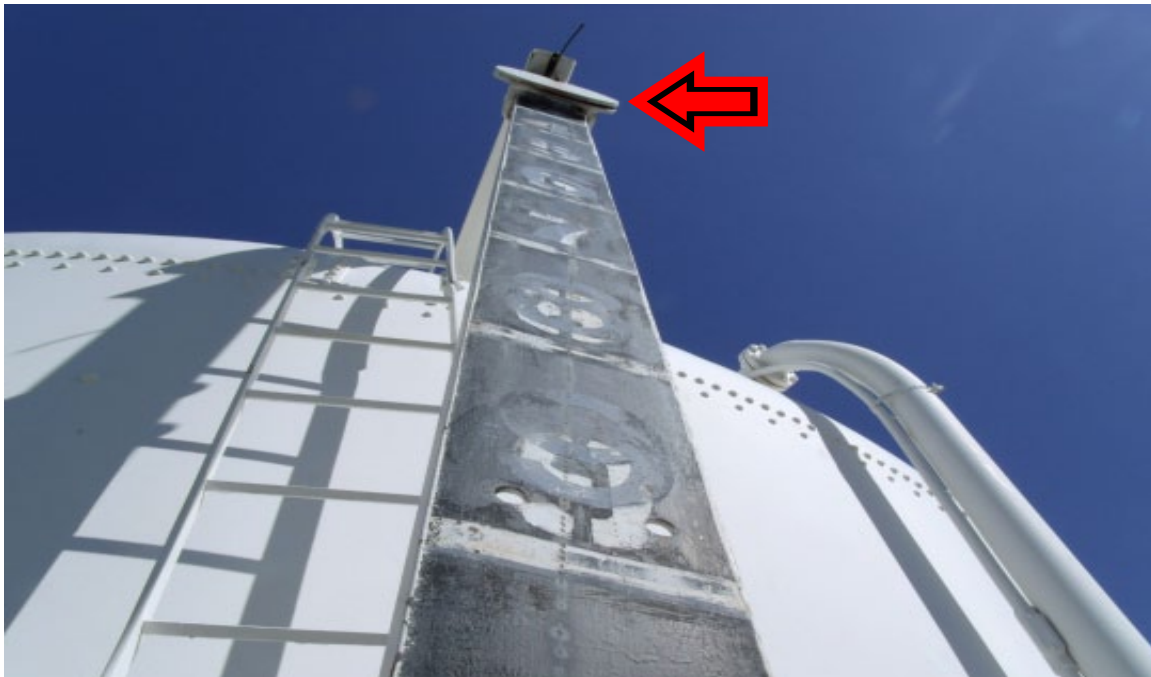
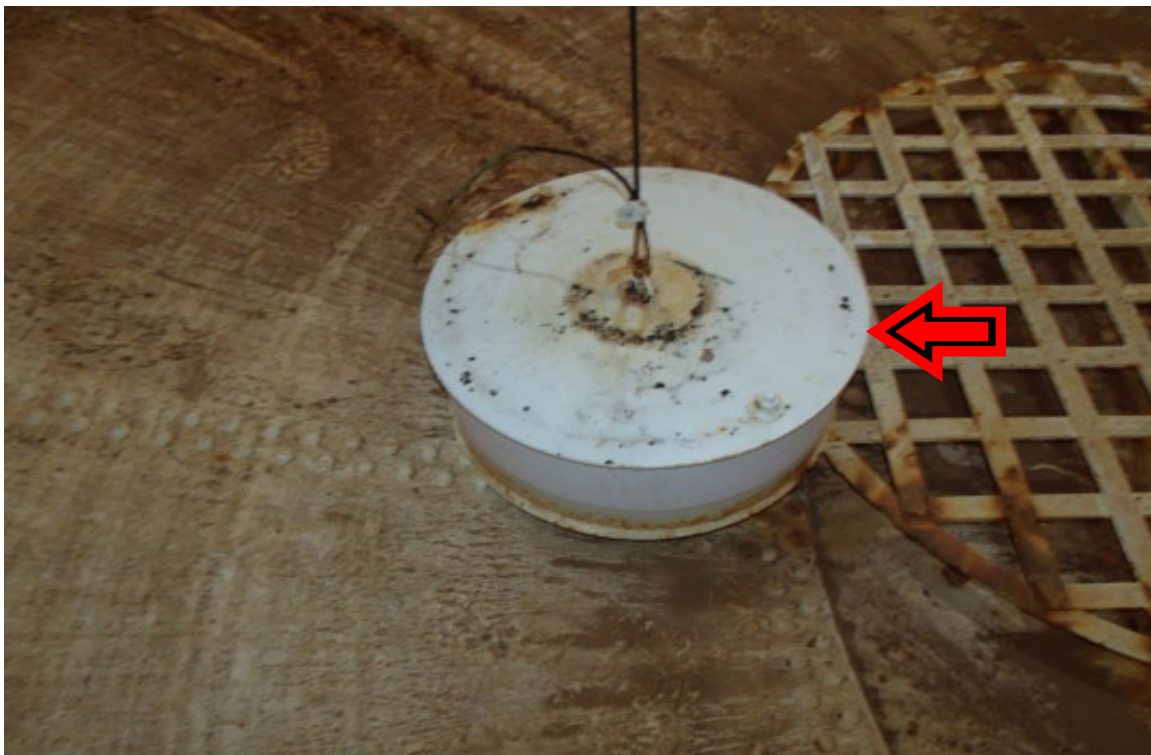
Photos show the condition of the liquid level indicator. We recommend cleaning and lubricating all moving parts on the liquid level indicator for preventative maintenance then adjust and calibrate the unit.

19. Clean and lubricate all moving parts on the liquid level indicator then adjust and calibrate the unit
20. Install an approved, anti-skid rung equipped, shell/roof access ladder complete with standoffs every 12' on center
Install a cable type ladder safety climb device
