**Veterans Administration
2121 N. Avenue
Grand Junction, CO 81501
RE: Boiler House
100,000 Gallon E.W.T.
May 17, 2013
Doyle Payne,
Assistant Chief Engineering Service
(970) 242-0731 ext. 2099
Job No. 313195**

ELEVATED TANK INSPECTION REPORT

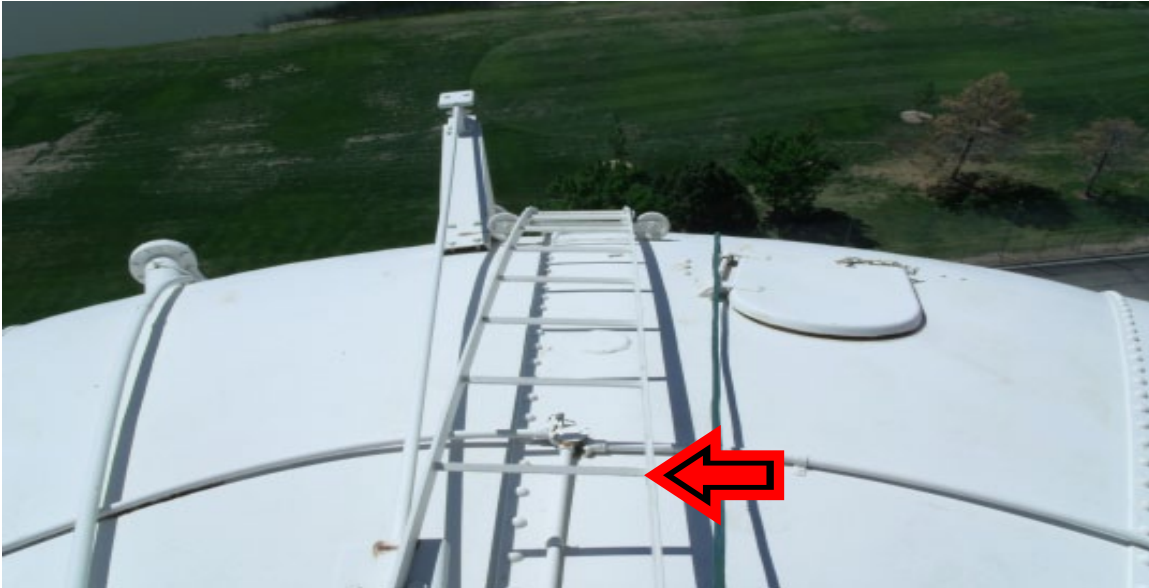
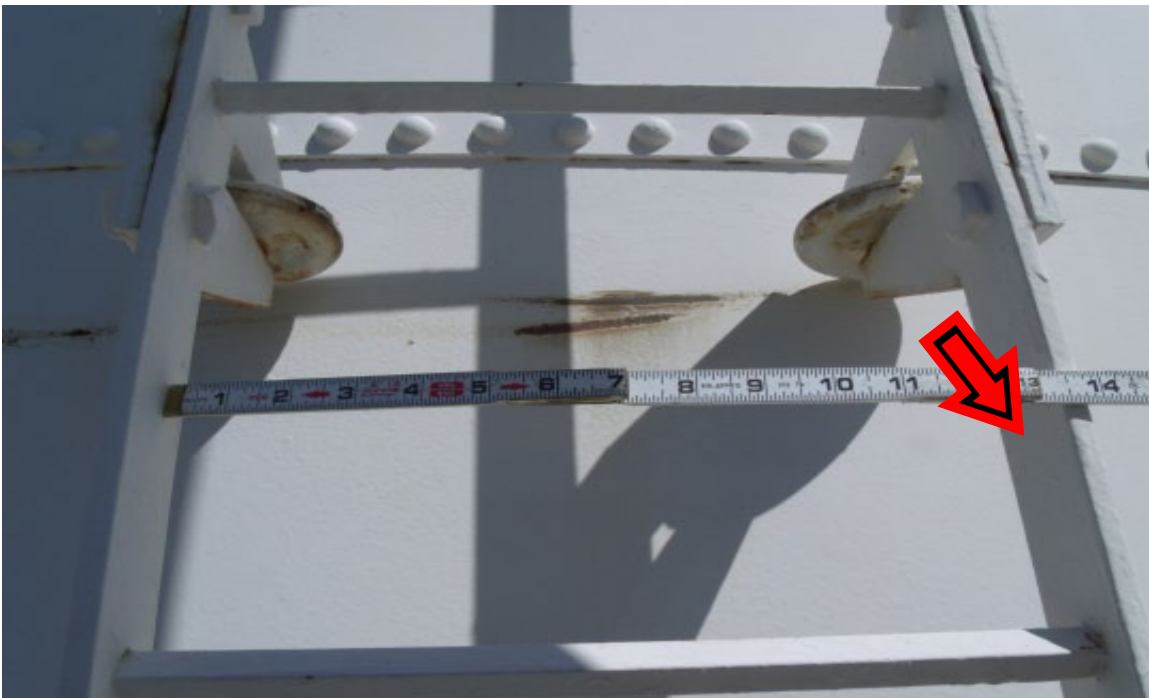
The photos show the shell/roof access ladder is equipped with anti-skid rungs but is only 13" wide, and is a roll-a-round type. **OSHA 19.27 Ladders** states; "Minimum clear distance between the sides of individual rung/step ladders and between the side rails of other fixed ladders must be 16 inches (41 cm)." We recommend installing an approved shell/roof ladder complete with standoffs every 12' on center and a cable type ladder safety device.

19. Clean and lubricate all moving parts on the liquid level indicator then adjust and calibrate the unit
20. Install an approved, anti-skid rung equipped, shell/roof access ladder complete with standoffs every 12' on center
Install a cable type ladder safety climb device

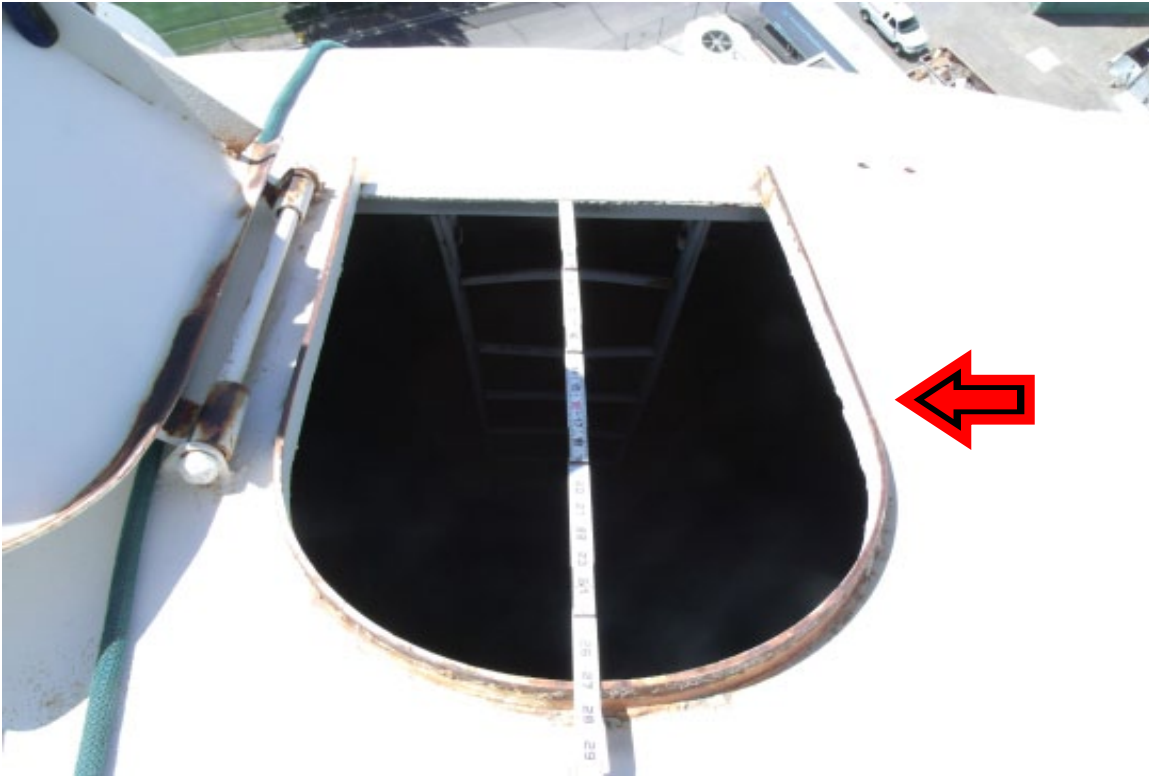
Photo shows the condition of the 27" x 19" roof manway. Roof openings on this tank require the following to be in compliance with [OSHA 29 CFR 1910.23\(a\)\(1\)](#) and [AWWA D100-11; 5.4.3.1 roof openings](#).

We recommend:

- Replace existing roof manway with a 30" manway with a 4" curb and a 2" overlap cover
- Post a **Confined Space Entry** sign on roof manway
- Install handrails around all roof openings

21. Replace existing roof manway with a 30" manway with a 4" curb and a 2" overlap cover
Post a **Confined Space Entry** sign on roof manway
Install handrails around all roof openings

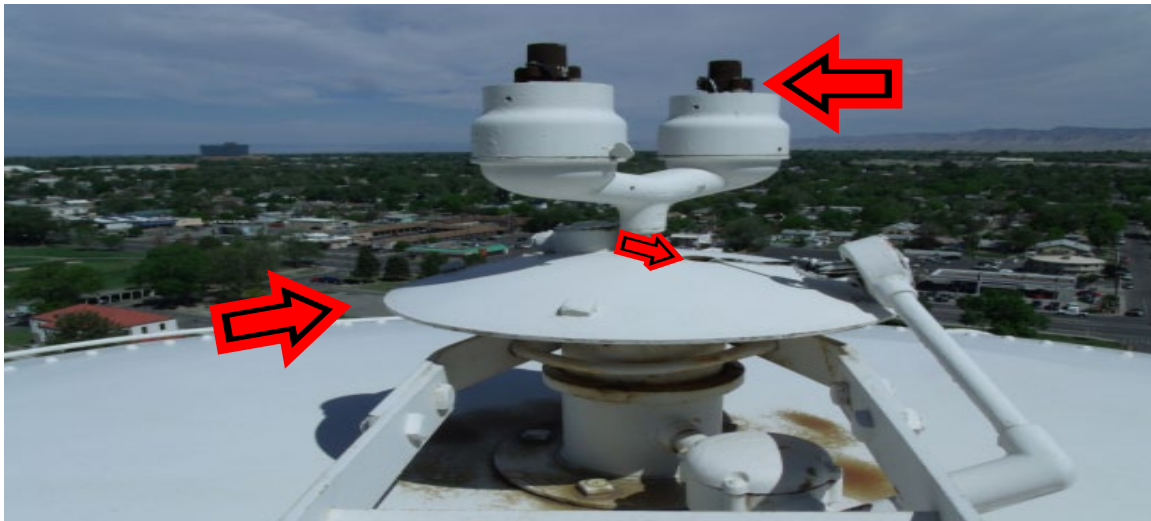
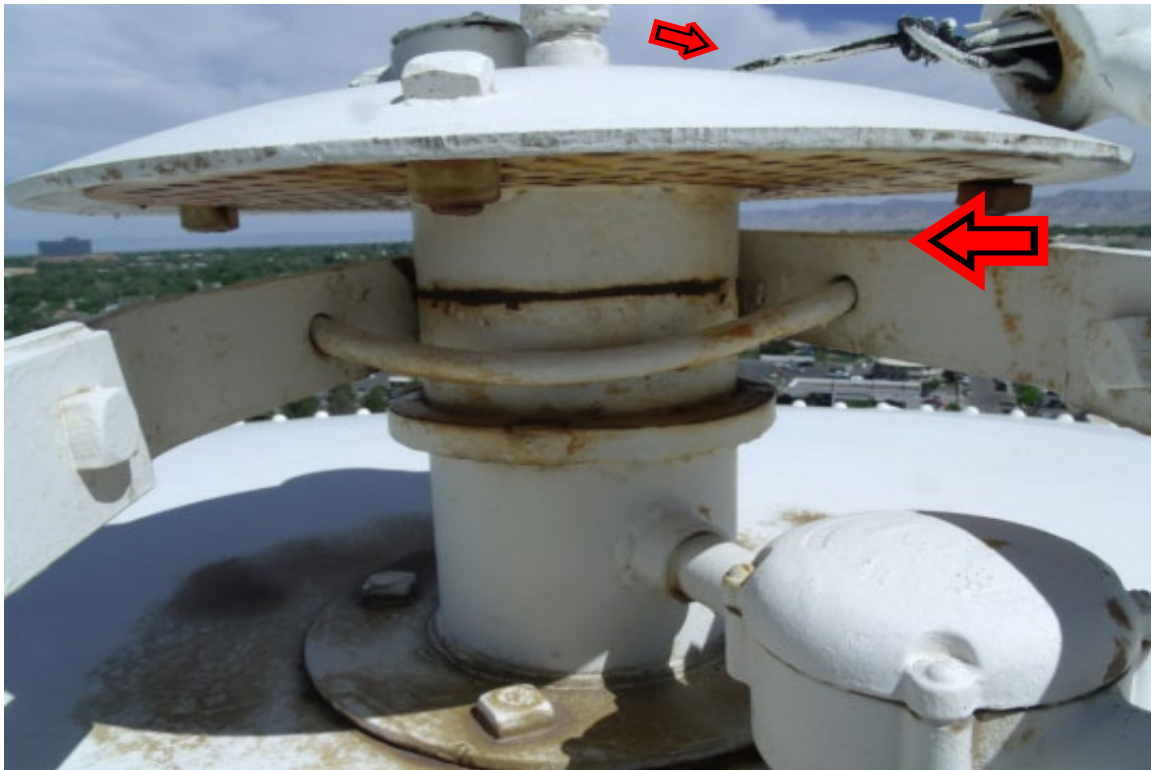
Photos show the condition of the existing roof vent. The vent is of an inadequate size and not compliant with **AWWA D-100; 5.5 vent**. **An improperly vented tank may cause external pressure to act on the tank which can cause buckling even at low pressure differential.** We recommend replacing the existing roof vent with a vacuum/pressure, frost proof vent and screen.

We recommend repairing or removing the obstruction light system.

22. Replace the existing roof vent with a vacuum/pressure vent and screen
Repair or remove the obstruction light system
24. Install an approved, anti-skid rung equipped, interior access ladder complete with standoffs every 12' on center
Install a cable type ladder safety climb device

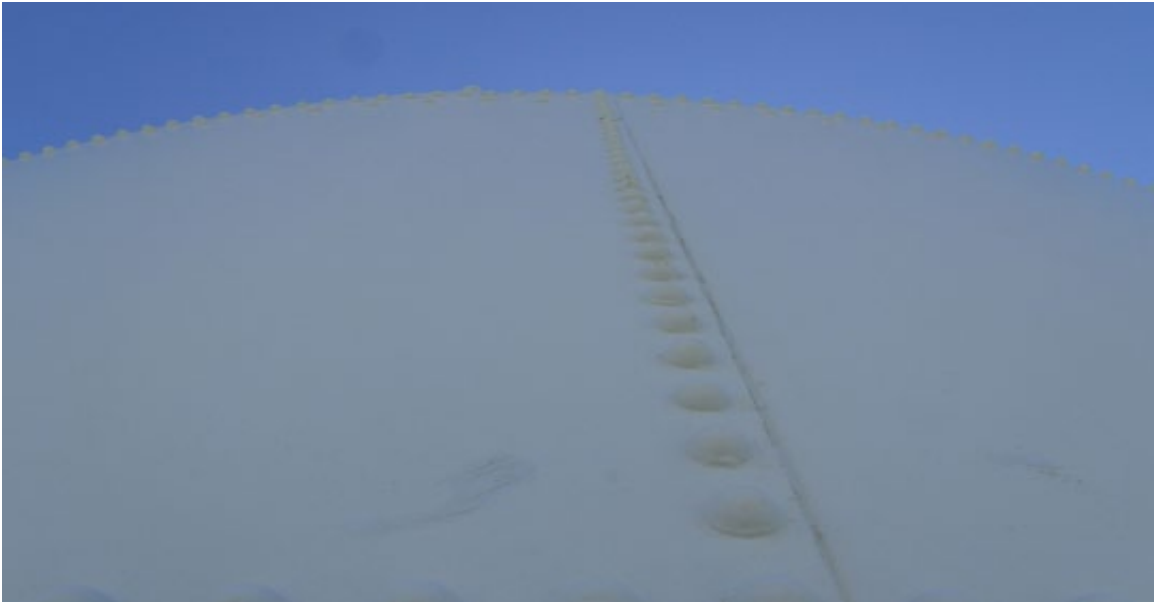
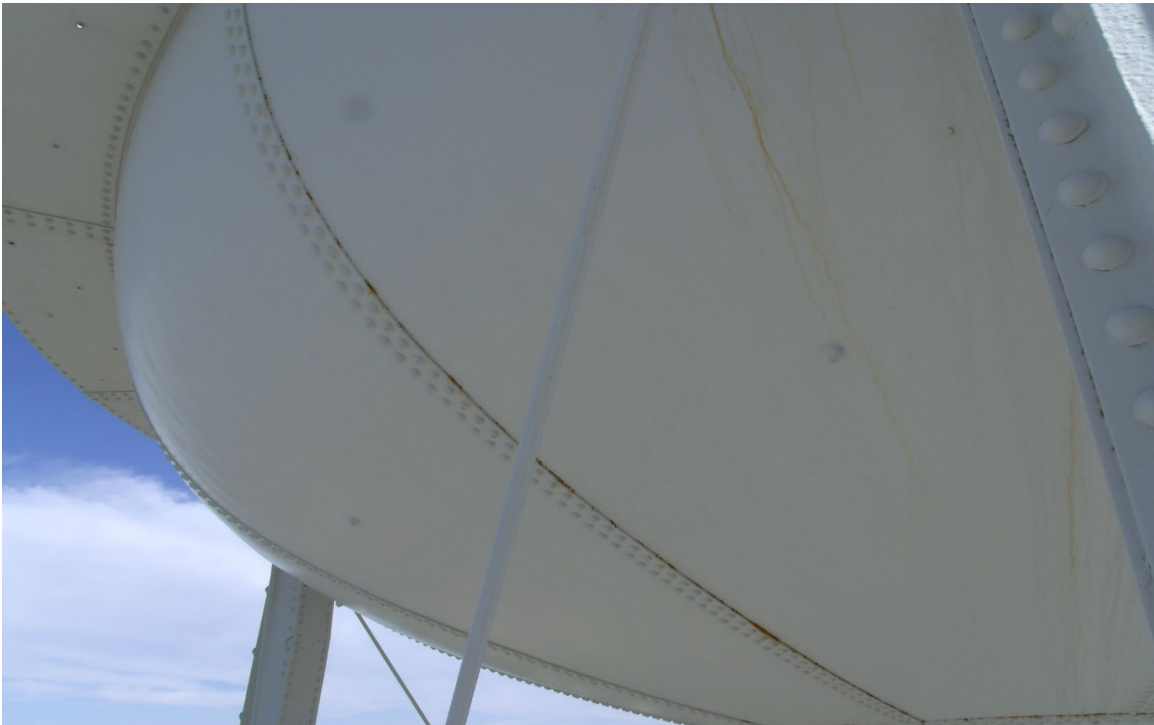
Photos show the tank exterior coating system which appears to be in good condition.

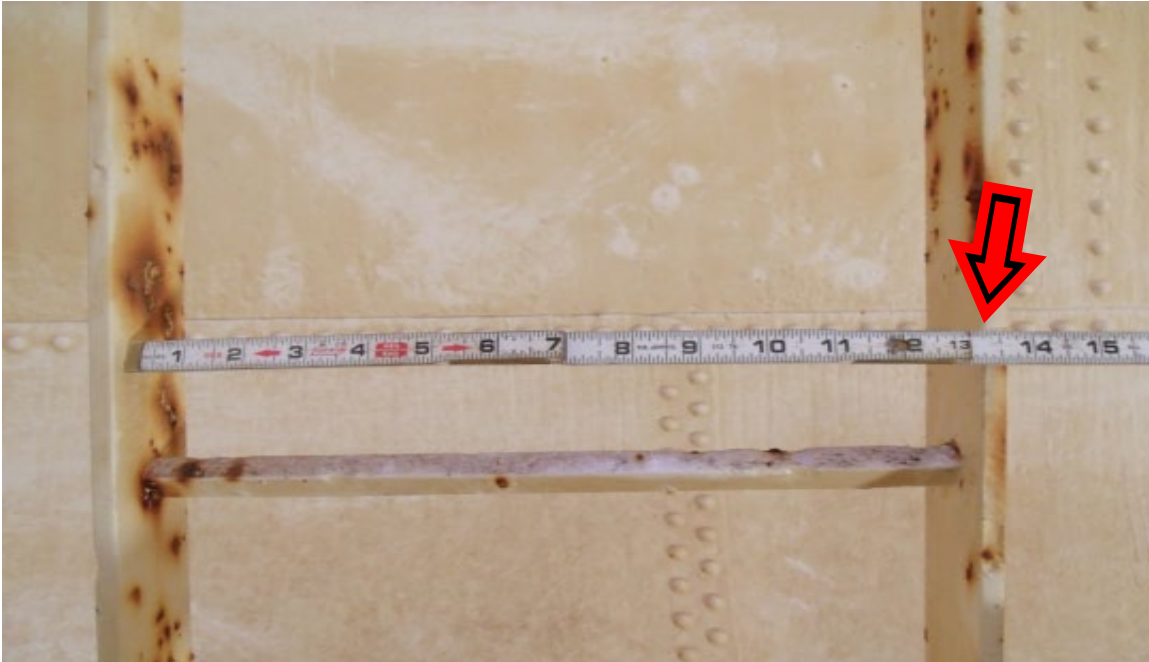
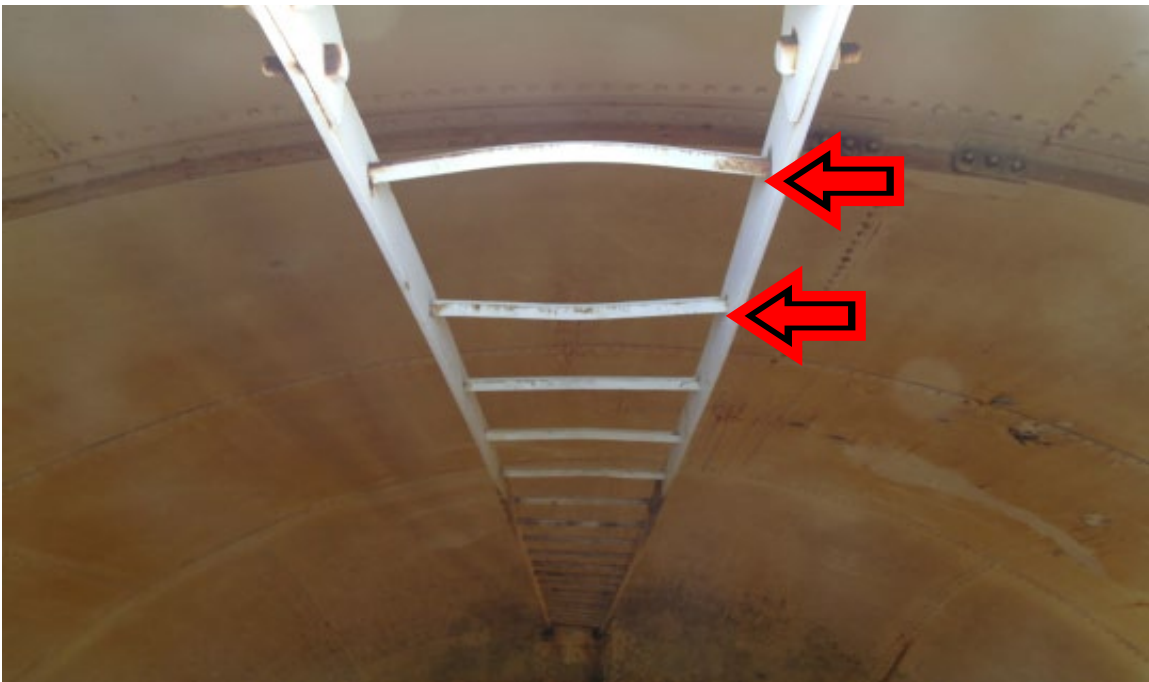
Photos show the interior access ladder is equipped with anti-skid rungs but is only 13" wide. (Also notice the bent rungs) **OSHA 19.27 Ladders** states; "Minimum clear distance between the sides of individual rung/step ladders and between the side rails of other fixed ladders must be 16 inches (41 cm)." We recommend installing an approved interior access ladder complete with standoffs every 12' on center and a cable type ladder safety device.

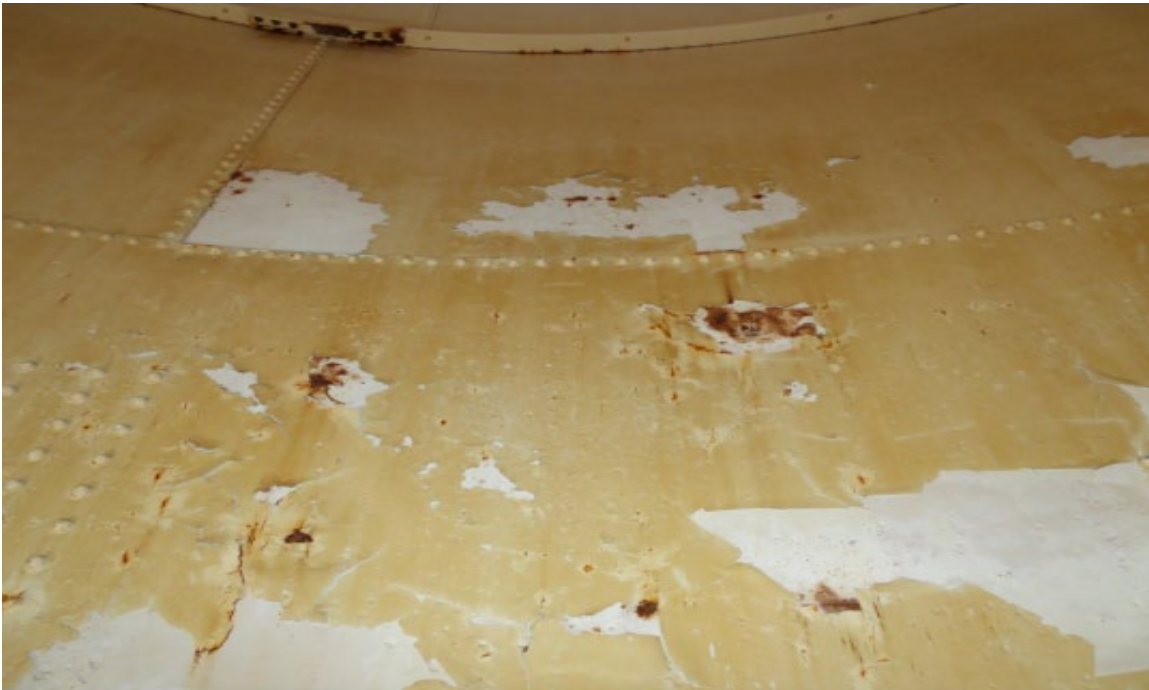
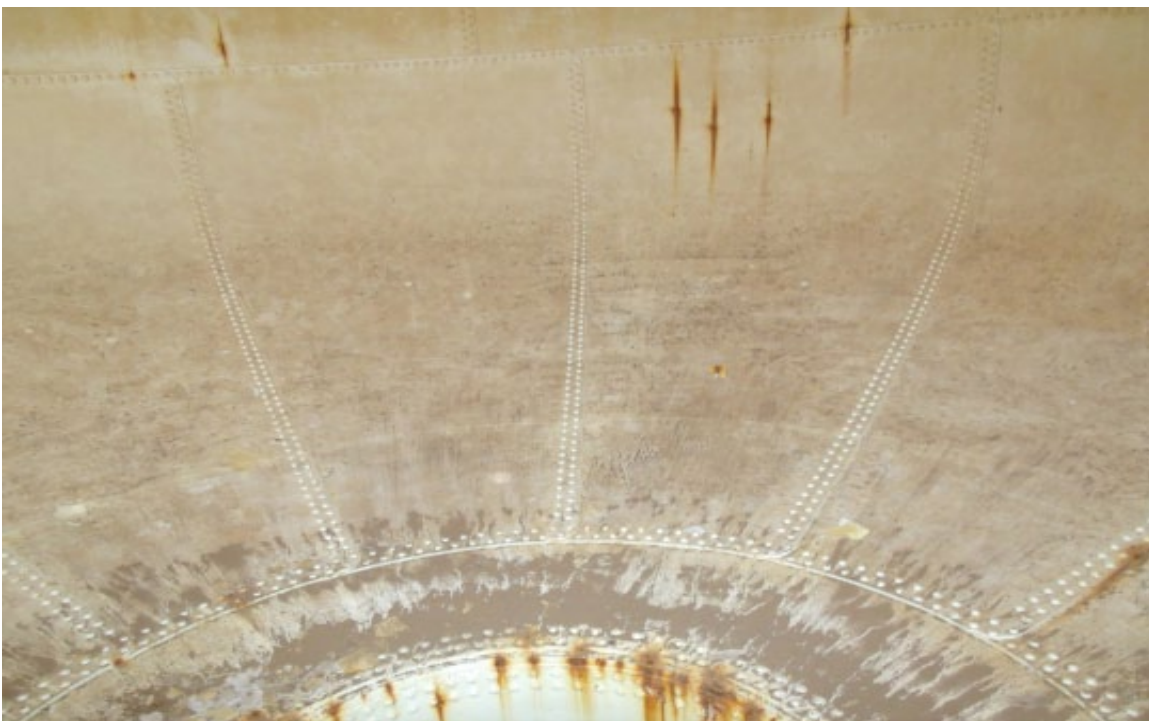
Photos show the tank interior after the clean out procedure.

We recommend installing a passive cathodic protection system on the interior of the tank.

25. Install a passive cathodic protection system on the interior of the tank

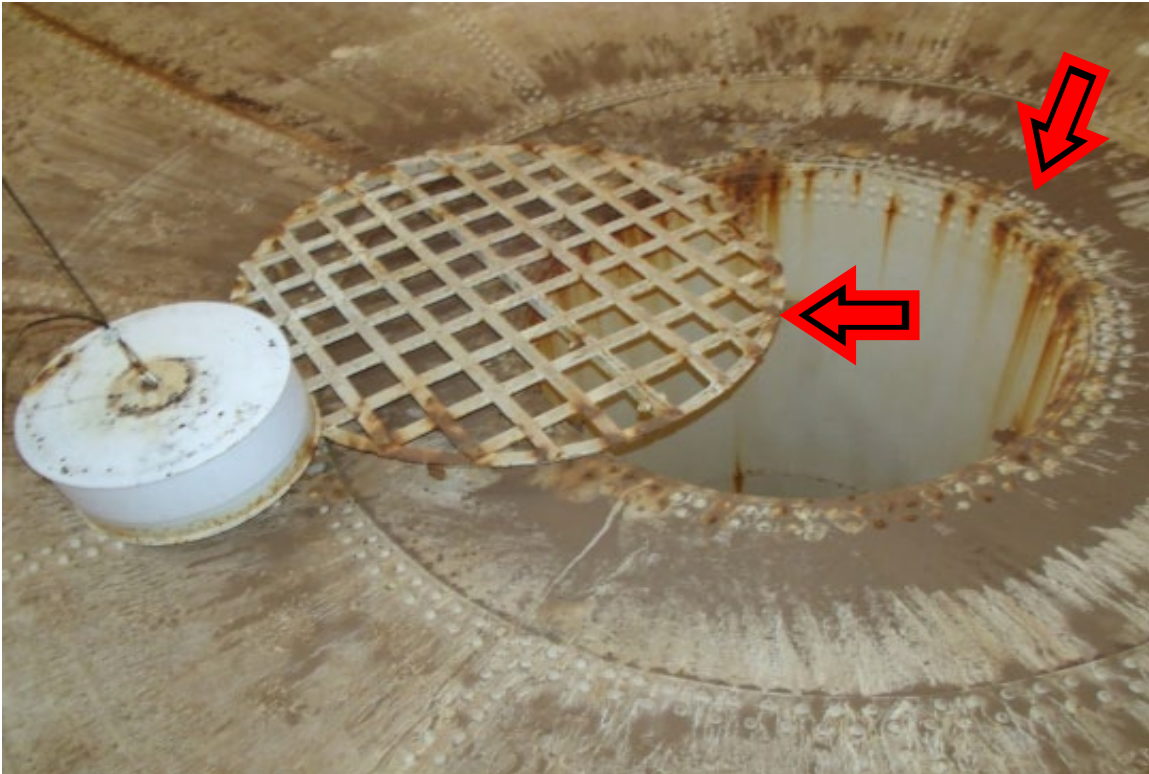
Photo shows the condition of the riser pipe opening. The riser opening is equipped with a safety grating in accordance with [AWWA D100-11;.5.1.1 Safety grill](#) and [OSHA 29 CFR 1910.23\(a\)\(1\)](#), which appears to be in good condition.

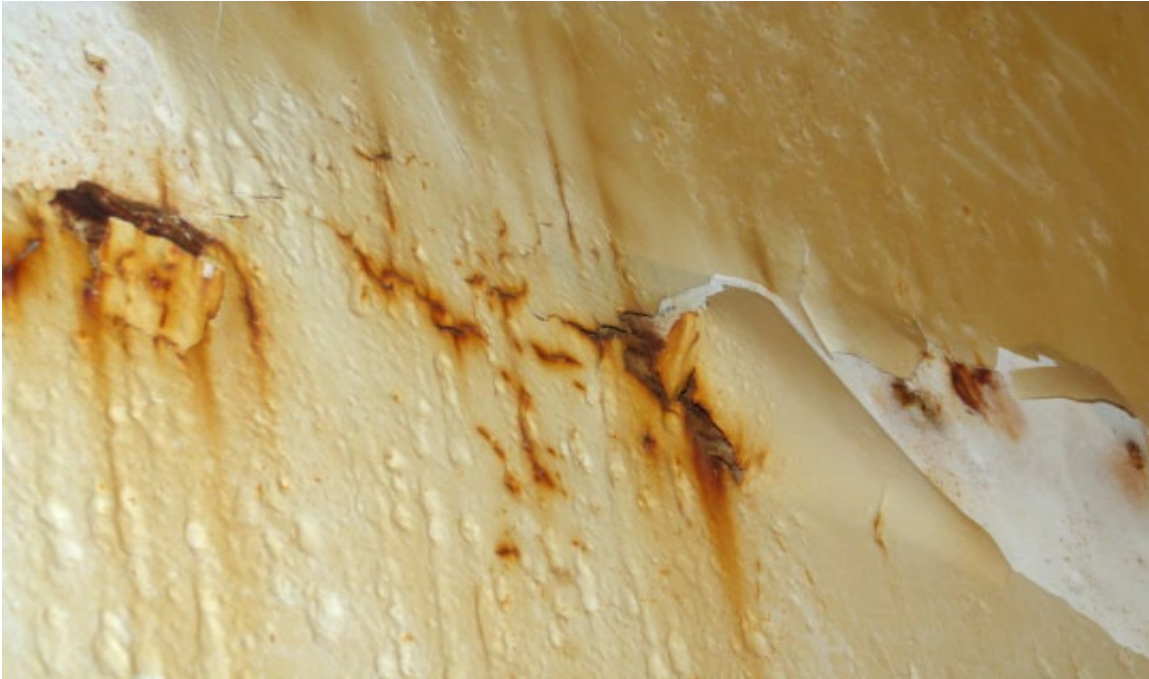
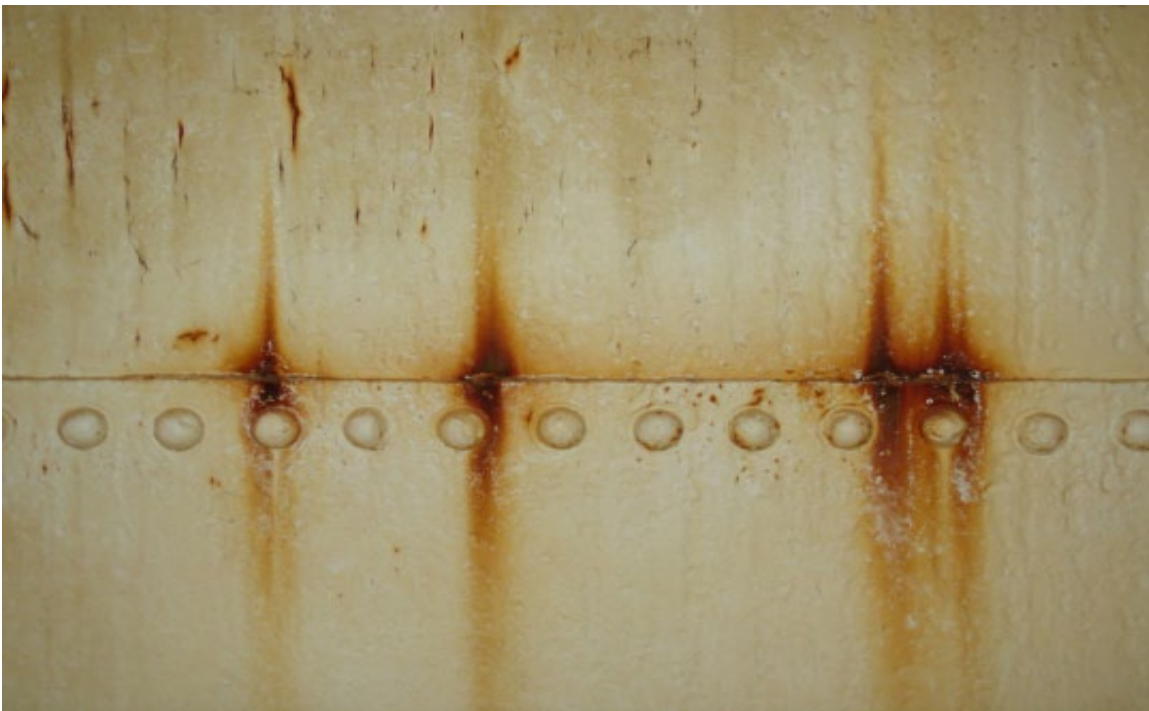
Photos show the condition of the interior liner. We recommend sandblasting the tank interior to an SSPC #10 (near white blast) condition, stripe coating all seams and welds, then applying an epoxy liner to achieve 8-10 mils of dry film thickness.

27. INTERIOR COATING SYSTEM: Sandblast all rusted and abraded areas of the tank interior to SSPC #10 (near white blast) condition, brushblast all remaining areas, stripe coat all seams and welds, then apply an epoxy liner to achieve 8-10 mils dry film thickness
