**Veterans Health Administration
W. G. Hefner Medical Center, Boiler #2
Refractory Replacement Recommendations
6/19/13**

Veterans Health Administration Contact: Benjamin Fine
ALSTOM Representative: Kurt Blomquist

Executive Summary

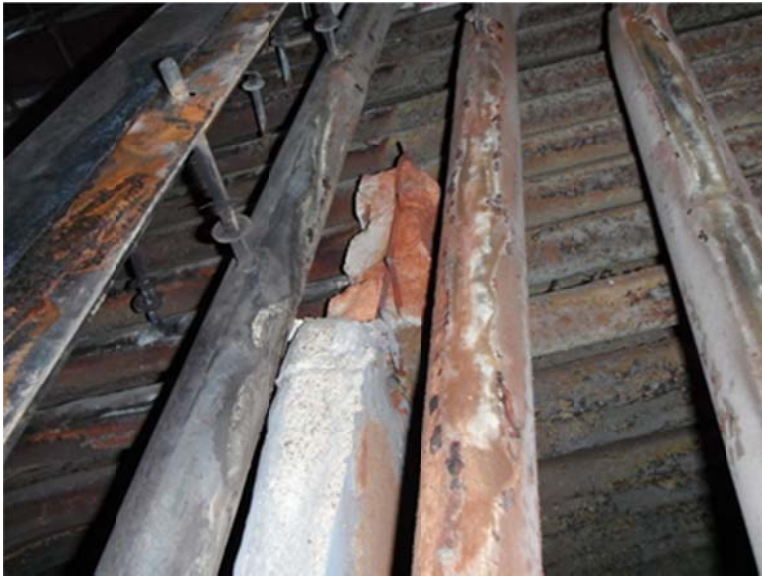
Minor damage was found on the Monolithic Baffles. The front baffle is comprised of an upper monolithic section, a removable tile, and lower monolithic section. The lower monolithic section connects with the tile portion that had been removed. The upper section of the Monolithic Baffle is only clearly visible from the left and right sides of the boiler. A small section has broken off on the left side where the baffle meets the refractory sidewall. The right side was in good condition. All visible areas were secure and not damaged or crumbling.

Damage on the left side of the front upper Monolithic Baffle.

Recommendation: The refractory baffles do not need to be removed and replaced. The sections in place are secure and in good condition. The sections at the sidewalls and on the bottom side of the front Monolithic Baffle that are missing material should be repaired with castable refractory. This will prevent hot combustion gases from bypassing the baffle and overheating the outlet and economizer of the boiler.

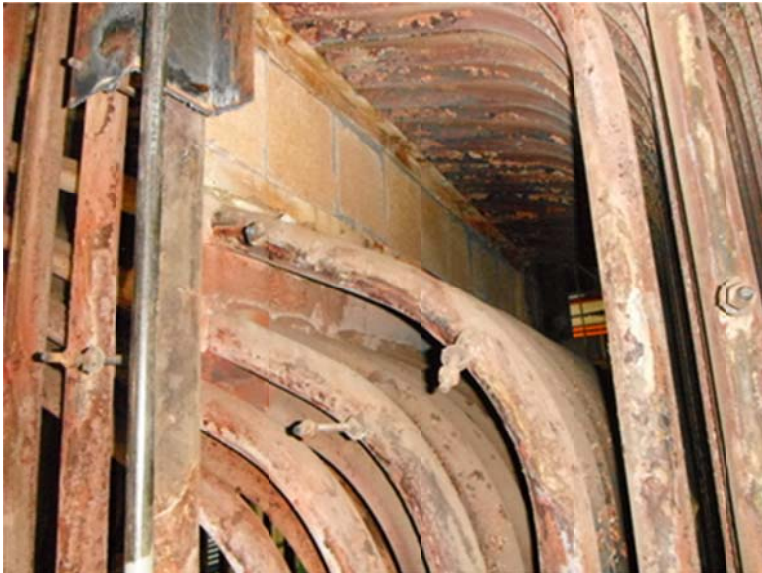
Front baffle general layout. Center and lower section shown.

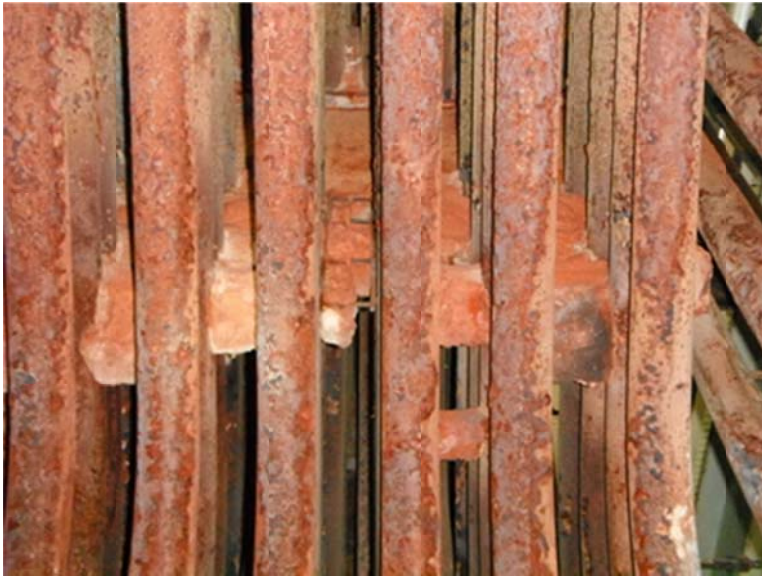
The front lower Monolithic Baffle is more accessible than the top and is damaged at multiple locations. Sections of refractory have fallen off and exposed the anchor wire at the center of the baffle. This likely occurred during the removal of the 2" tile section below. These damaged areas can be viewed and reached from a scaffold below inside the furnace. The sections of the baffle remaining all appeared secure with no cracks or crumbling that could allow them to fall.

Section of the front lower Monolithic Baffle that is damaged. The anchor wire has been exposed.

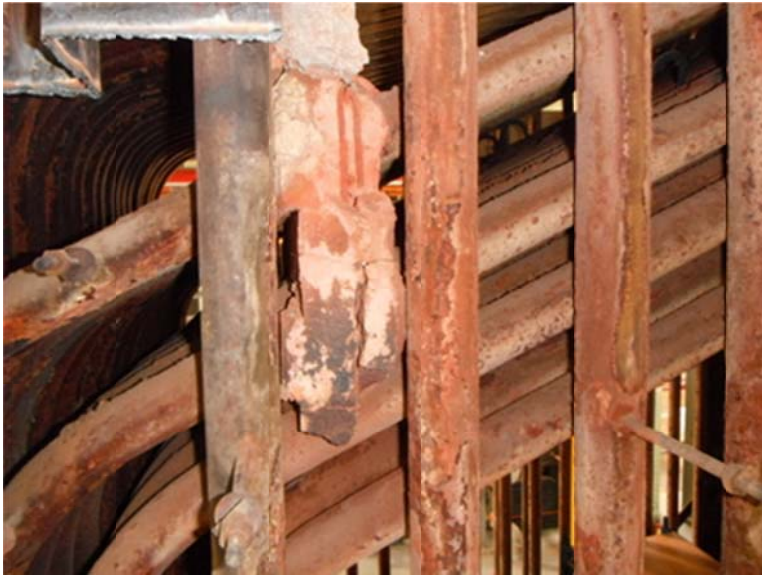
Damage on the left side of the front, lower Monolithic Baffle.

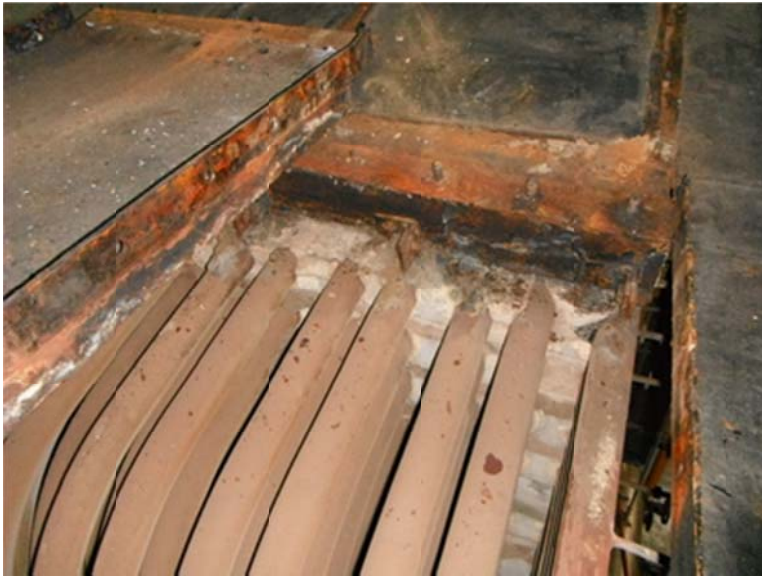
Top side of the rear Monolithic Baffle where a roof panel has been removed.

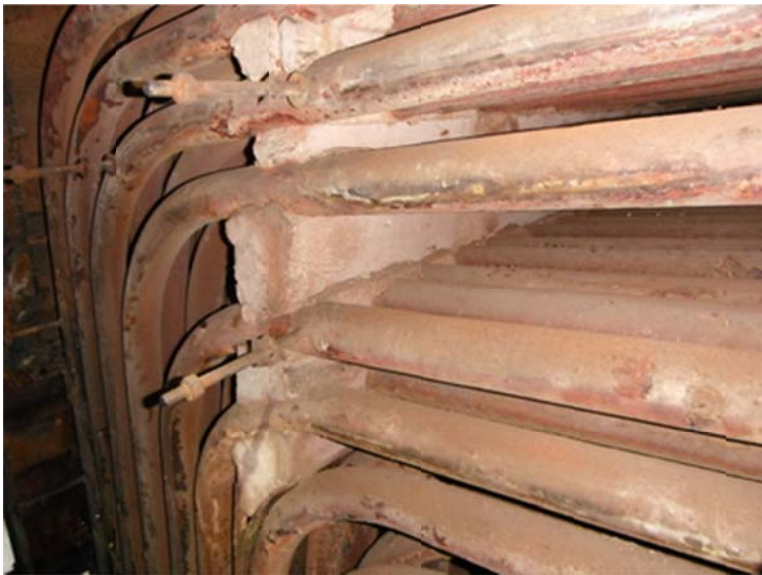
Left side view of the rear Monolithic Baffle. Minor damage where it meets the sidewall.

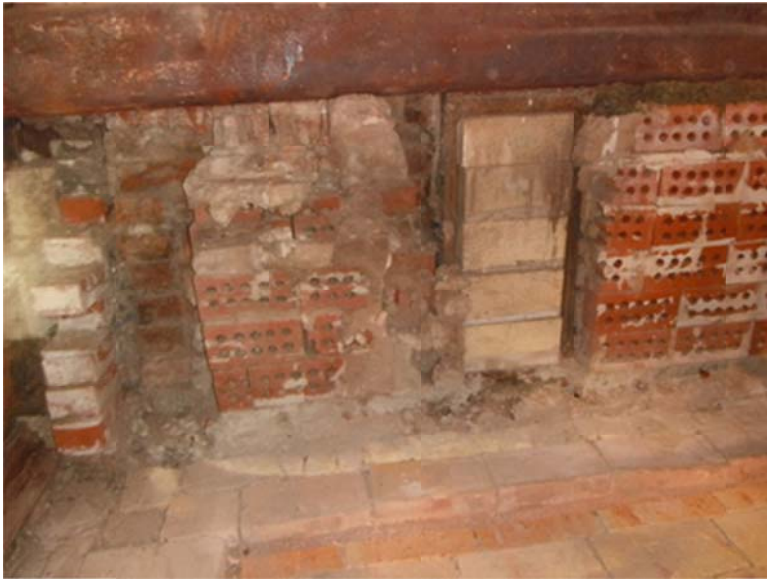
When the boiler was converted to wall firing from stoker firing, the stoker was removed which included concrete piers that lined the inside of the brick boiler foundation. This was replaced with masonry brick that was crudely installed on the inside of the existing brick foundation. Refractory brick was set against the inside section of the steel I-beams that support the lower waterwall headers. However, the I-beams are still exposed to the combustion fireball and temperatures.

View of added masonry brick at the front left corner of the furnace.

Recommendation: Remove the crudely installed masonry brick on the inside of the furnace foundation. Replace it with refractory brick filled in with castable refractory as needed that will properly insulate. The steel I-beams supporting the headers should not be visible from inside the furnace when complete.

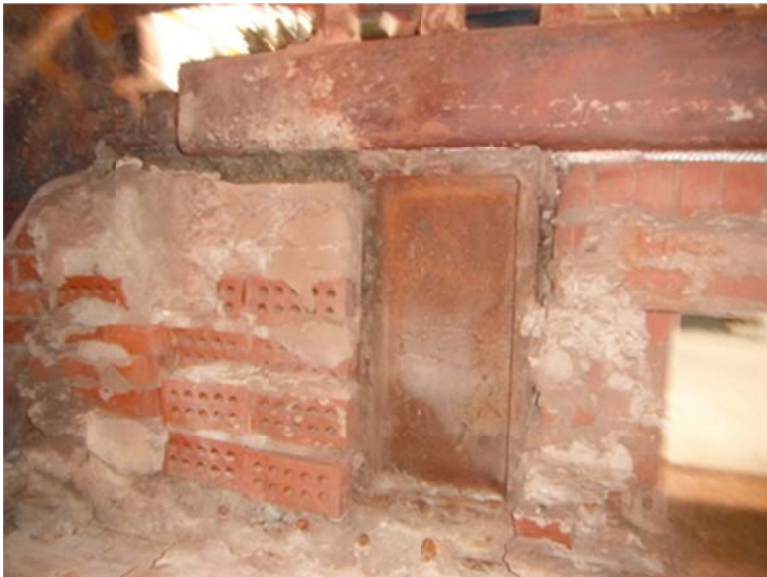
View of the added masonry brick at the rear right corner of the furnace. This support beam was left exposed.
