ASBESTOS CONTAINING BUILDING MATERIAL REPORT BUILDING 1

**Bay Pines VA Medical Center
10000 Bay Pines Boulevard
Bay Pines, Florida**

Project No. 2009011.002

November 9, 2009

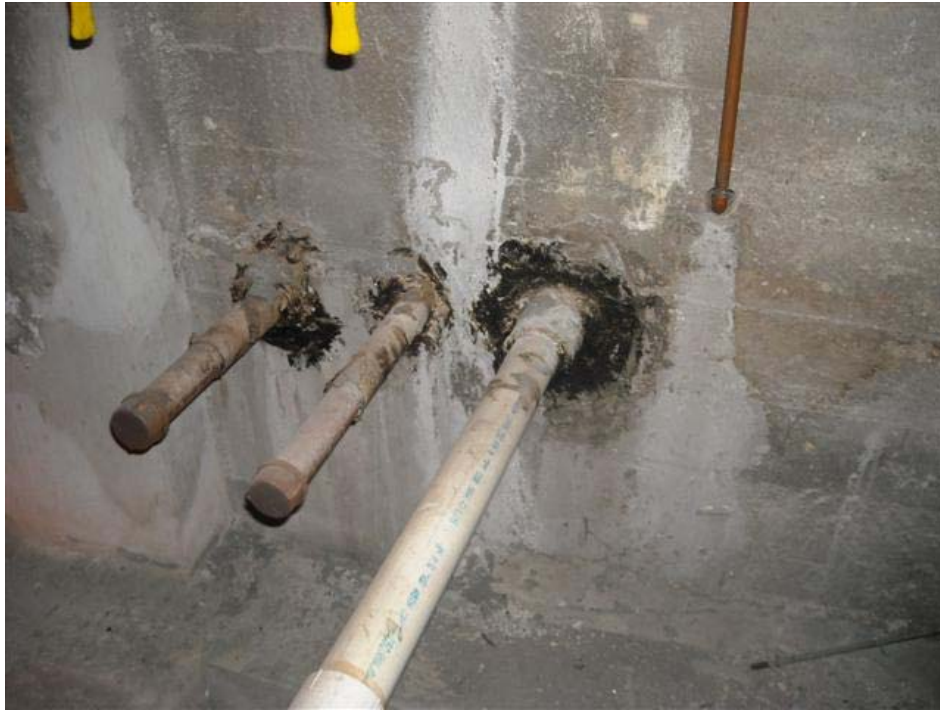
Building 1
Sample 13 - Black Fire Stop

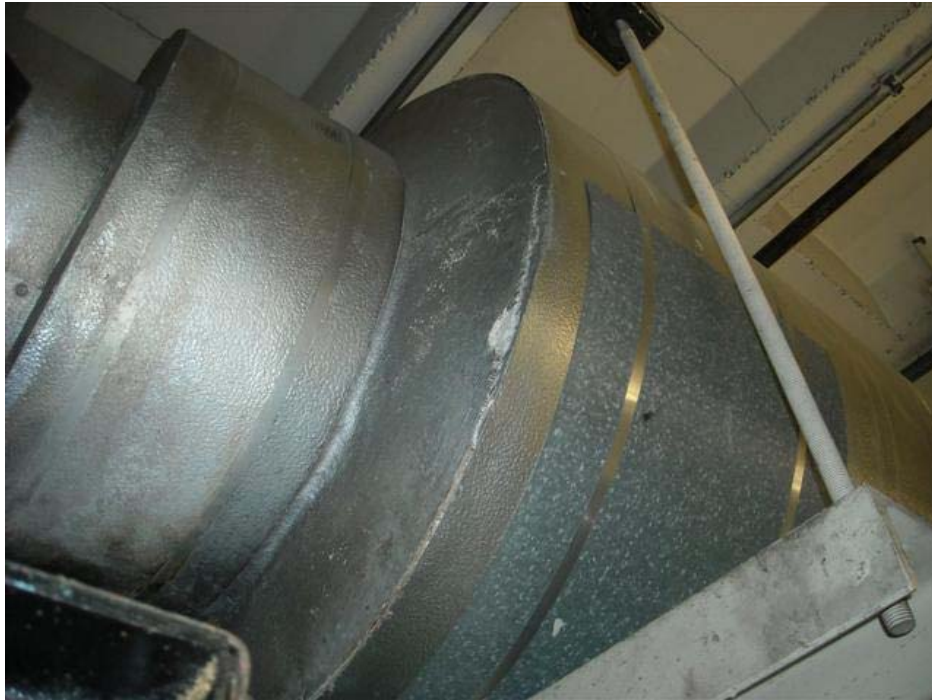
Building 1
Sample 58 - Generator Insulation Wrap

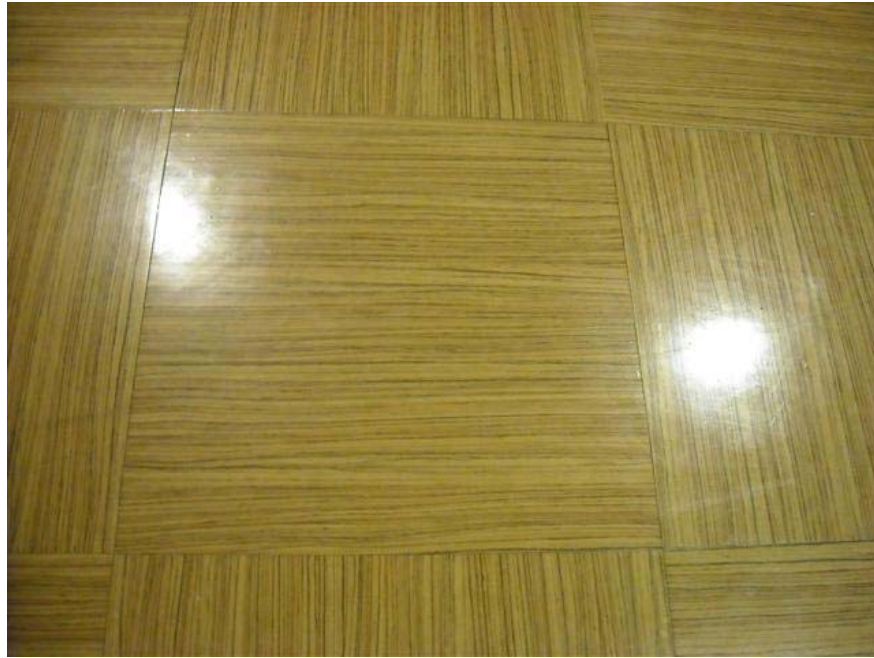
Building 1
Sample 64 - 18"x18" Wood Pattern FT Mastic

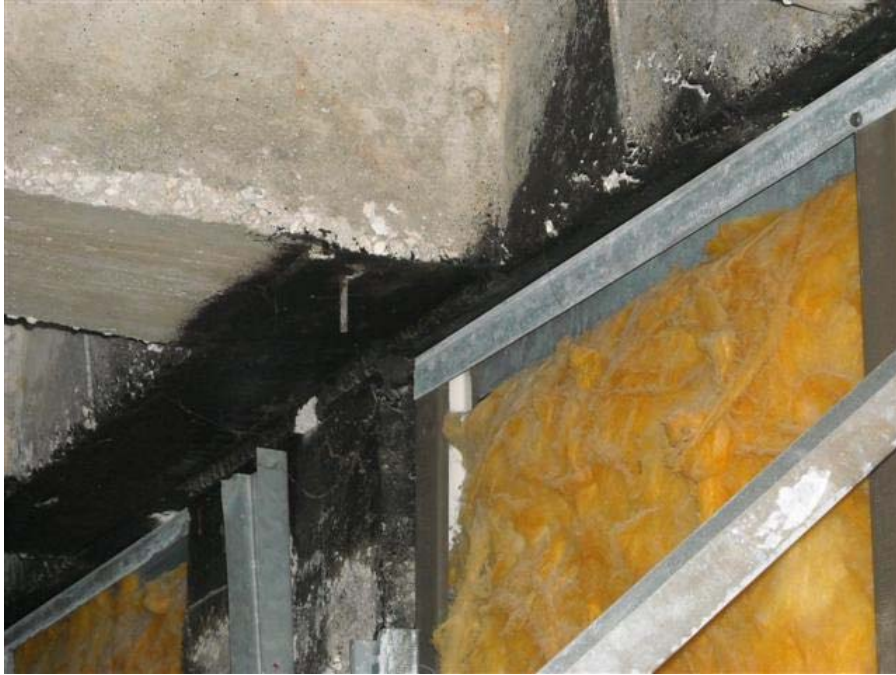
Building 1
Sample 76 - Black Waterproofing – Exterior Walls

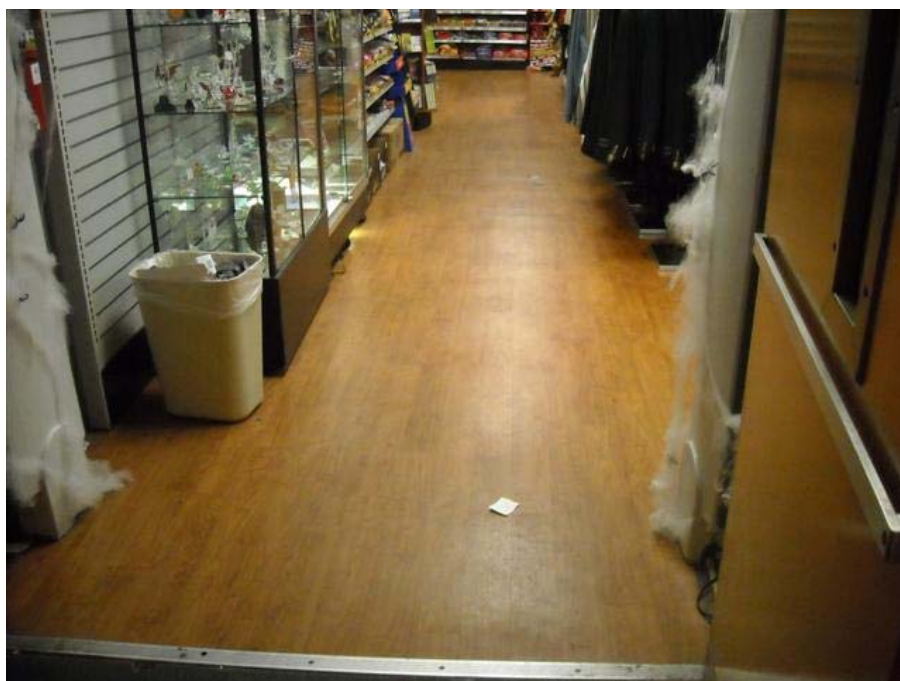
Building 1
Sample 82 – Wood Grain Linoleum Mastic

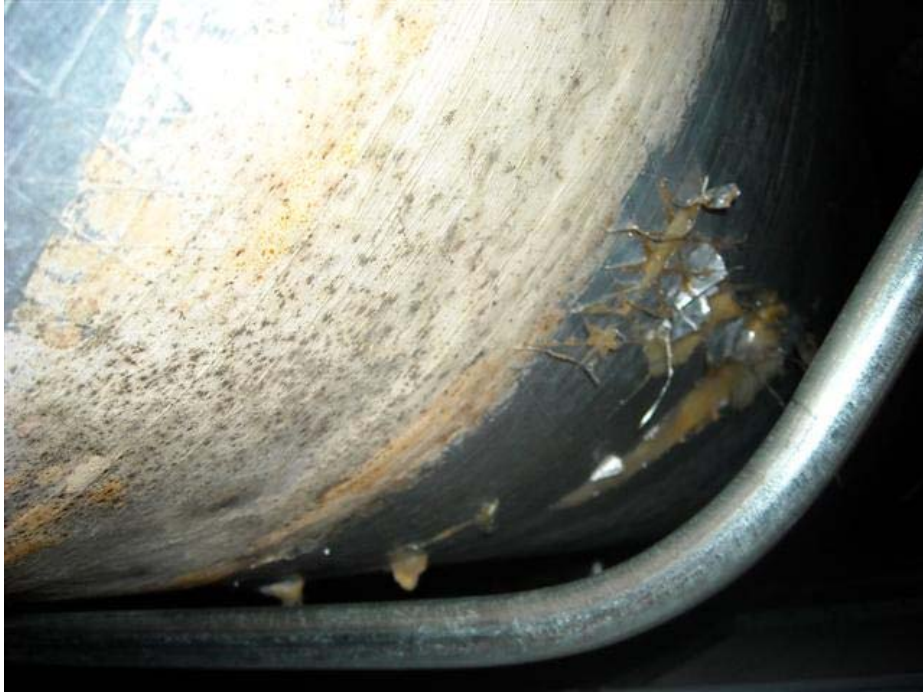
Building 1
Sample 123 – Off-White Duct Wrap

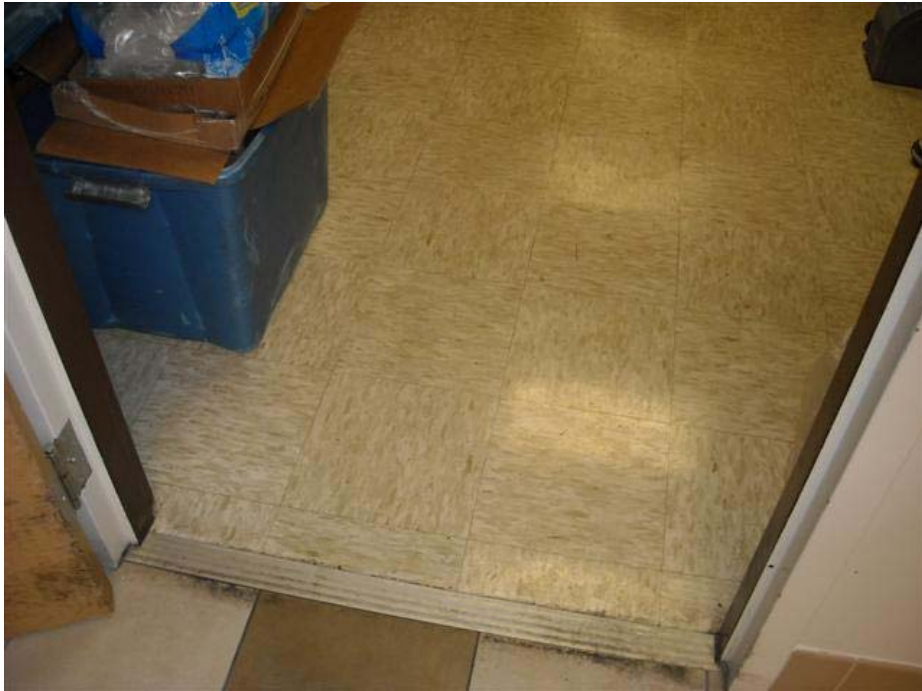
Building 1
Sample 150 – 12” Gray FT Mastic

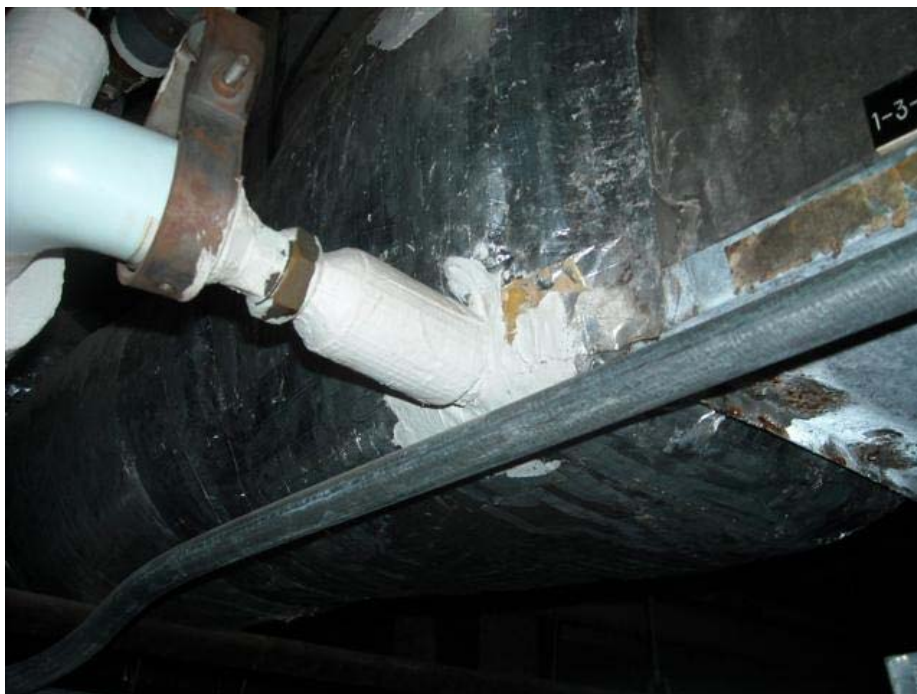
Building 1
Sample 165 – White Duct Mastic
