# **ASBESTOS CONTAINING BUILDING MATERIAL REPORT BUILDING 12**

**Bay Pines VA Medical Center  
10000 Bay Pines Boulevard  
Bay Pines, Florida**

Project No. 2009011.001

July 31, 2009

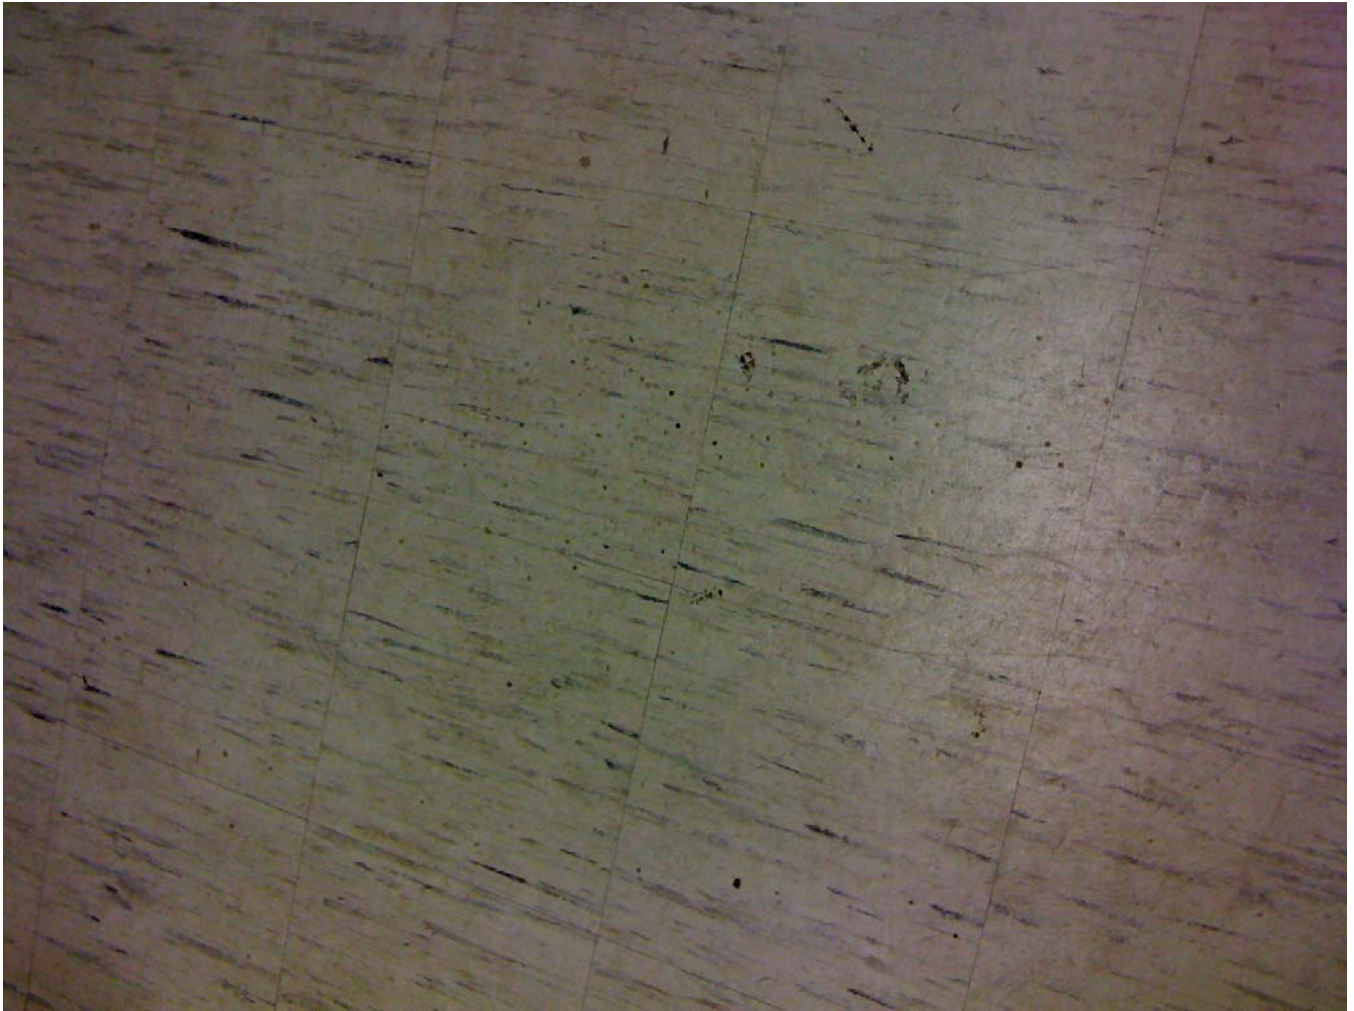
**Building 12**  
**Sample 38 Floor - 12" x 12" White Floor Tile**

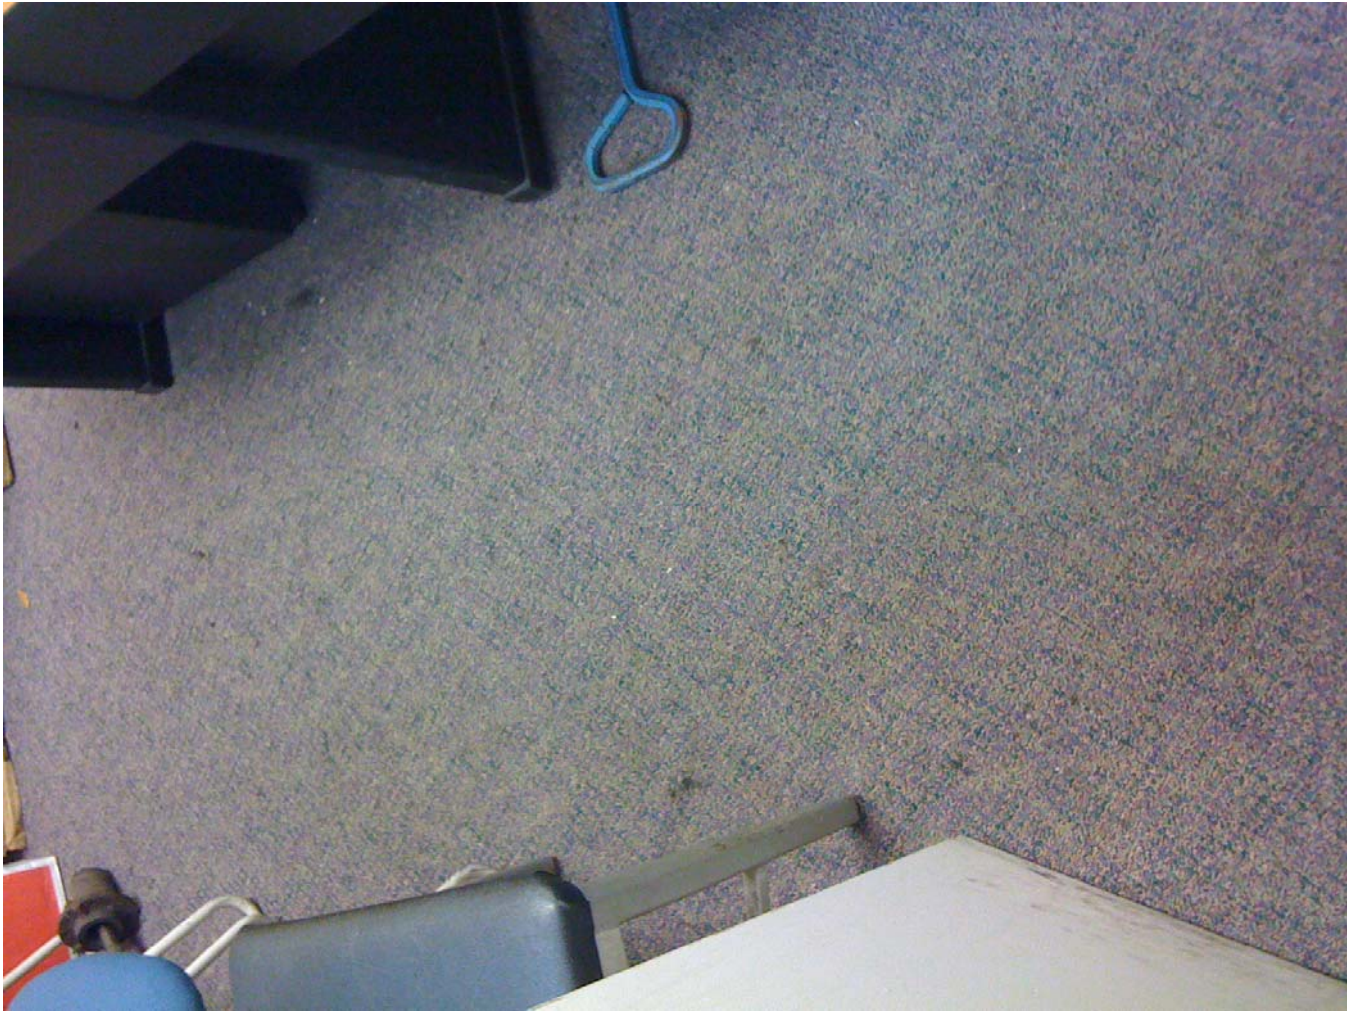
**Building 12**  
**Sample 41 – Brown Carpet Mastic**

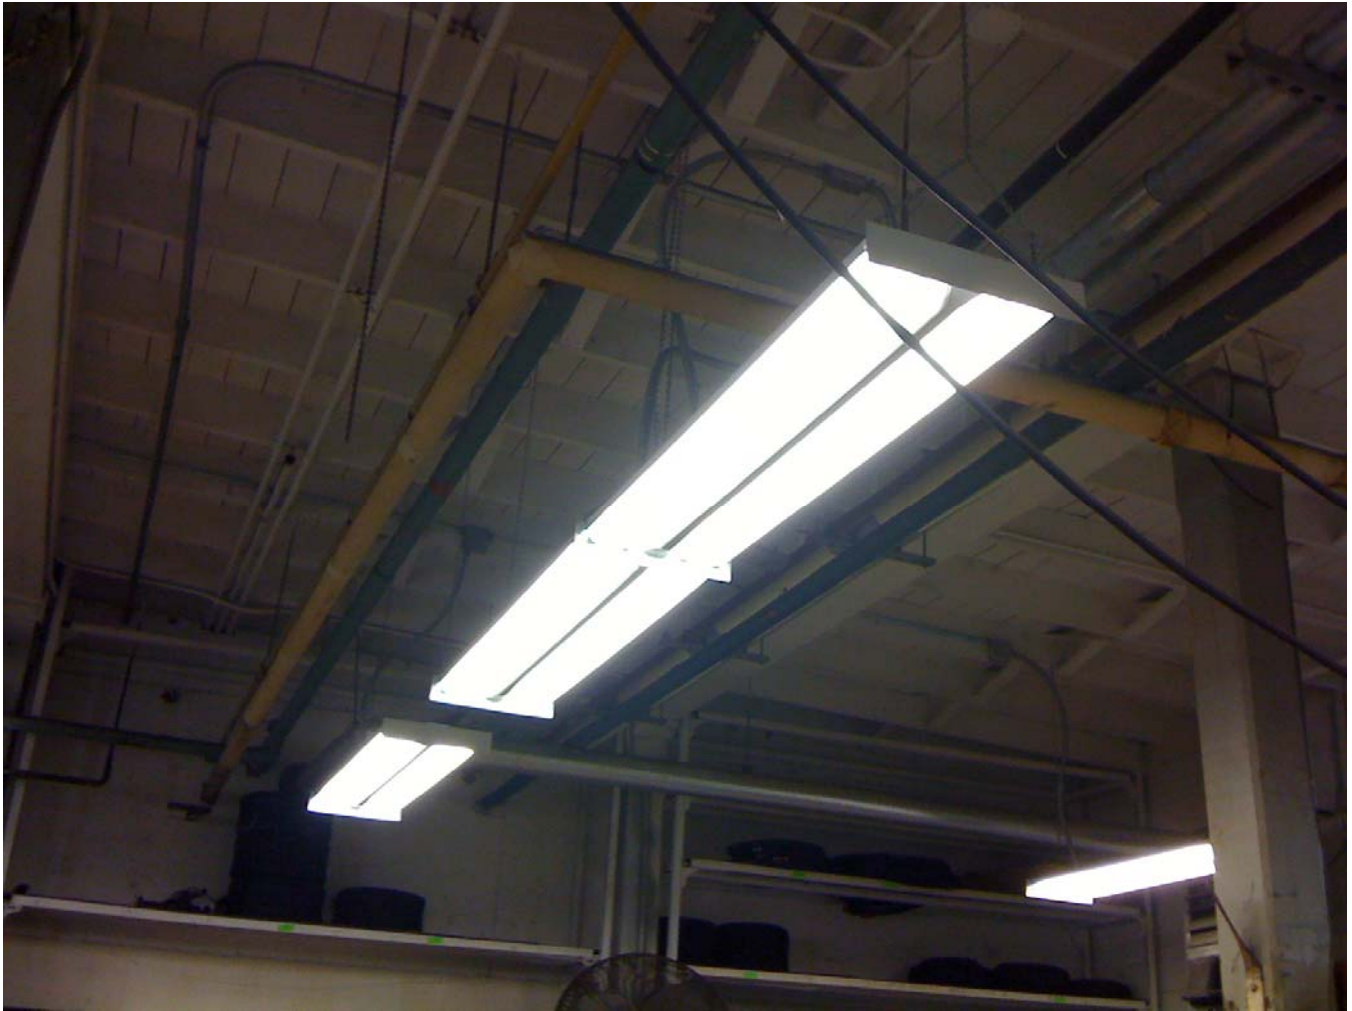
**Building 12**  
**Sample 53 - Air Cell Pipe Insulation**

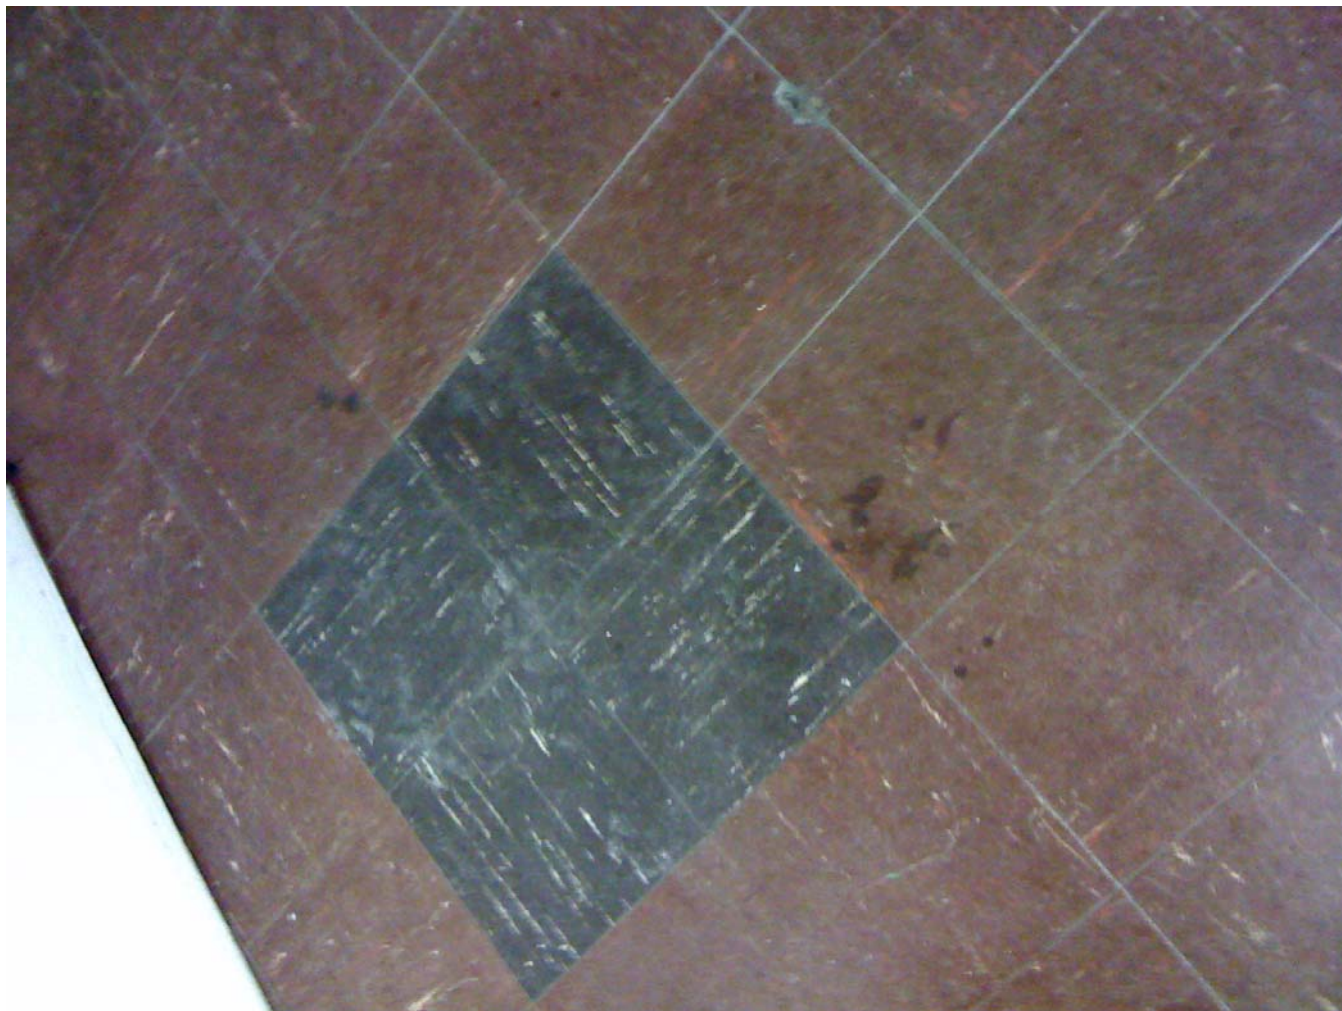
**Building 12**  
**Sample 59 - 9" x 9" Burgundy Floor Tile**  
**Sample 62 - 9" x 9" Dark Burgundy Floor Tile**

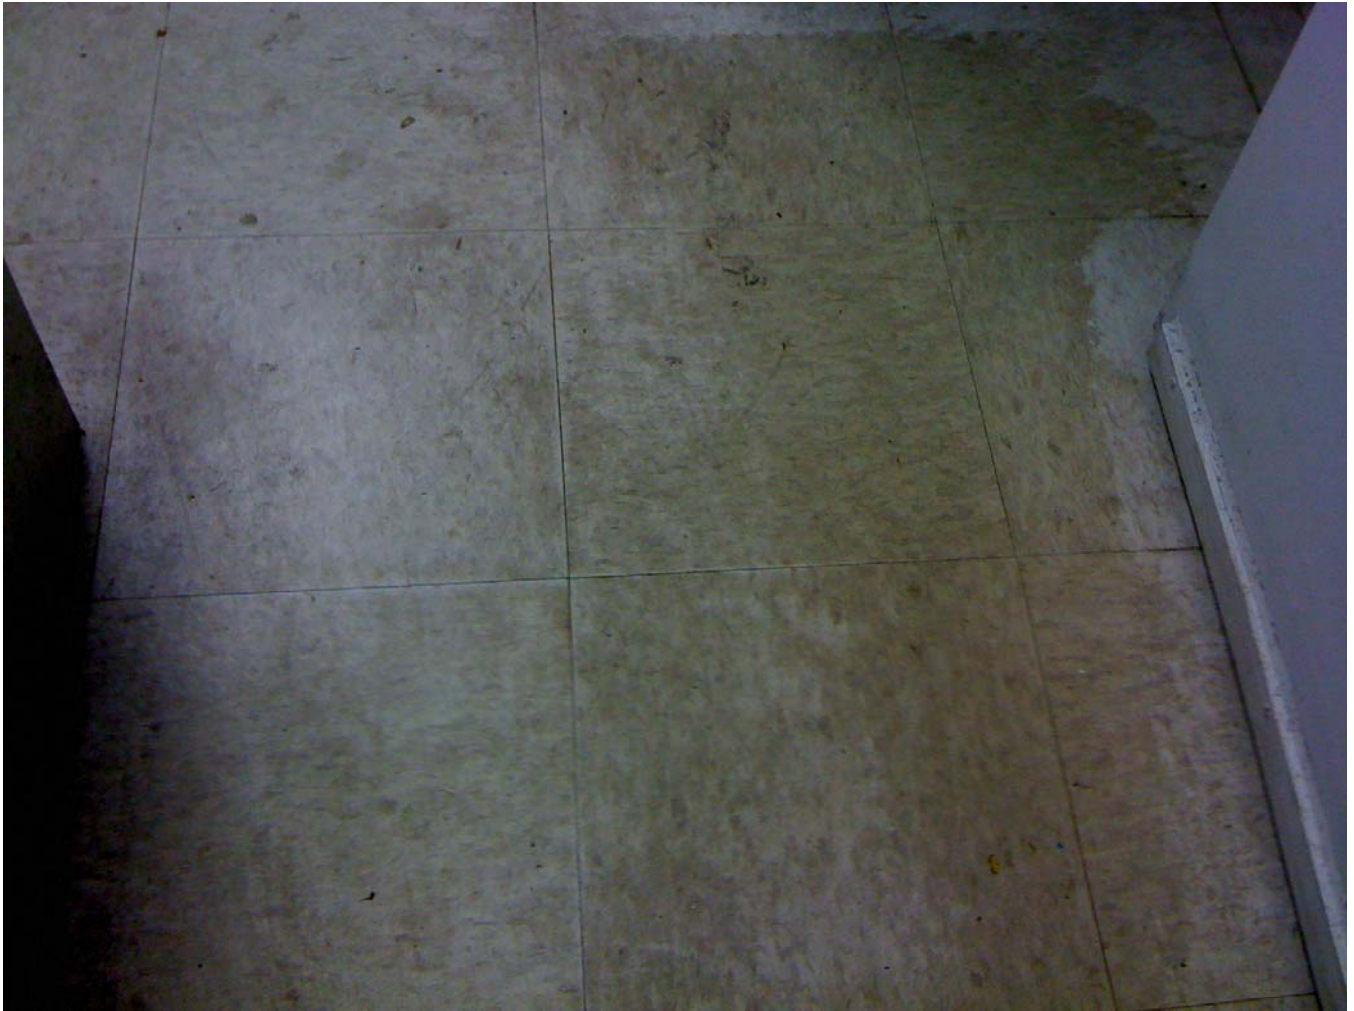
**Building 12**  
**Sample 56 - 9" x 9" Light Brown Floor Tile**
