ASBESTOS CONTAINING BUILDING MATERIAL REPORT BUILDING 13

**Bay Pines VA Medical Center
10000 Bay Pines Boulevard
Bay Pines, Florida**

Project No. 2009011.001

July 31, 2009

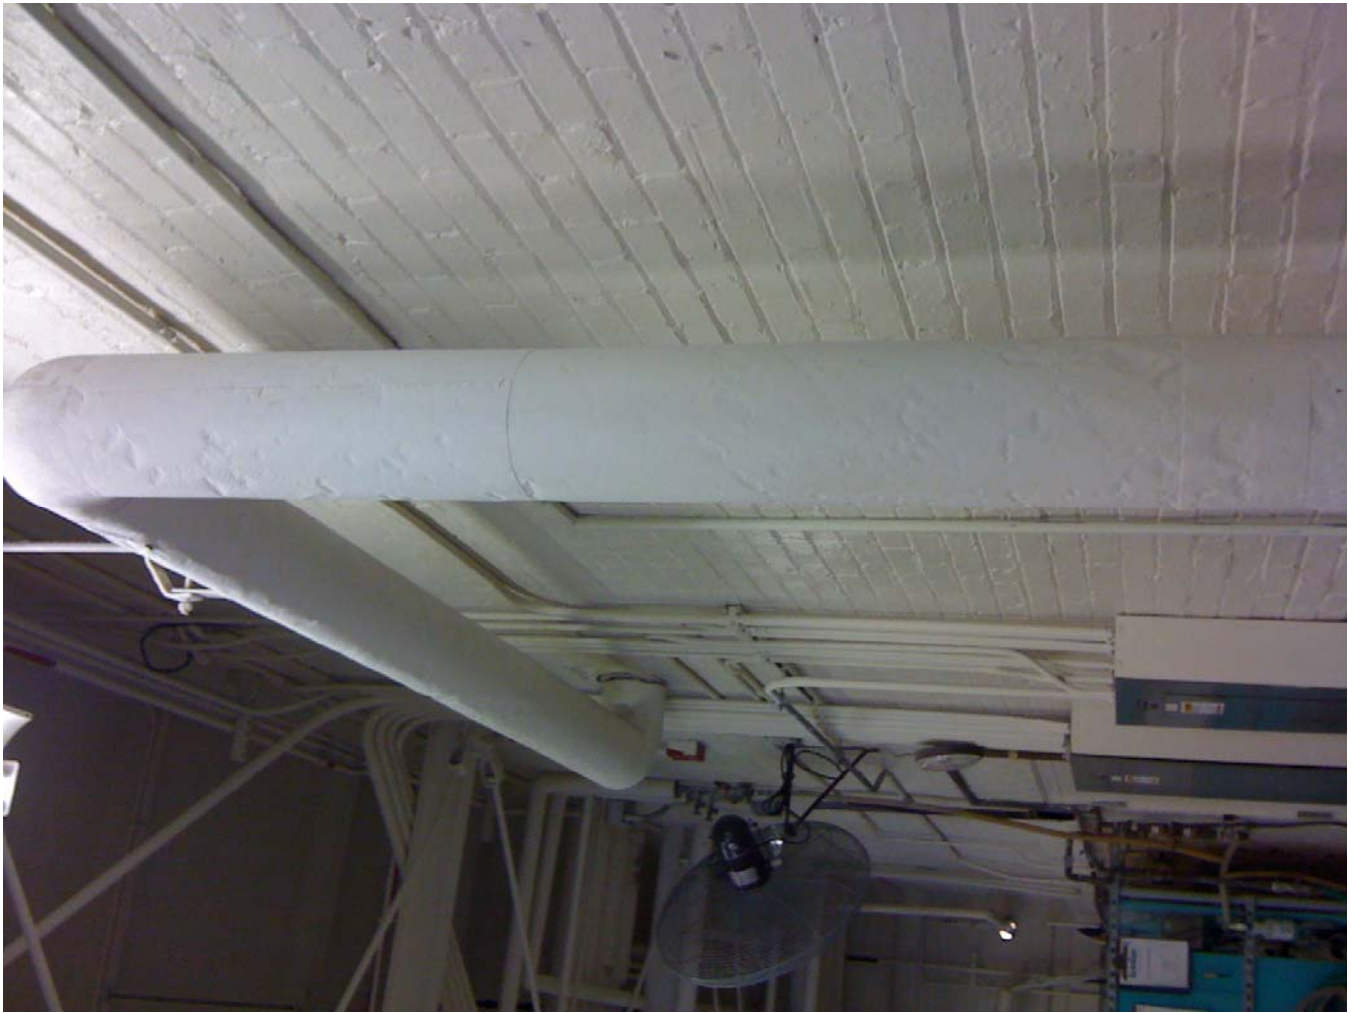
| Sample# | Sample Location | ACM Location | Description of Material | Percent and Type of Asbestos | Condition | Estimated Quantity | NESHAP Category |
|---|---|---|---|---|---|---|---|
| 7 | 14 | Room 14 | 8-10" Mudded Pipe Fitting Insulation | 70% Chrysotile | Good | 100 LF | Friable |

| Sample # | Room # | Area Designation | Description of Material | Asbestos % Type ^(a) | Estimated Quantity | Location | Condition | NESHAP Category |
|---|---|---|---|---|---|---|---|---|
| 13JWM 7 | 14 | | 8-10 " Mudded Pipe Fitting Insulation | 70% Chrysotile | 100 Linear Feet | Room 14 | Good | Friable |

Building 13
Sample 7 – Muddled Pipe Fitting Insulation

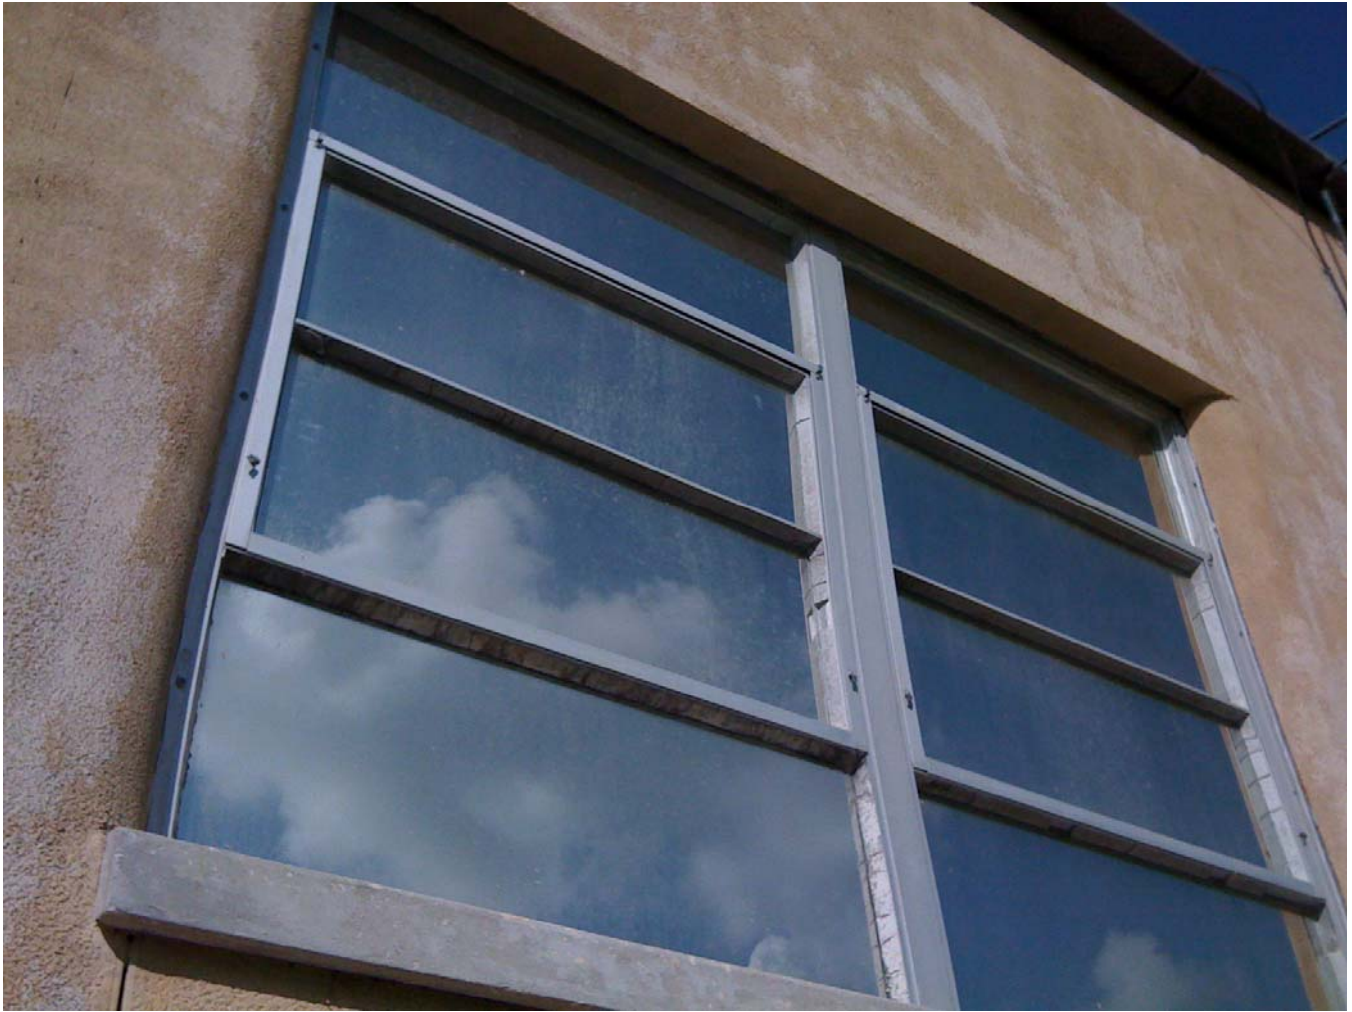
| Sample# | Sample Location | ACM Location | Description of Material | Percent and Type of Asbestos | Condition | Estimated Quantity | NESHAP Category |
|---|---|---|---|---|---|---|---|
| 31 | Exterior Windows | Exterior | Window Glazing | 3% Chrysotile | Good | 500 SF | Friable |

| Sample # | Room # | Area Designation | Description of Material | Asbestos % Type ^(a) | Estimated Quantity | Location | Condition | NESHAP Category |
|---|---|---|---|---|---|---|---|---|
| 13JWM 31 | | Exterior | Window Glazing | 3% Chrysotile | 500 Square Feet | Exterior Windows | Good | Friable |

Building 13
Sample 31 – Window Glazing

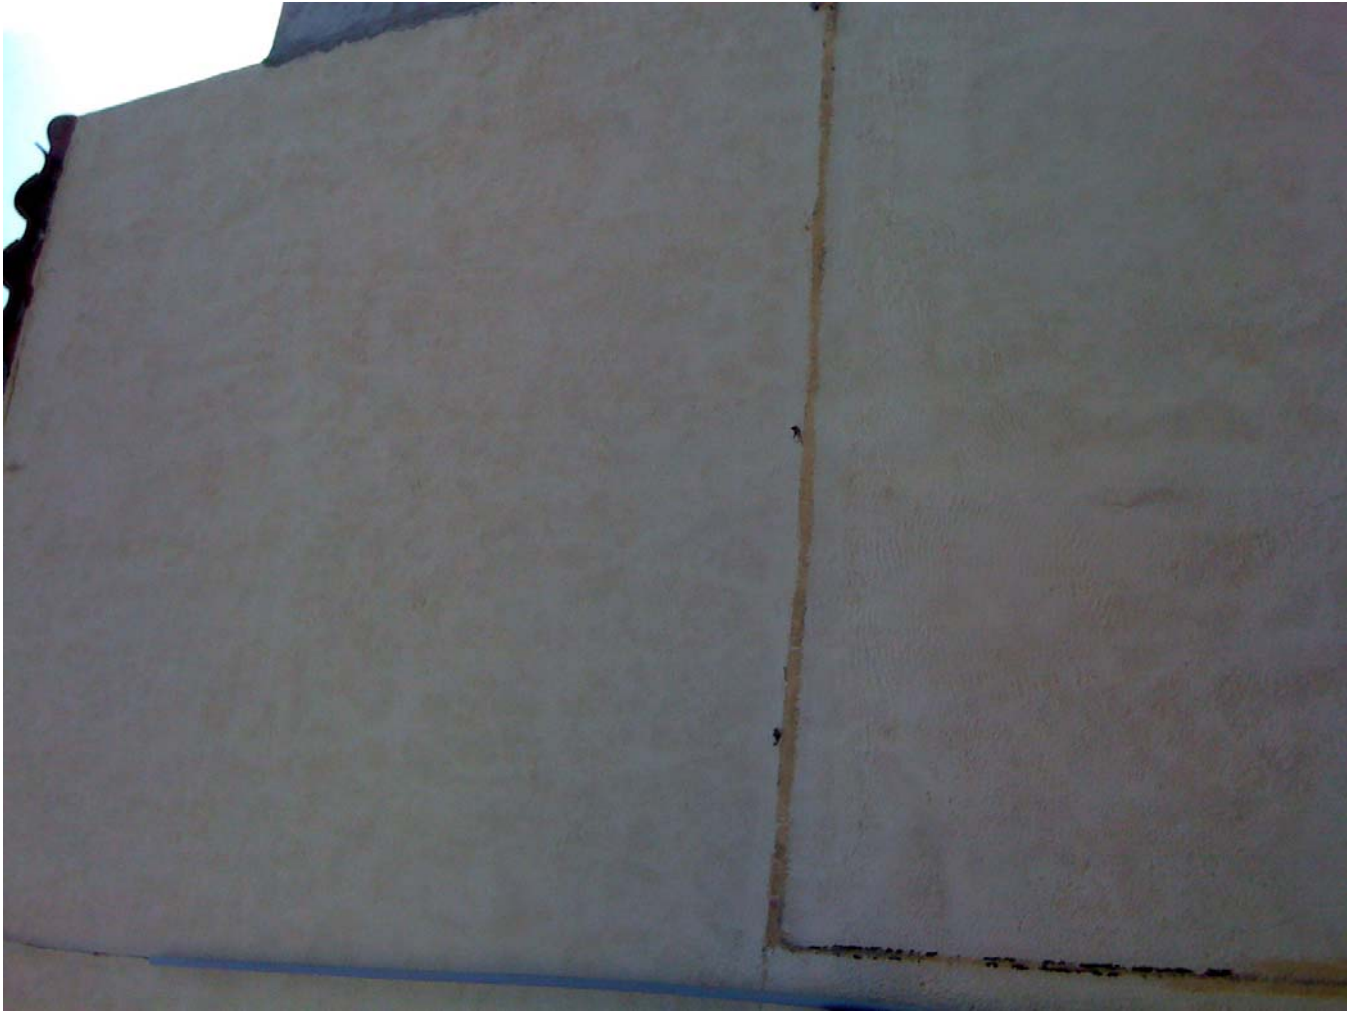
| Sample# | Sample Location | ACM Location | Description of Material | Percent and Type of Asbestos | Condition | Estimated Quantity | NESHAP Category |
|---|---|---|---|---|---|---|---|
| 35 | Entire Exterior | Exterior | Exterior Stucco | 3% Chrysotile** | Good | 9,000 SF | Friable |

| Sample # | Room # | Area Designation | Description of Material | Asbestos % Type ^(a) | Estimated Quantity | Location | Condition | NESHAP Category |
|---|---|---|---|---|---|---|---|---|
| 13JWM 35 | | Exterior | Exterior Stucco | 3% Chrysotile ^(c,d) | 9000 Square Feet | Entire Exterior | Good | Friable |

Building 13
Sample 35 – Exterior Stucco
