ASBESTOS CONTAINING BUILDING MATERIAL REPORT BUILDING 20

**Bay Pines VA Medical Center
10000 Bay Pines Boulevard
Bay Pines, Florida**

Project No. 2009011.001

July 31, 2009

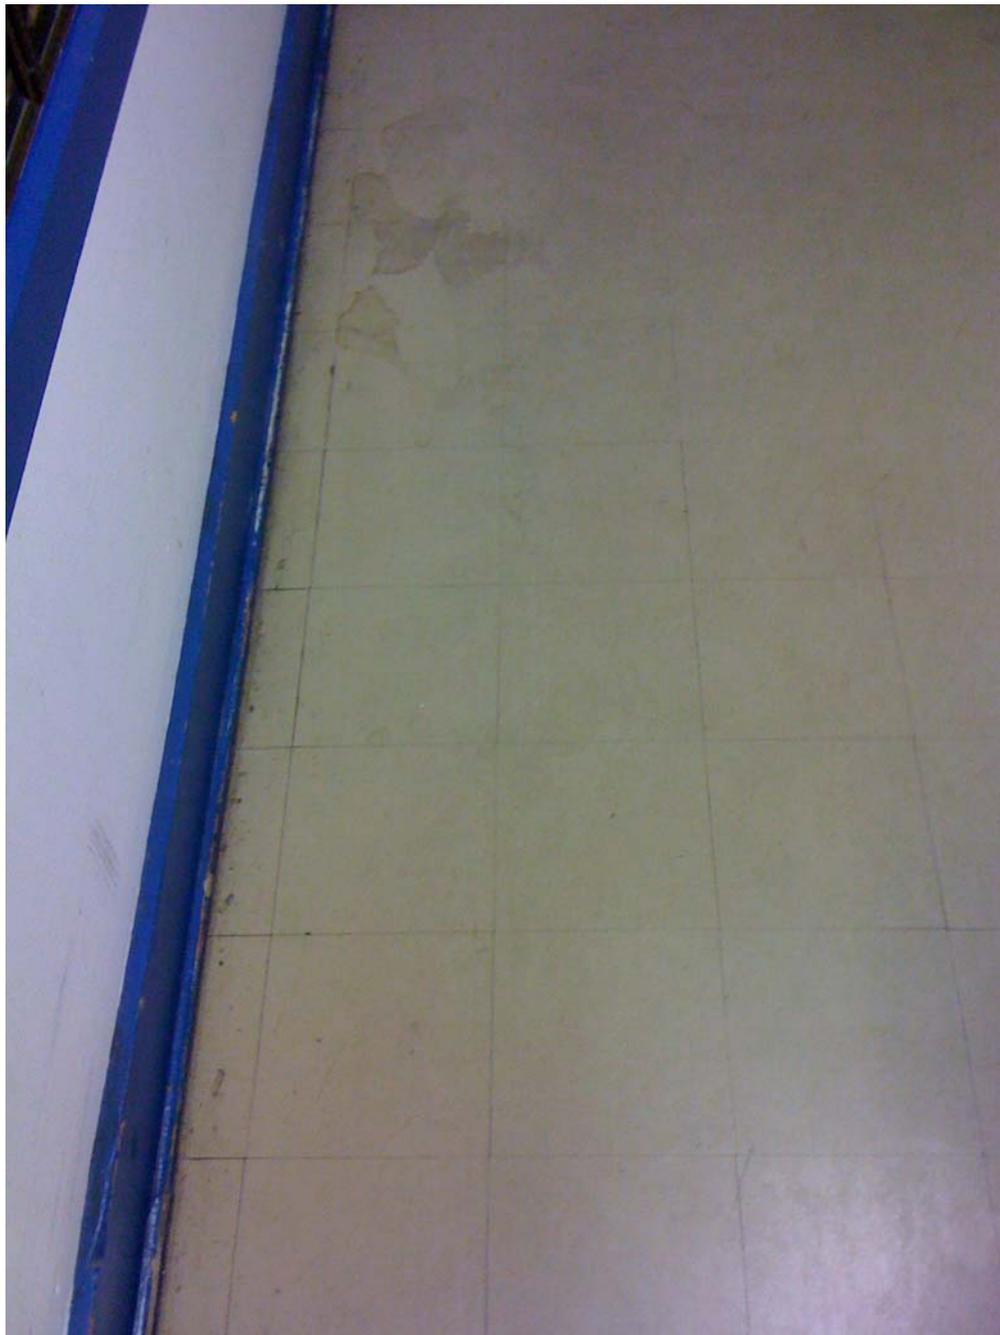
Building 20
Sample 32 Floor – 9" x 9" Light Brown Floor Tile and Mastic

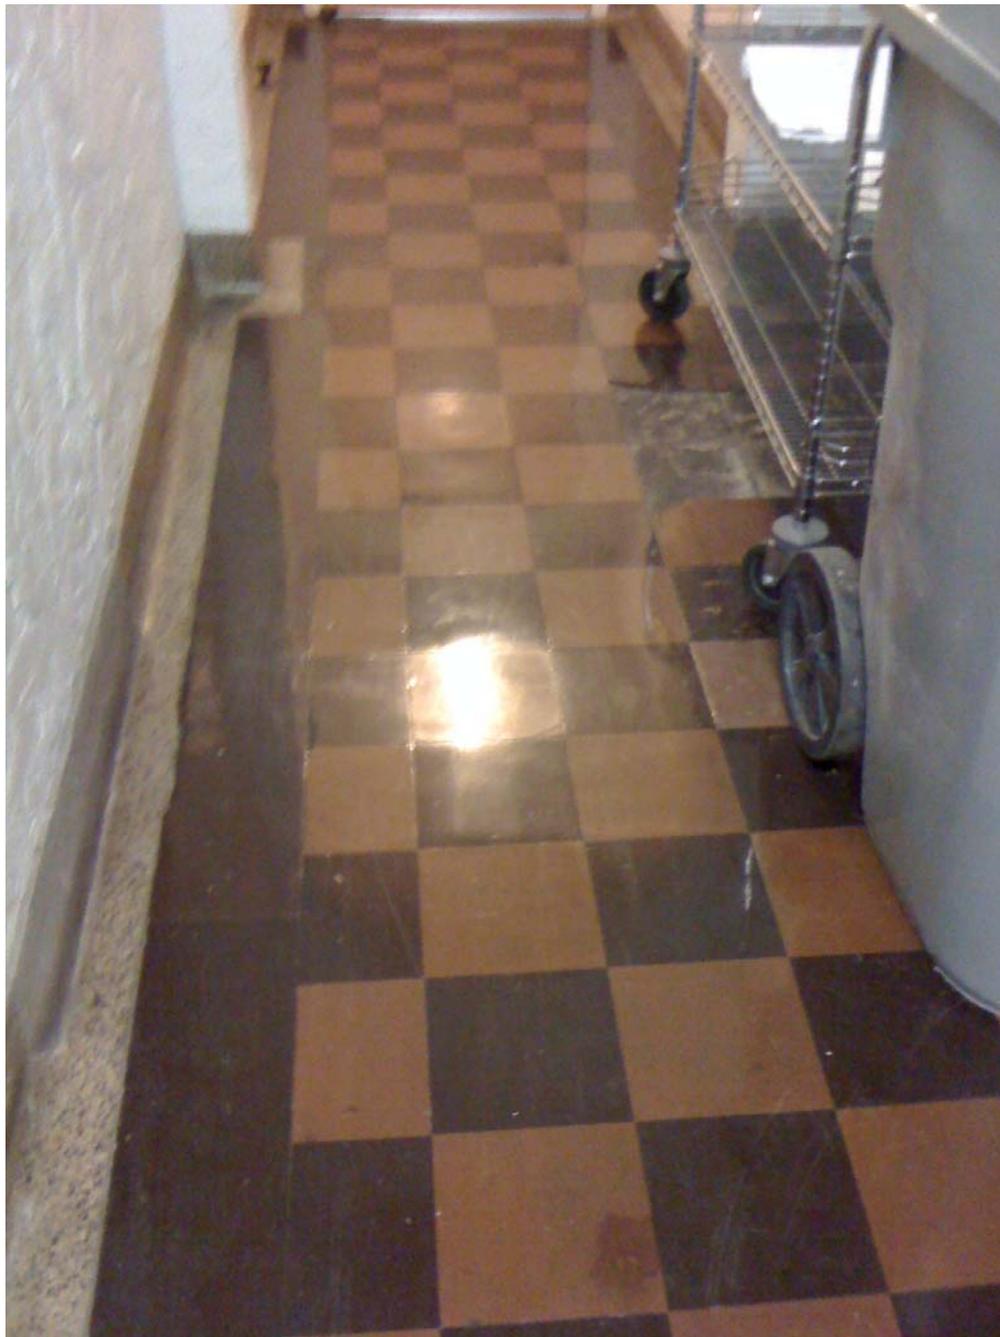
Building 20
Sample 44 Floor - 9" x 9" Burgundy Floor Tile
Sample 47 - 9" x 9" Tan Floor Tile and Mastic

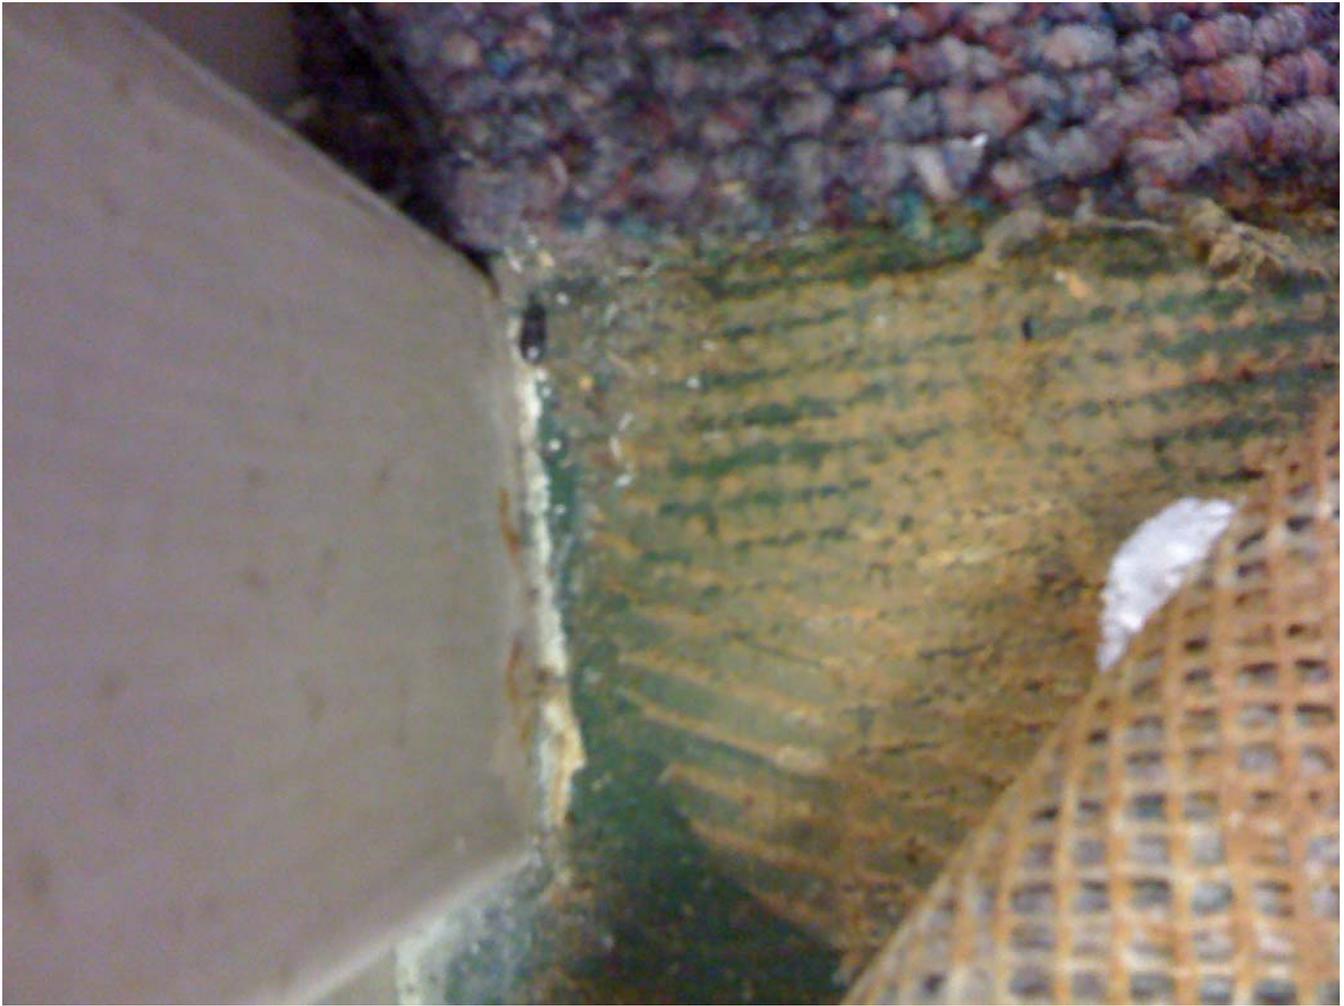
Building 20
Sample 50 Floor - 9" x 9" Green Floor Tile

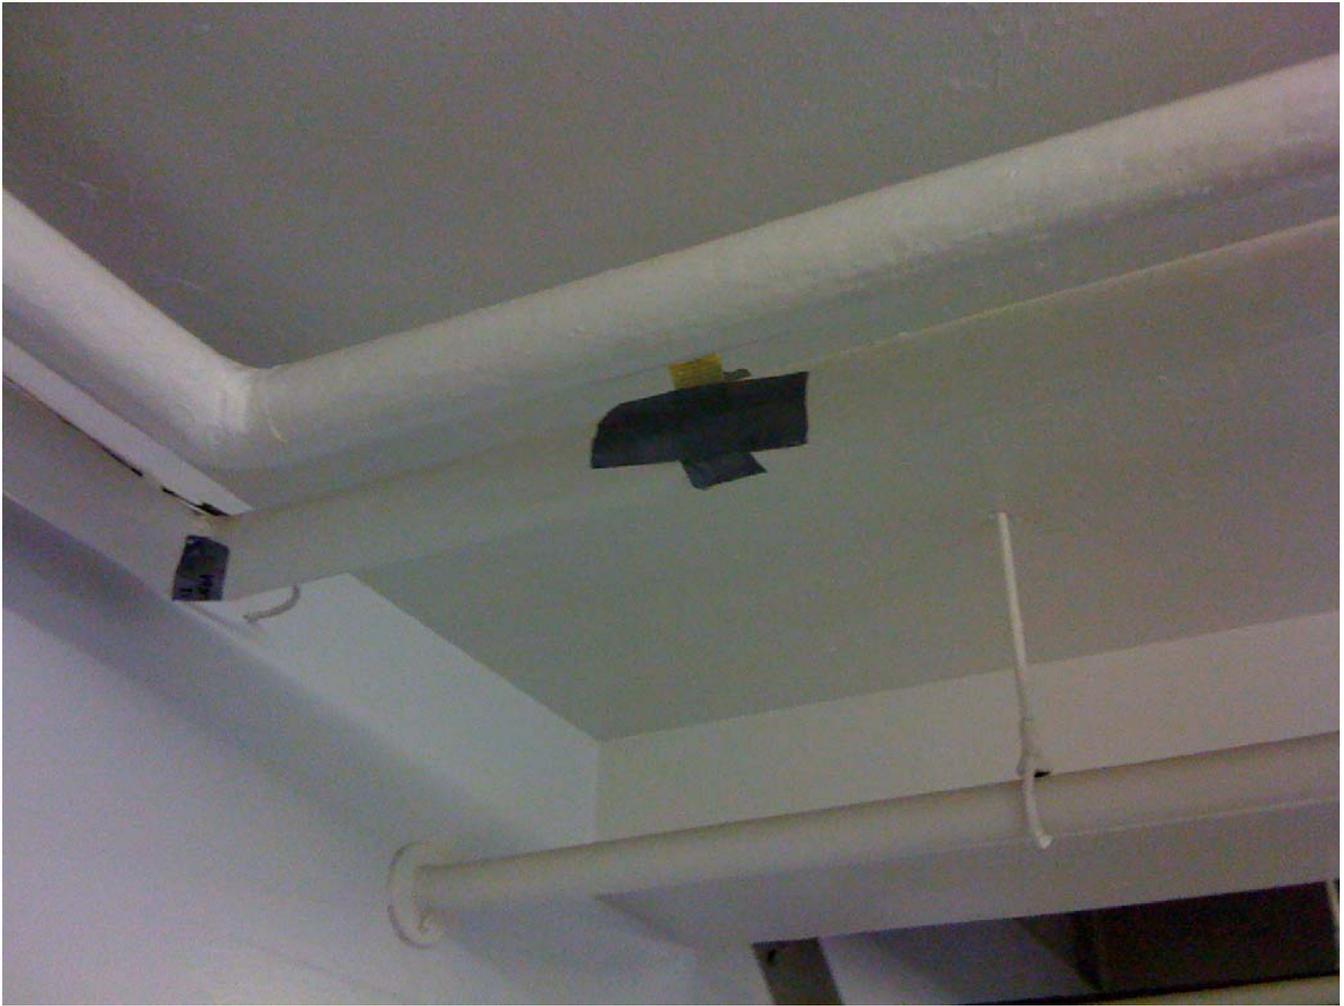
Building 20
Sample 72 – Pipefitting Insulation
Sample 75 – Pipe Insulation
