ASBESTOS CONTAINING BUILDING MATERIAL REPORT BUILDING 22

**Bay Pines VA Medical Center
10000 Bay Pines Boulevard
Bay Pines, Florida**

Project No. 2009011.001

July 31, 2009

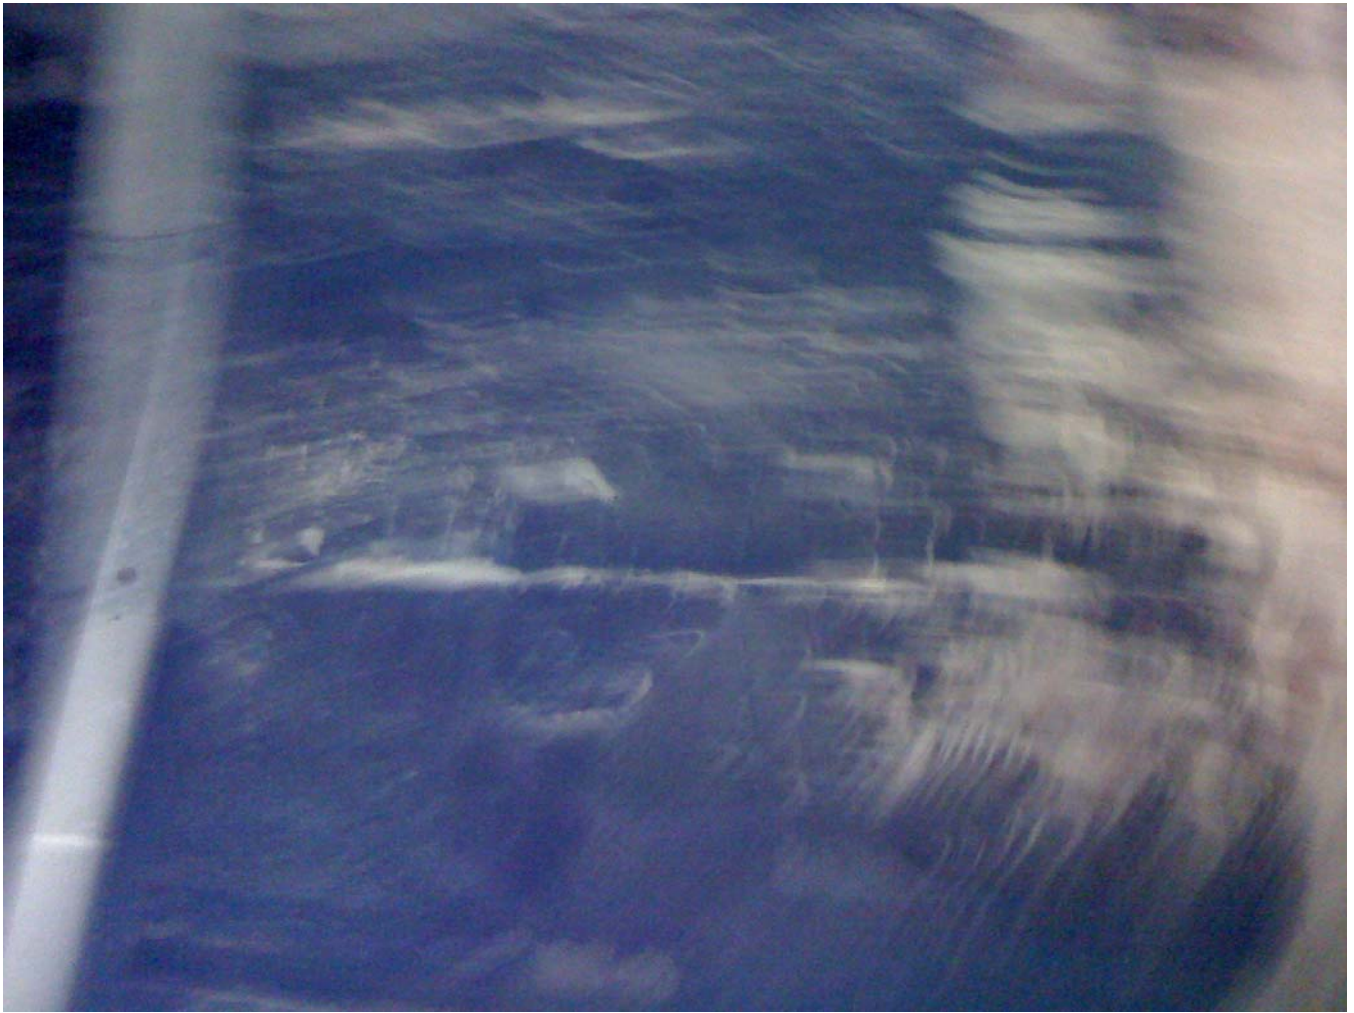
Sample#	Sample Location	ACM Location	Description of Material	Percent and Type of Asbestos	Condition	Estimated Quantity	NESHAP Category
44	Room 411	Interior Side of Exterior Brick	Black Waterproofing	10% Chrysotile	Good	23,300 SF	II

Building 22
Sample 44 – Black Waterproofing

If any asbestos-containing material is damaged or becomes damaged it should be repaired, if possible, or removed entirely.

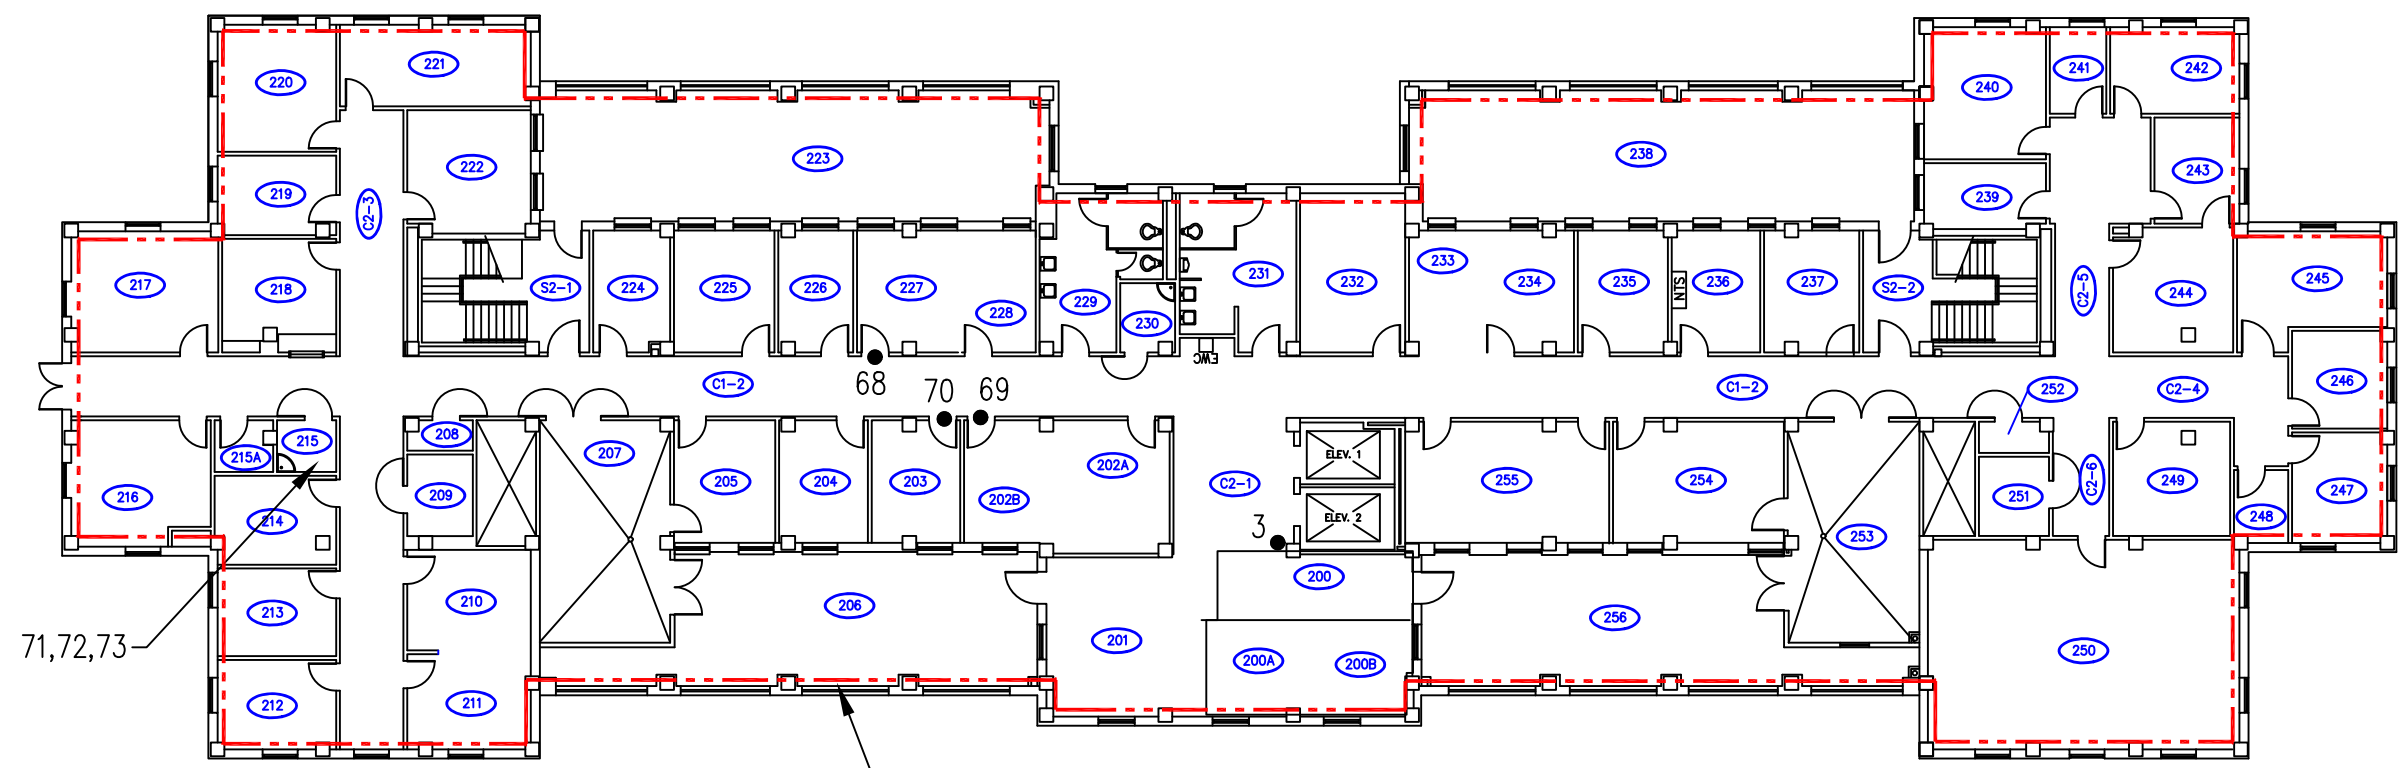
Drawing Title	Project Title	Date
SECOND FLOOR PLAN	ACM SURVEY	JULY 31, 2009
SCALE: 1/8" = 1'-0"	Building Number	Checked
	22	RKM
	Drawn	DJA
	Location	DRAWING NO.
	V.A.M.C. BAY PINES, FLORIDA	2
		Dwg. 2 of 4

WATER PROOFING ON INTERIOR SIDE OF EXTERIOR BRICK
