# **ASBESTOS CONTAINING BUILDING MATERIAL REPORT BUILDING 24**

**Bay Pines VA Medical Center  
10000 Bay Pines Boulevard  
Bay Pines, Florida**

Project No. 2009011.001

July 31, 2009

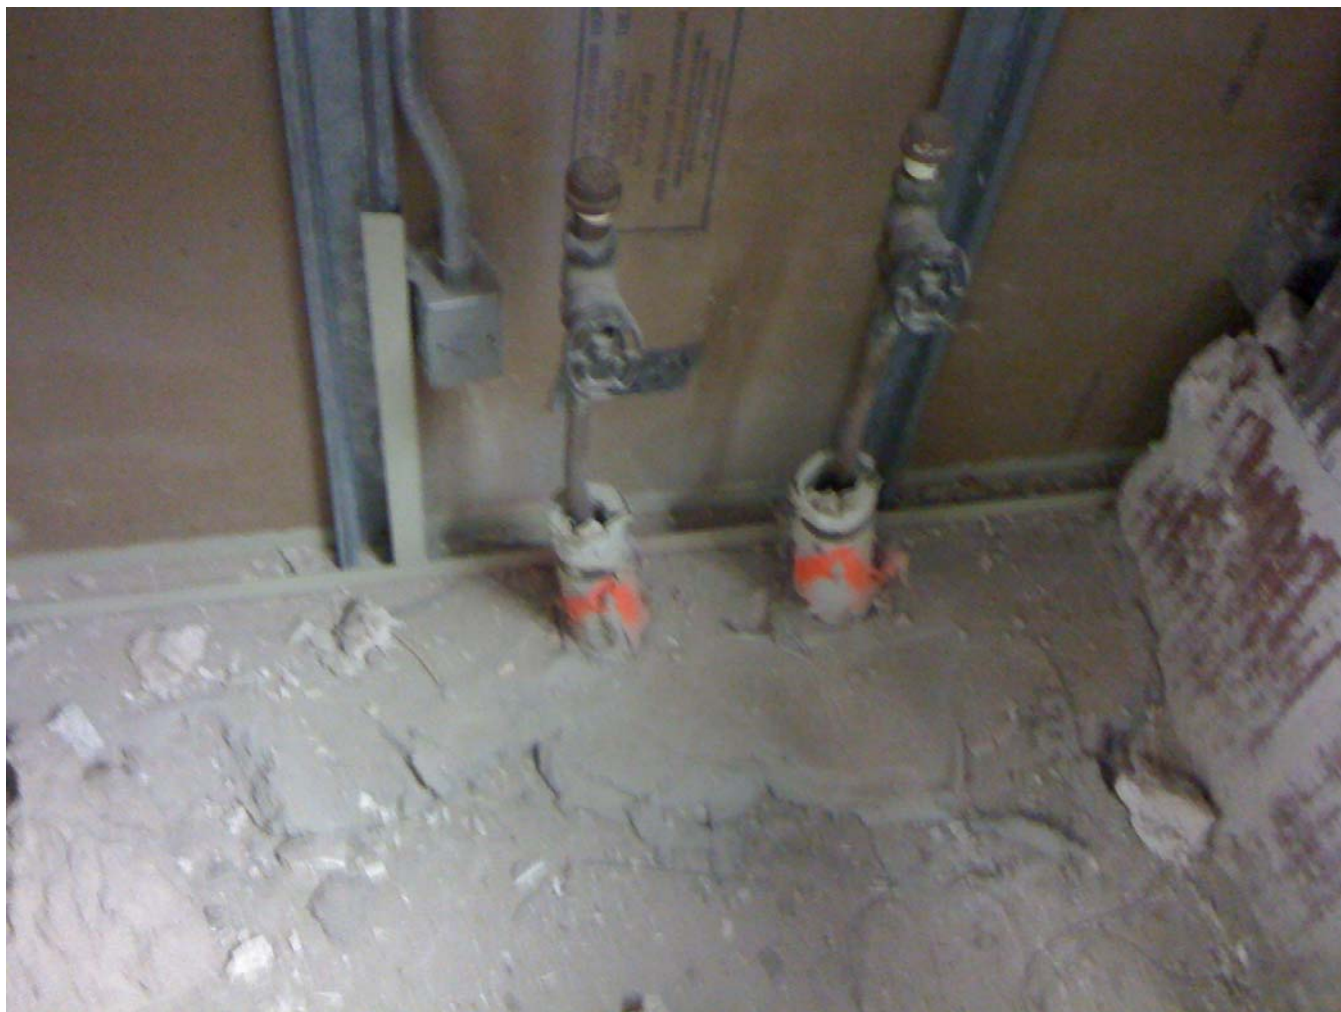
**Building 24**  
**Sample 51 – Water Pipe Insulation**

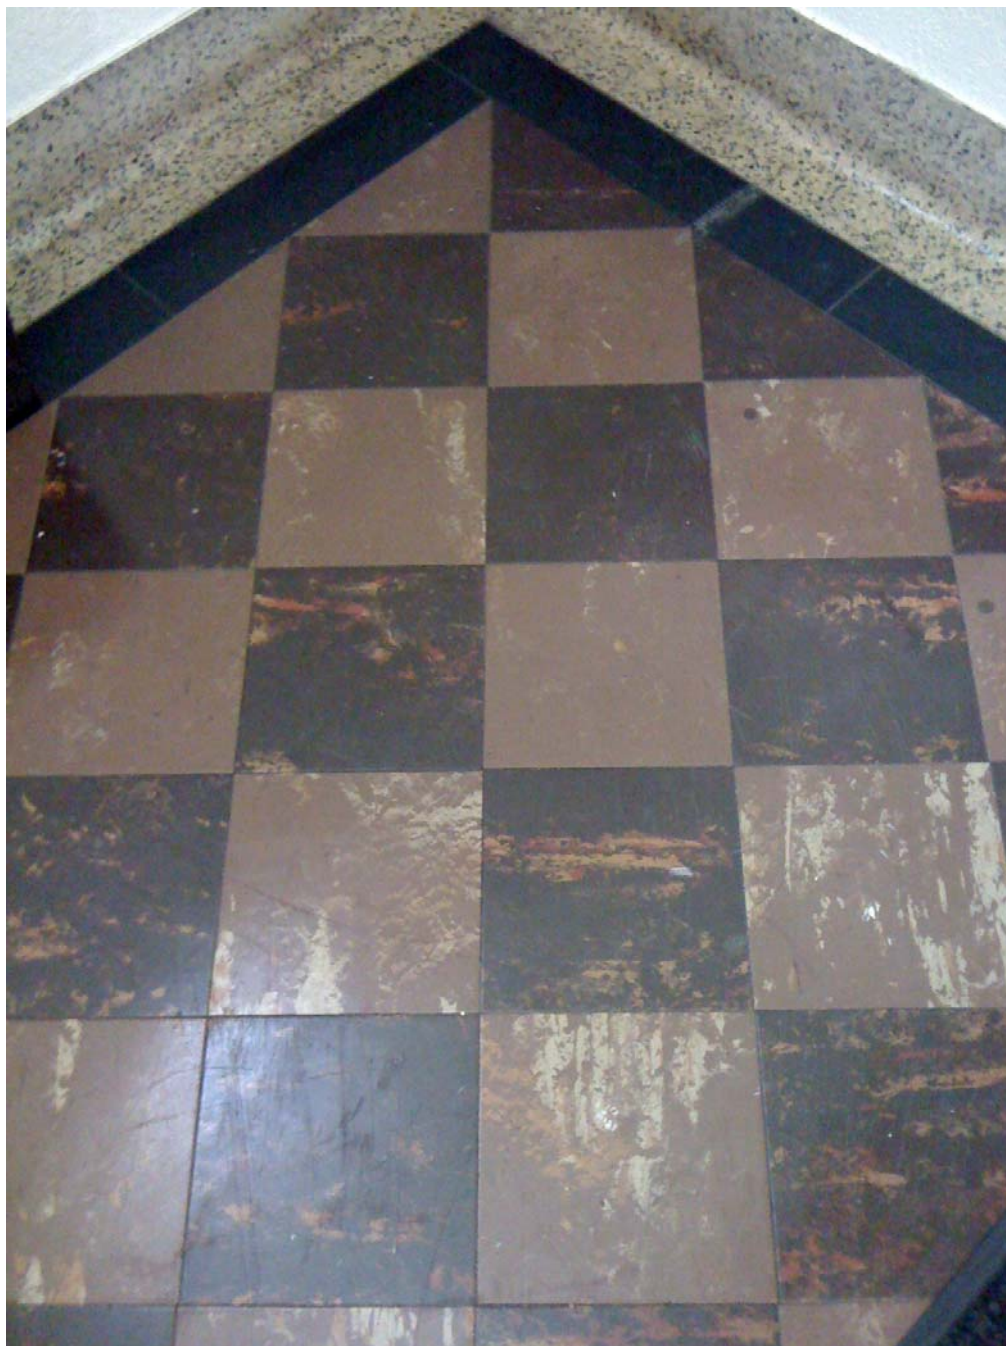
**Building 24**  
**Sample 92 Floor Tile - 9" x 9" Dark Brown Floor Tile and Mastic**
