# **ASBESTOS CONTAINING BUILDING MATERIAL REPORT BUILDING 35**

**Bay Pines VA Medical Center  
10000 Bay Pines Boulevard  
Bay Pines, Florida**

Project No. 2009011.001

July 31, 2009

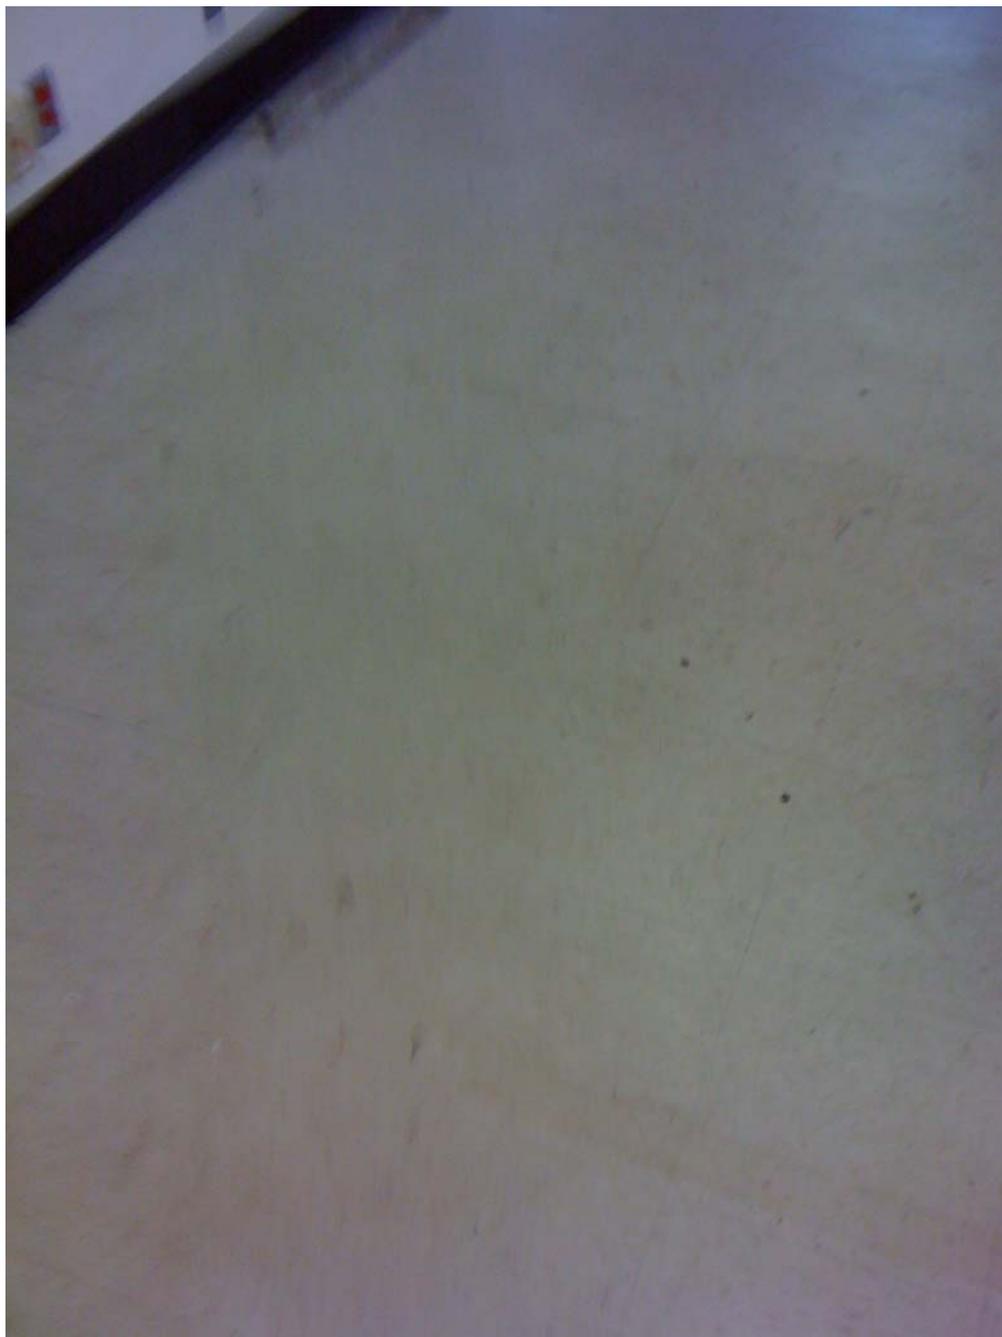
**Building 35**  
**Sample 1 – 12" x 12" White Floor Tile**

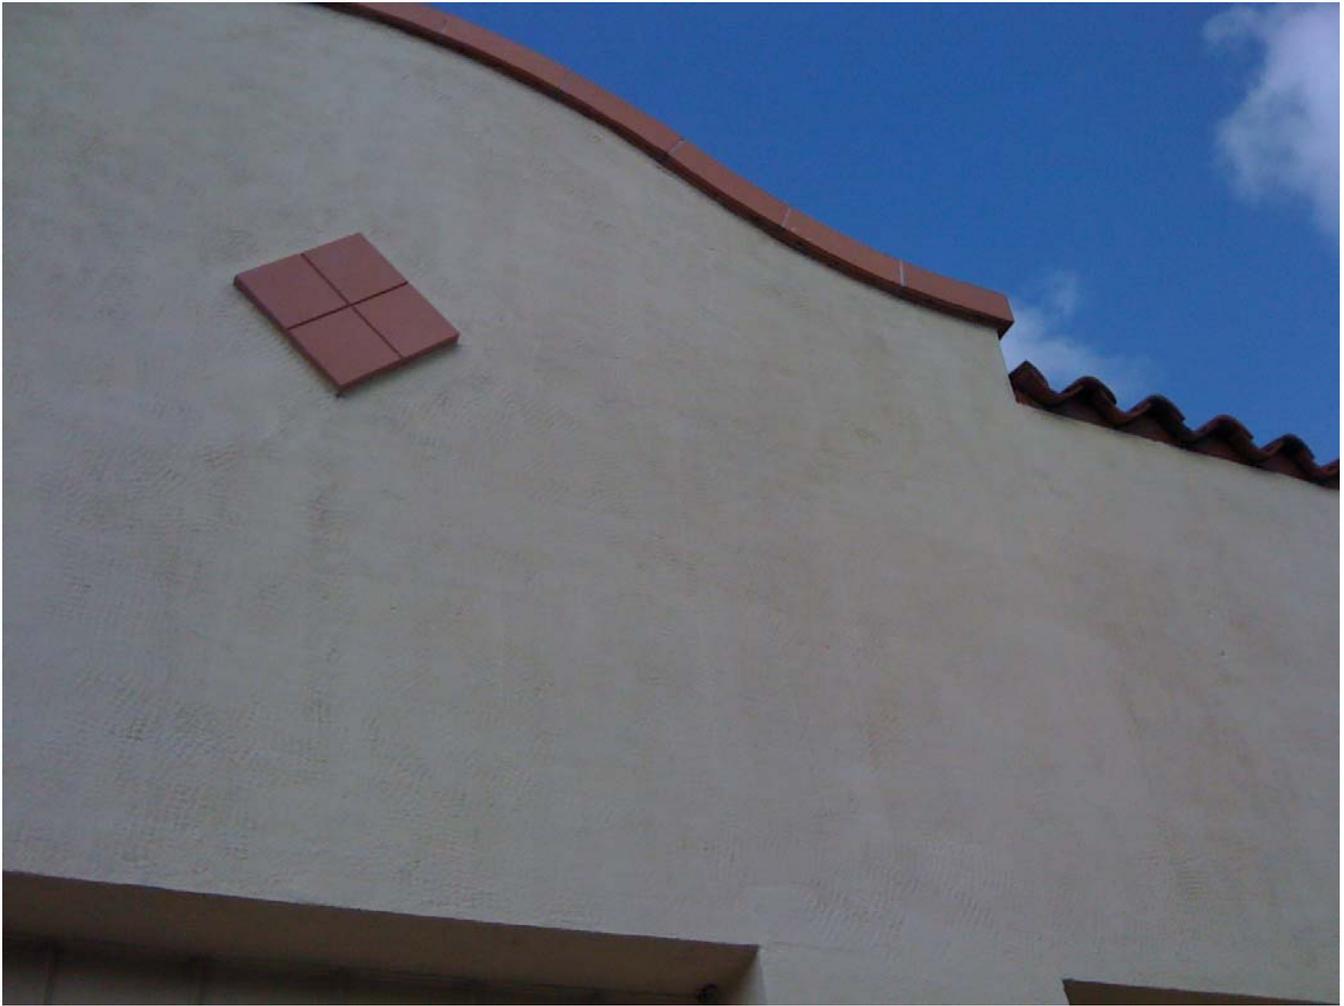
**Building 35**  
**Sample 24 - Exterior Stucco**

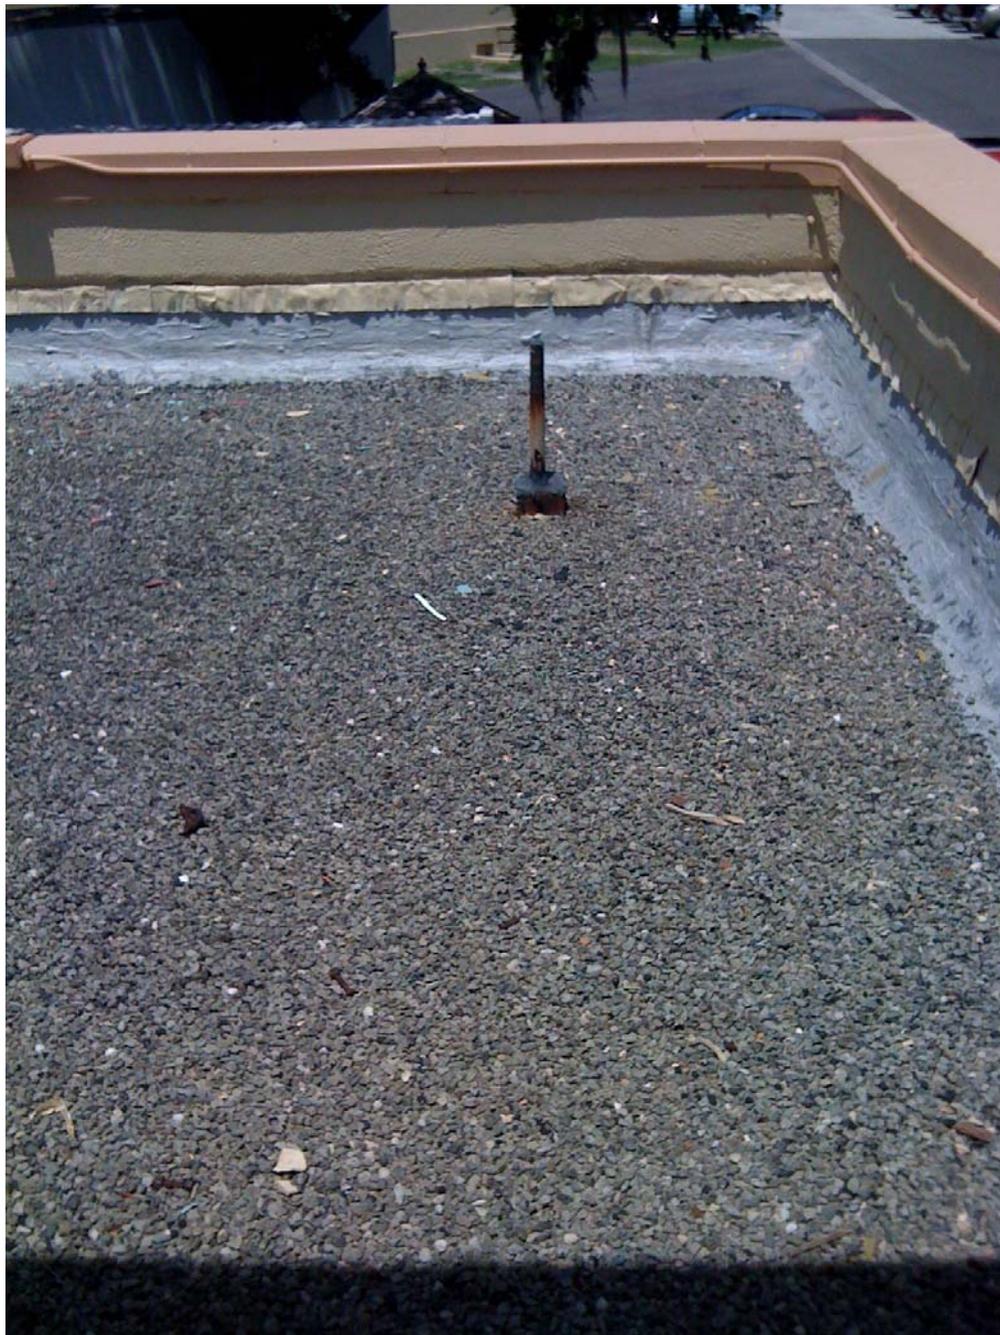
**Building 35**  
**Sample Roofing 35-4 - Flashing**

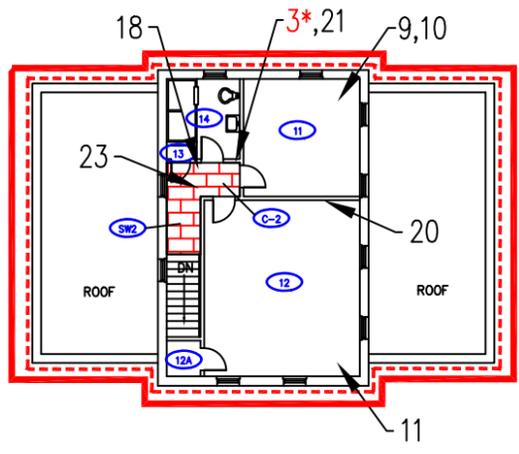
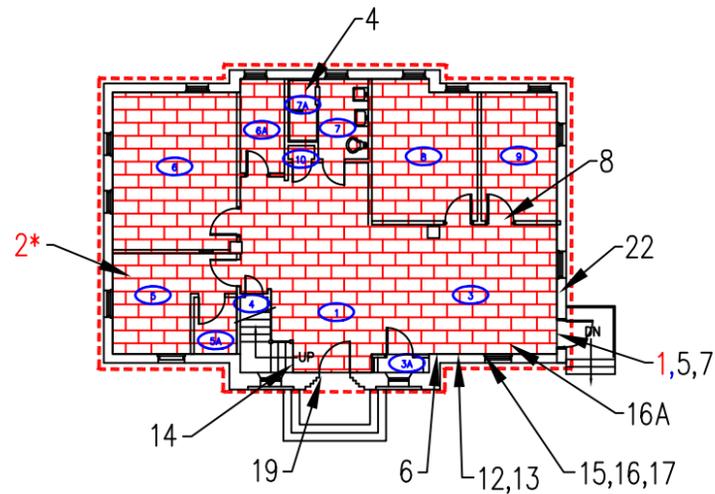
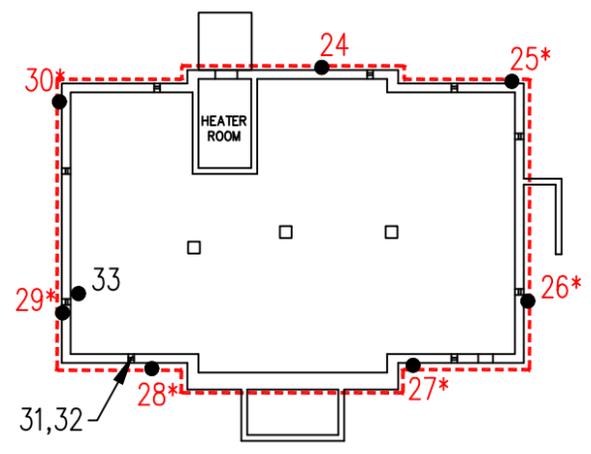
Drawing Title FOUNDATION, FIRST & SECOND FLOOR PLANS SCALE: 1/8" = 1'-0"		Project Title ACM SURVEY		Date JULY 31, 2009
Building Number 35		Checked RKM	Drawn DJA	Project No. 2009011.001
Location V.A.M.C. BAY PINES, FLORIDA		DRAWING NO. 1		Dwg. 1 Of 1

1. SAMPLES (35-SJN-1ROOF, 35-SJN-2ROOF, 35-SJN-3ROOF, 35-SJN-4ROOF, 35-SJN-5ROOF\*, 35-SJN-6ROOF\*) COLLECTED FROM ROOF.
2. CRAWL SPACE ENTRANCE DOOR LOCKED, NOT ACCESSIBLE.
3. CRAWL SPACE OBSERVED AND SAMPLED THROUGH WINDOW OPENINGS.
4. PIPE WRAP DEBRIS ON SOIL FLOOR.
5. PIPE INSULATION APPEARS TO BE FIBERGLASS.
