ASBESTOS CONTAINING BUILDING MATERIAL REPORT BUILDING 36

**Bay Pines VA Medical Center
10000 Bay Pines Boulevard
Bay Pines, Florida**

Project No. 2009011.001

July 31, 2009

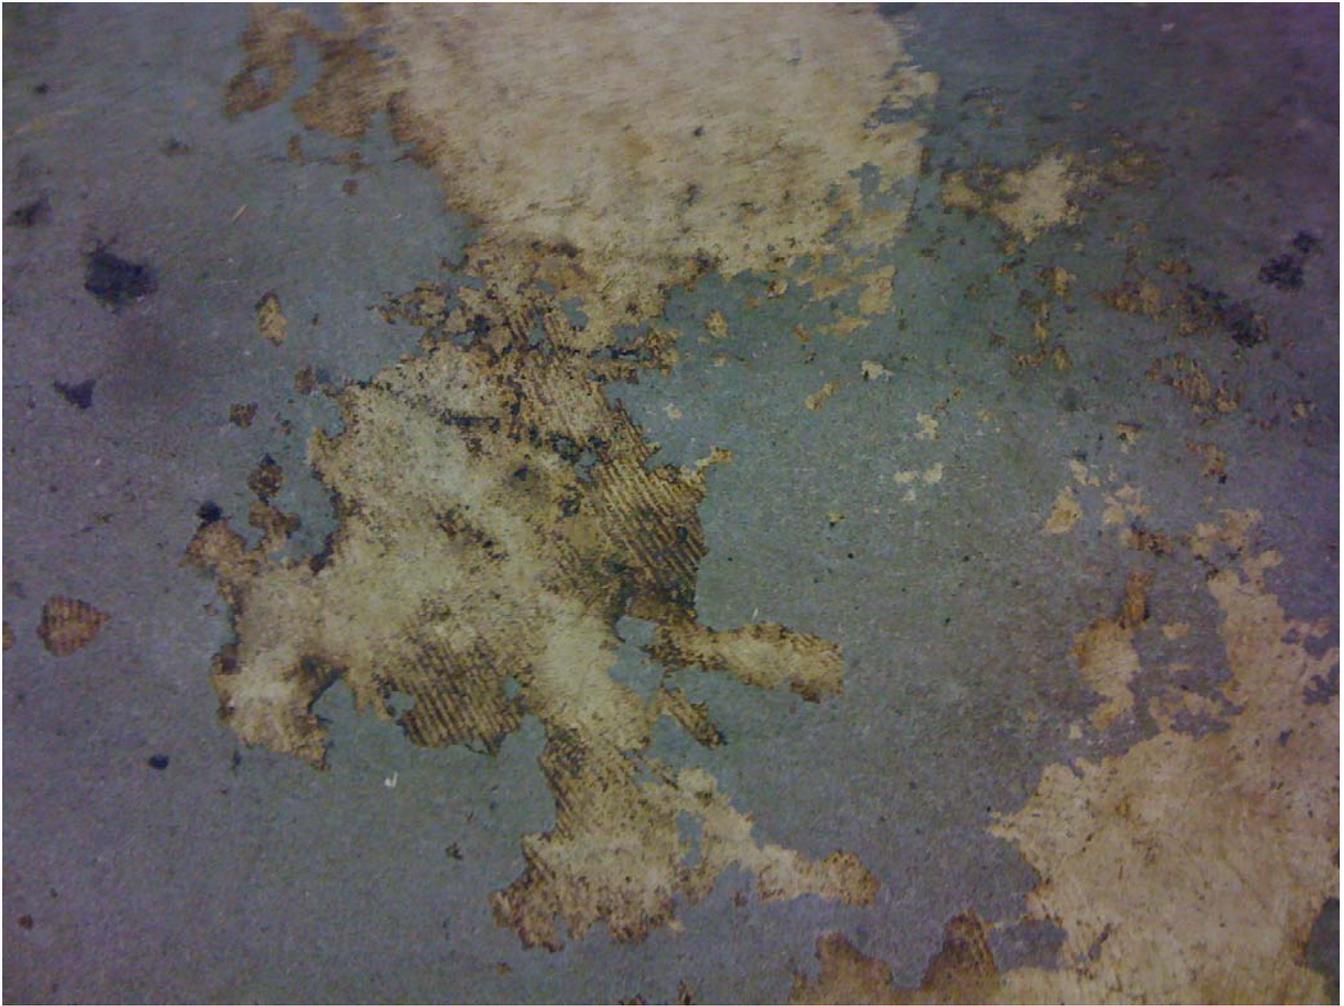
Sample#	Sample Location	ACM Location	Description of Material	Percent and Type of Asbestos	Condition	Estimated Quantity	NESHAP Category
23	Room 1 Warehouse	Warehouse	Residual Floor Tile Black Mastic	5% Chrysotile	Good	5,320 SF	I

Building 36
Sample 23 – Residual Floor Tile Black Mastic

If any asbestos-containing material is damaged or becomes damaged it should be repaired, if possible, or removed entirely.

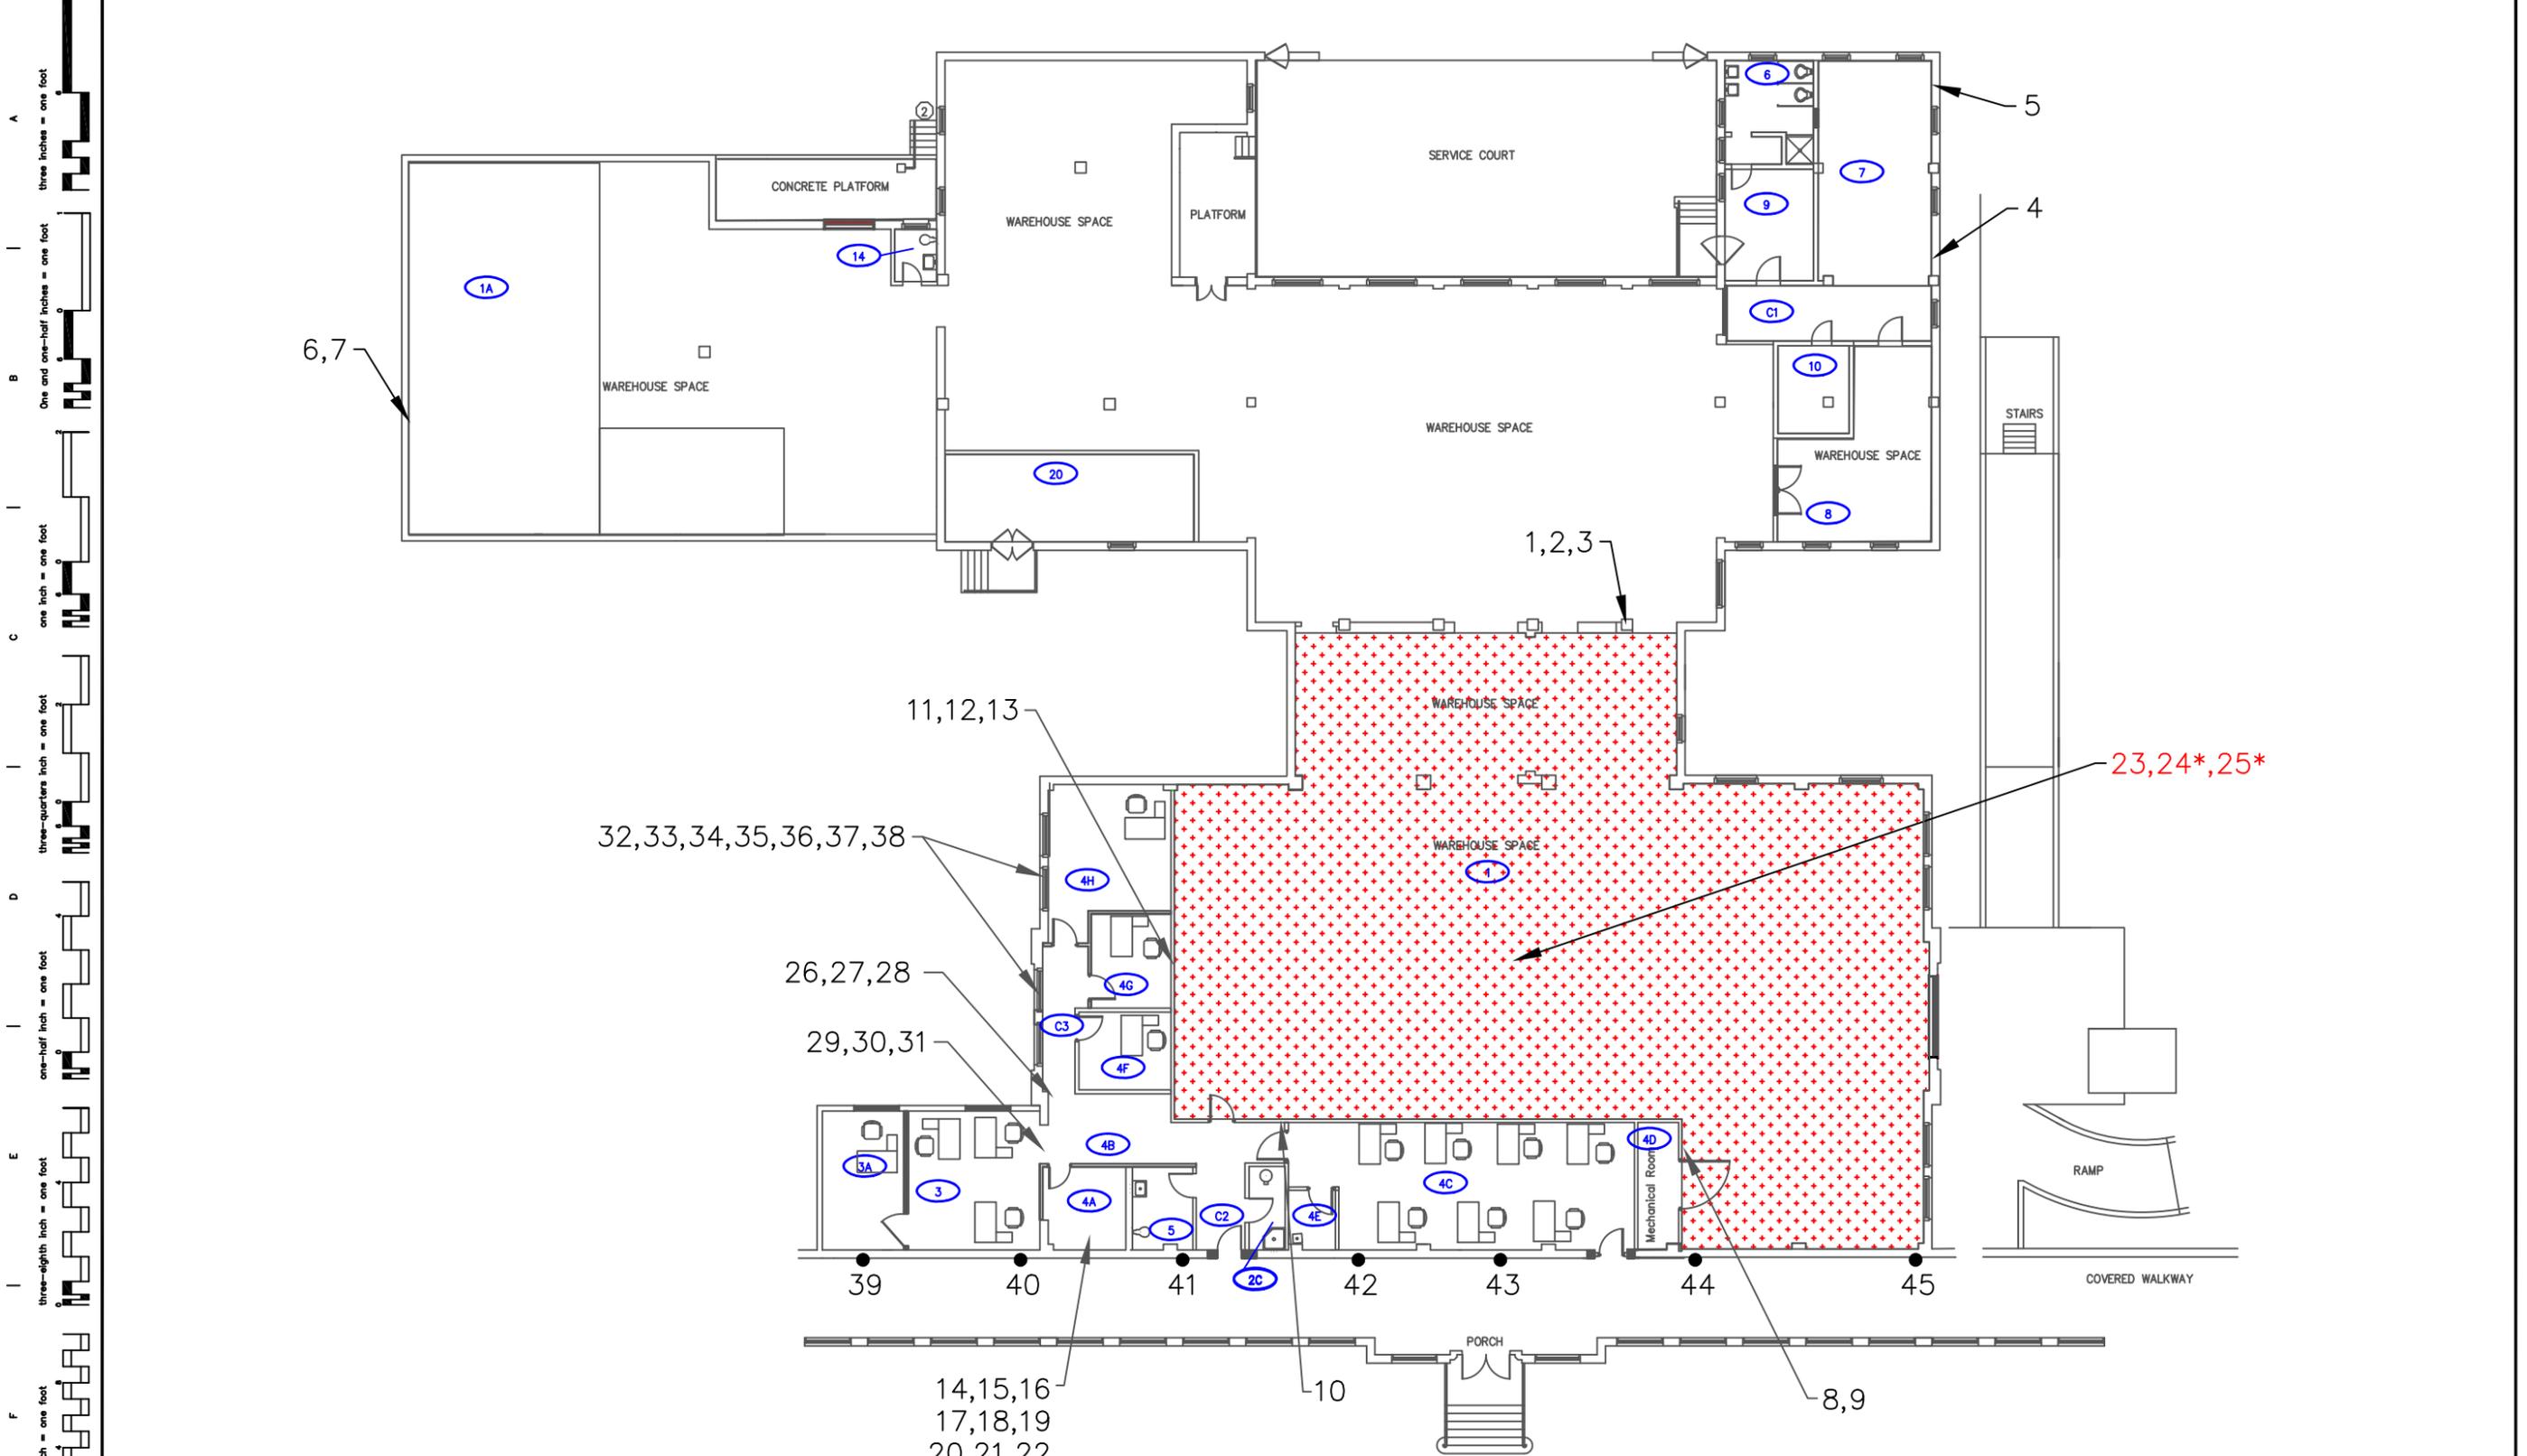
Drawing Title FLOOR PLAN		Project Title ACM SURVEY		Date JULY 31, 2009
SCALE: 1/8" = 1'-0"				Project No. 2009011.001
Building Number 36	Checked RKM	Drawn DJA	DRAWING NO. 1	
Location V.A.M.C. BAY PINES, FLORIDA			Dwg. 1 Of 1

The CADD drawing for this building shows approximate asbestos sample locations and shortened sample numbers. The floor plan legend shows positive sample numbers and associated positive (stop positives) in blue on the drawing. Building areas containing ACM are shown on the drawing in red with markings to indicate the kind of material (e.g., floor title).
