ASBESTOS CONTAINING BUILDING MATERIAL REPORT BUILDING 37

**Bay Pines VA Medical Center
10000 Bay Pines Boulevard
Bay Pines, Florida**

Project No. 2009011.001

July 31, 2009

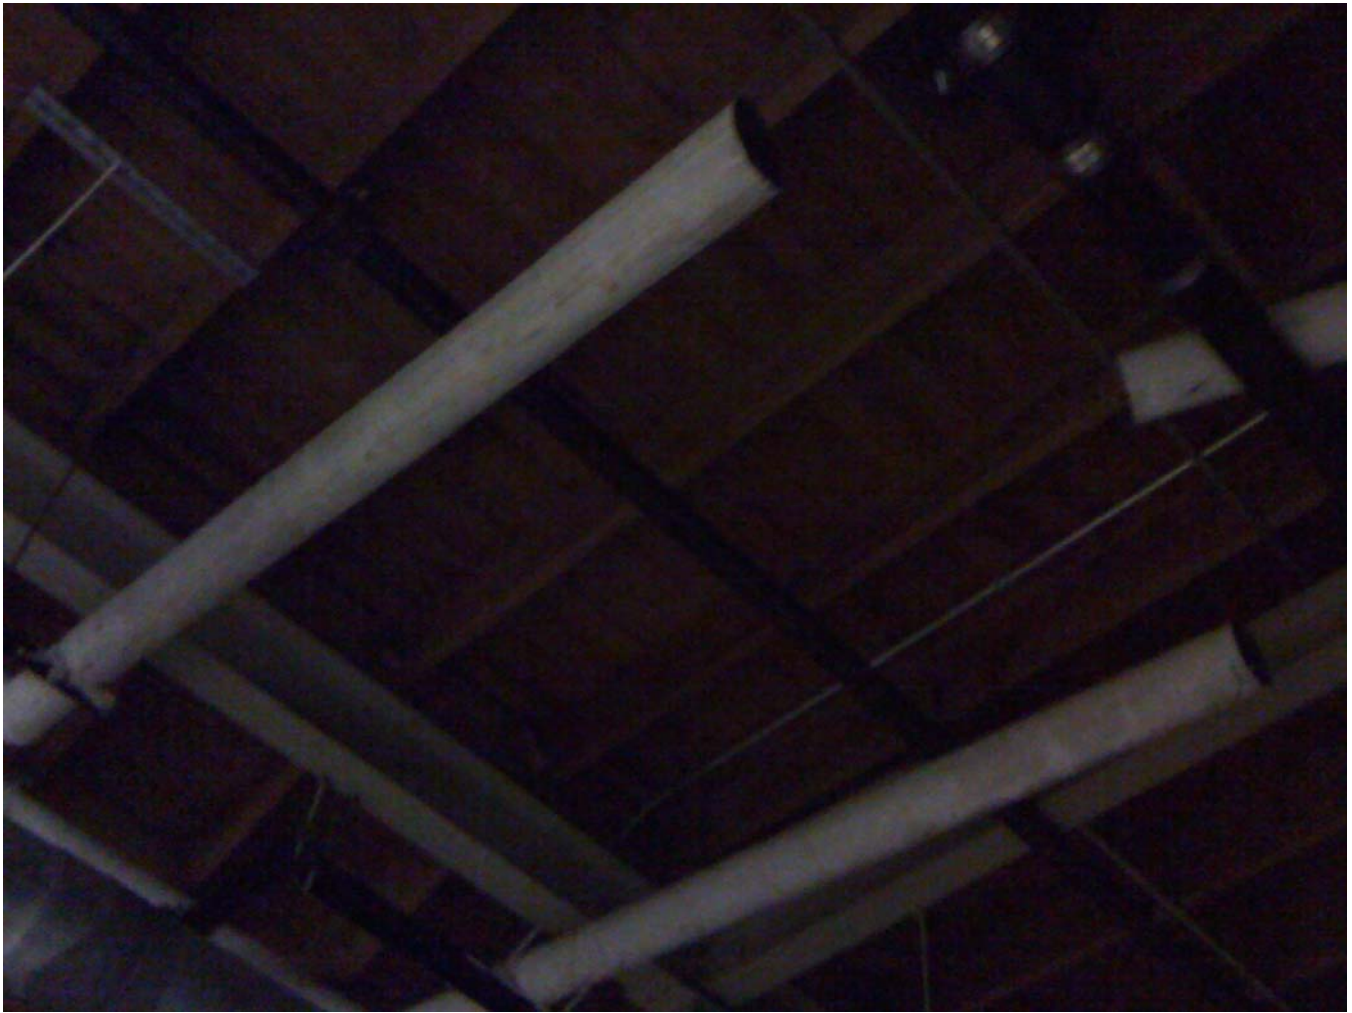
Building 37
Sample 28 – 4" Pipefitting Insulation

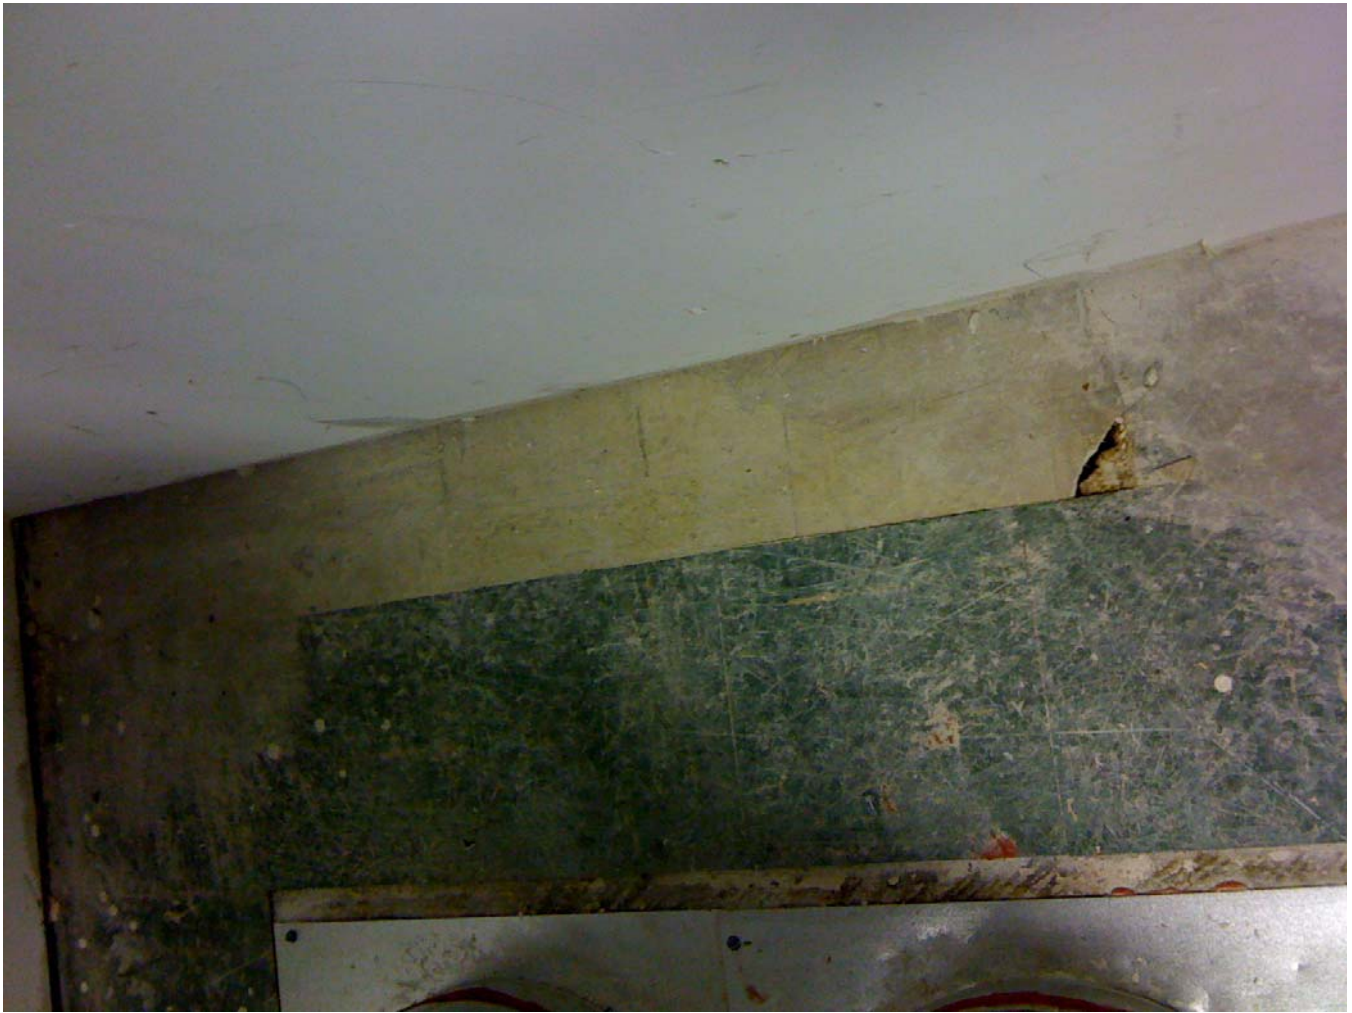
Building 37
Sample 46 Floor Tile - 12" x 12" Beige Floor Tile

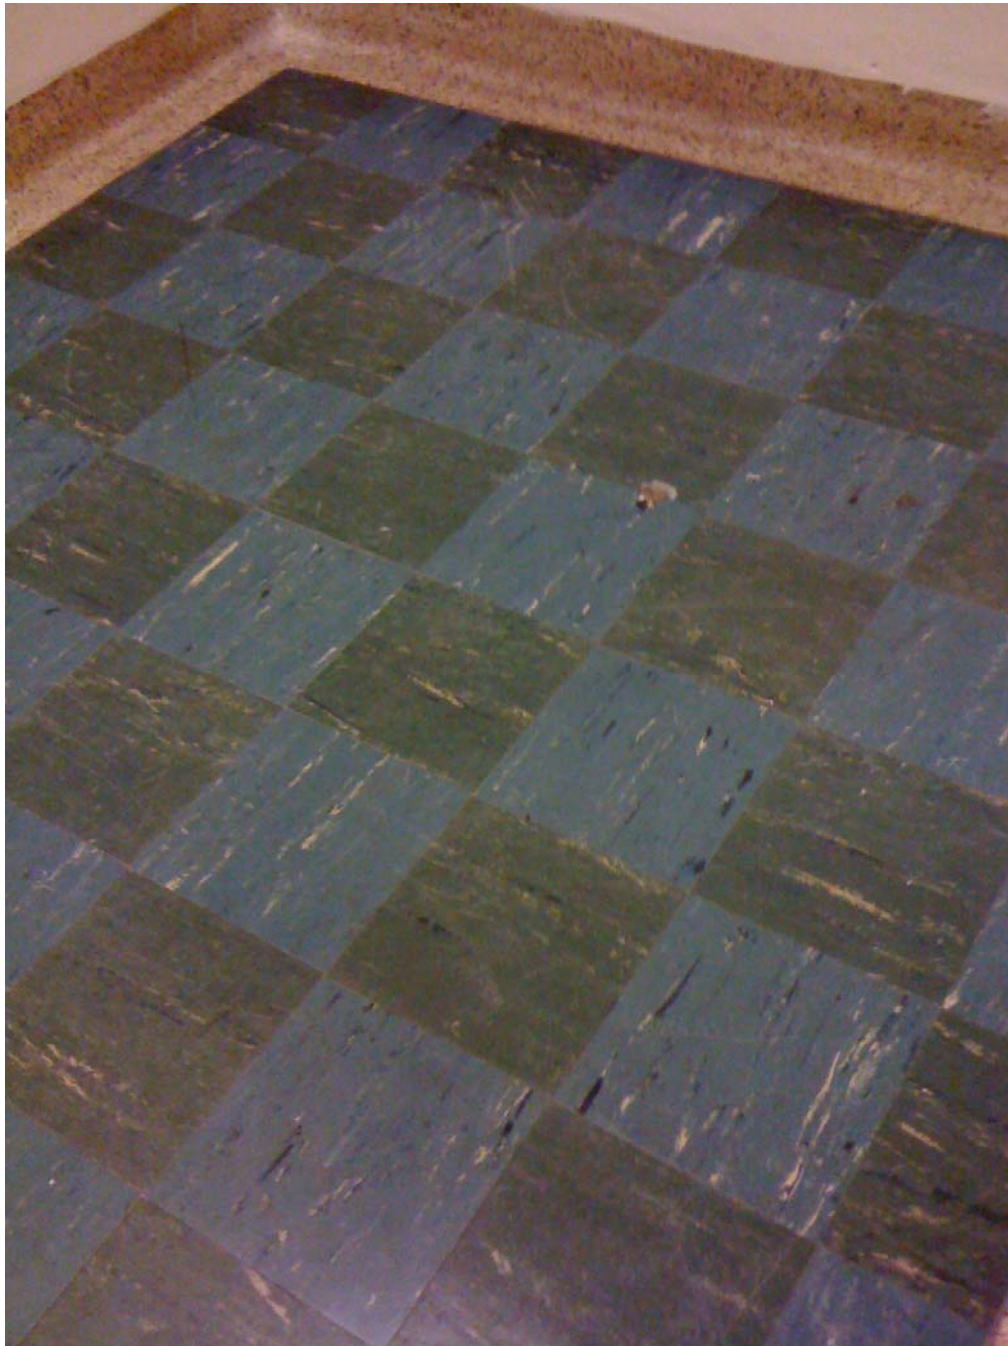
Building 37
Sample 64 Floor - 9" x 9" Blue Green Floor Tile

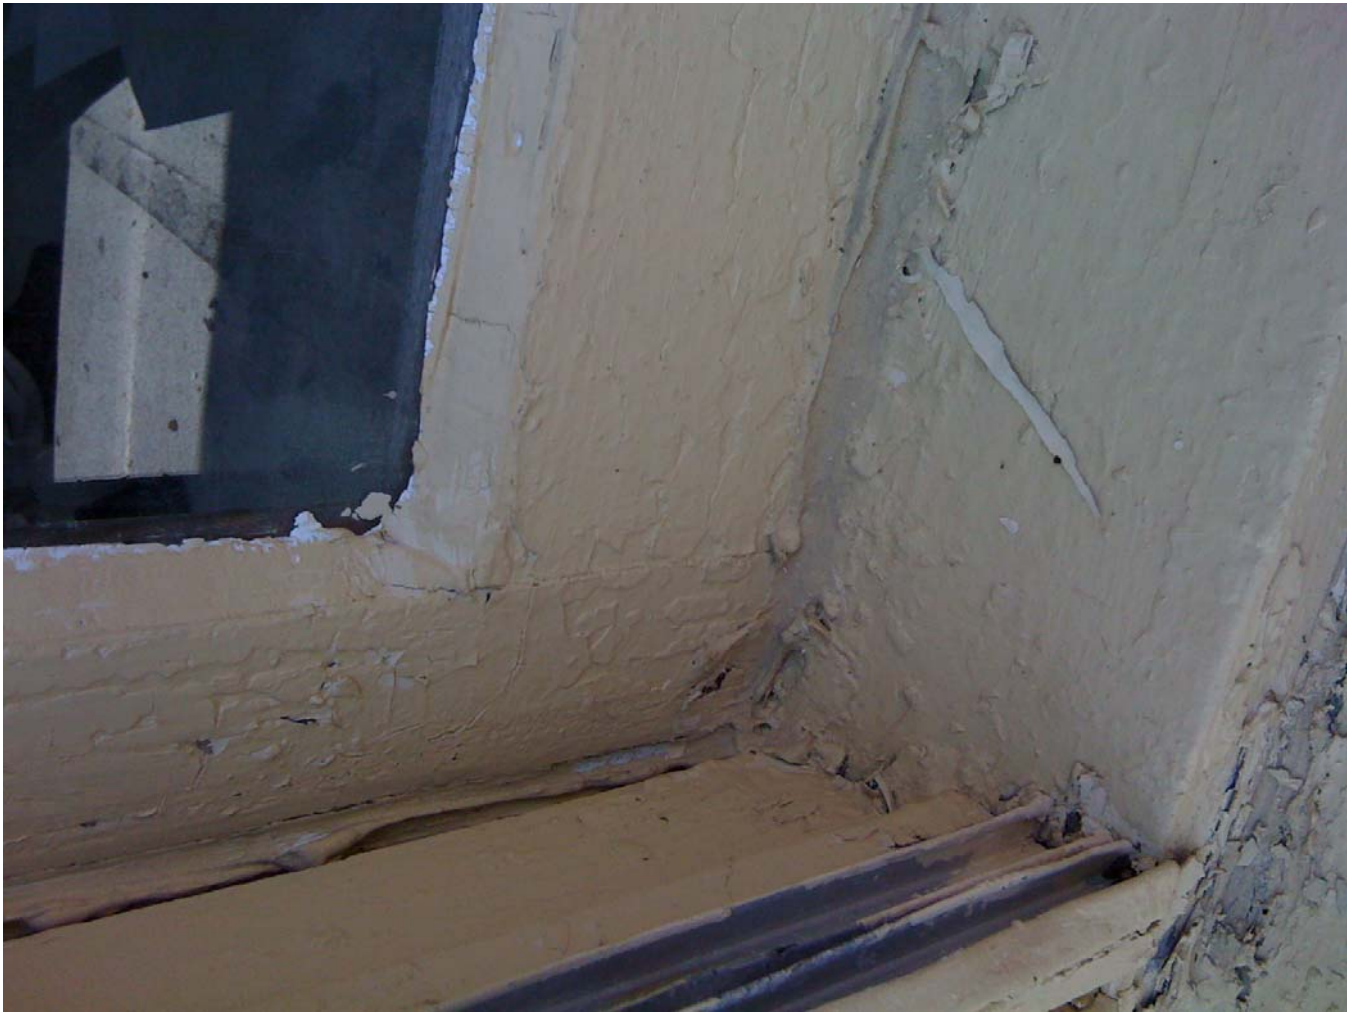
Building 37
Sample 73 – Window Caulking

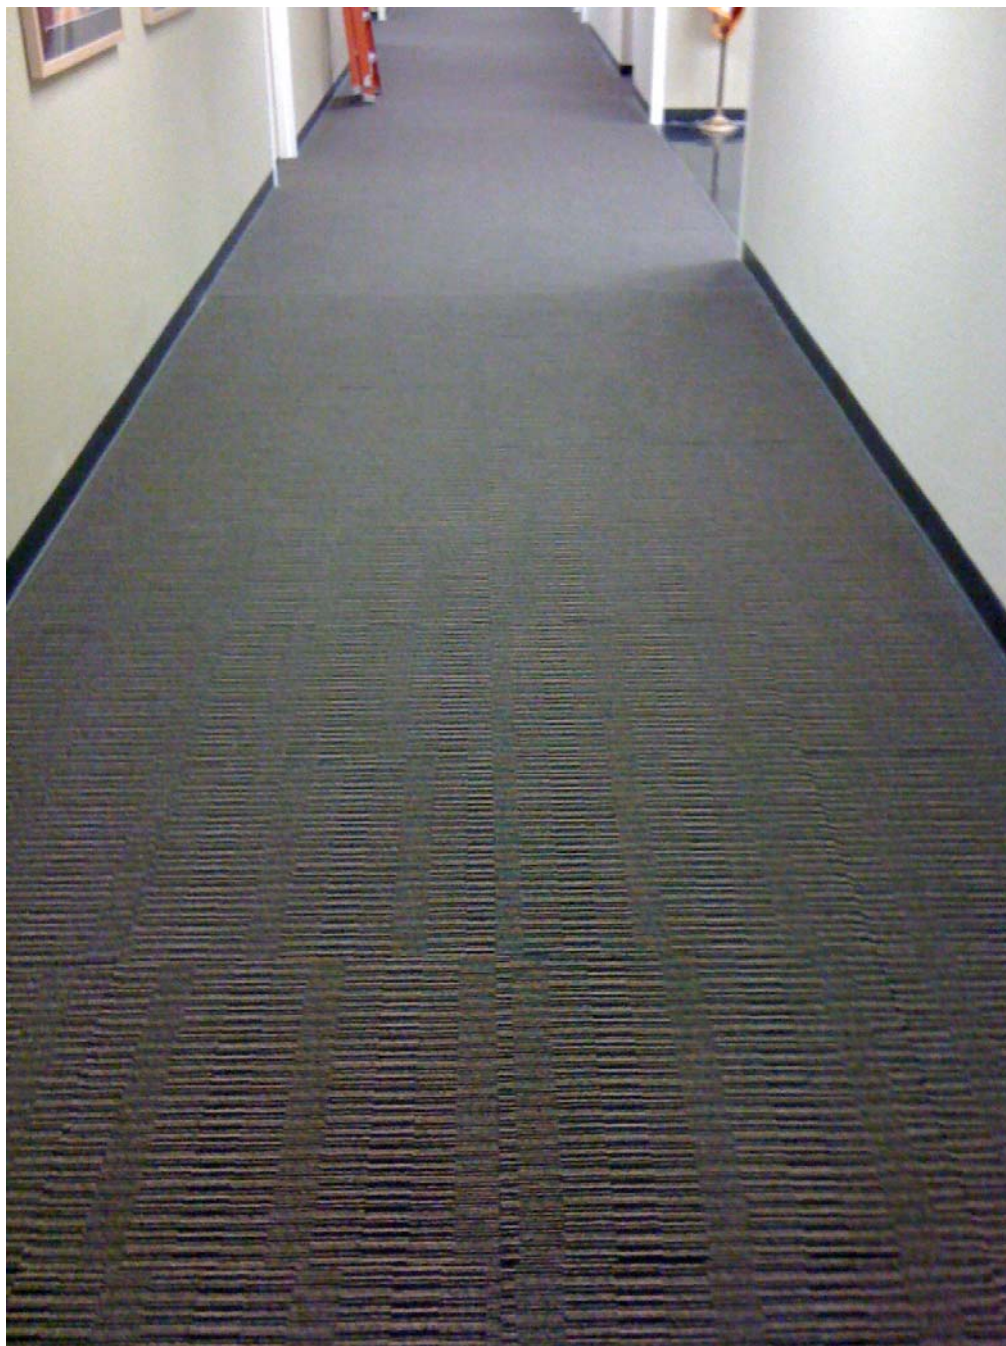
Building 37
Sample 82 Floor – 12” x 12” White Floor Tile Under Carpet

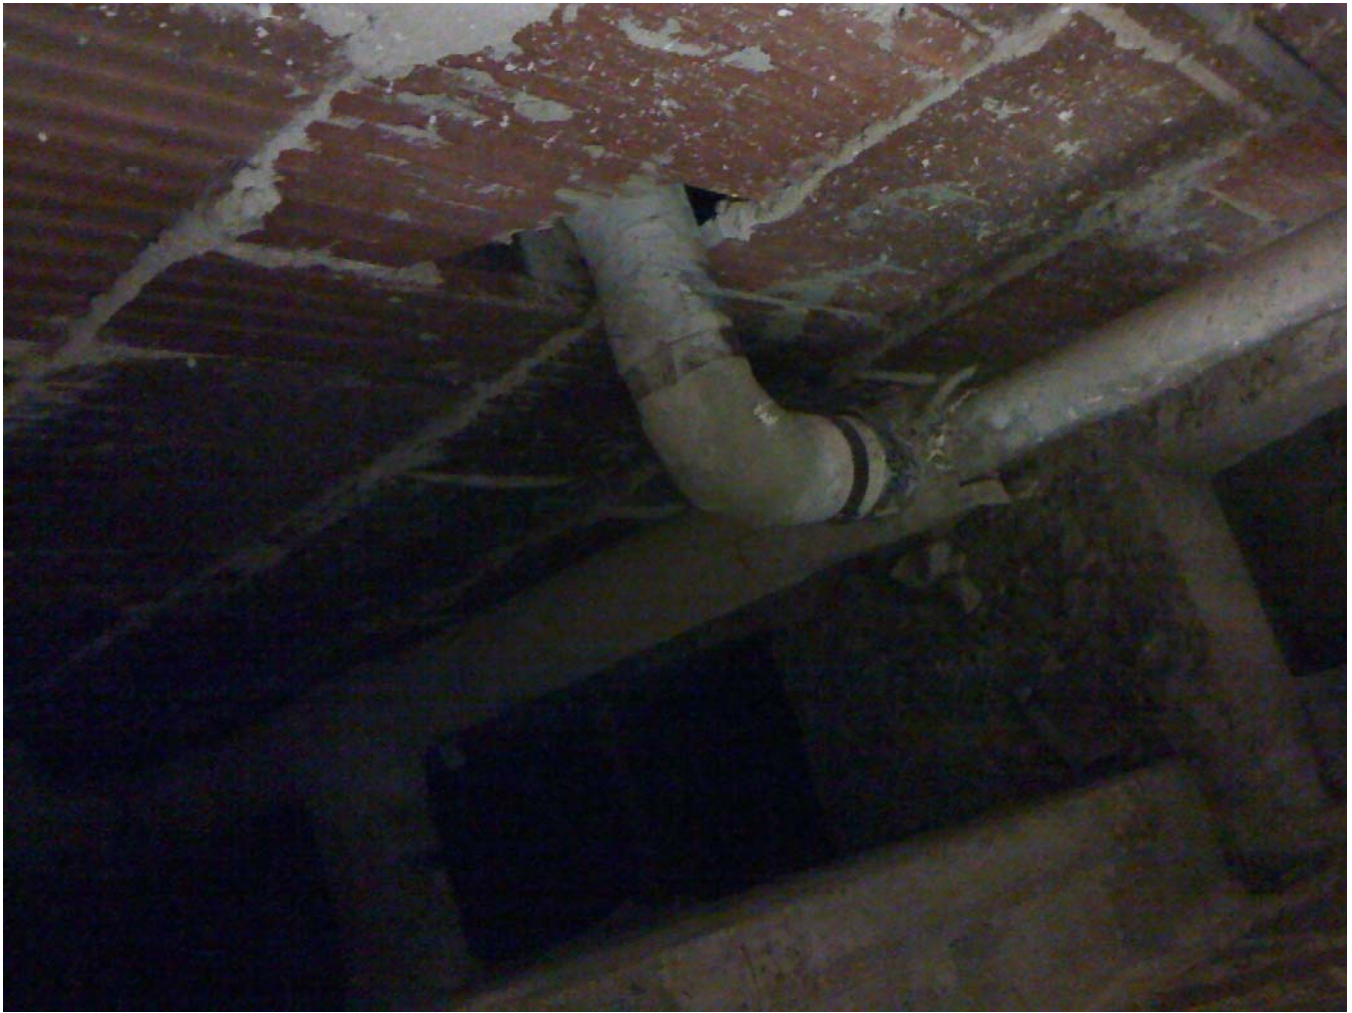
Building 37
Sample 107 – Pipe Insulation

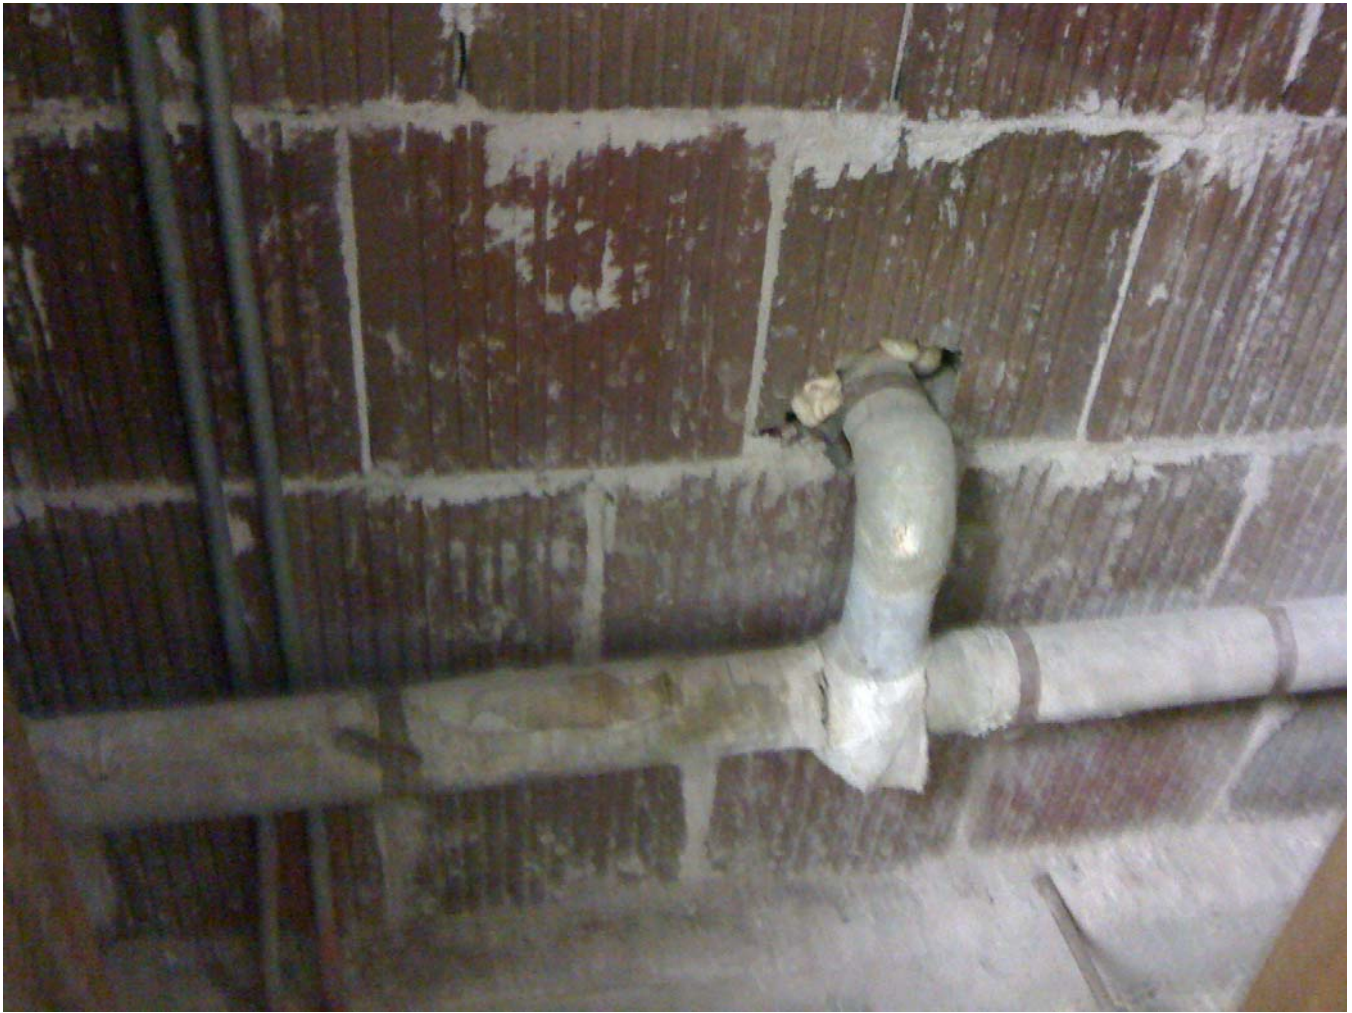
Building 37
Sample 110 - Pipefitting Insulation

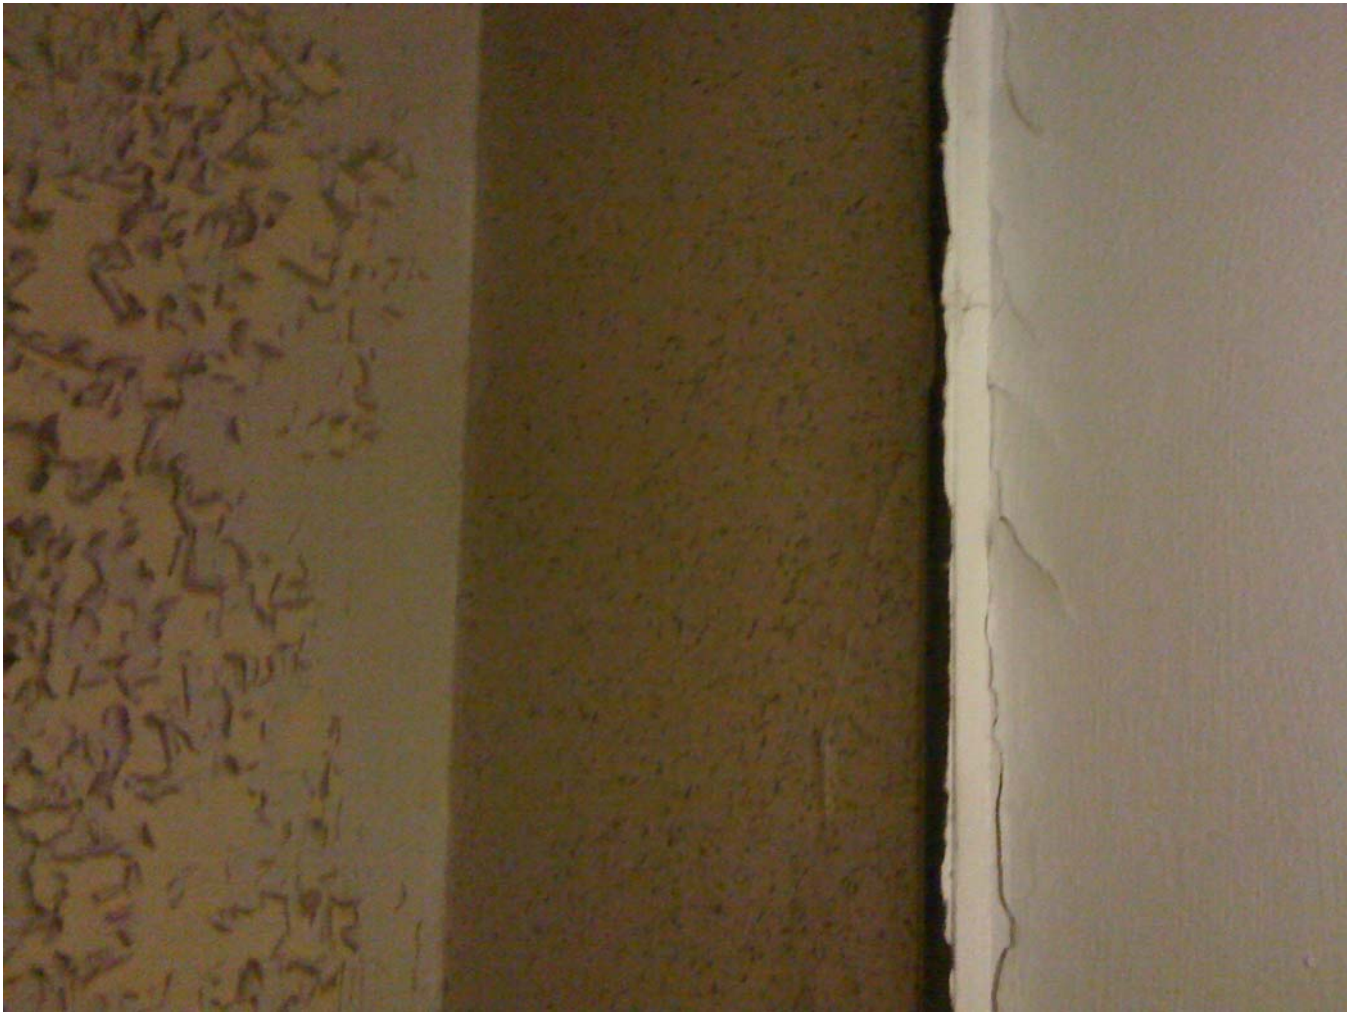
Building 37
Sample 113 - Residual Thick Ceiling Tile Mastic
Sample 119 Glue - Residual Ceiling Tile Mastic

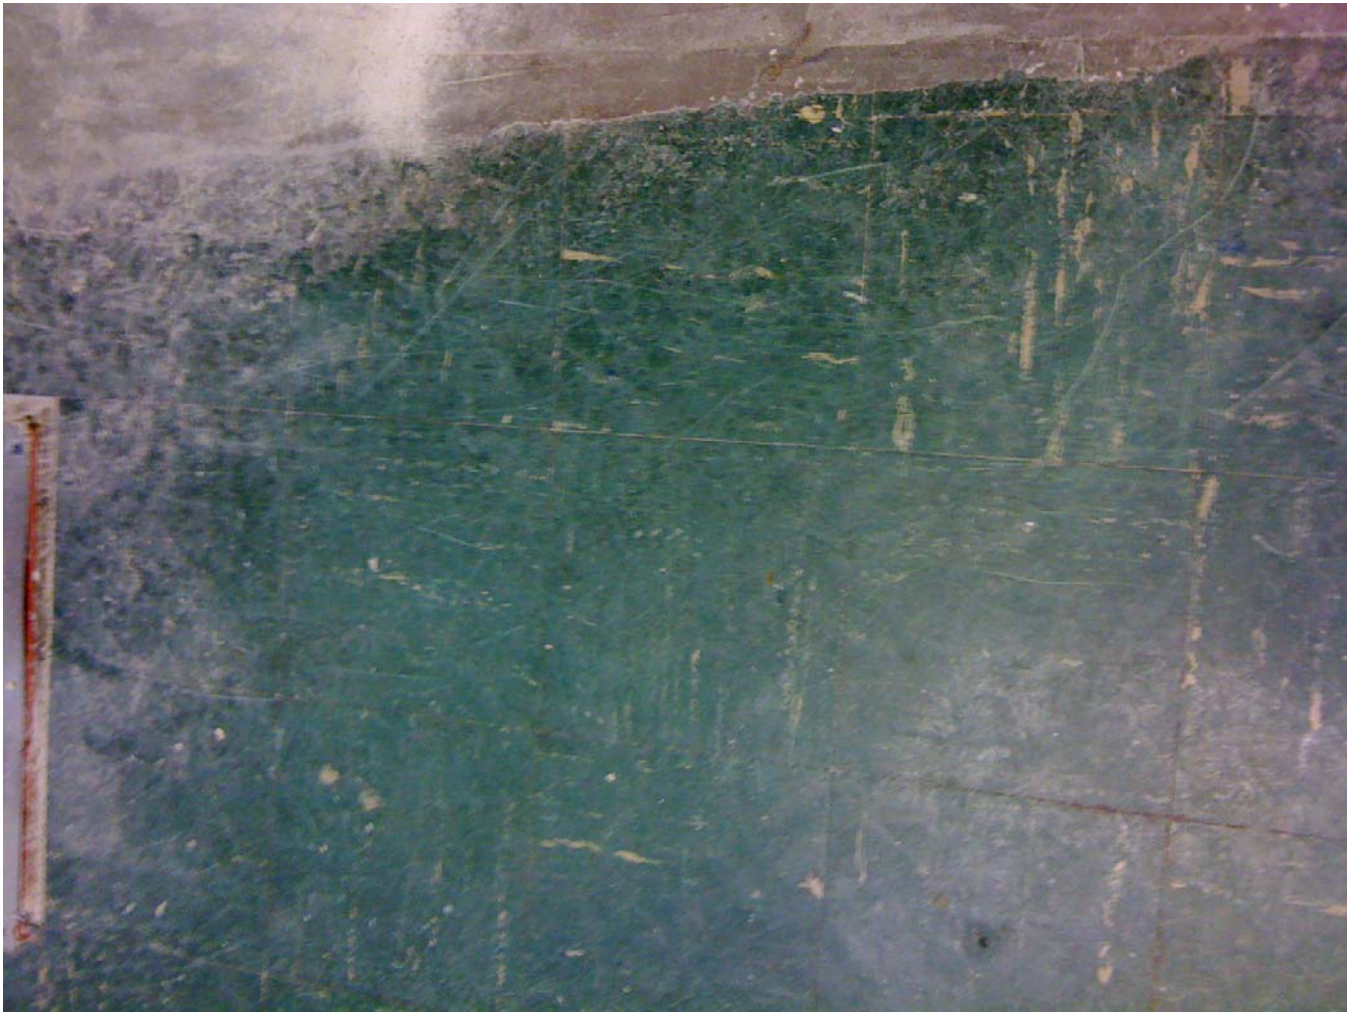
131 Floor	142S	Stair Landings	9"x9" Green Floor Tile	2 Chrysotile	Good	225 SF	I
132 Mastic	142S	Stair Landings	Black Mastic	5% Chrysotile	Good	225 SF	I
137	Room 110	Room 110	Pipe Insulation	15% Chrysotile	Good	200 LF	Friable

Building 37
Sample 131 Floor - 9"x9" Green Floor Tile
Sample 132 Mastic - Black Mastic

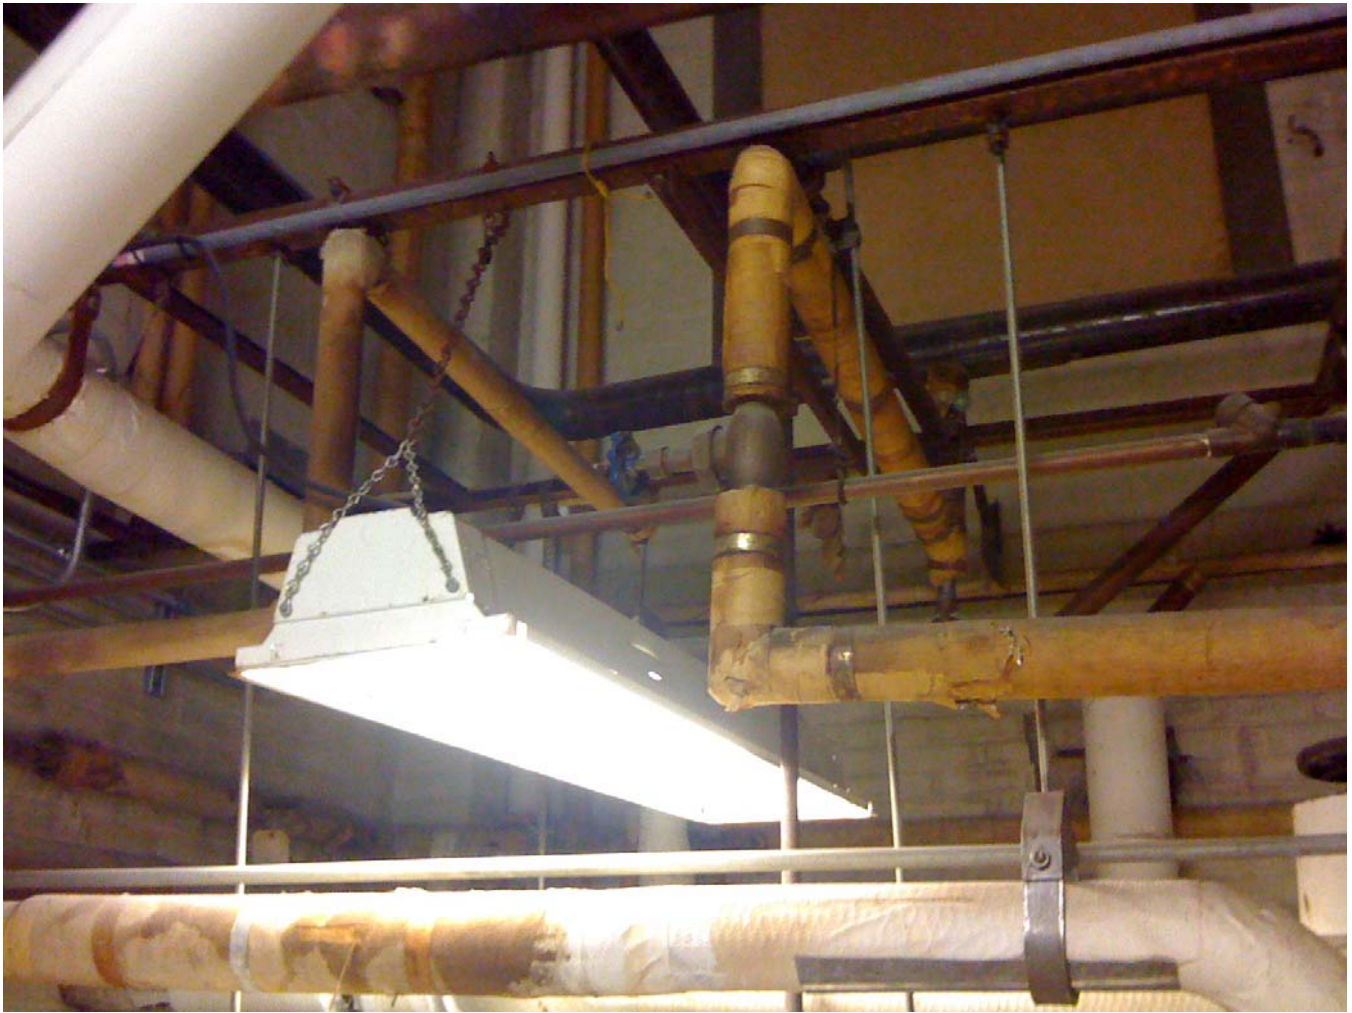
Building 37
Sample 137 - Air Cell-Like Pipe Insulation
