**LEAD-BASED PAINT INSPECTION AND
RISK ASSESSMENT REPORT
APARTMENT COMPLEX NO. 2
VA MEDICAL CENTER
MILES CITY, MONTANA**

Maxim Project No. 2008274.100

March 5, 2001

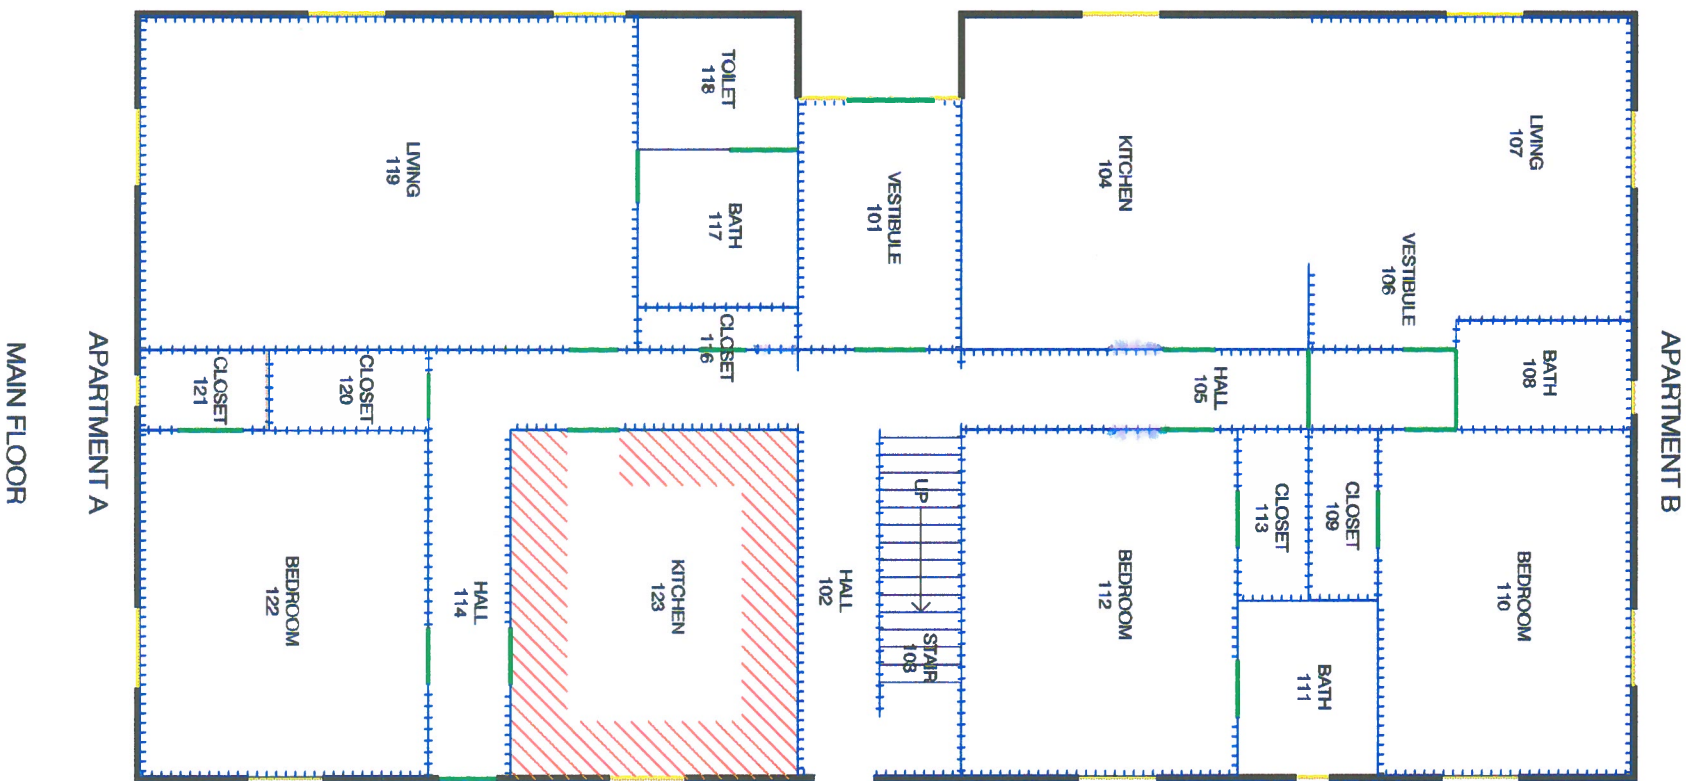
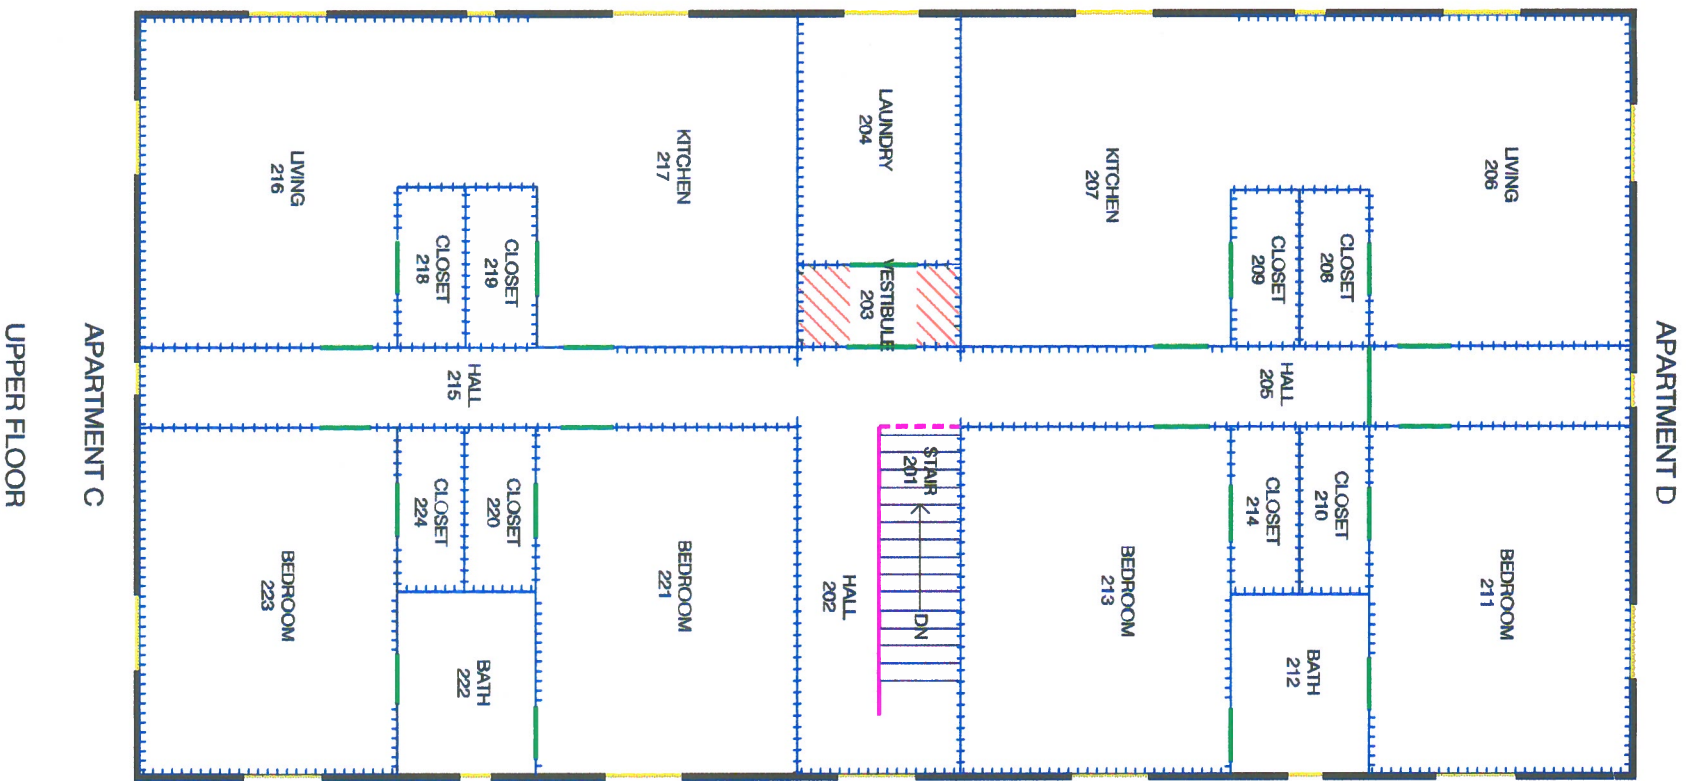
FIGURES FIGURE 1 - LBP BUILDING COMPONENT LOCATIONS

Building Component and General Location	Current Paint Color†	Lead Concentration mg/cm ² *
Wood cabinet doors in laundry room vestibule	White	1.9 (Avg.)
Wood baseboard throughout	White	2.0
Cabinet doors in kitchen, Apartment A	White	1.5 (Avg.)
Wood ironing board door in Apartment A	White	1.3
Wood screw board in bedroom closet, Apartment A	White	2.0
† Color as of the date of the inspection and may not reflect conditions at a later date.		
* mg/cm ² = milligrams per square centimeter

The general condition of the paint on the above components ranges from poor to intact. In general, the only components with evidence of poor condition paint were the window frames. The condition of the remaining components was fair to intact.
