Project Manual for: Building 4

Oscar G. Johnson VA Medical Center
Iron Mountain, Michigan
Asbestos Management Plan
VA Project 585-14-111

February 2015

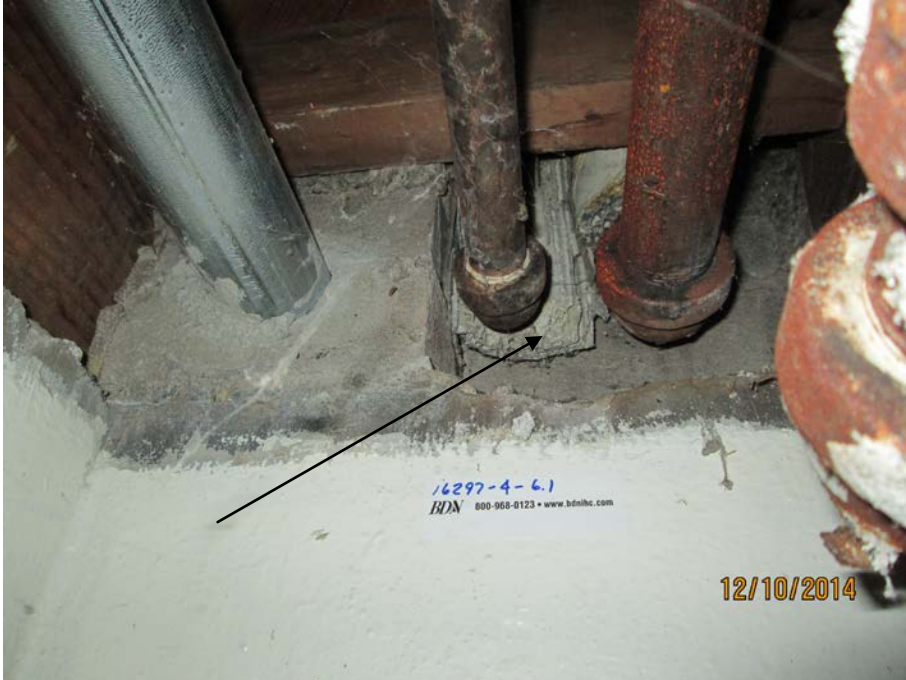
16297-4-6.1 - Corrugated Paper Pipe Insulation

BDN identified one asbestos-containing material and recommends that this material be removed by a licensed asbestos abatement contractor prior to renovation or demolition activities that would disturb this material in any way. Personal and clearance air samples should be collected to demonstrate that asbestos fibers are not released through the abatement process.
