Department of Veterans Affairs

Repair Building Façade Deficiencies

Atlanta VA Medical Center
1670 Clairmont Road
Decatur, GA 30033-4004
Project No. 508-10-105

Construction Documents

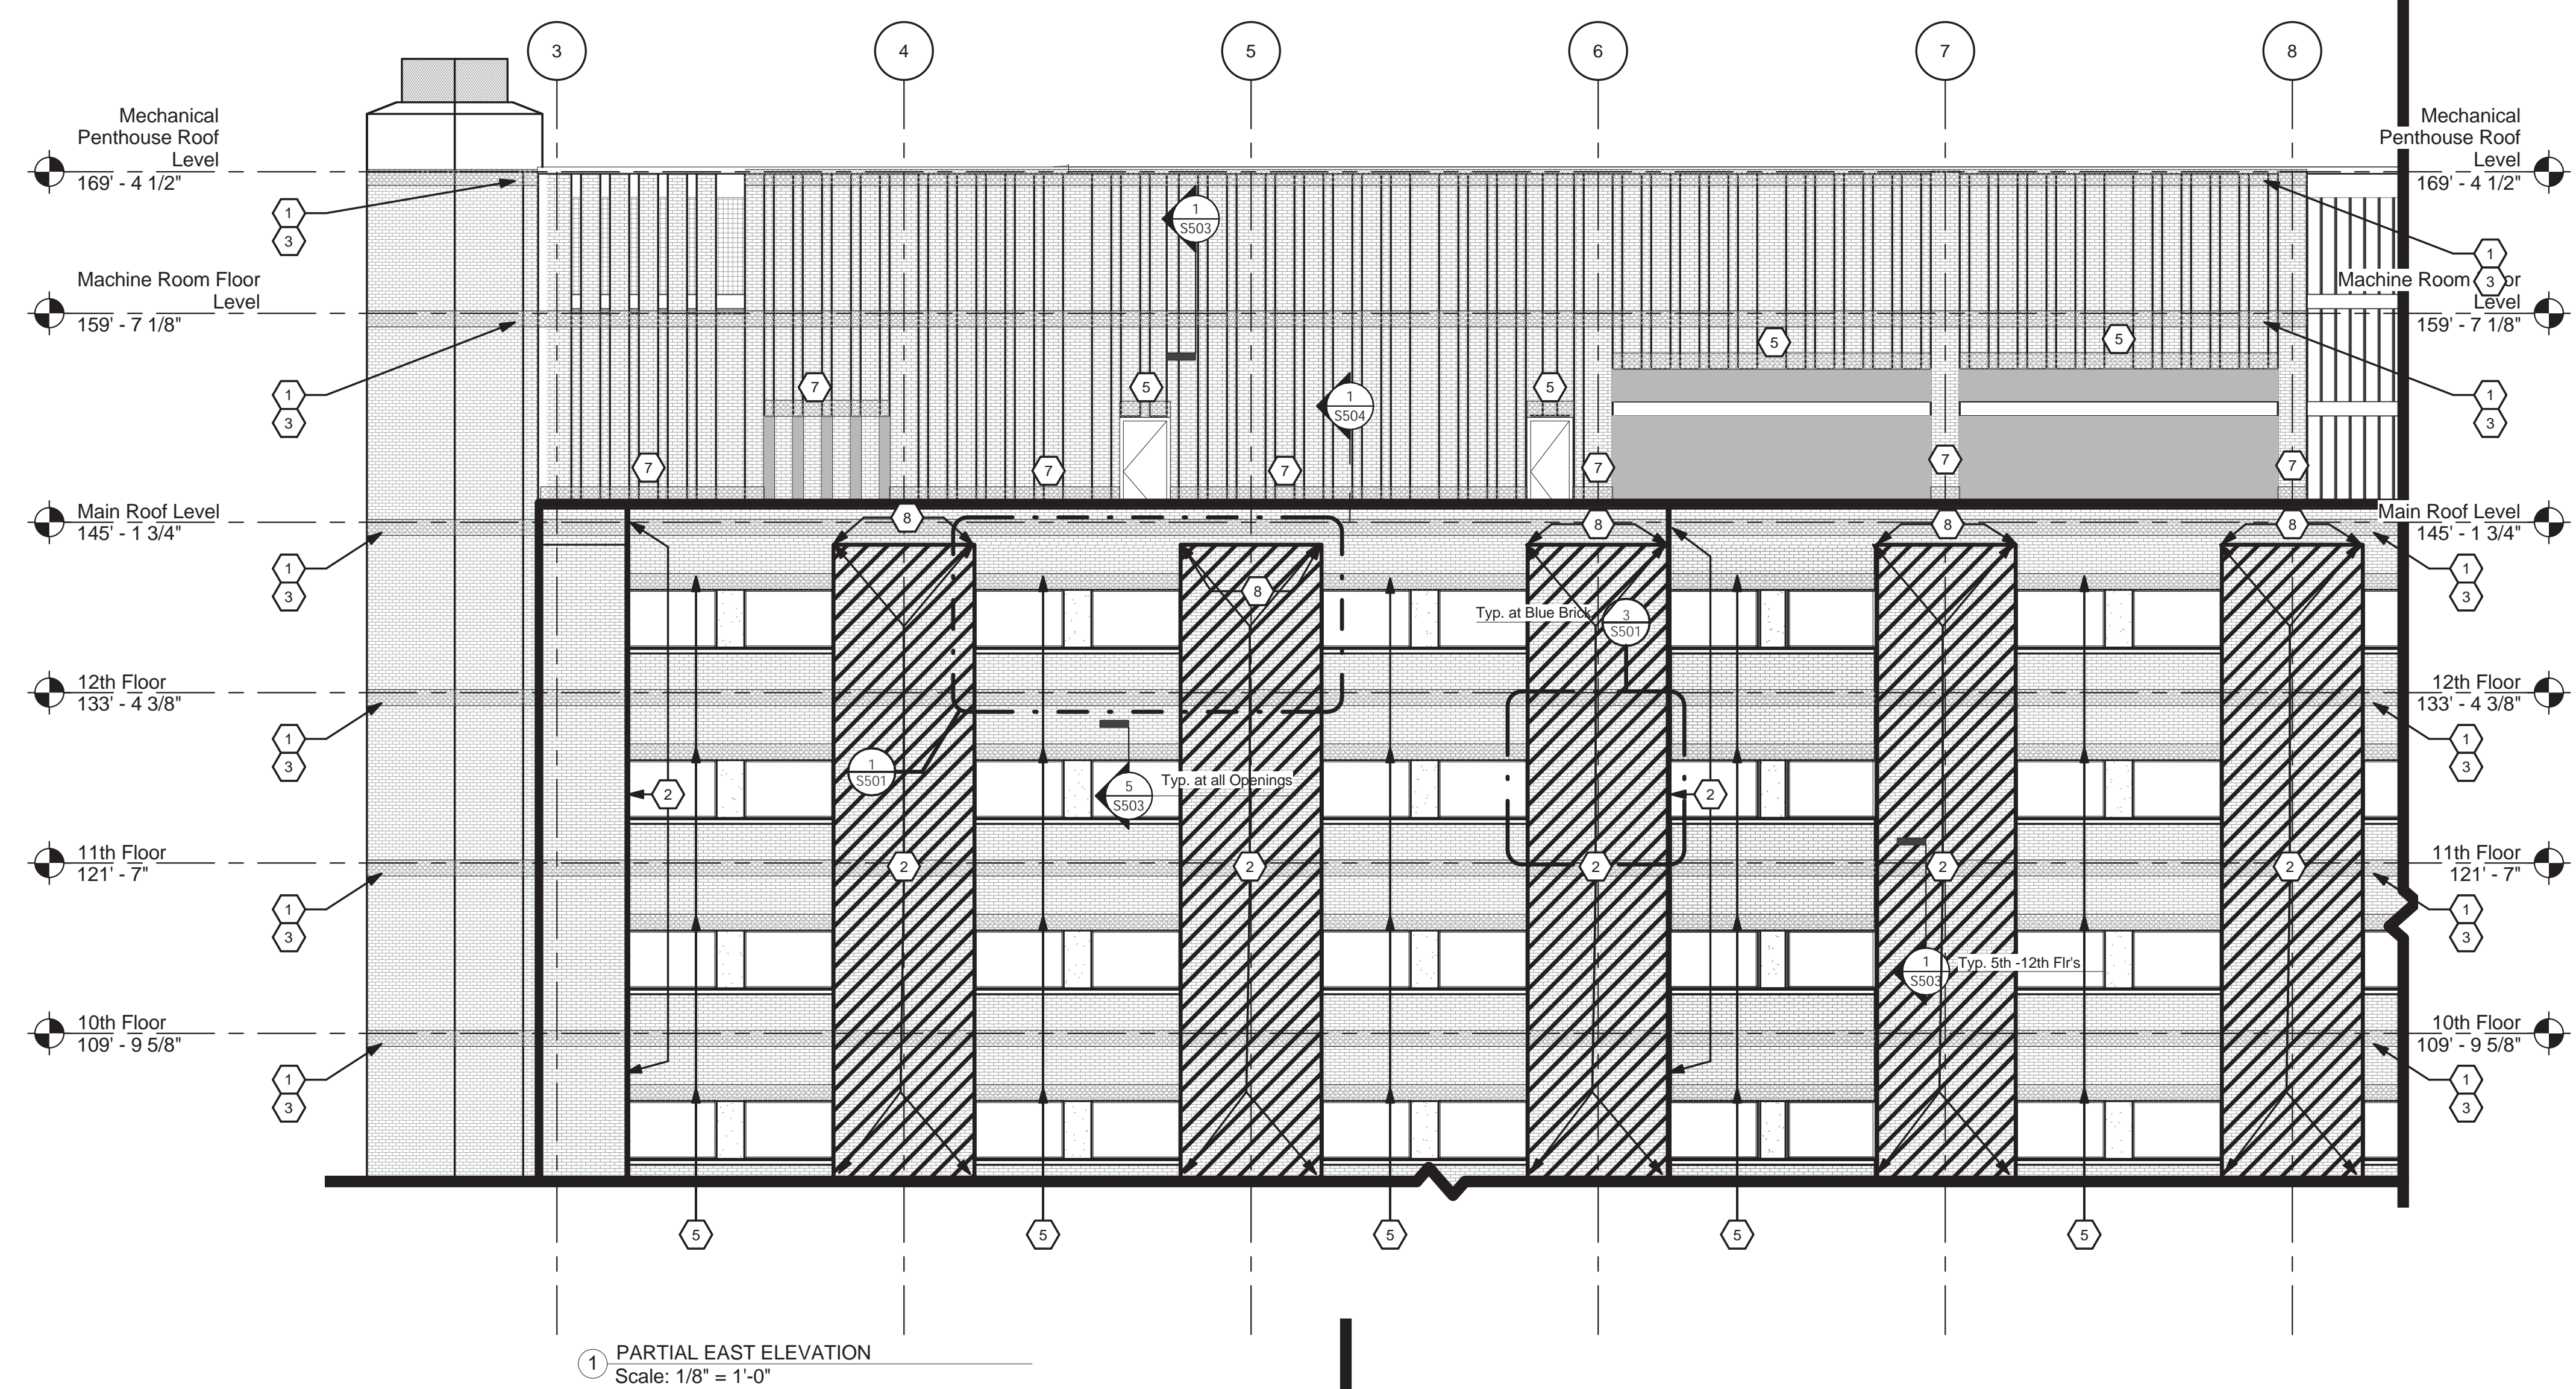
1 PARTIAL EAST ELEVATION
Scale: 1/8" = 1'-0"

- Remove and replace sealant at all pipe penetrations through the brick.
 - Remove and replace shelf angle at the 4th floor on the south elevation appears to have rotated away from the wall. See detail 3/S503.

4	Remove and replace steel shelf angle and repair concrete spandrel beam as per Details 1, 2, 3, 5 / S502 and 4 / S503.
5	Above existing openings, remove three to five courses of brick to access the steel shelf angle. Install new flashing system with metal drip edge. Provide new brick to match existing. (Refer to Details 5, 6 / S503 and all other applicable details, notes and specifications.)
6	Install Retrofit Ties. (Refer to Details 3, 6, 8, 9 / S501 and all other applicable details, notes and specifications.)
7	Repair flashing at base of wall. (Refer to Detail 1/S504 and all other applicable details, notes and specifications.)
8	Extent of New Reglet Flashing Continuous along the top at areas indicated. (Refer to Detail 7/S501 and all other applicable details, notes and specifications.)

- General Notes:
- All mortar joints are to be tuckpointed on the entire building tower as per detail 3/S501.
 - Windows: During the flashing replacement process, the steel lintels above windows should be cleaned and coated. This will require removing the brick masonry above the lintel, abrasively cleaning the steel, priming and replacing the brick.

- Shelf Angles: In the process of exposing shelf angles, the steel shelf angles should be cleaned and coated. This will require removing the brick masonry below and above the shelf angles, abrasively cleaning the steel, priming and painting the steel with a rust inhibitor paint, installing a new flashing system to divert water out of the wall system, and replacing the brick.
