## **FORENSIC-GEOTECHNICAL EXPLORATION, DATA EVALUATION, AND SINKHOLE REMEDICATION / STABILIZATION SERVICES REPORT**

**Existing Sinkhole - Florida National Cemetery  
Proposed Stabilization Program  
6502 SW 102nd Avenue  
Bushnell, Sumter County, Florida**

**KCI Project No. 28133363.07  
VA Project No. 911NRM14001**

*KCI Technologies, Inc.  
July 2014*

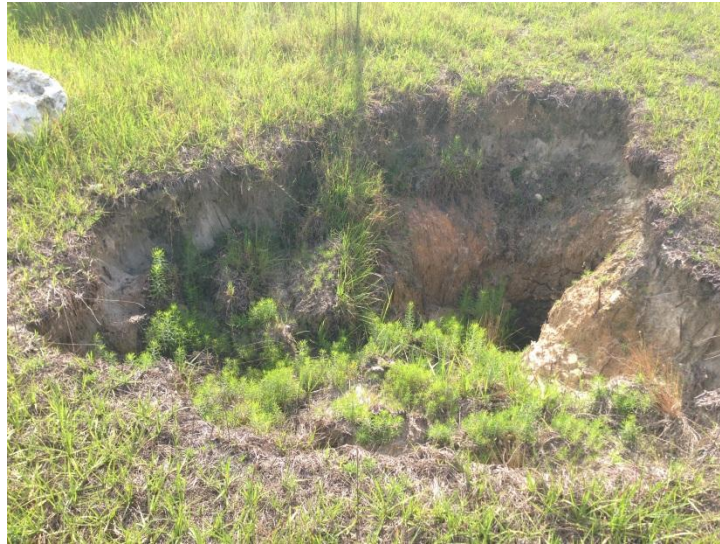
The existing subsidence is approximately centered within the southern half of the pond with a top that is approximately 12 ft. at the widest dimension and 15 ft. deep. While the top of the subsidence has sloughed-in and apparently increased in size (according to Mr. Blizzard) due to rain events that occurred prior to our site visit, the actual diameter of the subsidence seems to be approximately 2 ft. in diameter starting about 4 ft. below the ground surface to the bottom of the subsidence (approximately 15 ft. below ground).

**Photo 1: View of the existing sinkhole**

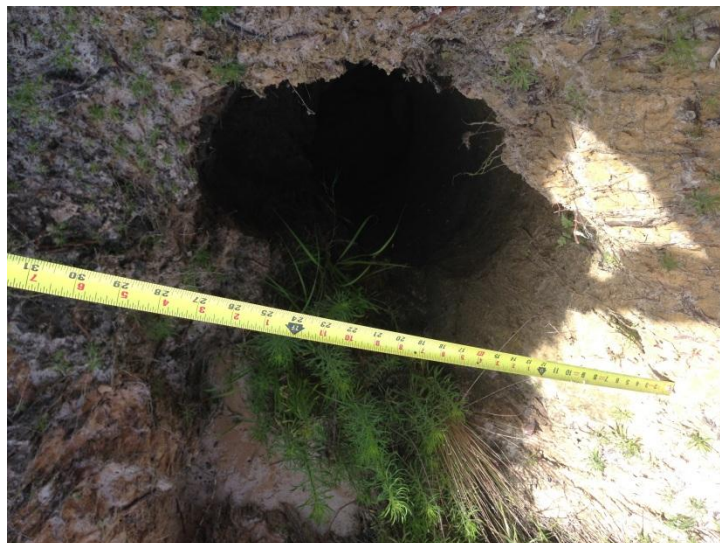
**Photo 2: Top view of the existing sinkhole**

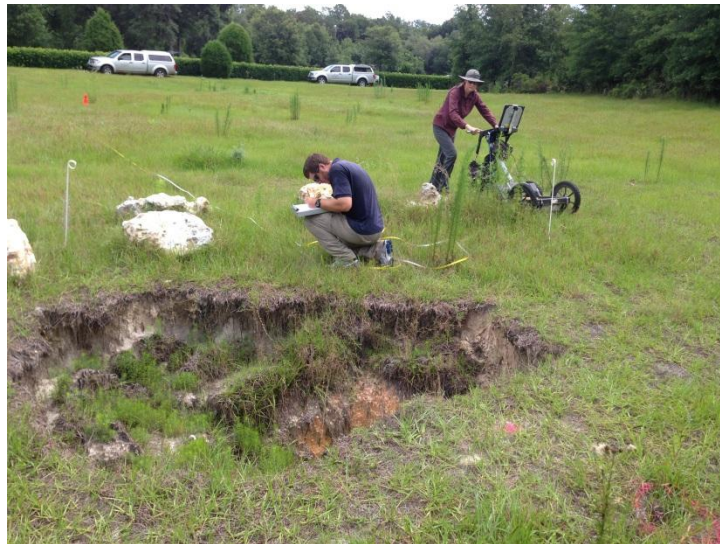
**Photo 3: View of the GPR survey in progress**

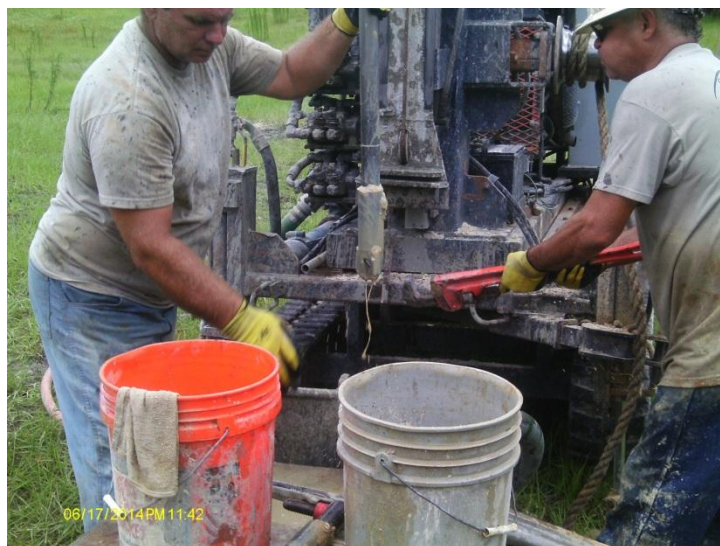
**Photo 4: View of SPT drilling in progress**
