OVERVIEW:

PROJECT NAME / NUMBER: Houston National Cemetery  
 QUOTATION NUMBER: 20150507-1  
 DATE: 5/7/15  
 CUSTOMER P.O. NUMBER: \_\_\_\_\_  
 CUSTOMER NAME: U.S. Department of Veterans Affairs  
 ADDRESS (LINE 1): \_\_\_\_\_  
 ADDRESS (LINE 2): \_\_\_\_\_

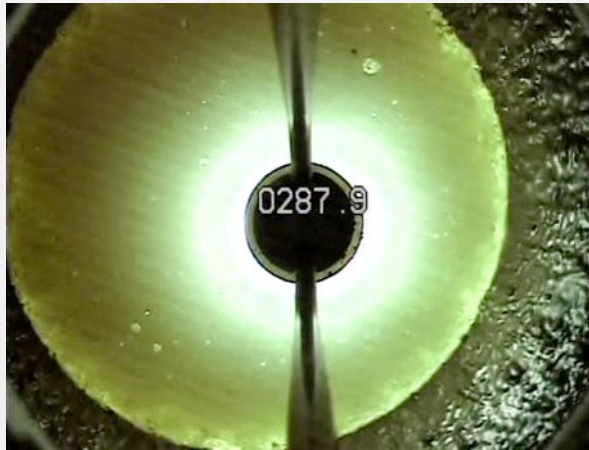
Static Water Level with lite oil film

There are both pump and well indications that the well was not keeping up with the pump design. This well should have had 15 – 20ft of oil floating at the static water level due to normal operation over the years. Since only a thin oil film was present this indicates that the pump was breaking suction and pumped out the oil. Other findings that lead us to this conclusion are the scour marks at 481' and the pumping equipment damage including a broken shaft.

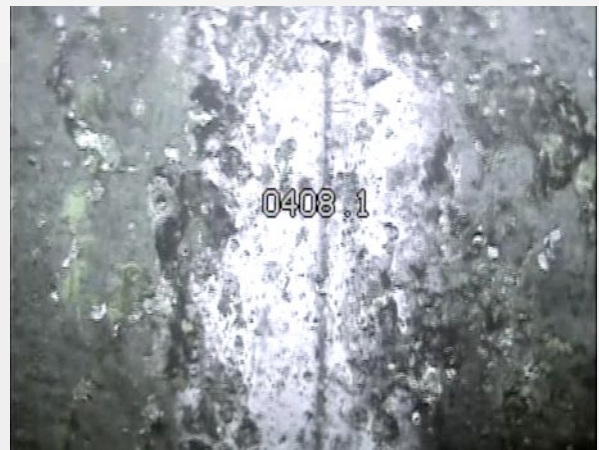
Vertical Casing Seam

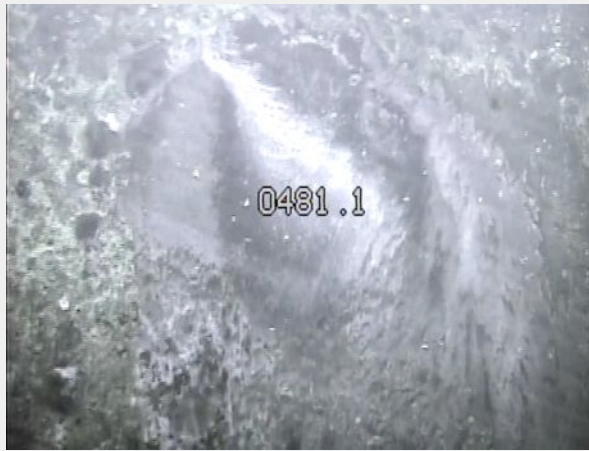
Scour Marks caused by the pump

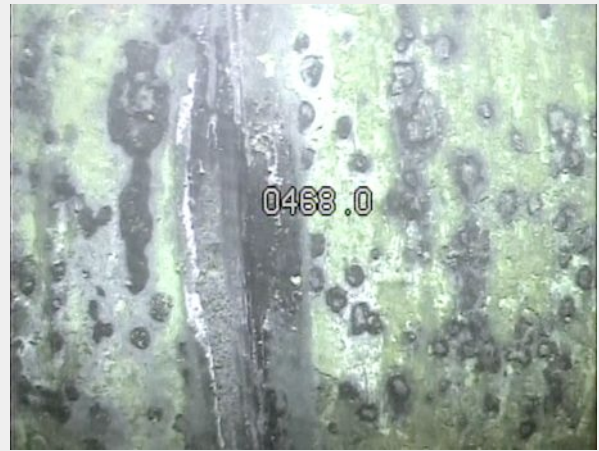
Vertical Casing Seam

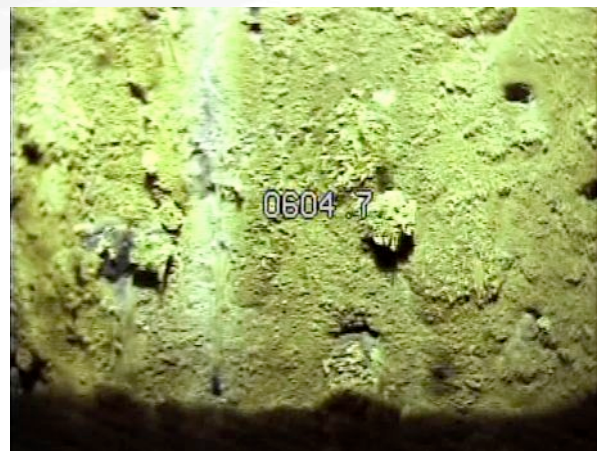
Clogged Screen

Our best guess is that the well is operating with 80 – 85% clogged screens. Well conditions like this cause the following problems: premature pumping equipment failure, gravel washouts, casing and screen washouts, increased sand production, and eventually well collapse. This needs to be addressed before ordering and installation of new pumping equipment.

Well Rehabilitation is needed before the pump installation. See the attached proposed scope of work.

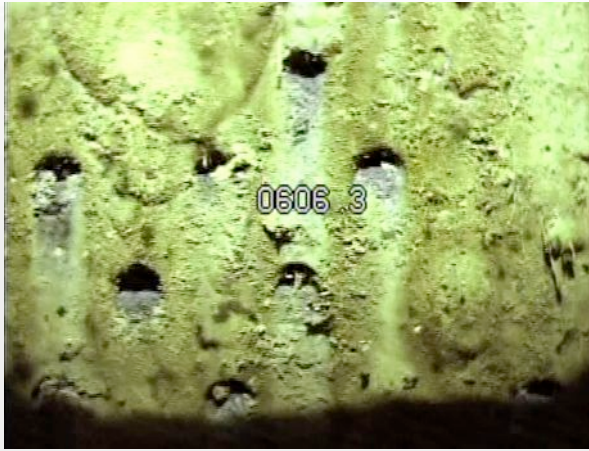
Partially Open Screen

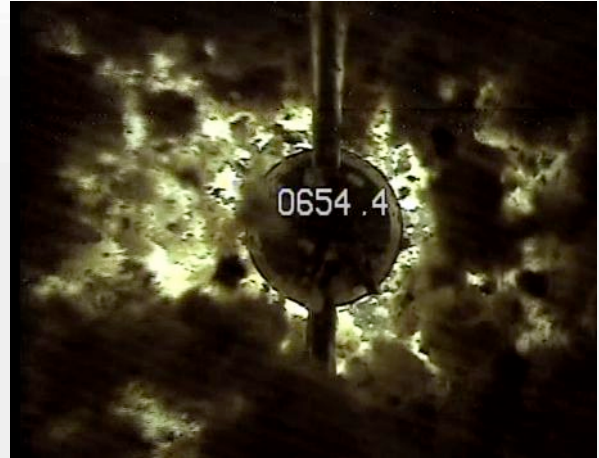
Iron Bacteria

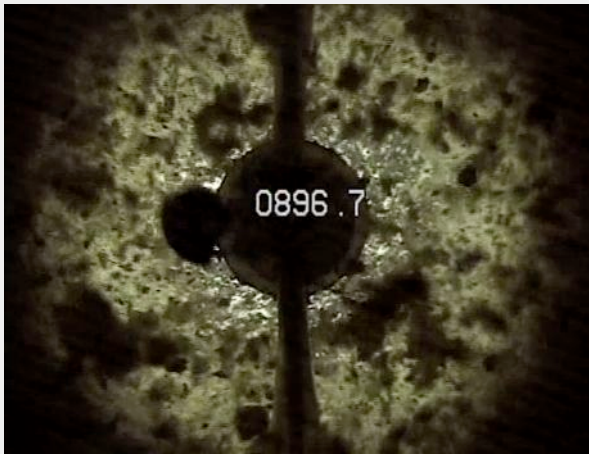
Iron Bacteria

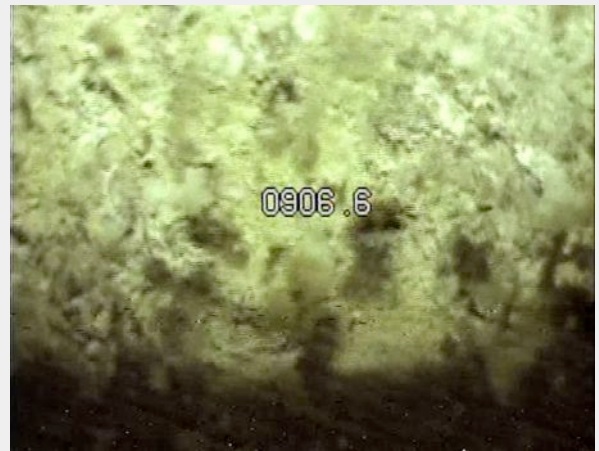
Clogged Screens – Pinholes can be seen

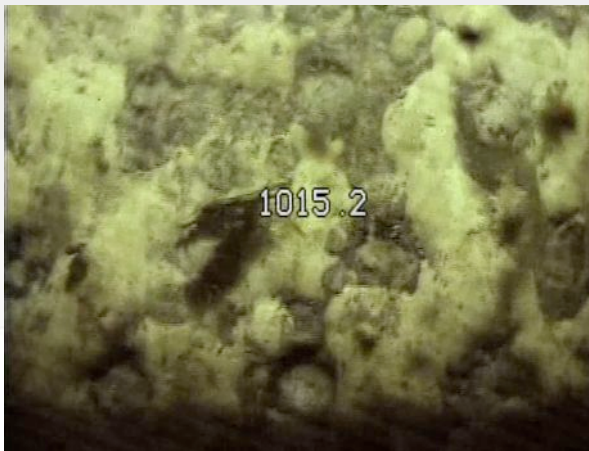
Clogged Screen Section
