# **Asbestos-Containing Building Materials Survey Report**

## **Outpatient Support (Building 66) Fort Roots, North Little Rock, Arkansas 72114**

Report Date: May 19, 2014

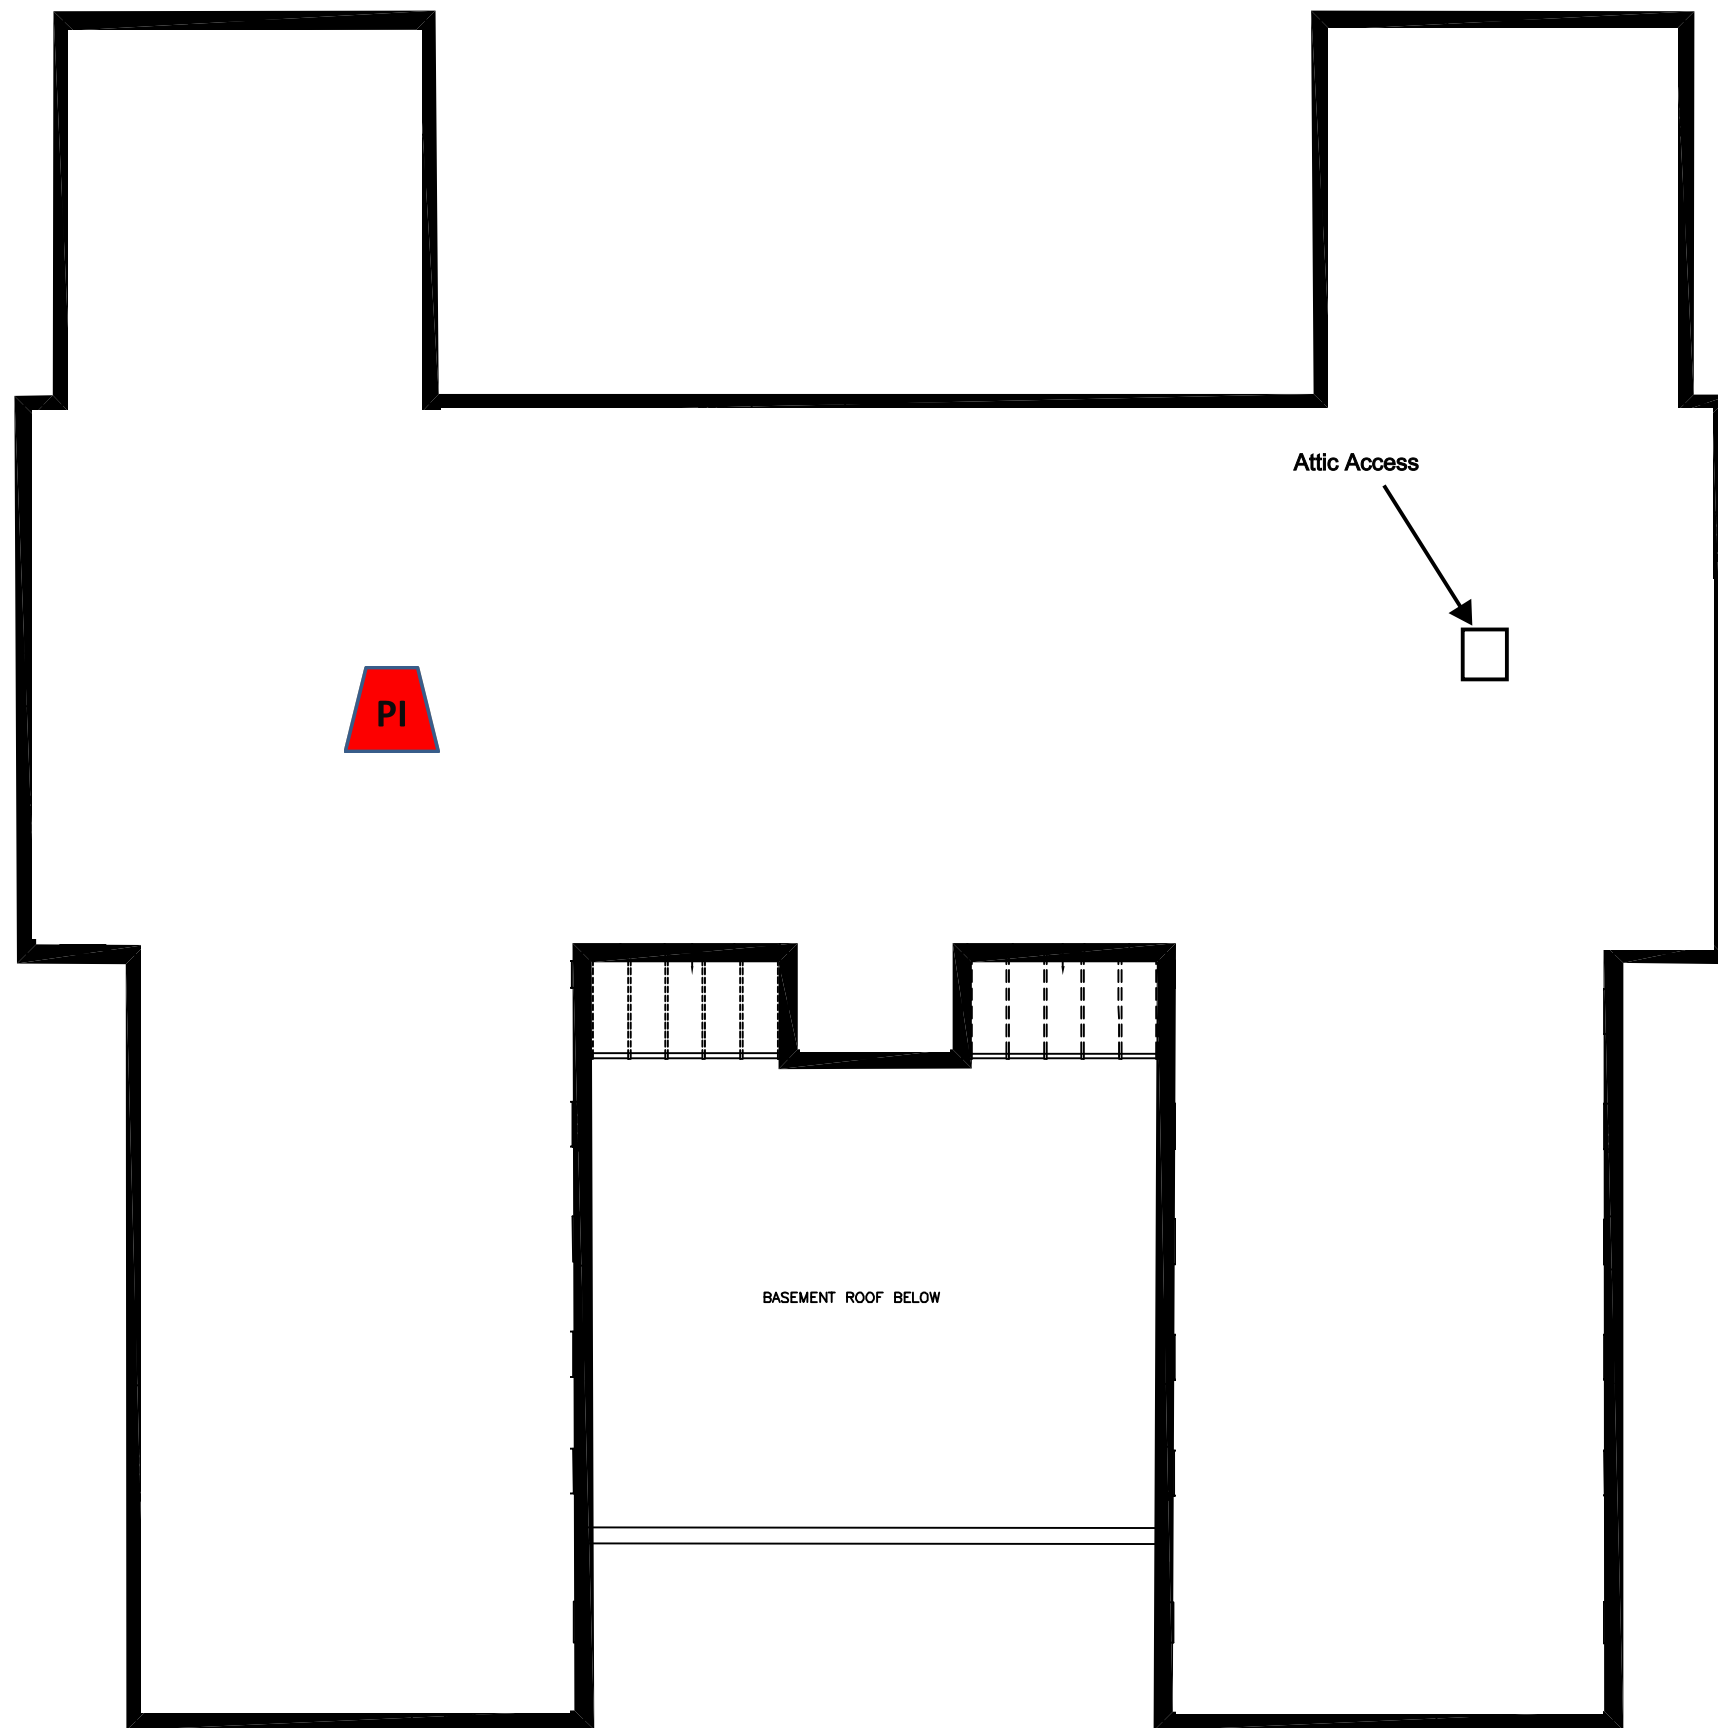
BUILDING 103 - ATTIC

- TSI02B: Mastic - Black (on Cork) located in the attic was found to be in fair condition. The material is loose and not attached to any piping. It is recommended the area be restricted until the material can be removed.

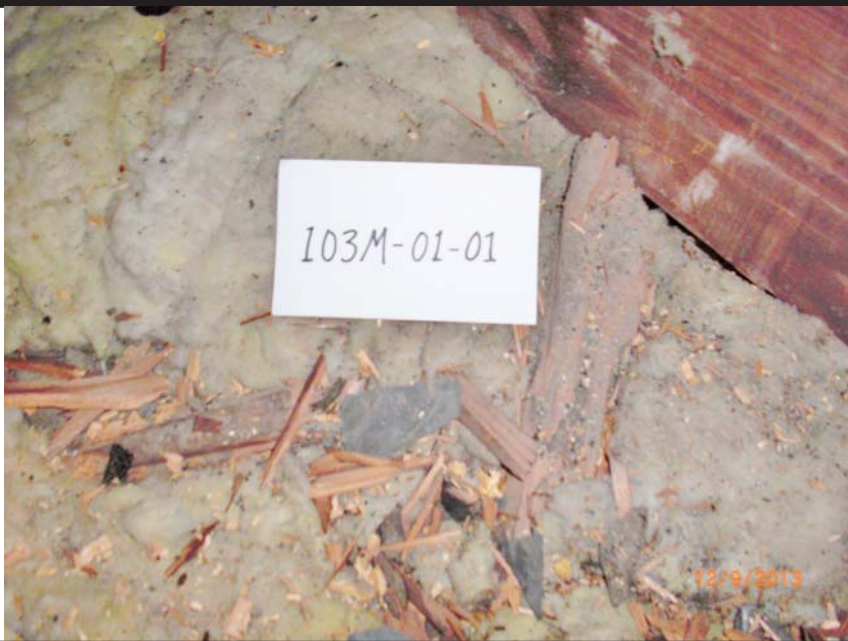
Hard Layered Material (Grey)

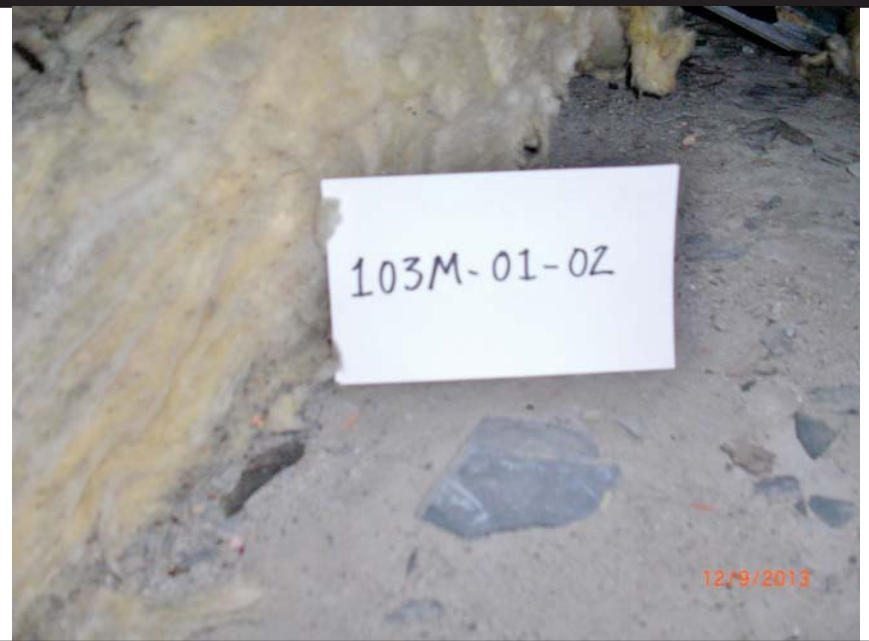
Hard Layered Material (Grey)

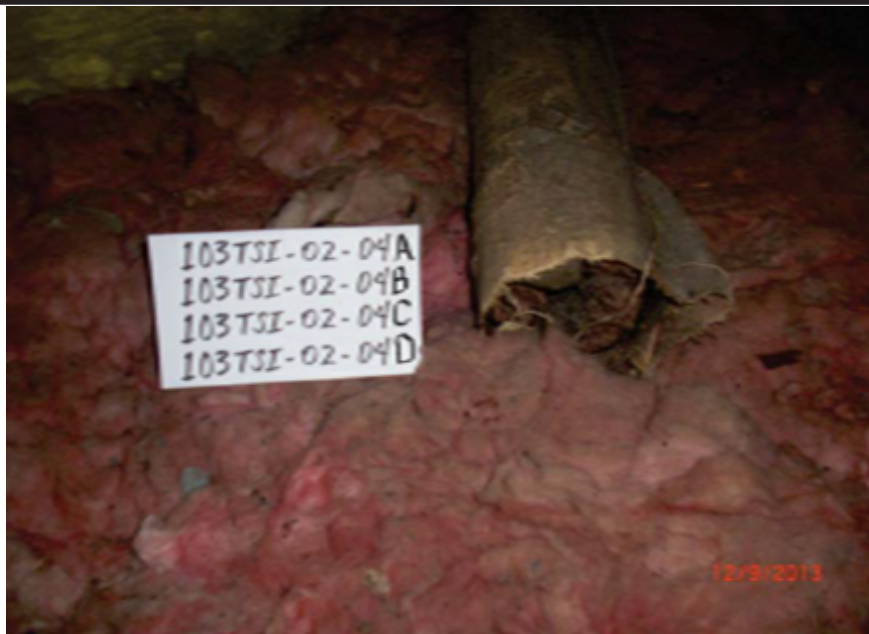
Sheetrock (NOT SUBMITTED) - A, Cork (Brown) - B,  
Backing (Black) - C, Mastic (Black) -

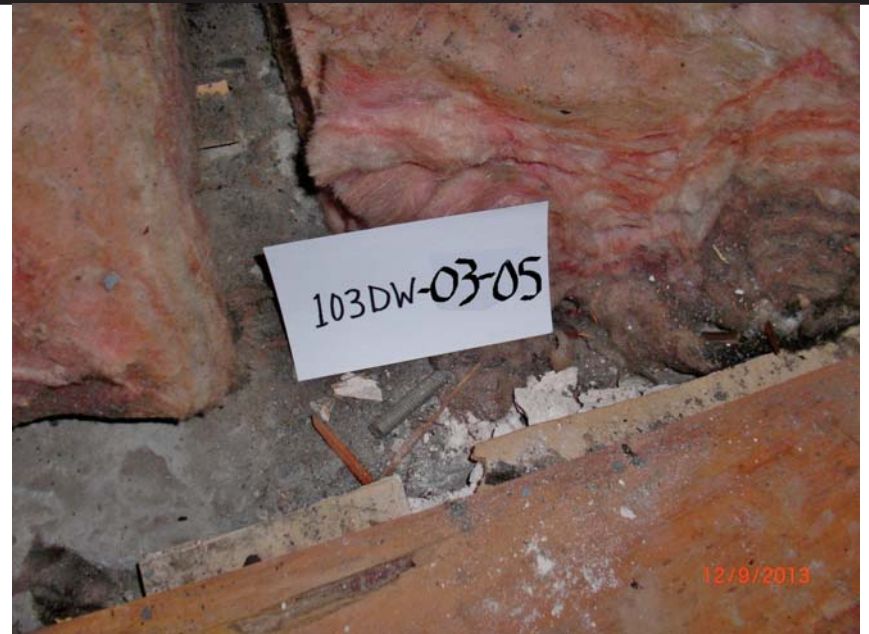
Sheetrock (White) - A  
Backing (Brown) - B
