**Limited NESHAP Renovation Asbestos Survey**

Bay Pines VA  
Building 22, Third Floor  
10000 Bay Pines Boulevard  
Bay Pines, Pinellas County, Florida 33711

June 16, 2014

**AD# 31656**

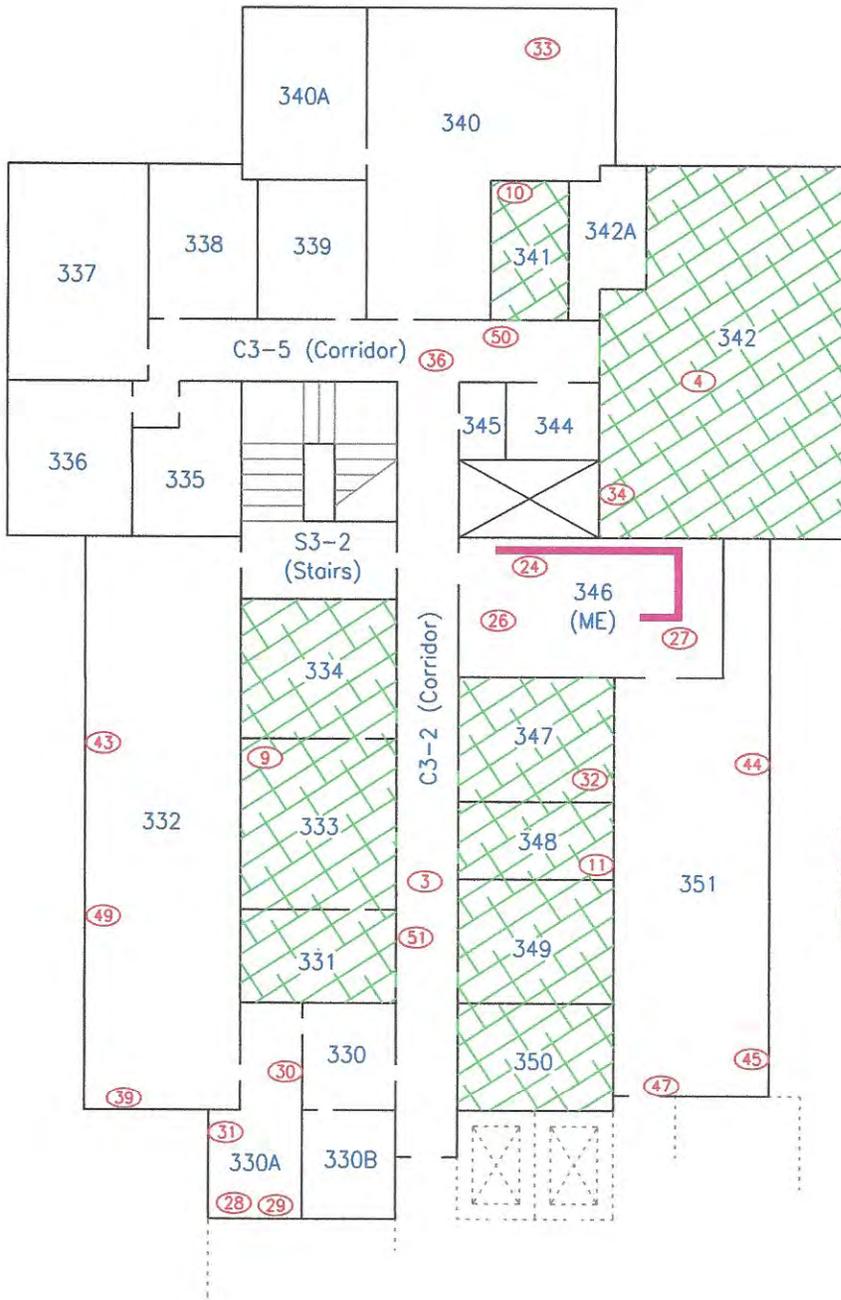
DRAWING 1 OF 2

HA 8: White & Beige Mastic  
 on Chiller Pipe Runs & Elbows  
 HA 12: Black Mastic Remnants  
 Under Carpet and Glue

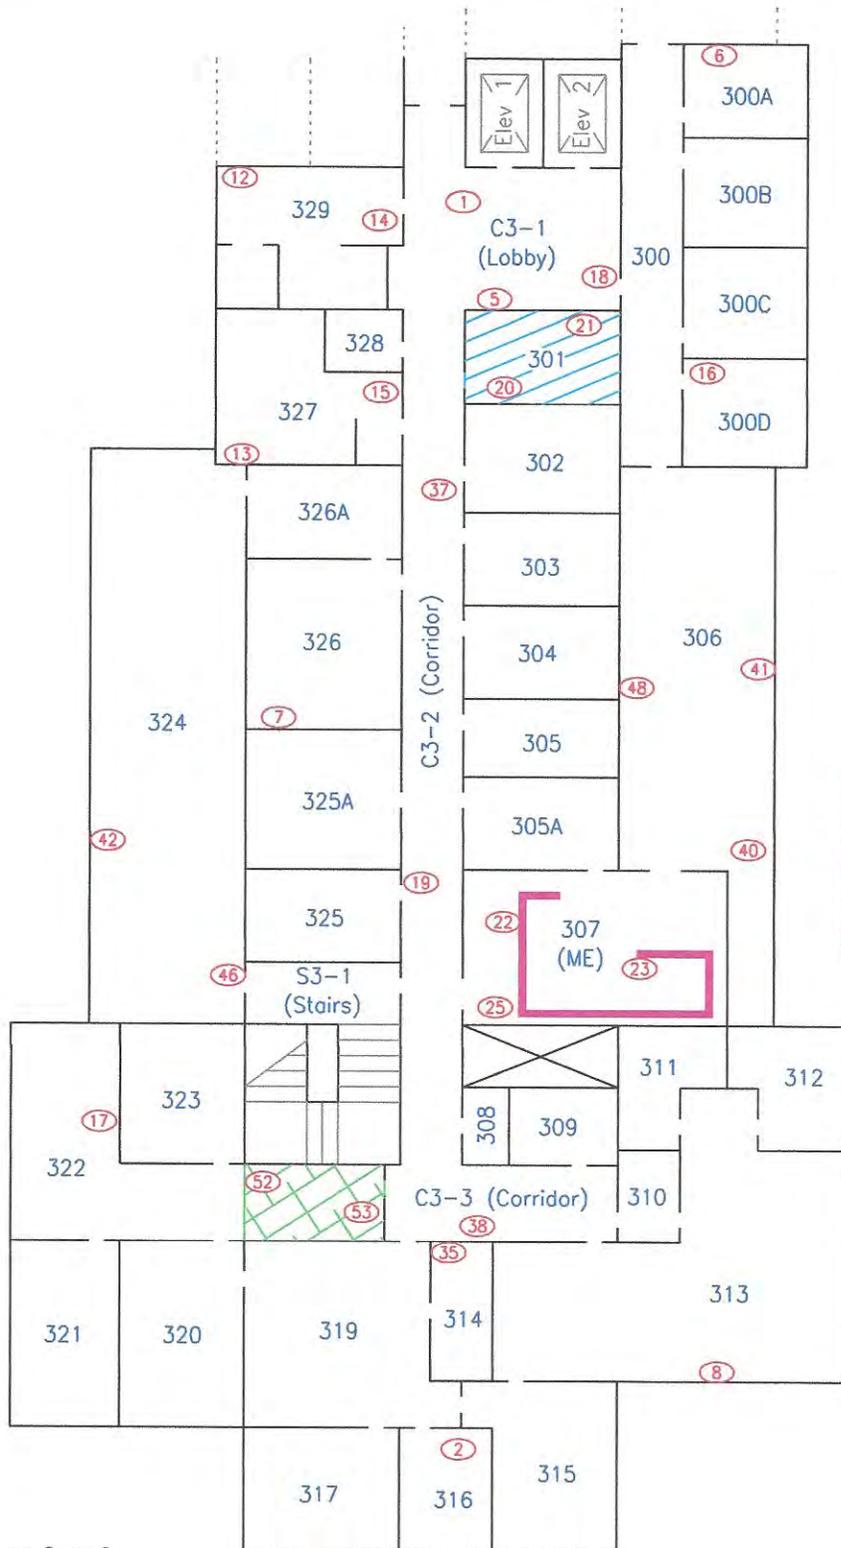
DRAWING 2 OF 2

HA 7: Black Mastic Under Two Layers of Floor Tile
-

HA 8: White & Beige Mastic on Chiller Pipe Runs & Elbows
-

HA 20: Black Mastic Under Floor Tile Under Carpet
