HAZARDOUS MATERIALS INSPECTION REPORT:

***Abate Asbestos on Convectector Piping
Veterans Affairs Medical Center
3200 Vine Street
Cincinnati, Ohio
(VA Project #: 539-16-202)
(L&A Project #: 15-0033)***

July 31, 2014

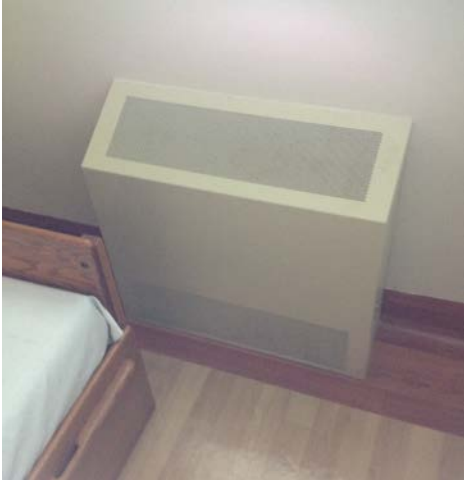
7th Floor Patient Room

Figure 1: Representative view of radiator cover. Lead based paint was not detected in excess of 1.0 mg/cm².

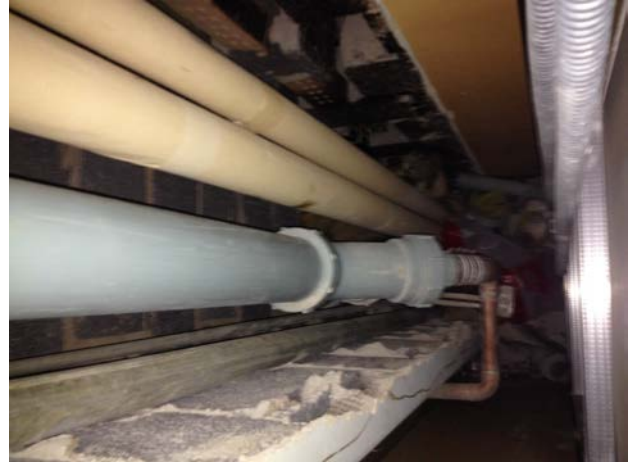
7th Floor Perimeter Pipe Chase

Figure 2: Representative view of pipe enclosure in area previously abated, indicating that in renovated areas, ACM pipe insulation was also abated within the enclosures.

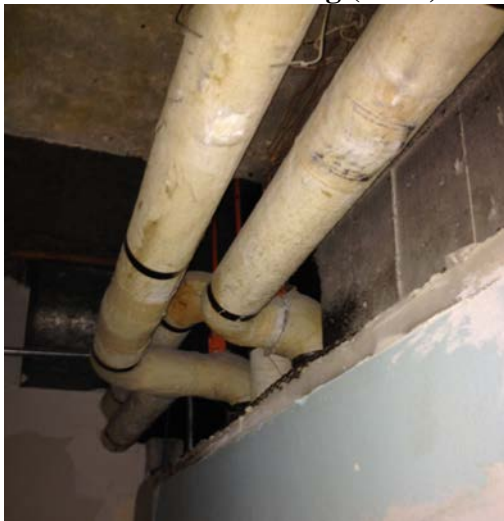
7th Floor East Wing (B706)

Figure 3: Representative view of asbestos containing pipe insulation above drop ceiling.

The following confirmed/assumed RACM are present throughout the upcoming project renovation areas. These materials must be removed by a State of Ohio Licensed Asbestos Hazard Abatement Contractor prior to renovation work which will impact these materials.

- Pipe Insulation (Above Ceilings and Within Vertical Riser Enclosures)

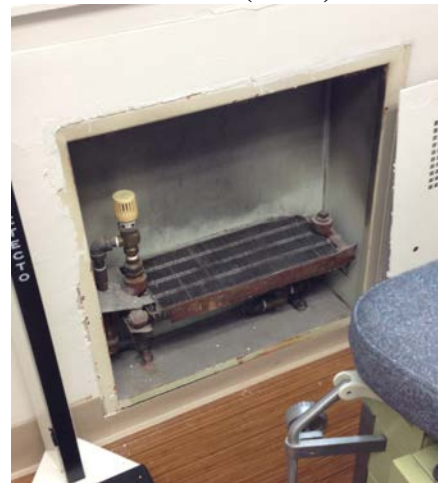
8th Floor (A802)

Figure 4: Representative view of recessed radiator enclosure with asbestos containing transite backing board with asbestos caulking. Metal cover plate does not contain lead paint in excess of 1.0 mg/cm².

The following confirmed and assumed asbestos containing materials are present in the renovation work areas but are not projected to be impacted. If the scope of work changes and these materials are going to be disturbed, they must first be abated by a State of Ohio Licensed Asbestos Hazards Abatement Contractor.

- Recessed radiator enclosure transite backing boards and associated caulking (Category II Non-Friable ACM). Note: Caulking debris was observed in some locations which will need to be properly decontaminated by a licensed abatement contractor prior to work by other trades.
- Resilient Flooring Materials and Mastics (Assumed)(Category I Non-Friable Asbestos Containing Material)
