**Re: Asbestos and Lead-based Paint Inspection
Perry Point Nurse System Design
Buildings 361 and 364
Veterans Administrations
Perry Point, Maryland
Apex Job No: 13533.003**

ASBESTOS AND LEAD-BASED PAINT INSPECTION

**Perry Point Nurse Call System Design
Buildings 361 and 364
Veterans Administrations
Perry Point, Maryland**

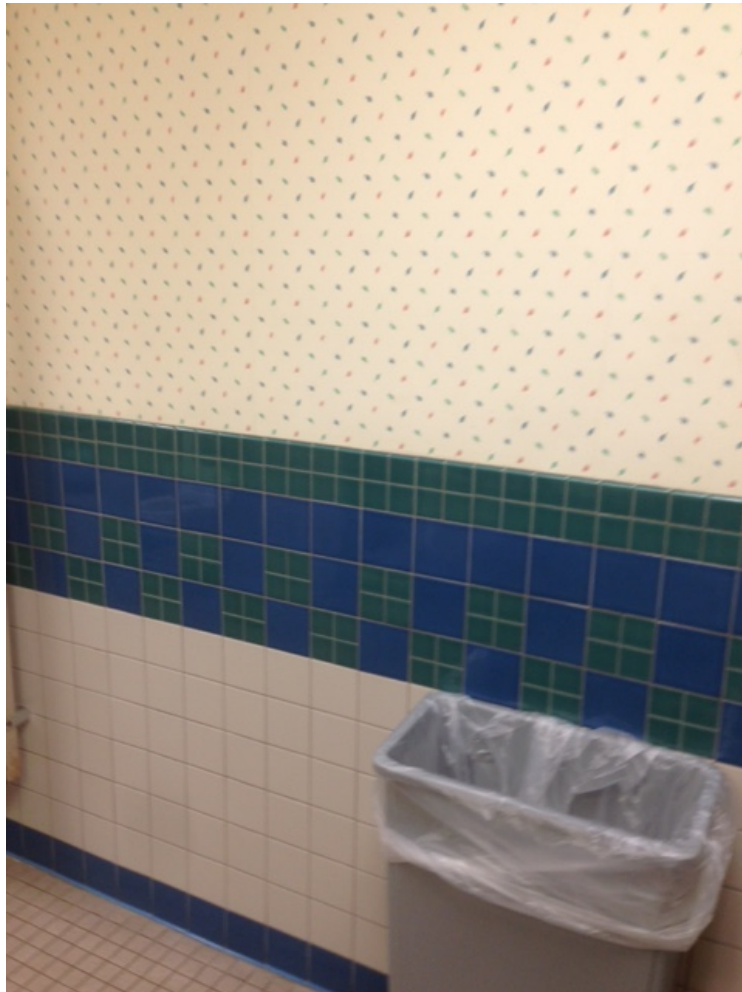
- Multi-color ceramic wall tiles in bathrooms of building 361.

361 Men's Bathroom, Lead Tile

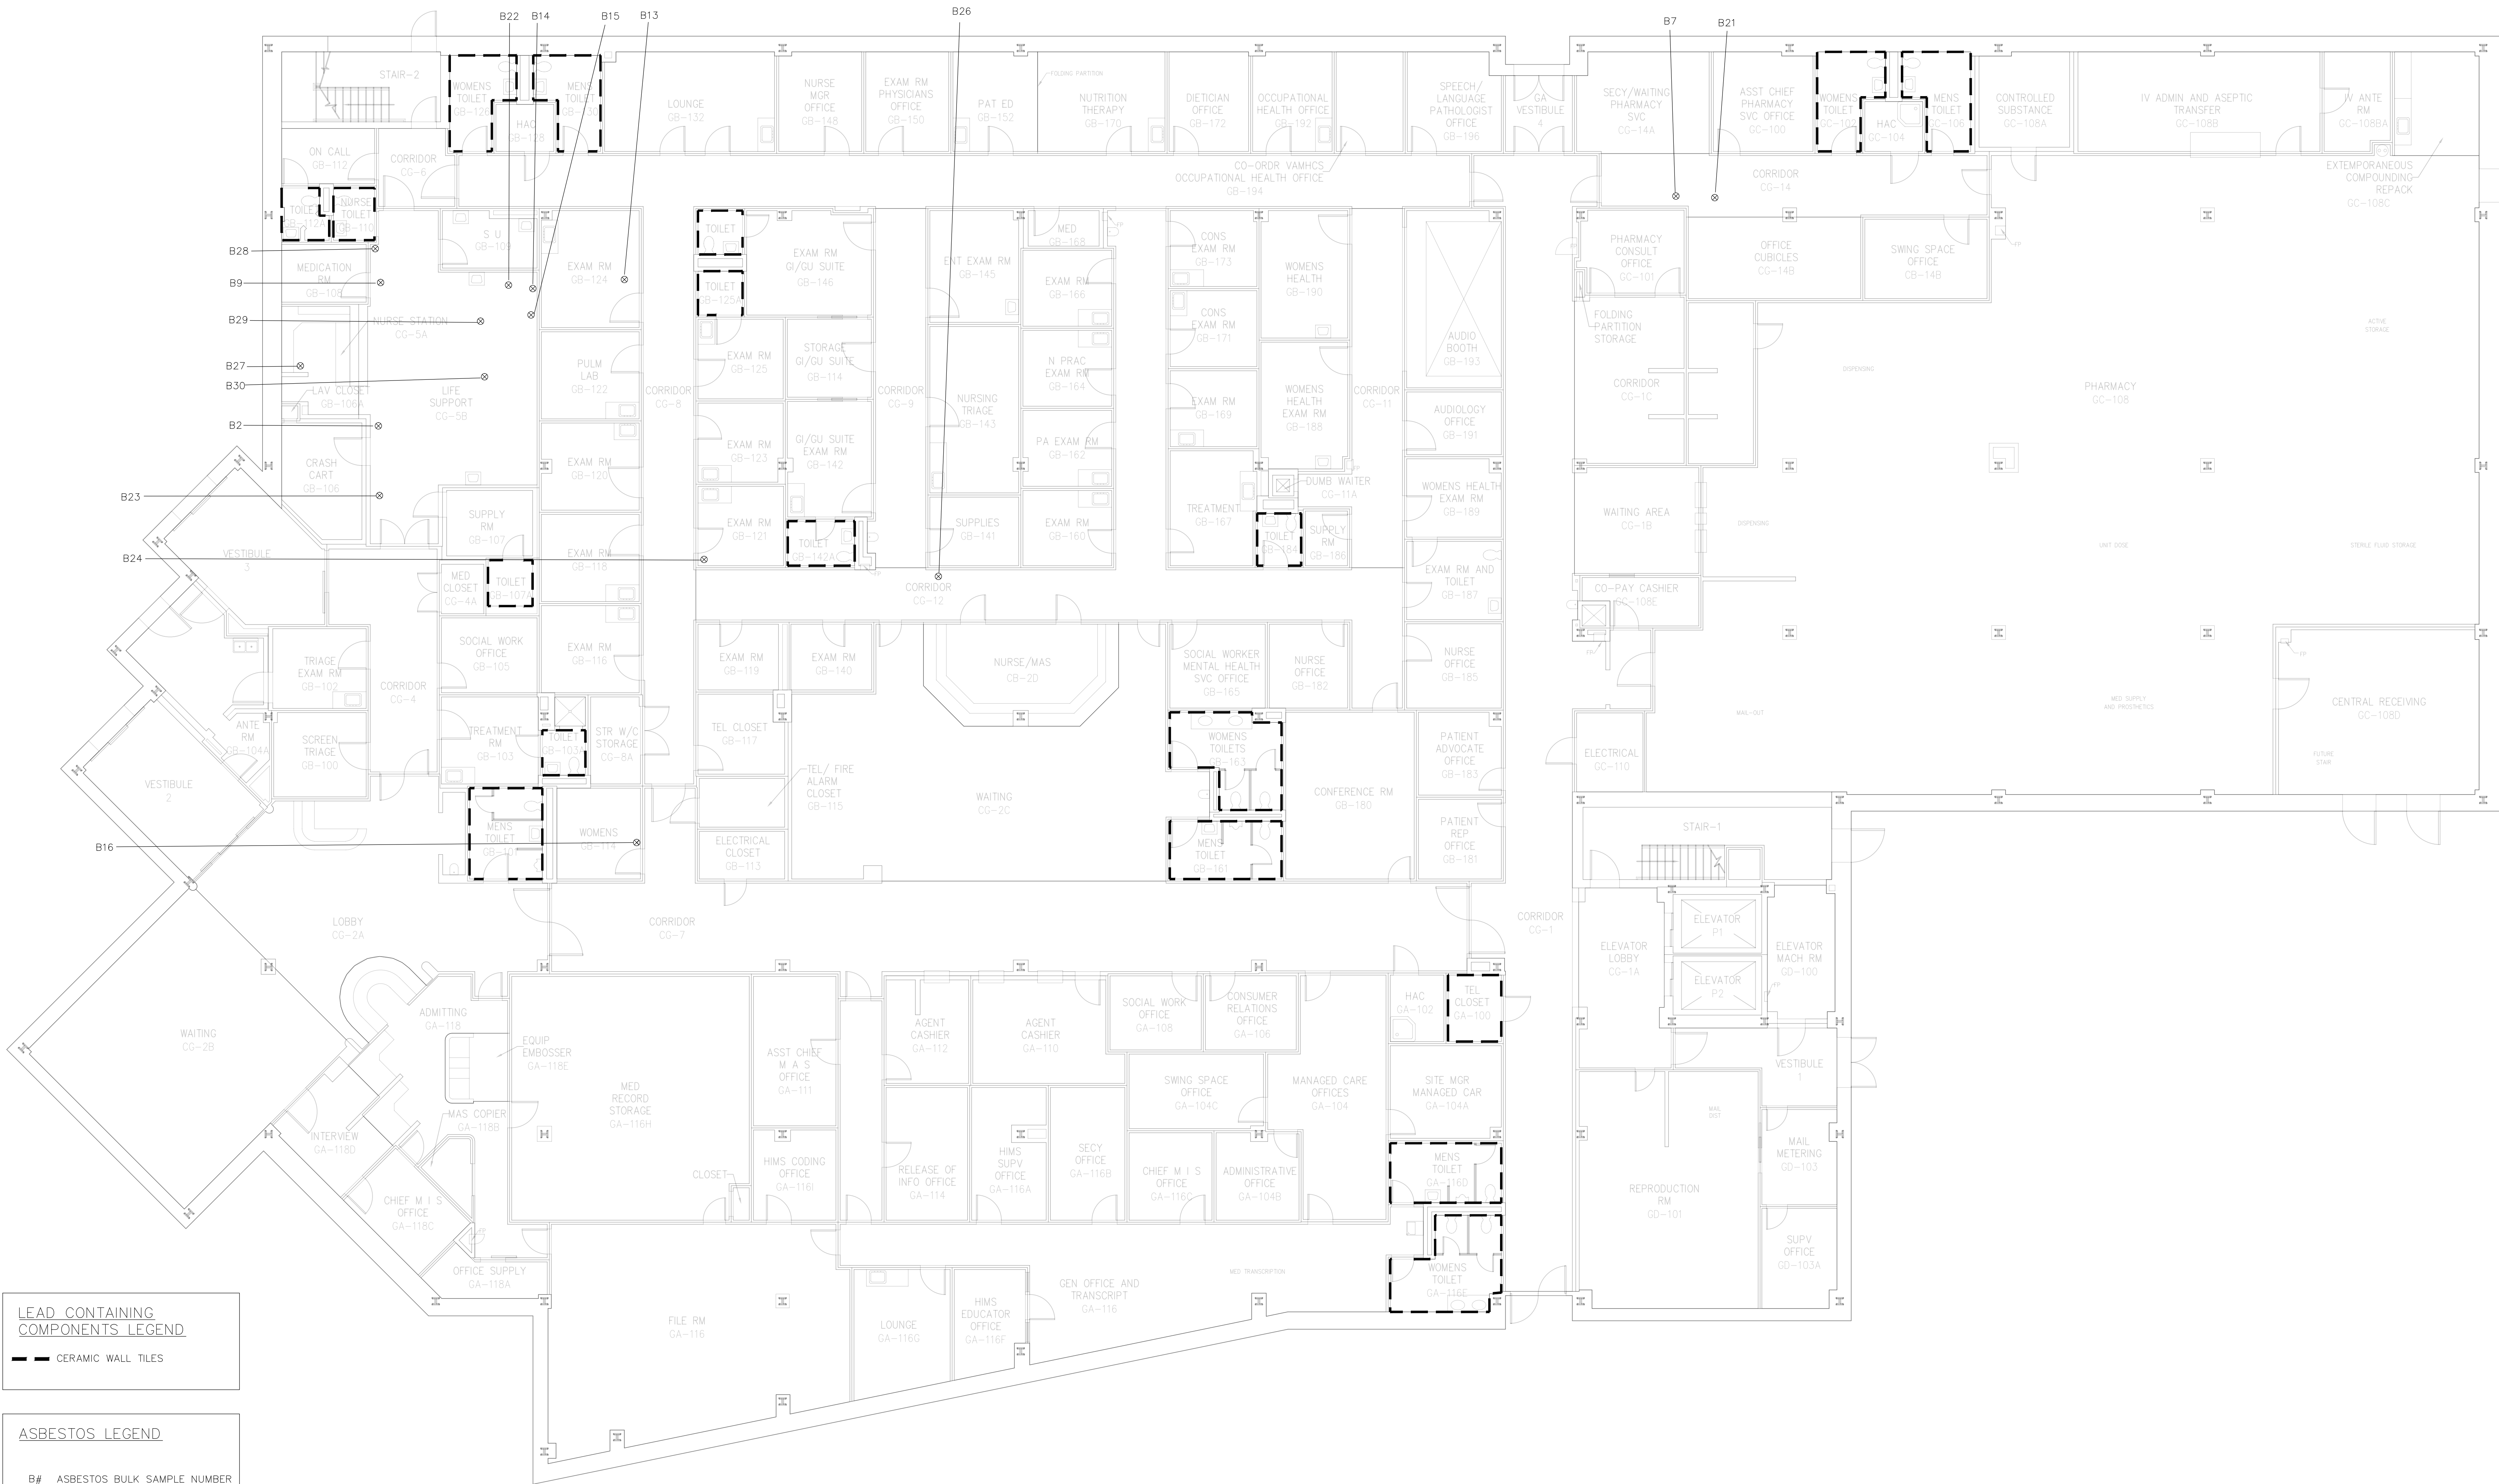
LEAD CONTAINING COMPONENTS LEGEND

— CERAMIC WALL TILES

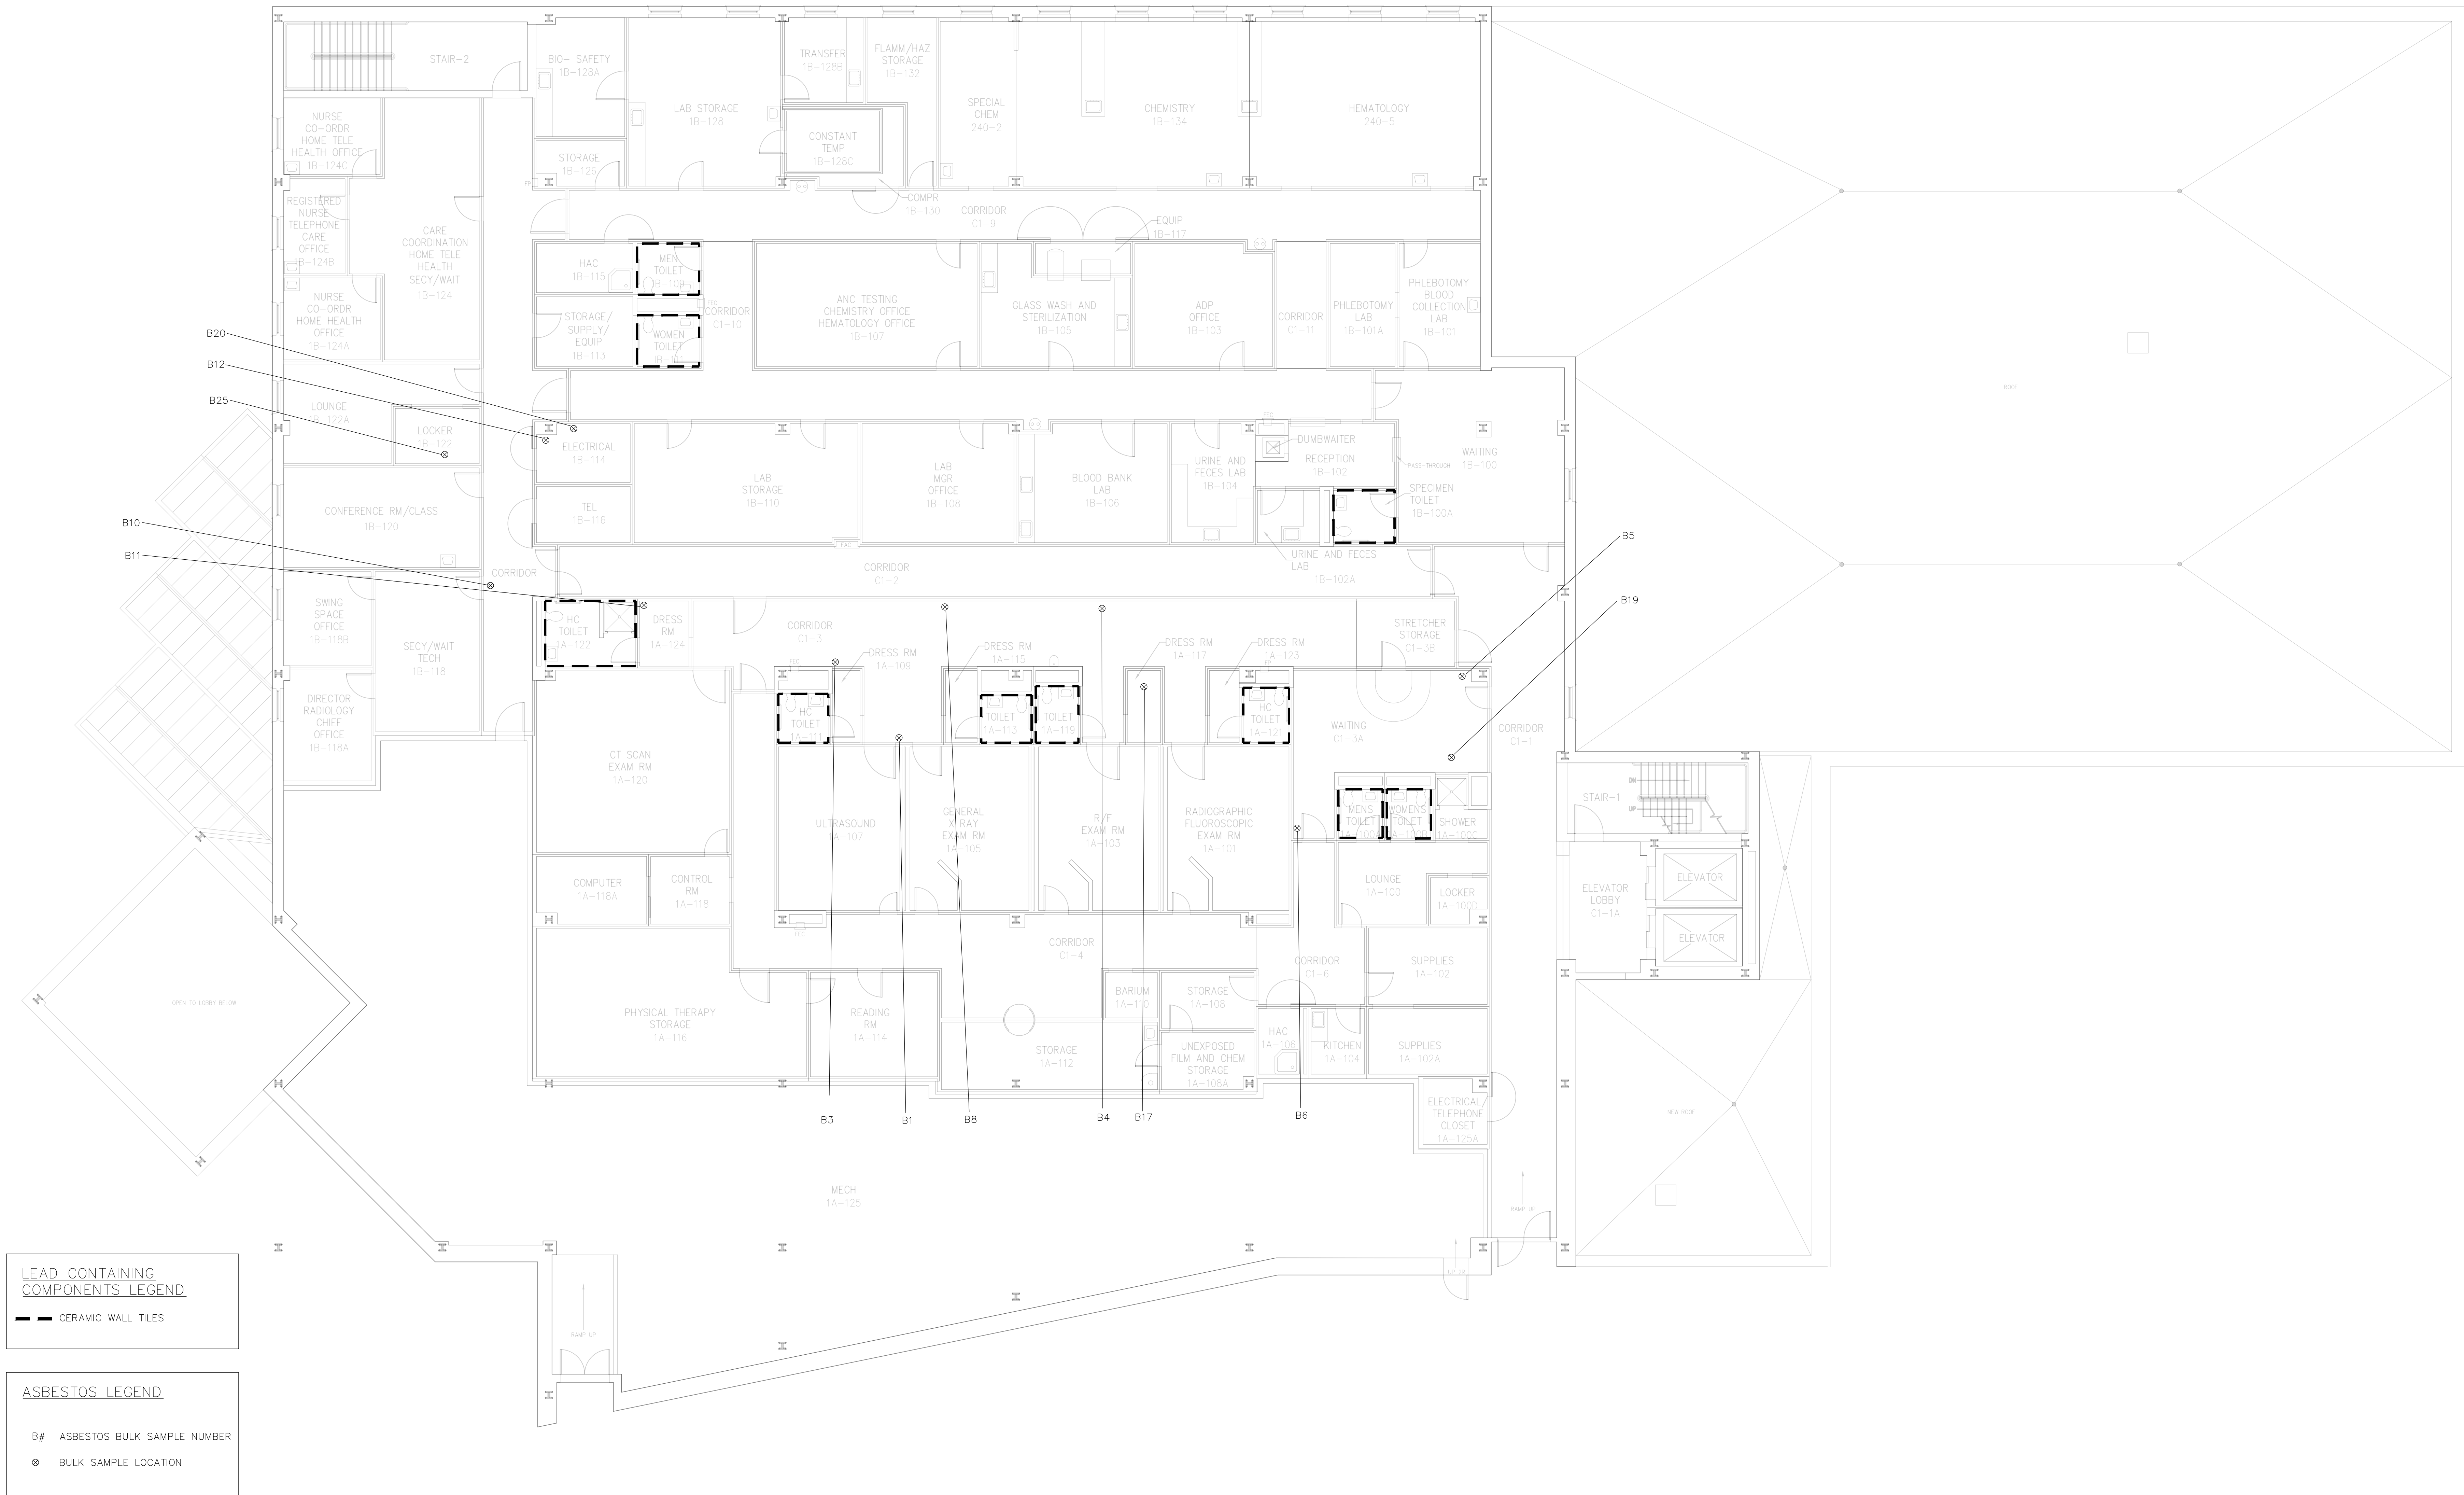
LEAD CONTAINING COMPONENTS LEGEND

— CERAMIC WALL TILES
