LIMITED HAZARDOUS MATERIAL PRE-RENOVATION SURVEY REPORT

Maintenance Garage - Roof Replacement Project
Rome VA Medical Center
125 Brookley Road
Rome, New York 13441

**RE: Limited Hazardous Material Pre-Renovation Survey Report
 Rome VA Medical Center – 125 Brookley Road, Rome, New York
 Maintenance Garage – Roof Replacement Project
 AECC Project Number: 14-141**

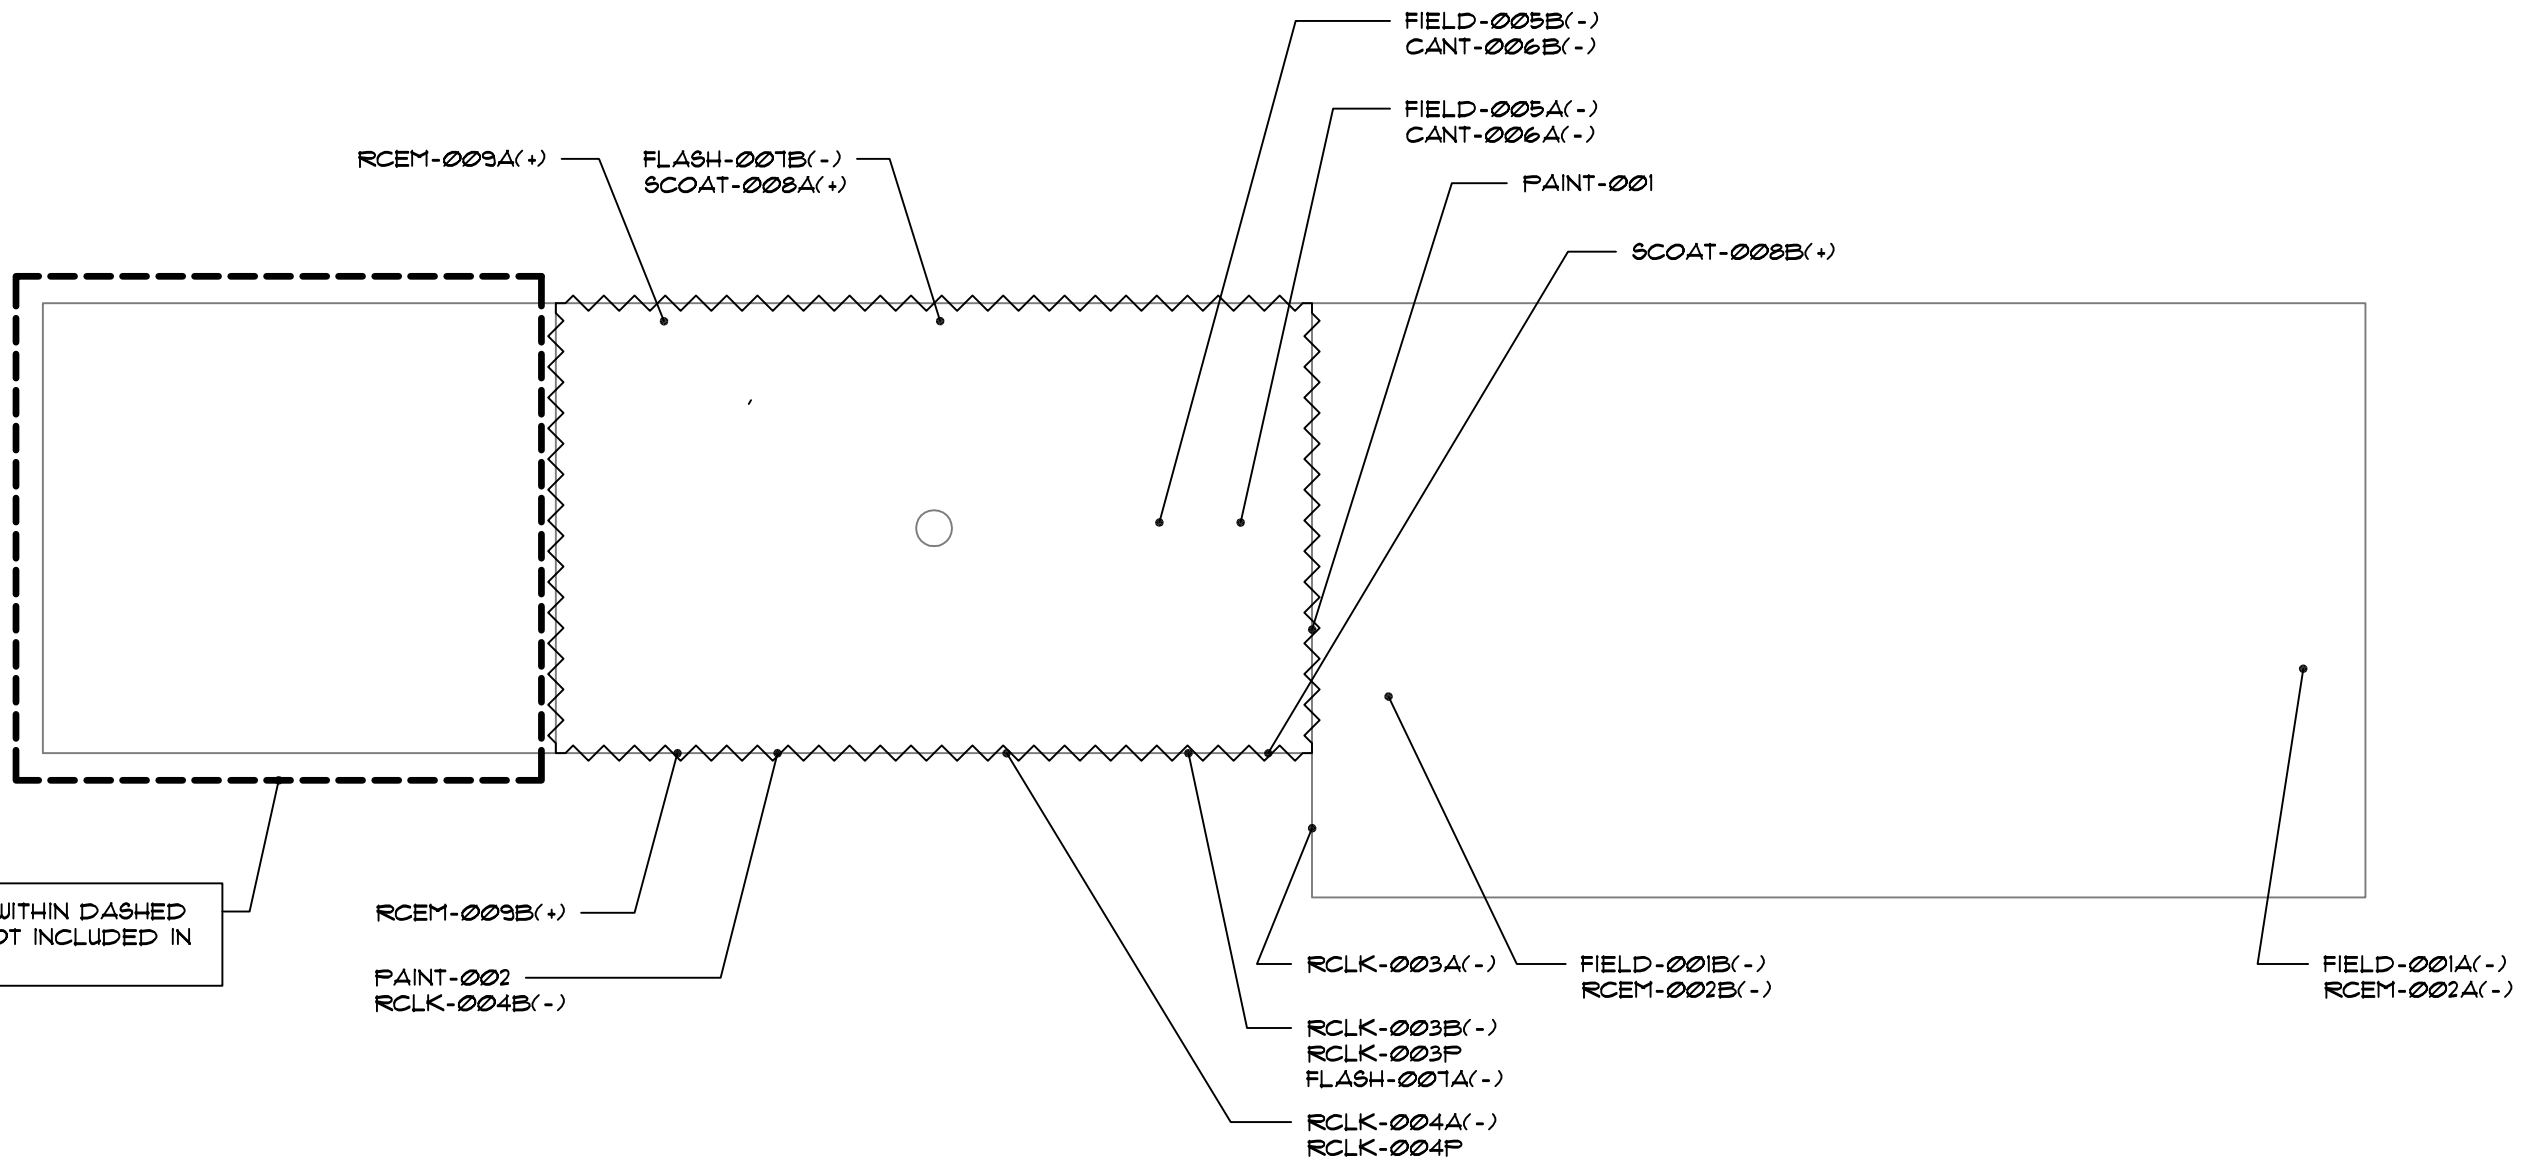
FIGURE 1

BUILDING MATERIAL	MATERIAL LOCATION	ESTIMATED QUANTITY	MATERIAL CONDITION
Silver Roof Coating (SCOAT-008)	Southern Roof – Over Garage	30 SF	NF, Intact
Black/Gray Roofing Cement (RCEM-009)	Southern Roof – Over Garage	12 SF	NF, Intact

ASBESTOS-CONTAINING SILVER ROOF COATING AND/OR ROOFING CEMENT
