**COMPREHENSIVE SURVEY FOR ASBESTOS CONTAINING
MATERIALS**

**Building 5
Veterans Affairs Medical Center
1970 Roanoke Blvd
Salem, Virginia 24153
Adelaide Project No. VAMC: 10079.00-IN**

July 24, 2010

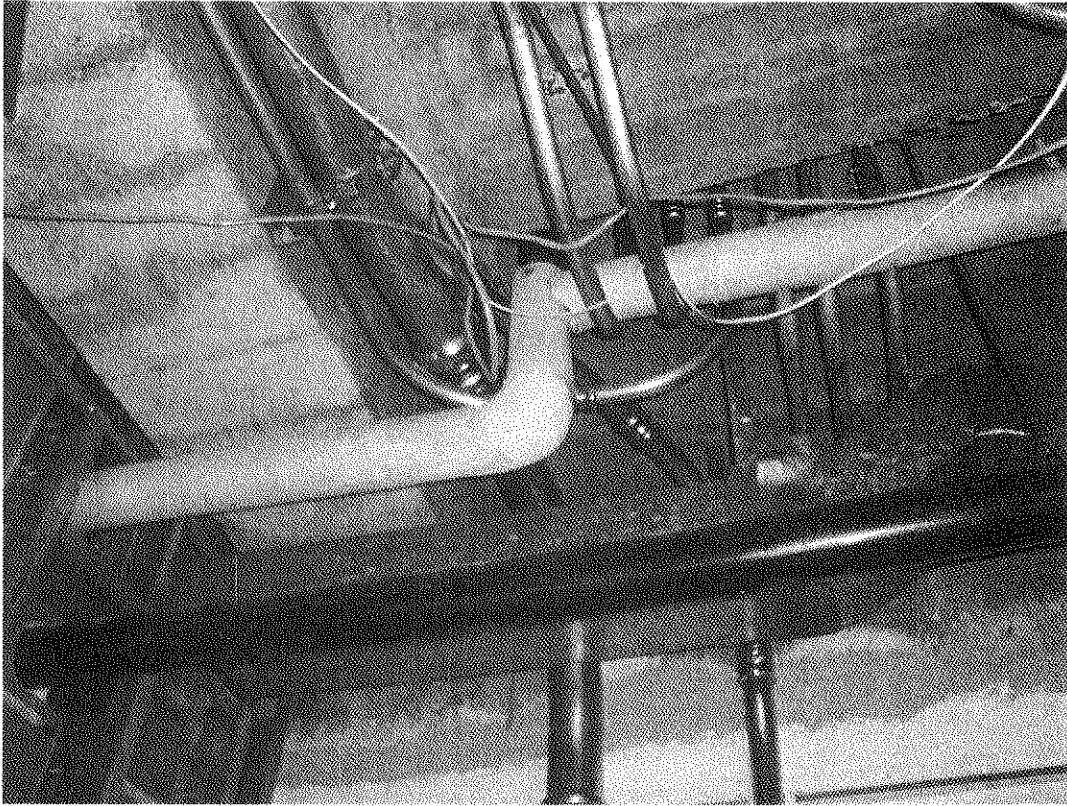
Mudded Fittings on Fiberglass Pipe Insulation – Chrysotile 10%

Asbestos: These areas must be abated prior to building demolition or renovation if they are to be disturbed.

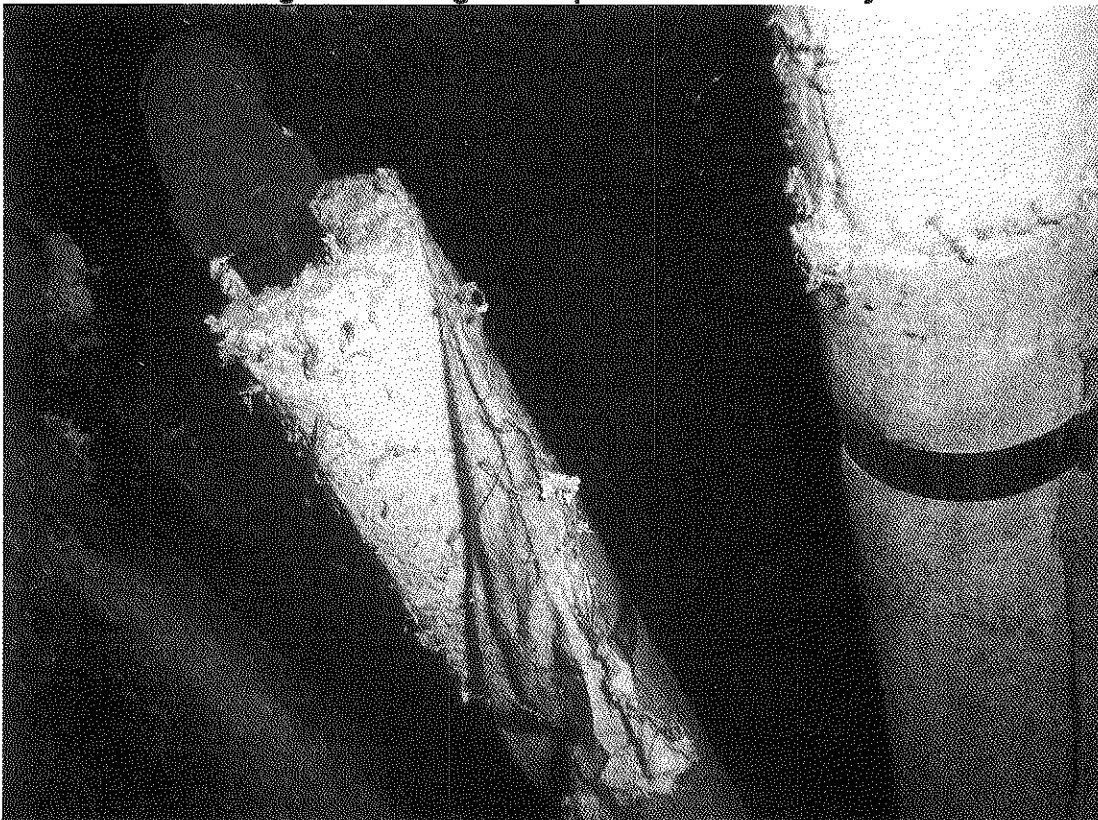
Significantly Damaged MAG Pipe Insulation above drop ceilings – Chrysotile 35%

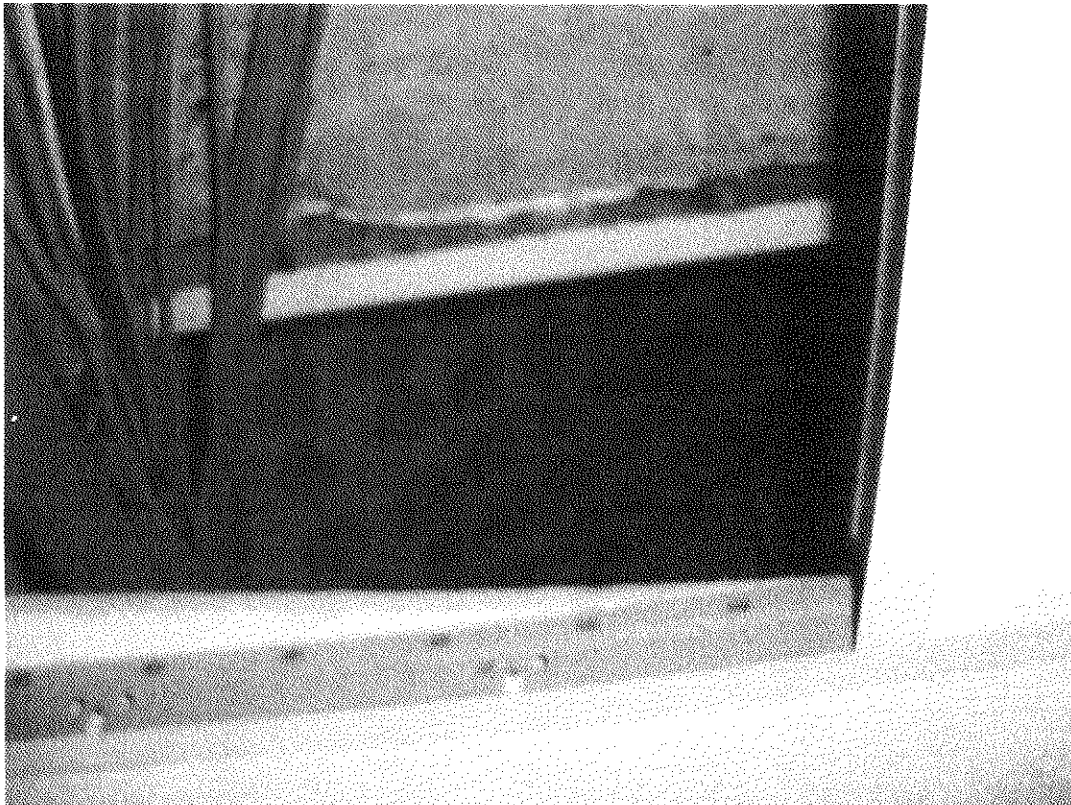
Glue Pucks on Ceiling associated with 1'x1' Ceiling Tiles – 3% Chrysotile

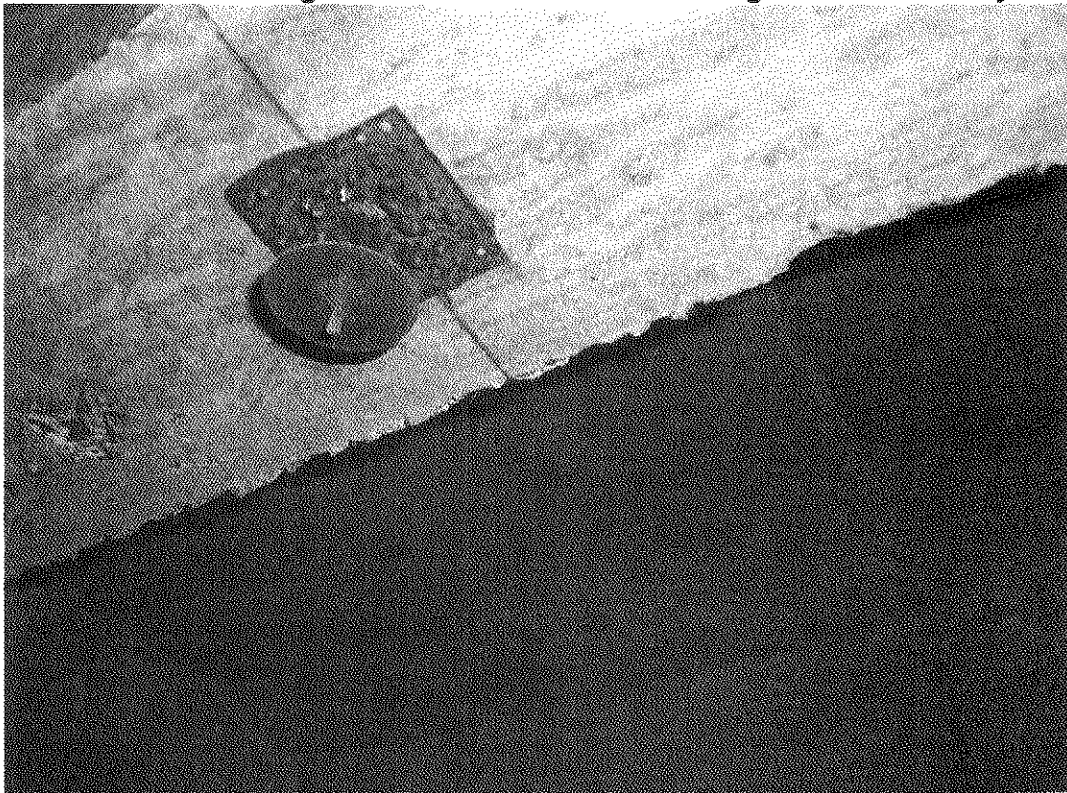
Glue for spike hangers attached to concrete ceiling – 3% Chrysotile

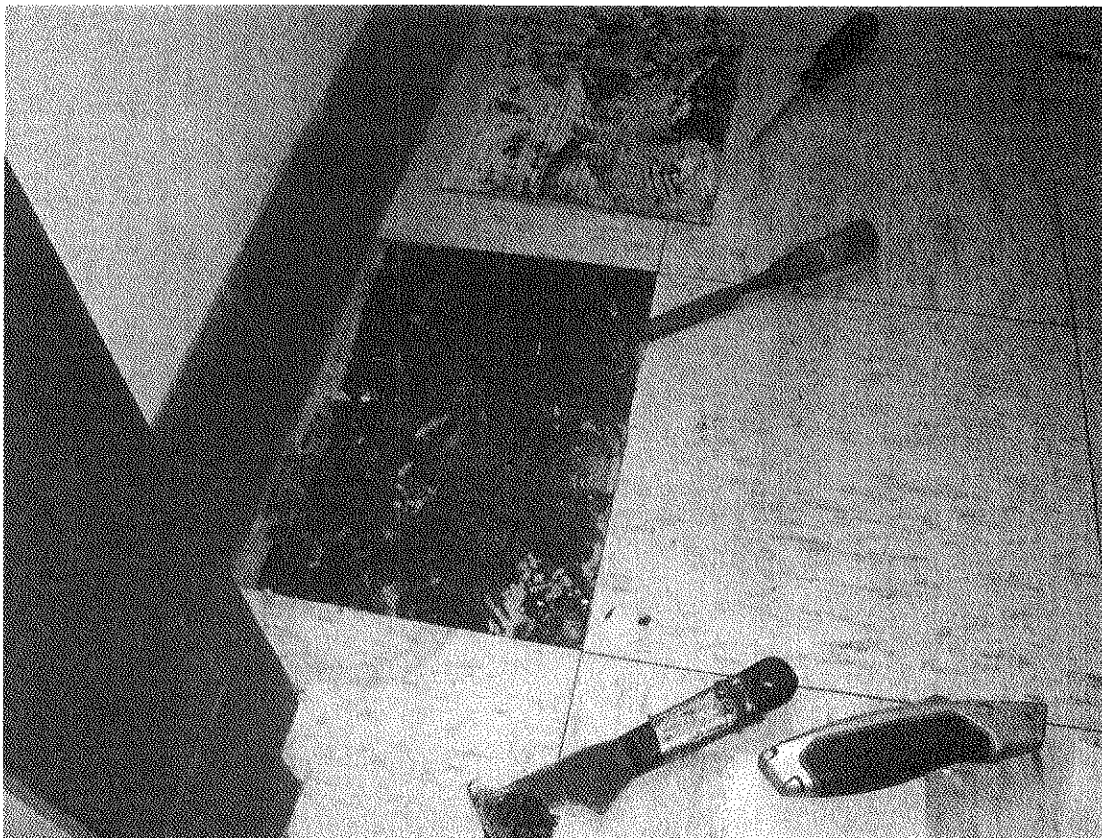
Floor Tile mastic for 12"x12' Cream w/ brown streaks tile – 3% Chrysotile

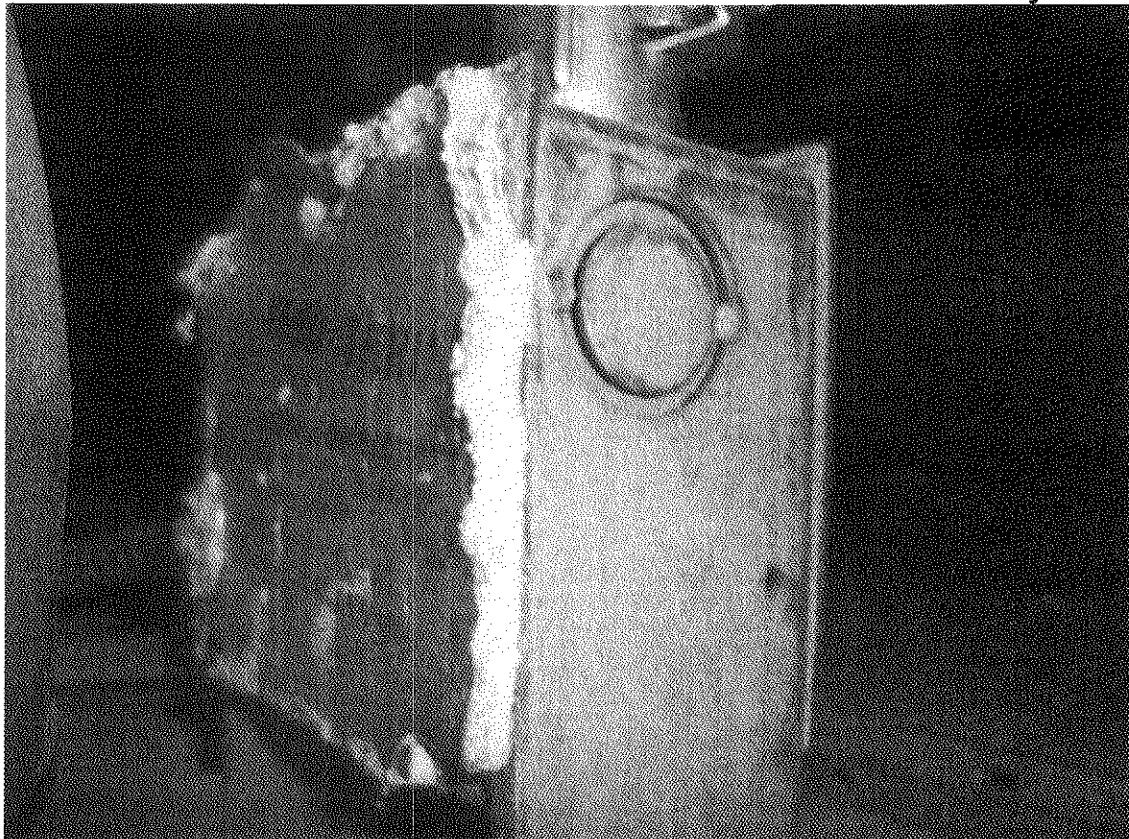
Fibrous Cardboard type back on recessed lights electrical junction box – 25% Chrysotile

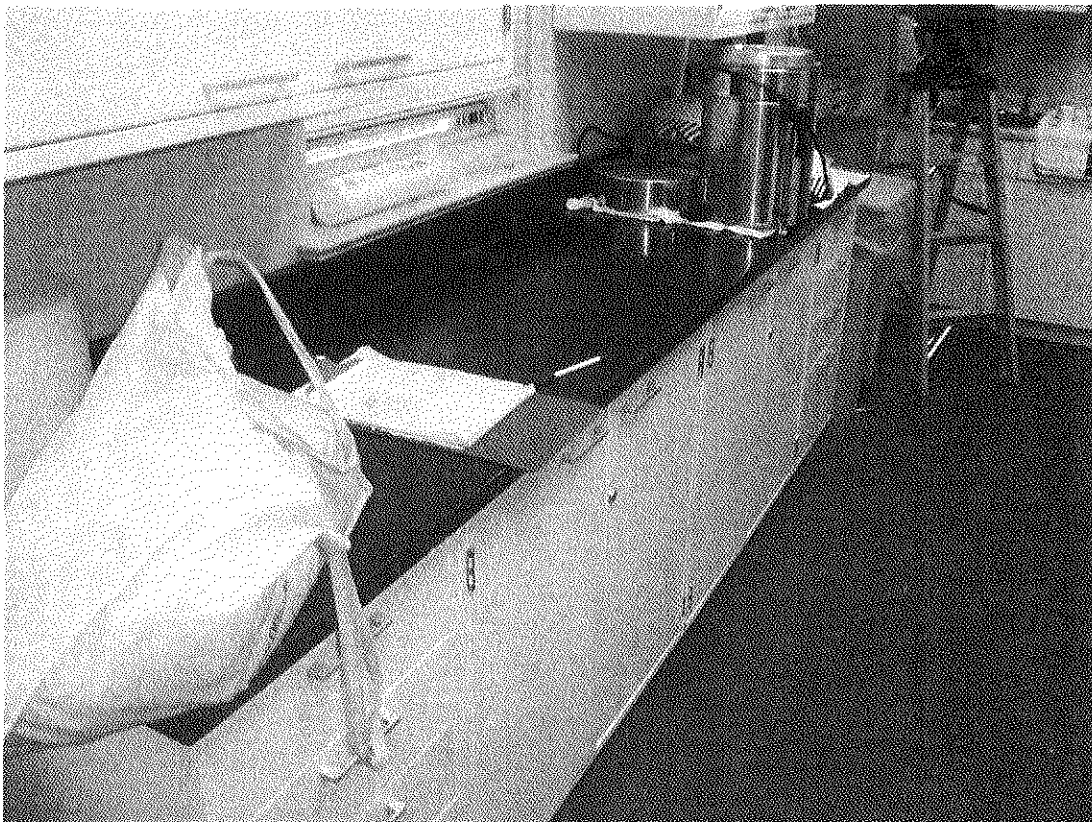
Black Kitchen Counter Top – Chrysotile 15%

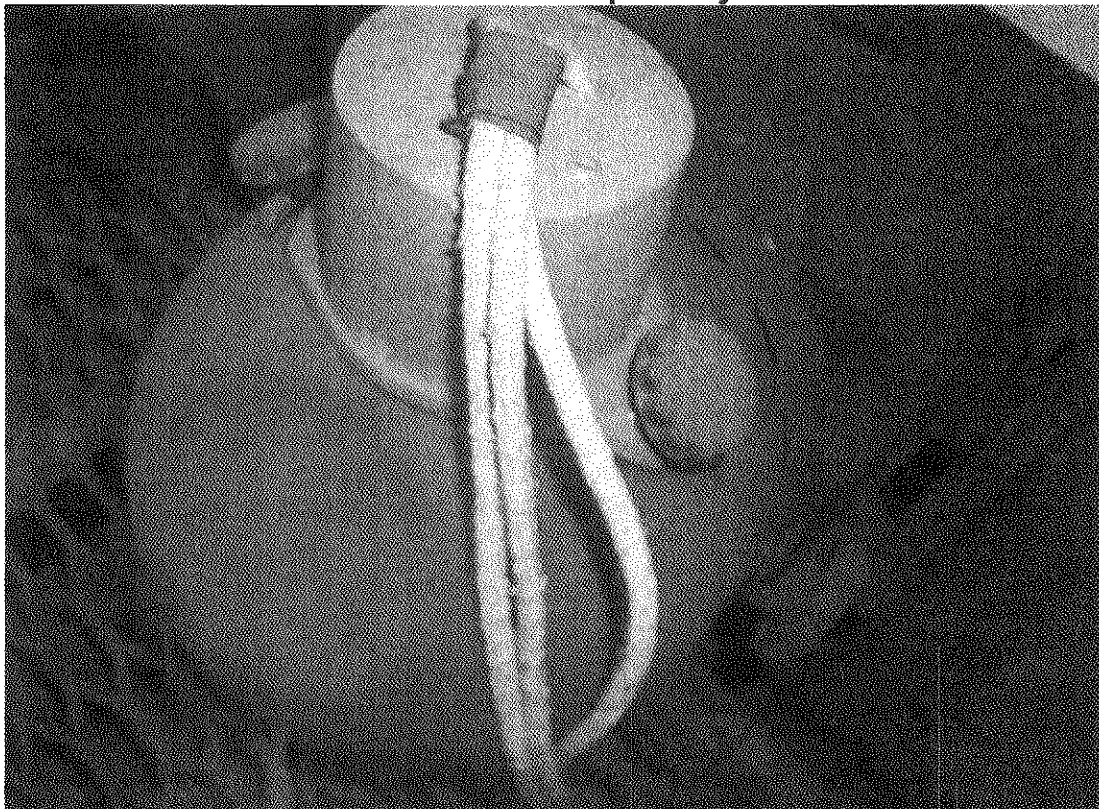
Electrical Wiring Wrap for Spot Lights (White) – 30% Chrysotile

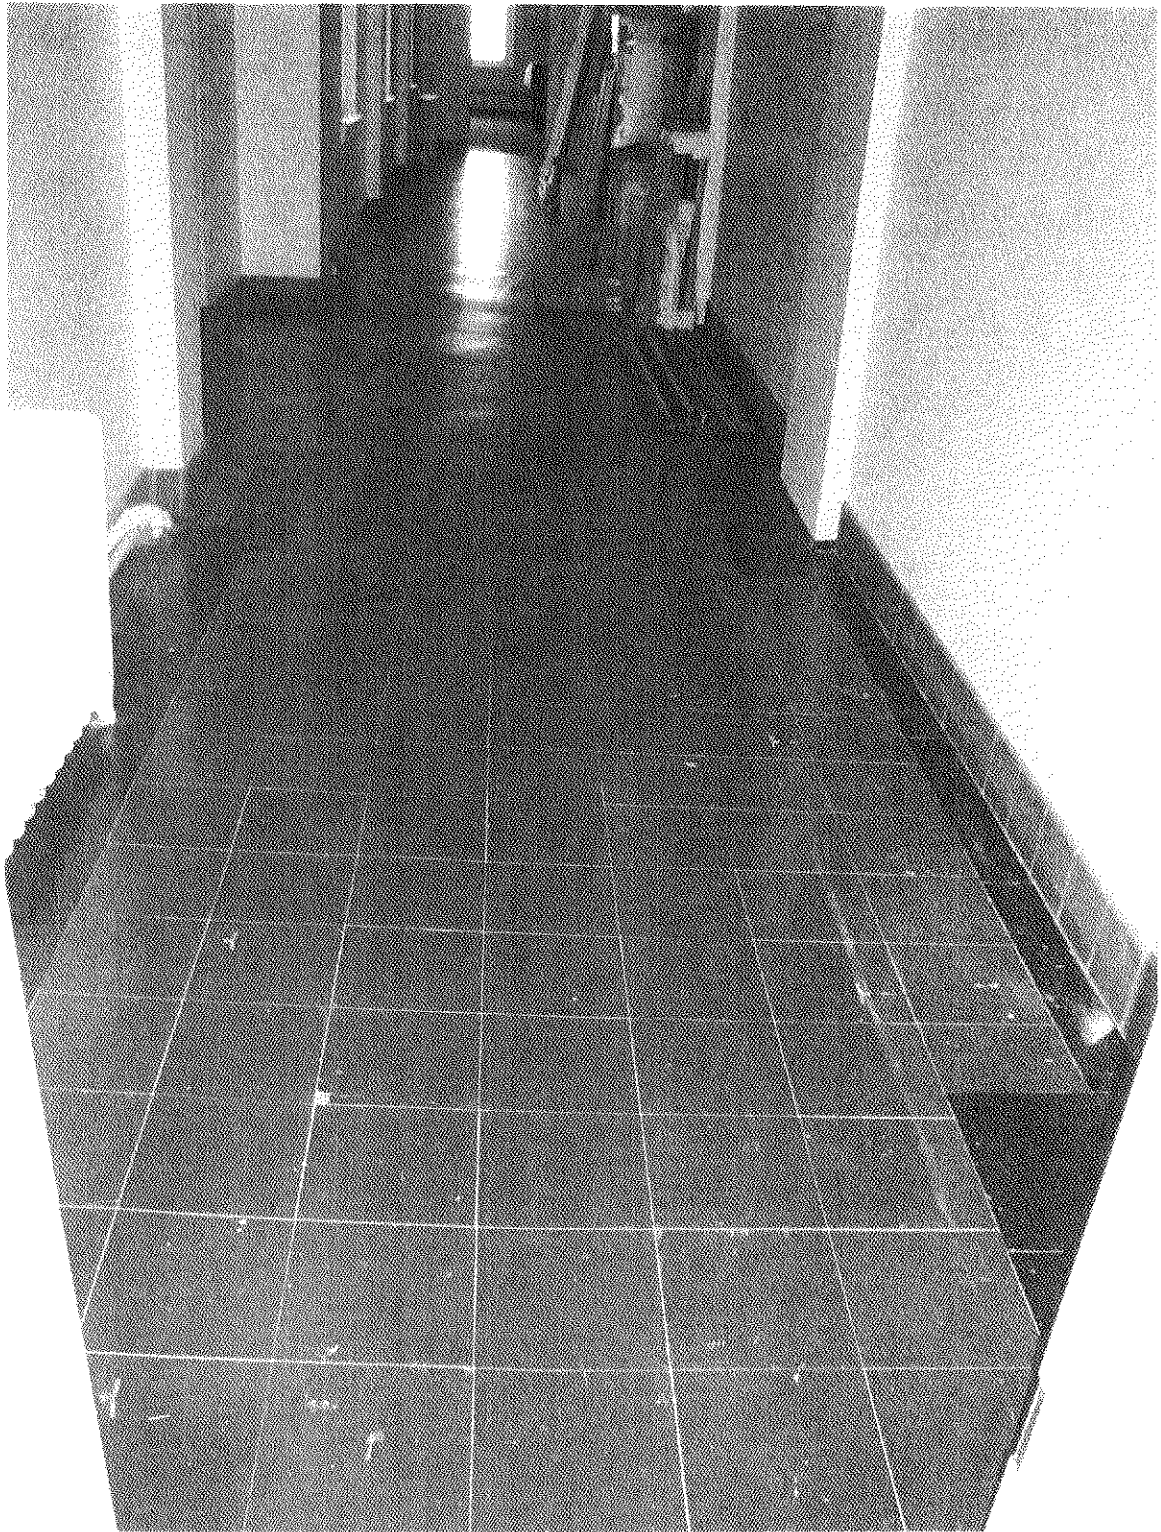
Black and Red 9"x9" Floor Tiles – Chrysotile 15%
