**COMPREHENSIVE SURVEY FOR ASBESTOS CONTAINING
MATERIALS**

**Building 9
Veterans Affairs Medical Center
1970 Roanoke Blvd
Salem, Virginia 24153
Adelaide Project No. VAMC: 10079.00-IN**

July 28, 2010

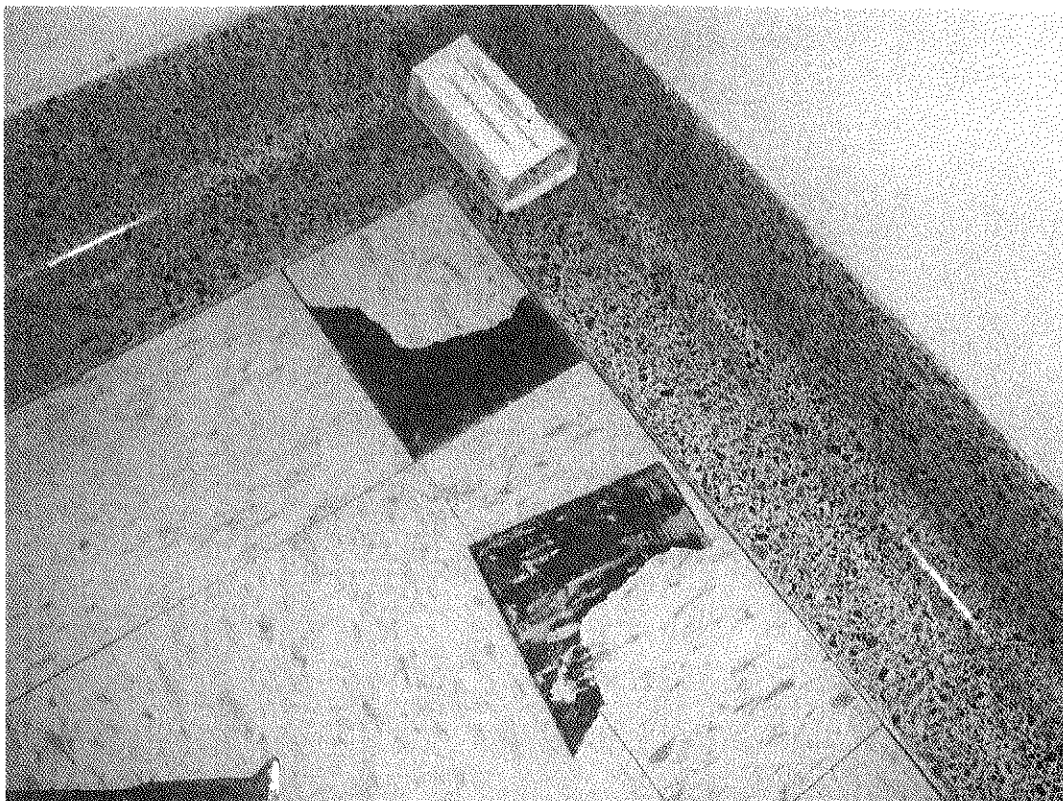
| Space # | Homogenous Area | Material Description | Quantity | Condition Response Action |
|---|---|--|---|--|
| | 4 | Floor Tile Mastic Associated with 12"x12" Off white with light brown streaks | 250 SF | Good/Defer Action/None Required |

HA#4 – Floor tile mastic associated with 12"x12" off white w/ light brown streaks

Asbestos: These areas must be abated prior to building demolition or renovation if they are to be disturbed.

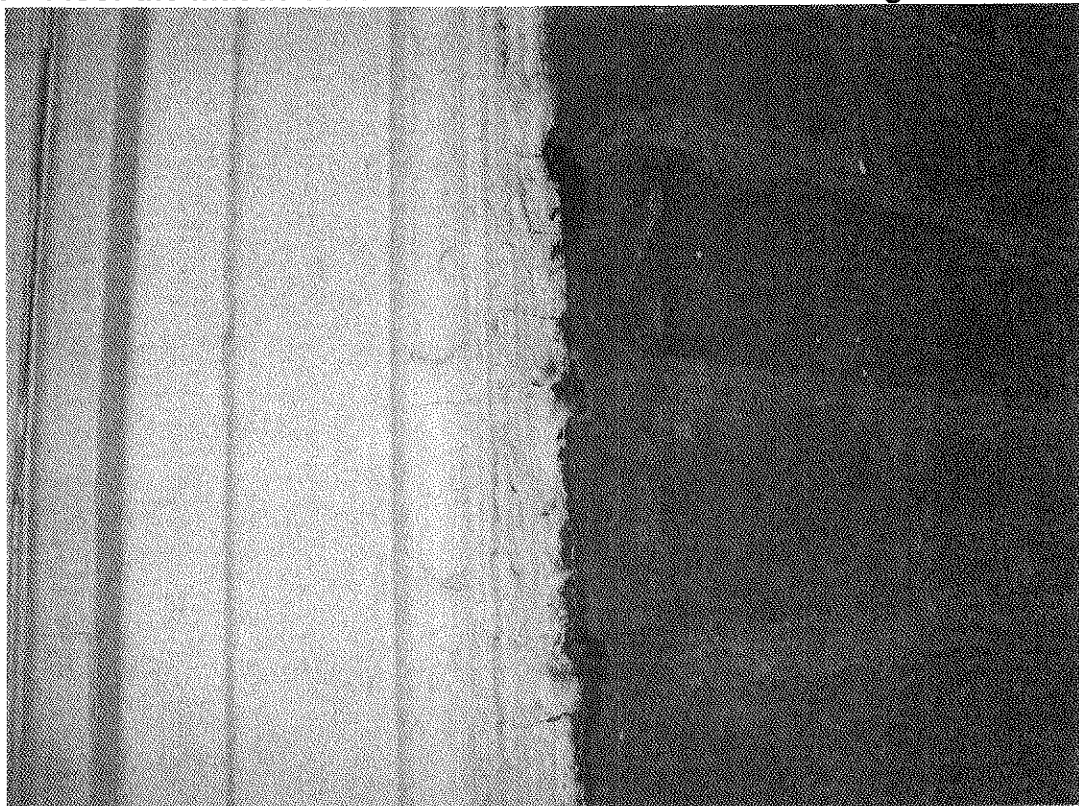
| Material | Approximate Quantity | Locations Of Material | Asbestos Content and Type |
|--|---|---|---|
| Old Exterior Window Caulk | 5000 LF | All Exterior Windows | 4% Chrysotile |

Window caulk

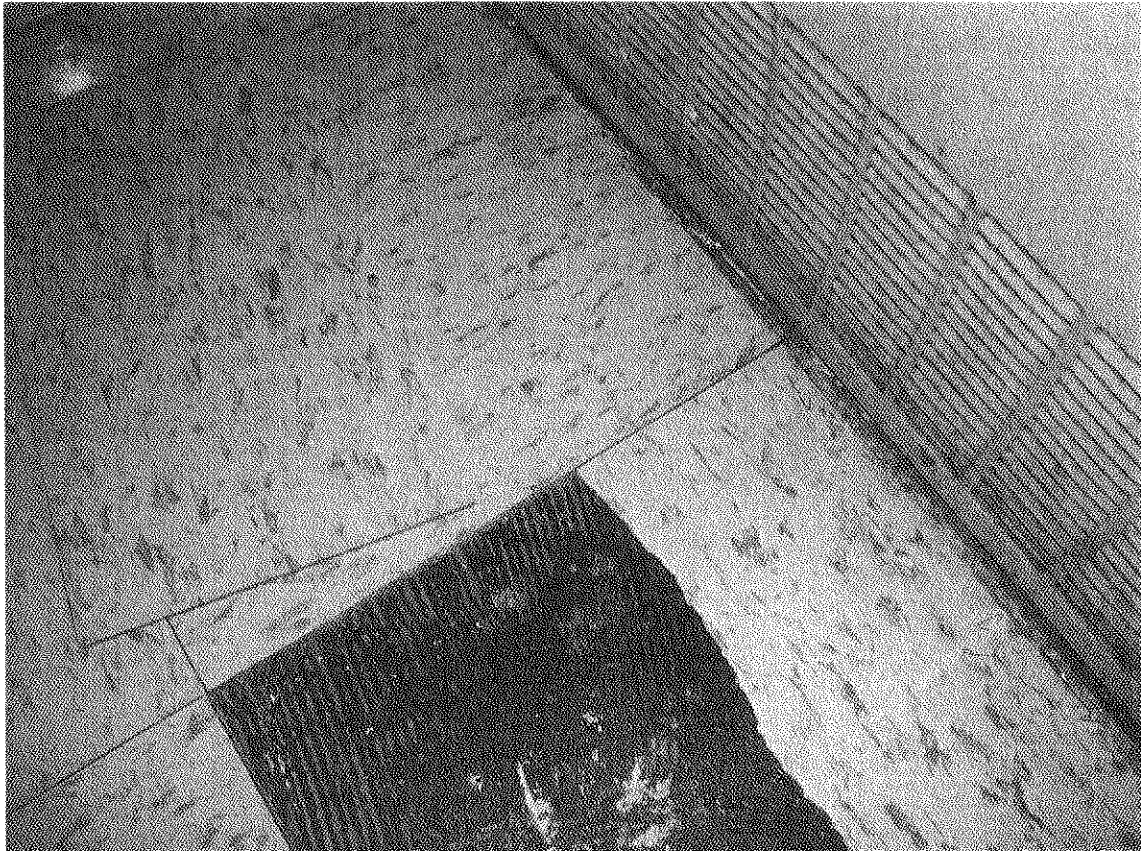
| Material | Approximate Quantity | Locations Of Material | Asbestos Content and Type |
|--|---|---|---|
| 12"x12" Floor Tile—White with gold marks | 391 SF | Room 227A | 2% Chrysotile |
| Floor Tile Mastic for 12"x12" white with gold marks | 391 SF | Room 227A | 5% Chrysotile |

Room 227A – 12"x12" white w/ gold floor tile and mastic

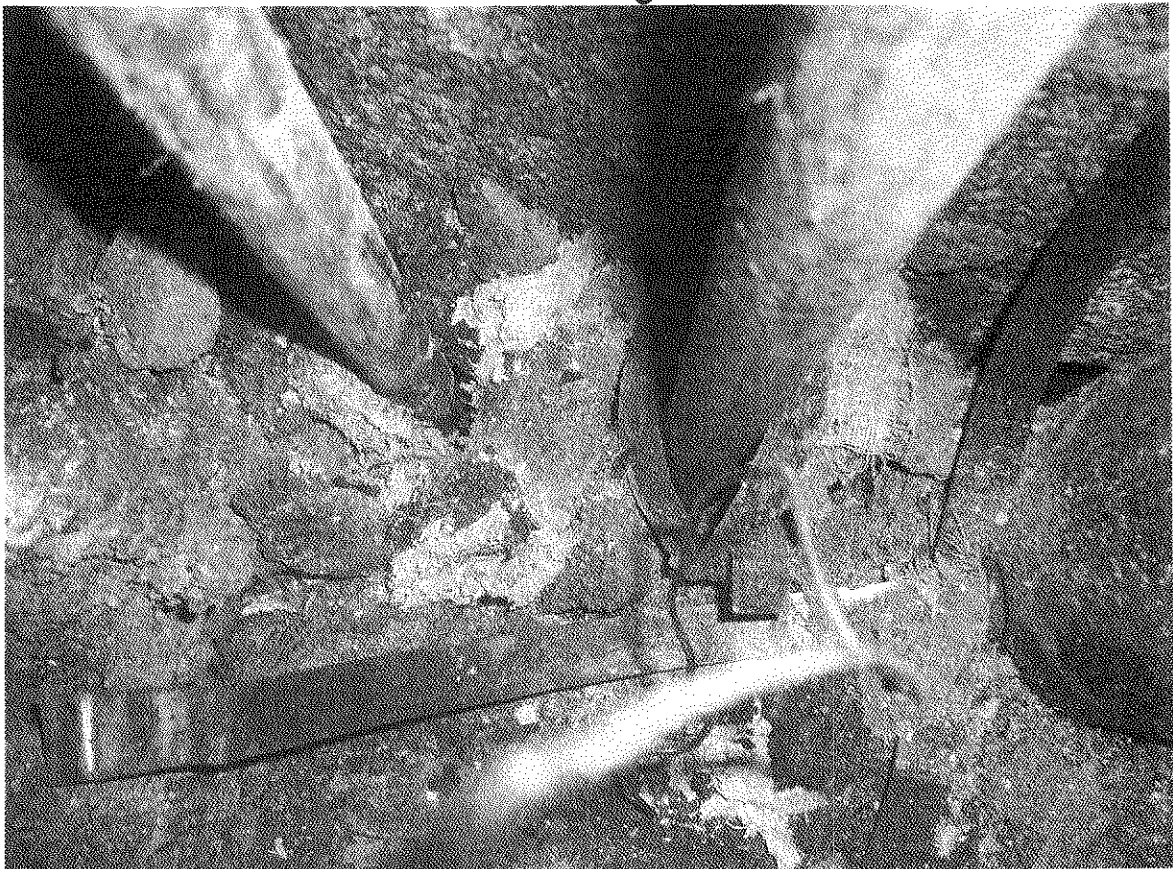
| Material | Approximate Quantity | Locations Of Material | Asbestos Content and Type |
|--|---|---|---|
| Suspect Pipe Insulation Debris on the Floor** | 23 SF | Chase 110A | 67% Chrysotile |

**Area needs to be decontaminated

| Space # | Homogenous Area | Material Description | Quantity | Condition Response Action |
|---|---|--|---|---|
| Chase 110A | 16 | Poorly abated pipes and pipe insulation debris on the floor | 23 SF | Significant Damage/Removal /Required-High Priority |

Chase 110A – debris on floor in chase

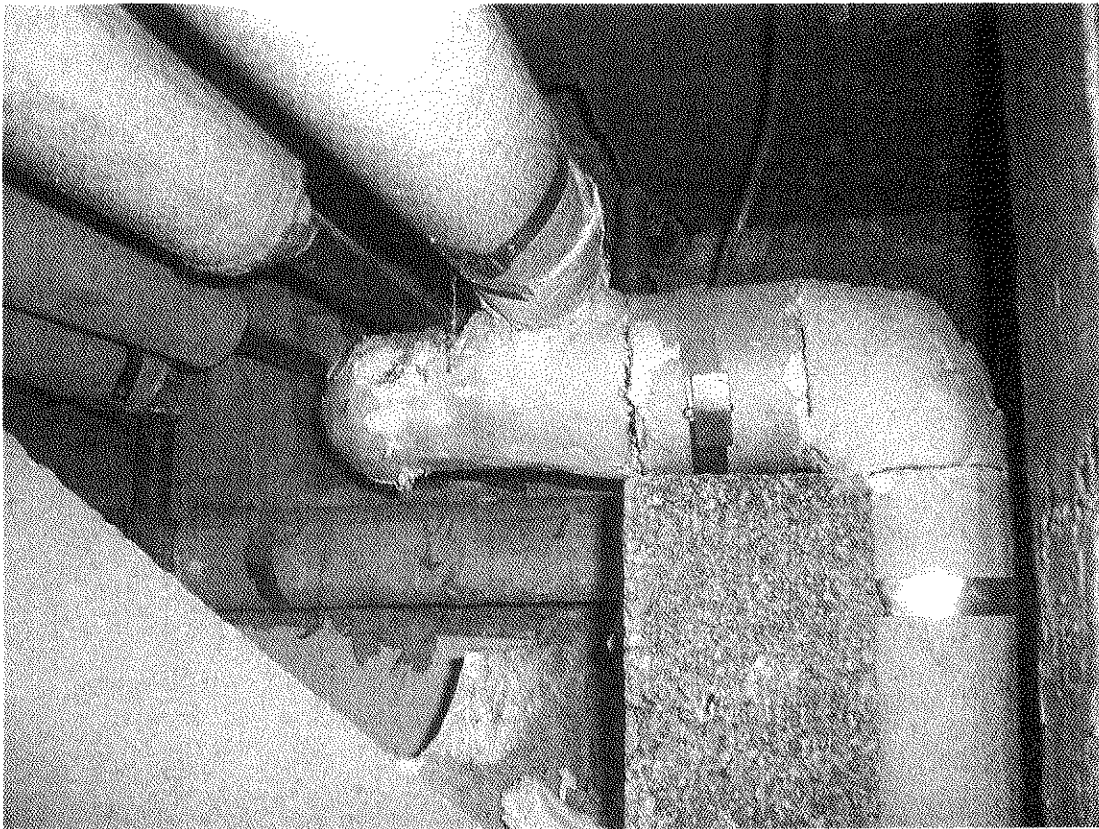
| Space # | Homogenous Area | Material Description | Quantity | Condition Response Action |
|---|---|--|---|--|
| 117 | 28 | Pipe Insulation above drop ceiling | 40 LF | Damage/Removal /Required |
| | 29 | Pipe Fitting Insulation | 8 LF | Damage/Removal /Required |

Room 117 – Significantly damaged pipe insulation and debris on drop ceiling

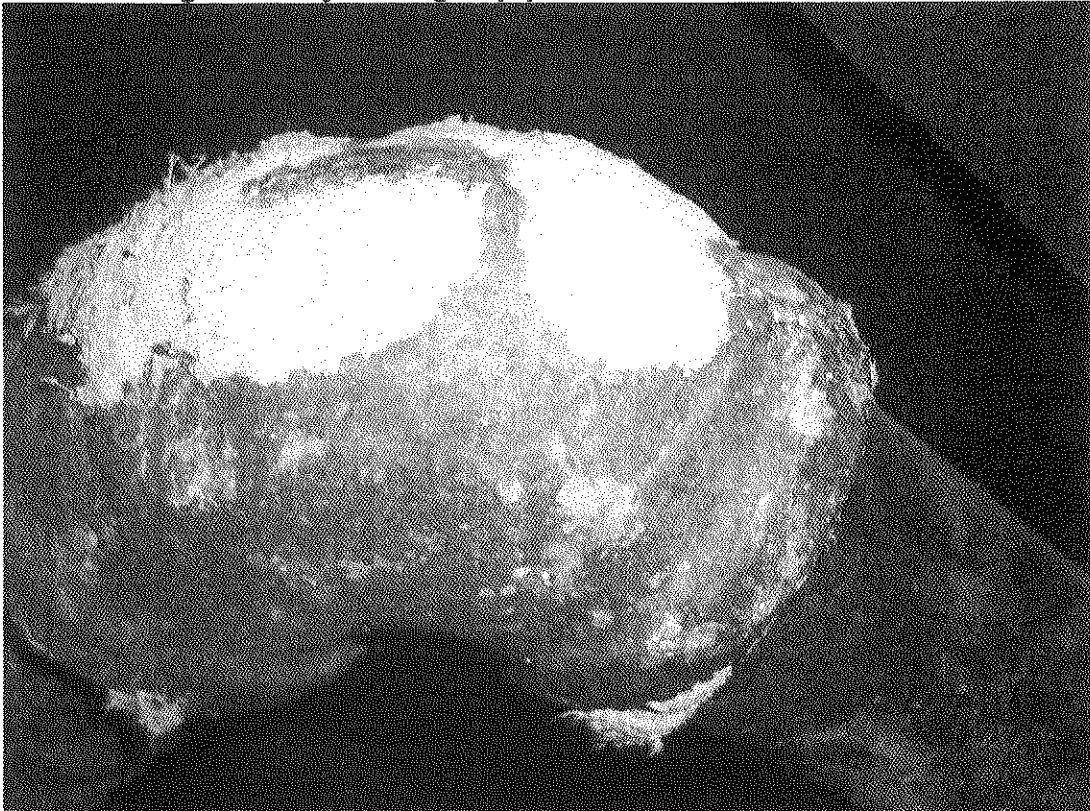
| Space # | Homogenous Area | Material Description | Quantity | Condition Response Action |
|---|---|--|---|--|
| 118A | 28 | Very poorly abated pipe insulation above drop ceiling | 3 LF | Significant Damage/Removal /Required-High Priority |

Room 118A – Poorly abated pipe insulation fittings

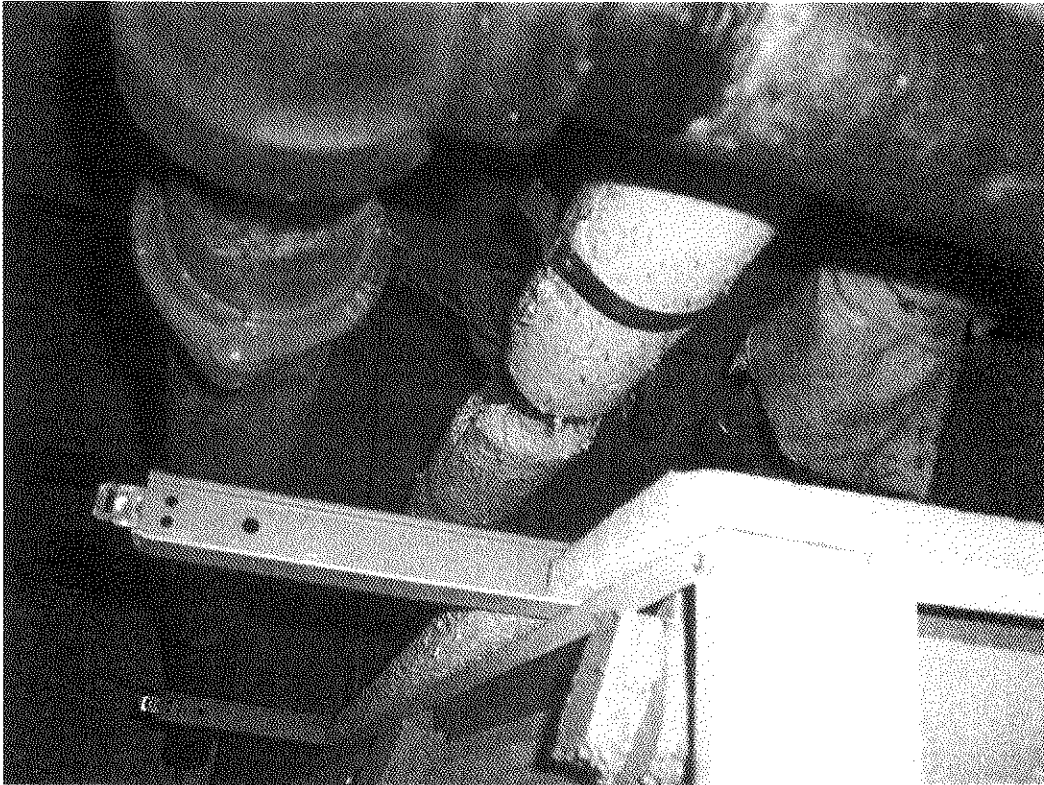
Room 119a – Significantly damaged pipe insulation

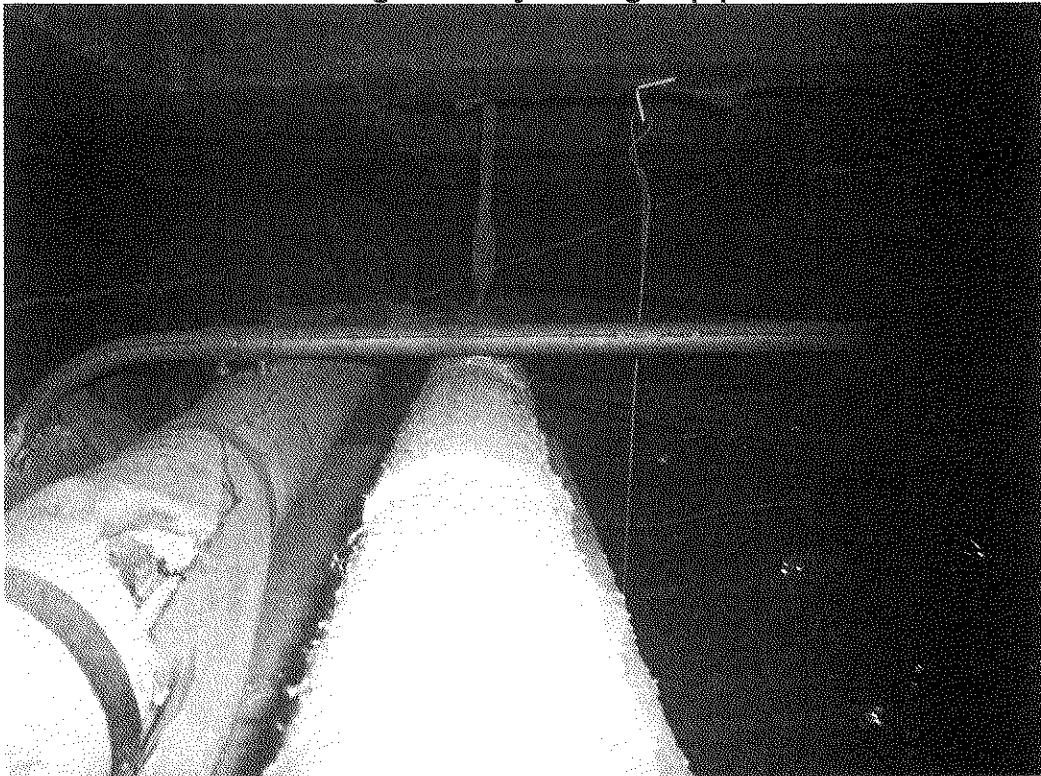
Room 130 – Asbestos Pipe Insulation significantly damaged

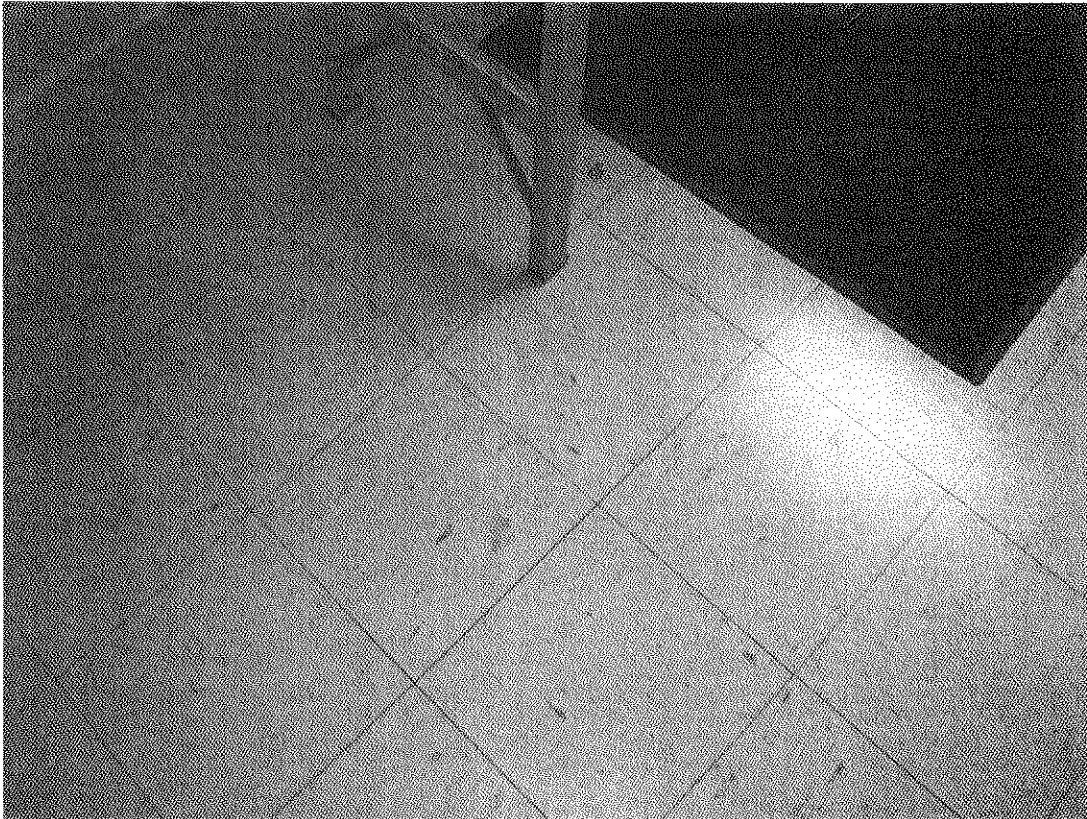
| Material | Approximate Quantity | Locations Of Material | Asbestos Content and Type |
|--|---|---|---|
| 12"x12" Floor Tile – Off White with small and few gold marks | 4044 SF | Room 11, 11B, 11C, 12, Corridor 13, 13A, 14 | 2% Chrysotile |
| Floor tile mastic for 12"x12" Floor Tile – Off White with small and few gold marks | 4044 SF | Room 11, 11B, 11C, 12, Corridor 13, 13A, 14 | 6% Chrysotile |

12"x12" Off white with few gold marks and mastic

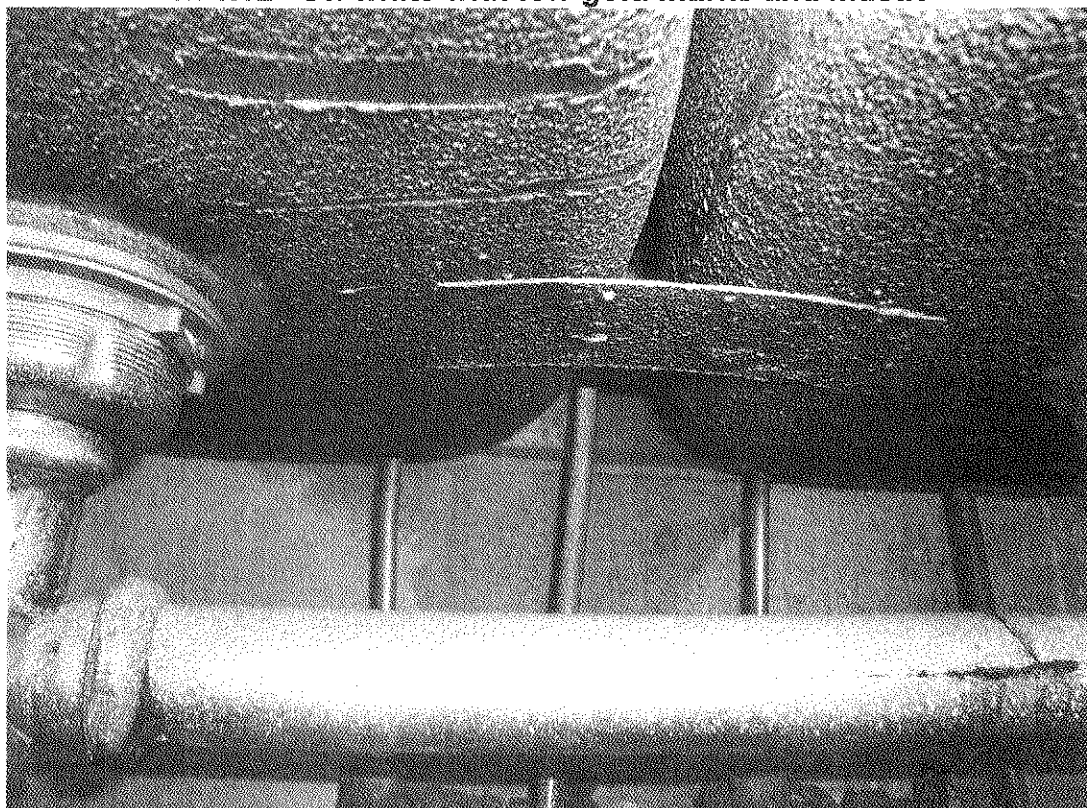
| Material | Approximate Quantity | Locations Of Material | Asbestos Content and Type |
|--|---|---|---|
| Kitchen Sink Basin Coating | 4 SF | Room 11B | 4% Chrysotile |

| Space # | Homogenous Area | Material Description | Quantity | Condition Response Action |
|---|---|--|---|---|
| | 23 | Kitchen Sink Basin Coating | 4 SF | Good/Defer Action/None Required |

Room 11B – Sink basin coating
