**COMPREHENSIVE SURVEY FOR ASBESTOS CONTAINING  
MATERIALS**

**Building 12  
Veterans Affairs Medical Center  
1970 Roanoke Blvd  
Salem, Virginia 24153  
Adelaide Project No. VAMC: 10079.00-IN**

**June 28, 2010**

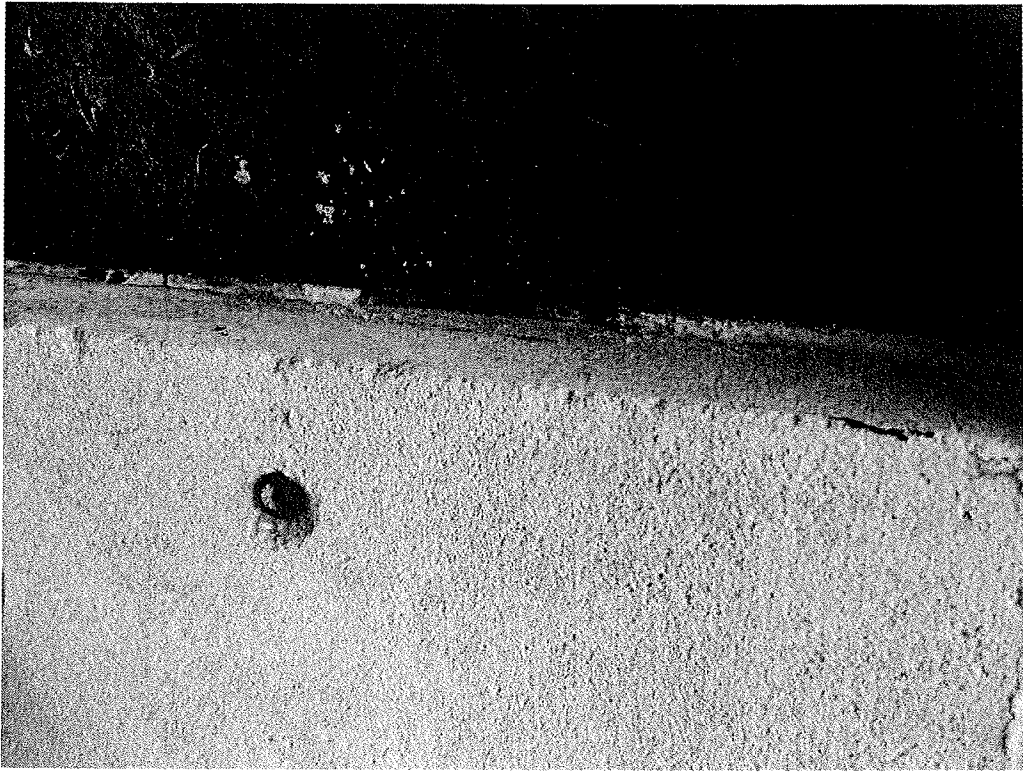
**Exterior Caulk around Black Vents – Gray- Hard**

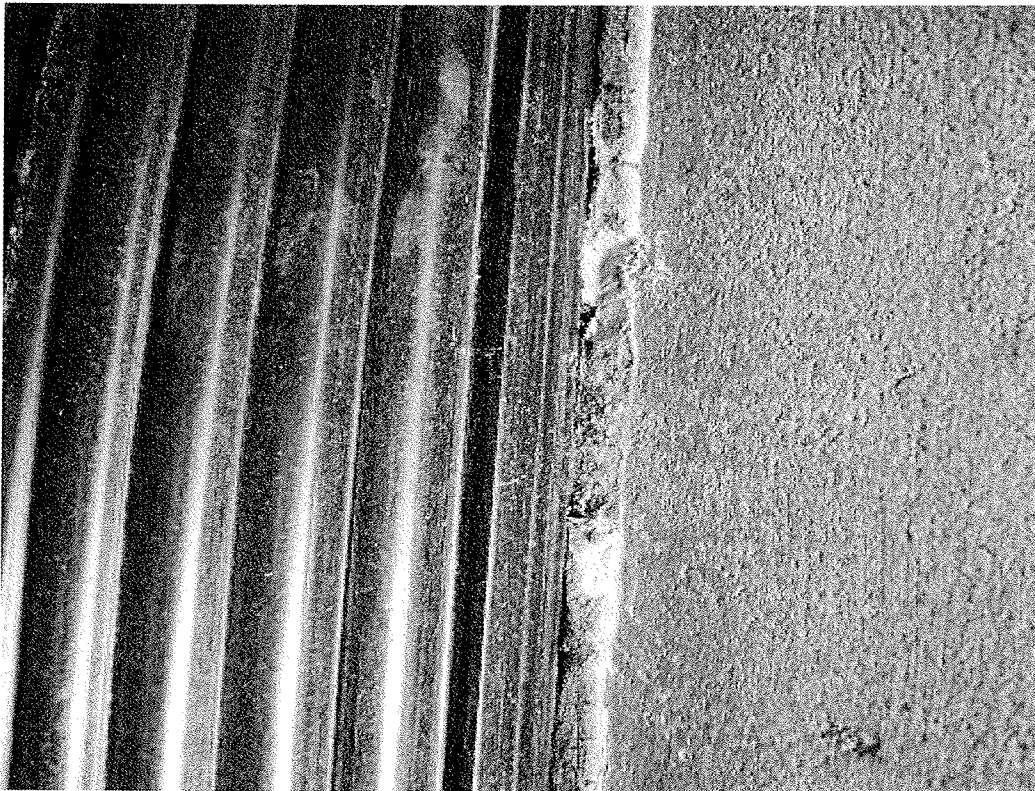
**Main Door Caulk-Greenish/Gray**

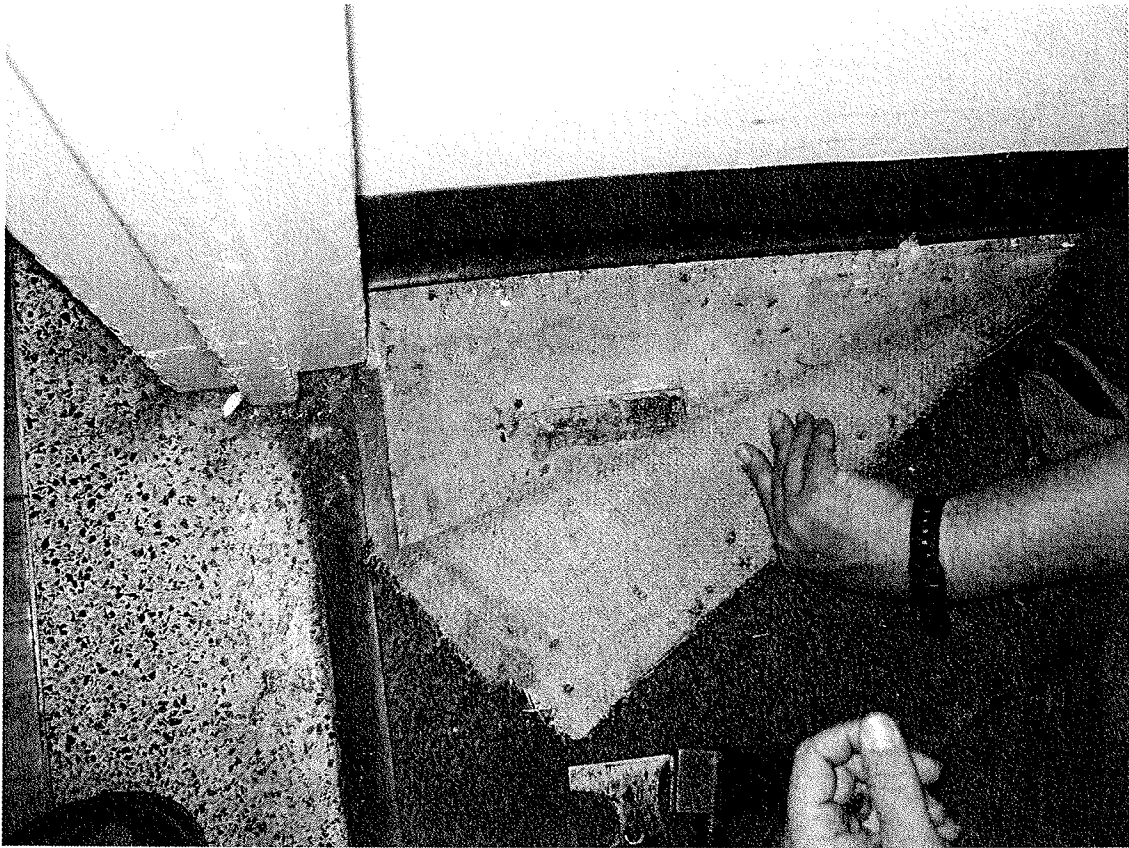
**9x9 Red Floor Tile and Mastic under Carpet**

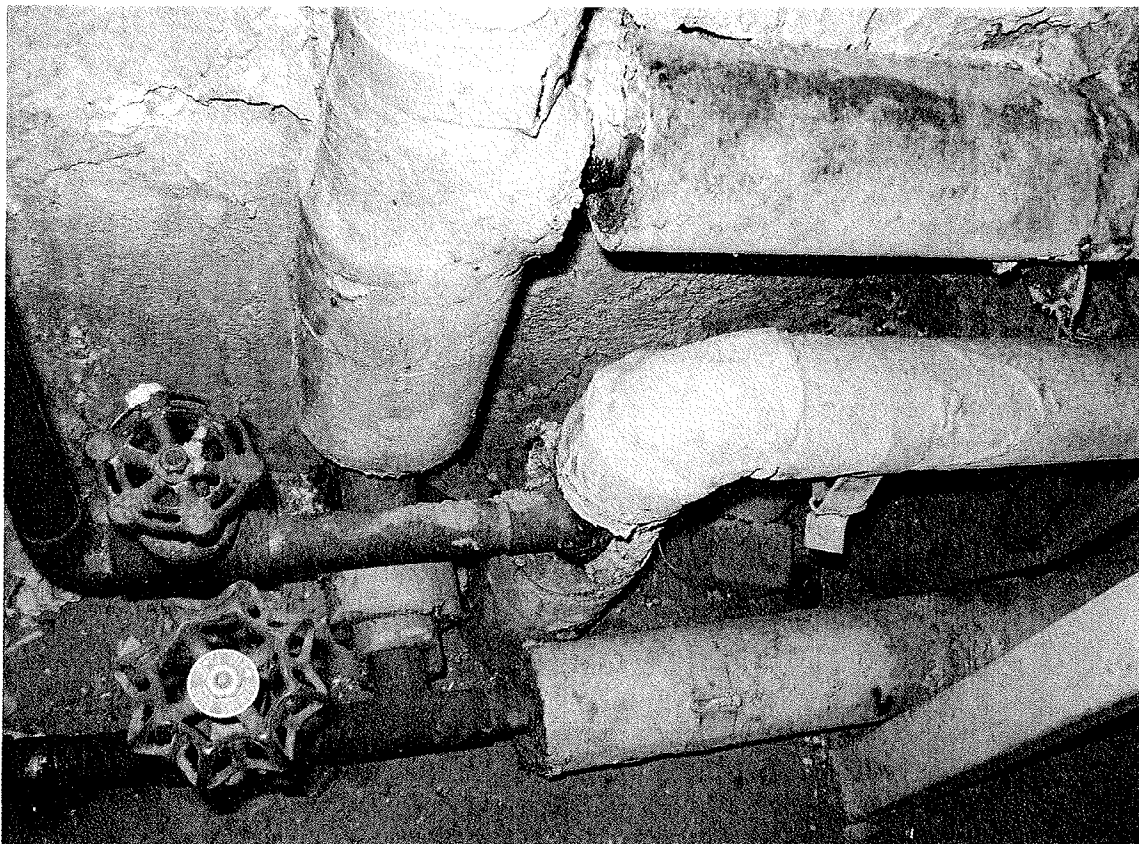
**Pipe Insulation- Brownish Yellow and MJP**

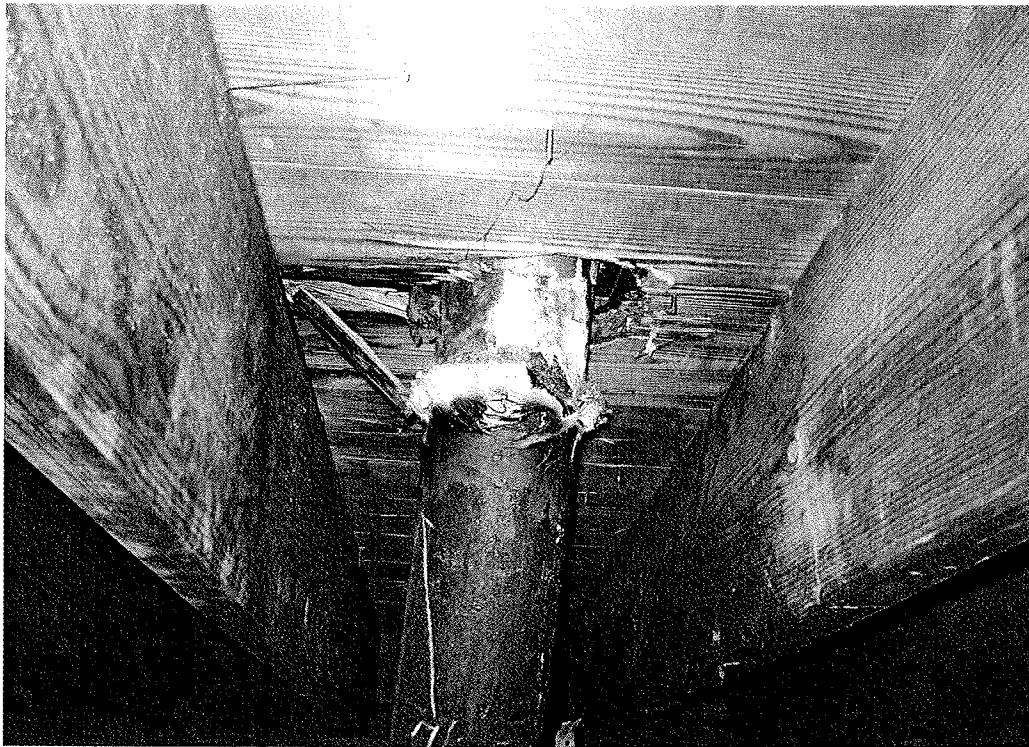
**Roof Drain Sealant- Black**

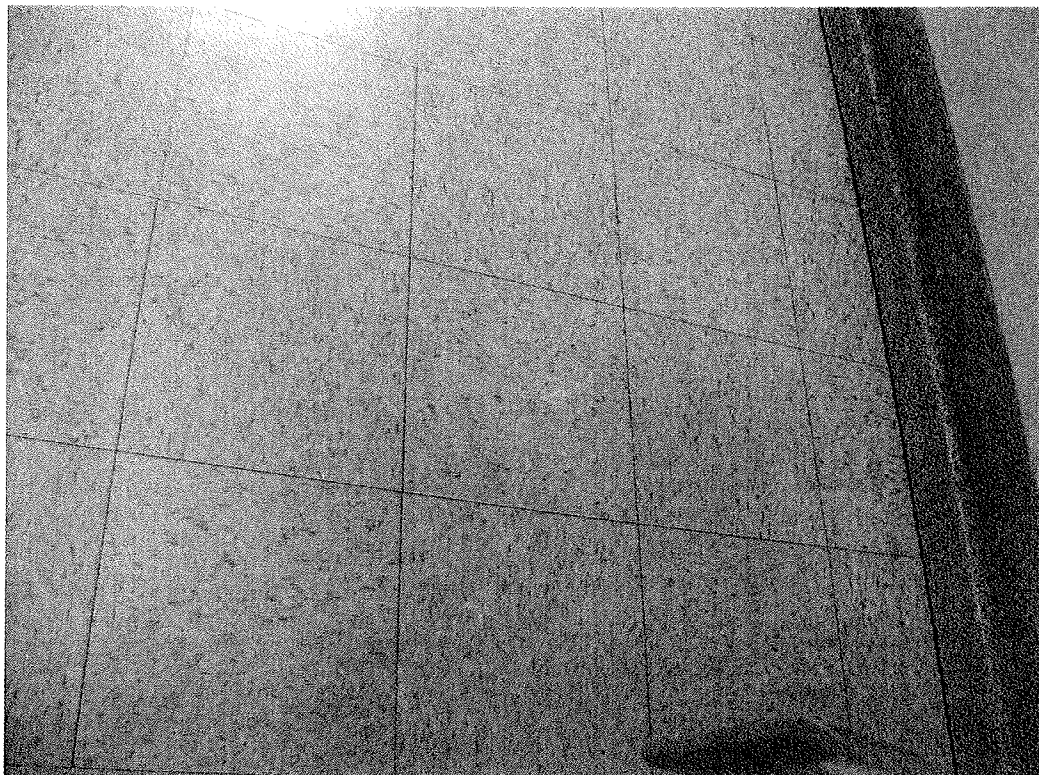
**12 x12 Floor Tile Light Brown with Marble Design**
