**COMPREHENSIVE SURVEY FOR ASBESTOS CONTAINING
MATERIALS**

**Building 75
Veterans Affairs Medical Center
1970 Roanoke Blvd
Salem, Virginia 24153
Adelaide Project No. VAMC: 10079.00-IN**

June 28, 2010

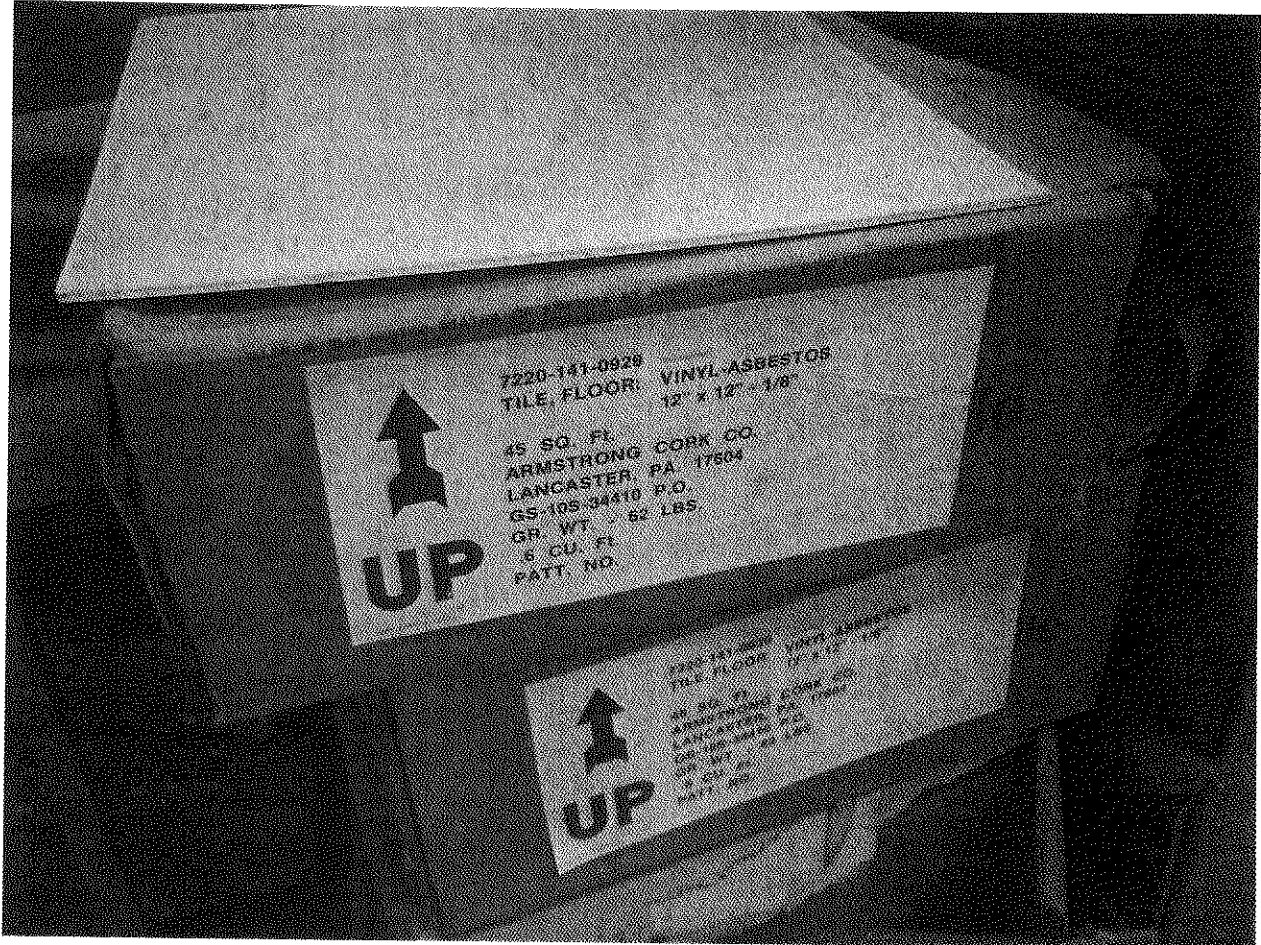
Known Positive Vinyl Asbestos 12x12 White w/ Short Grey Streaks

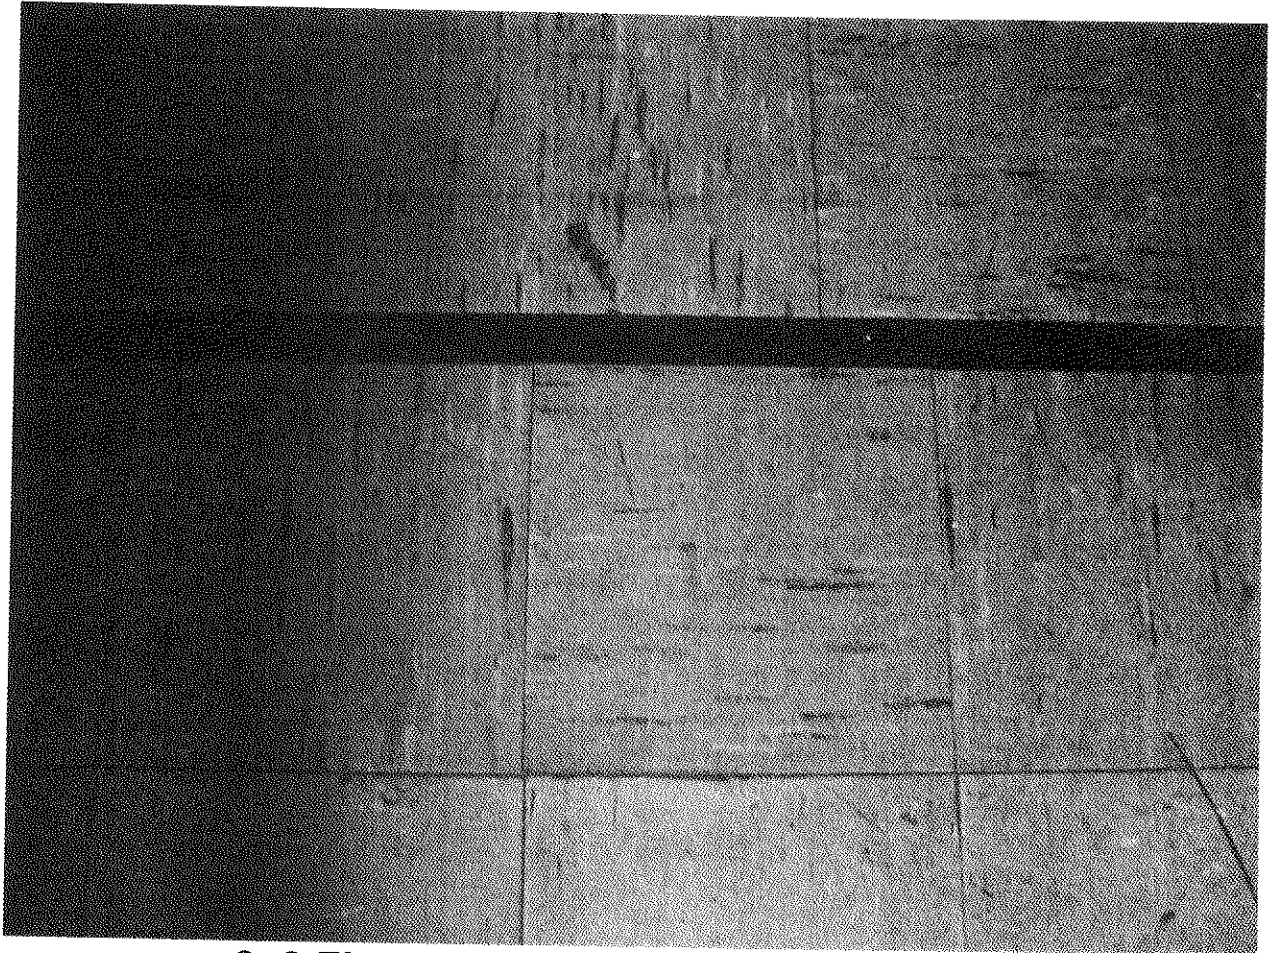
9x9 Floor Tile Beige with Black Streaks

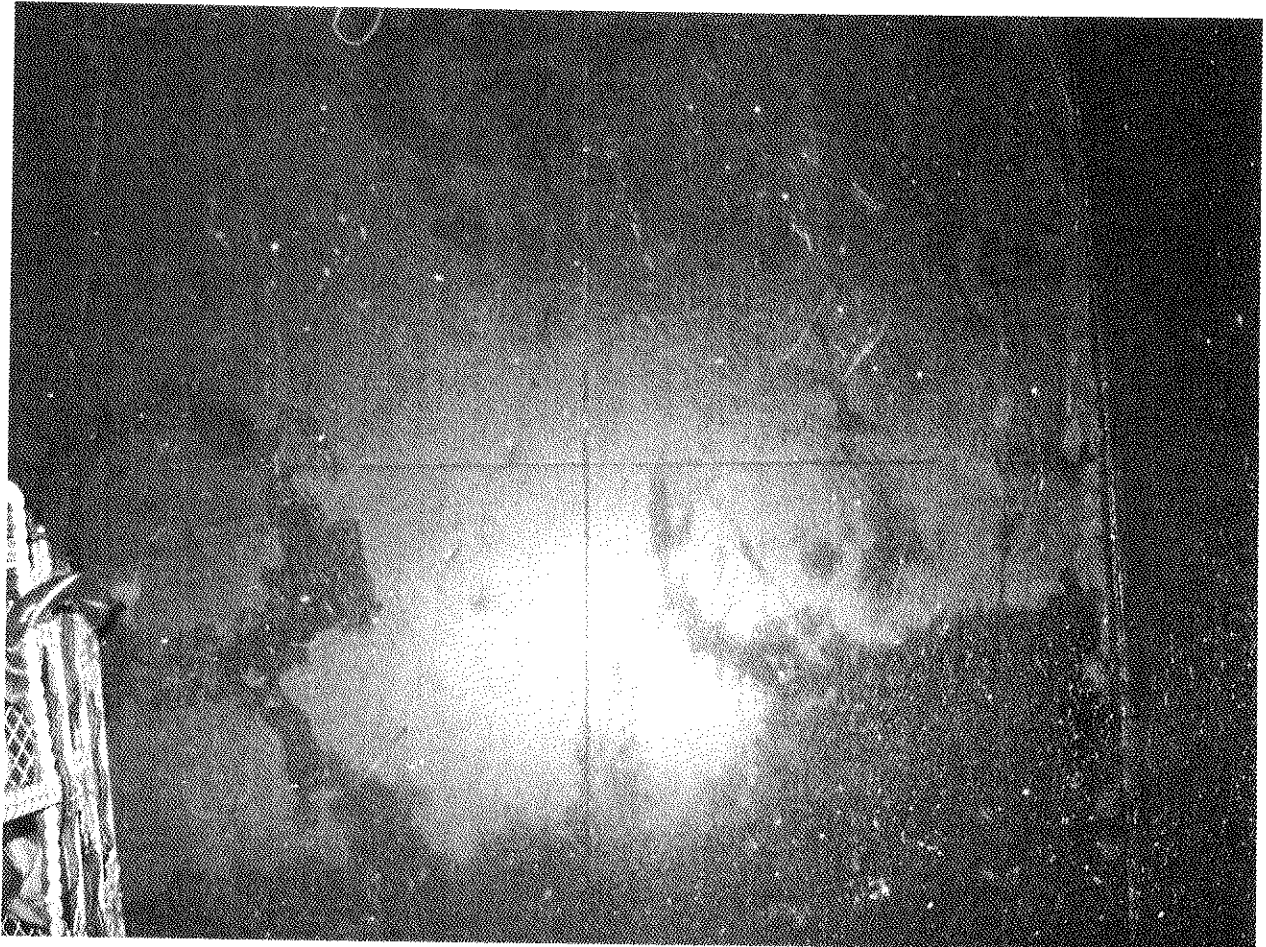
Floor Tile 9" x 9" Orange

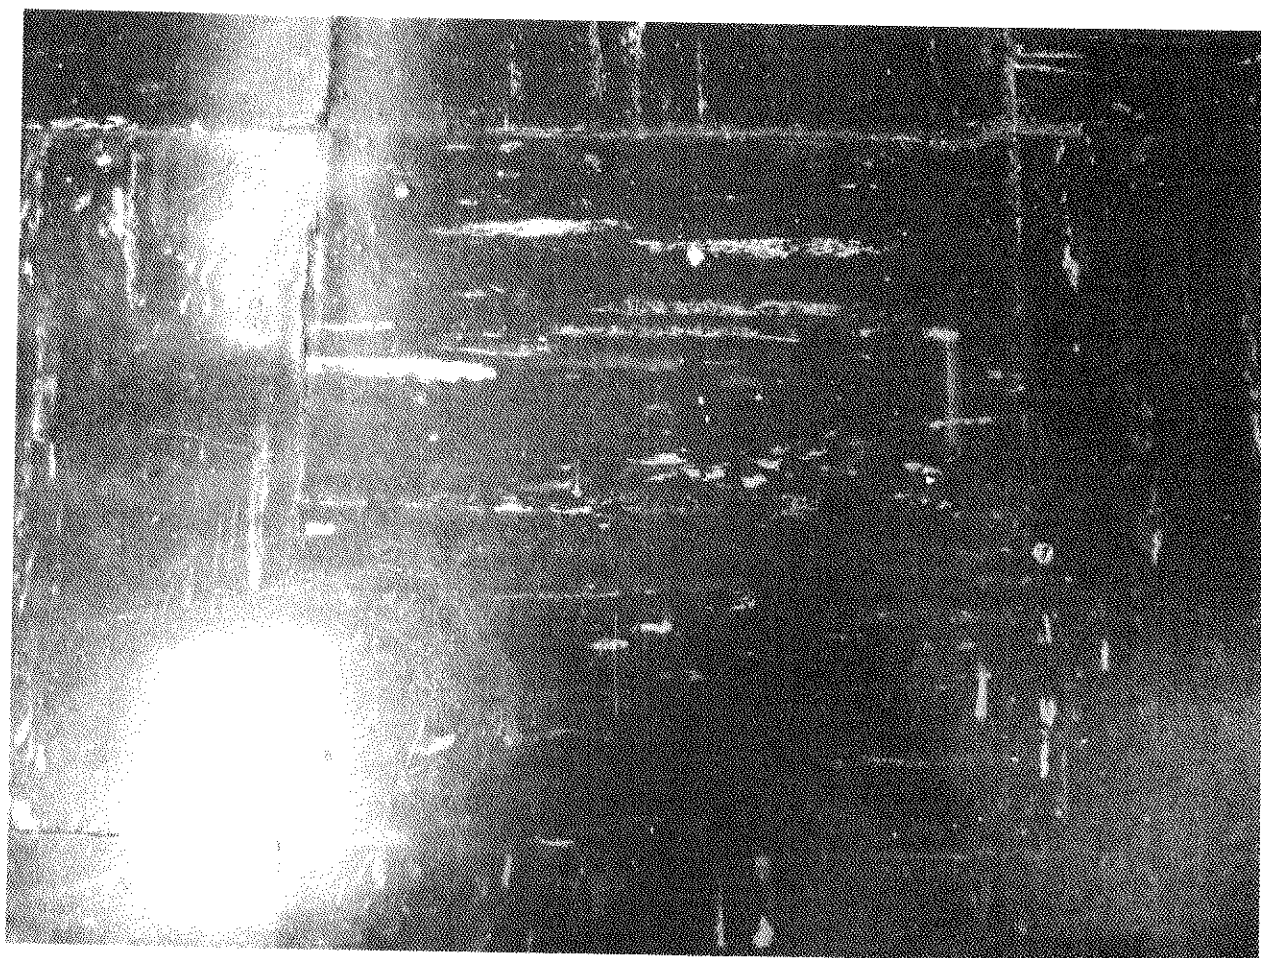
Floor Tile 9" x 9" Brown

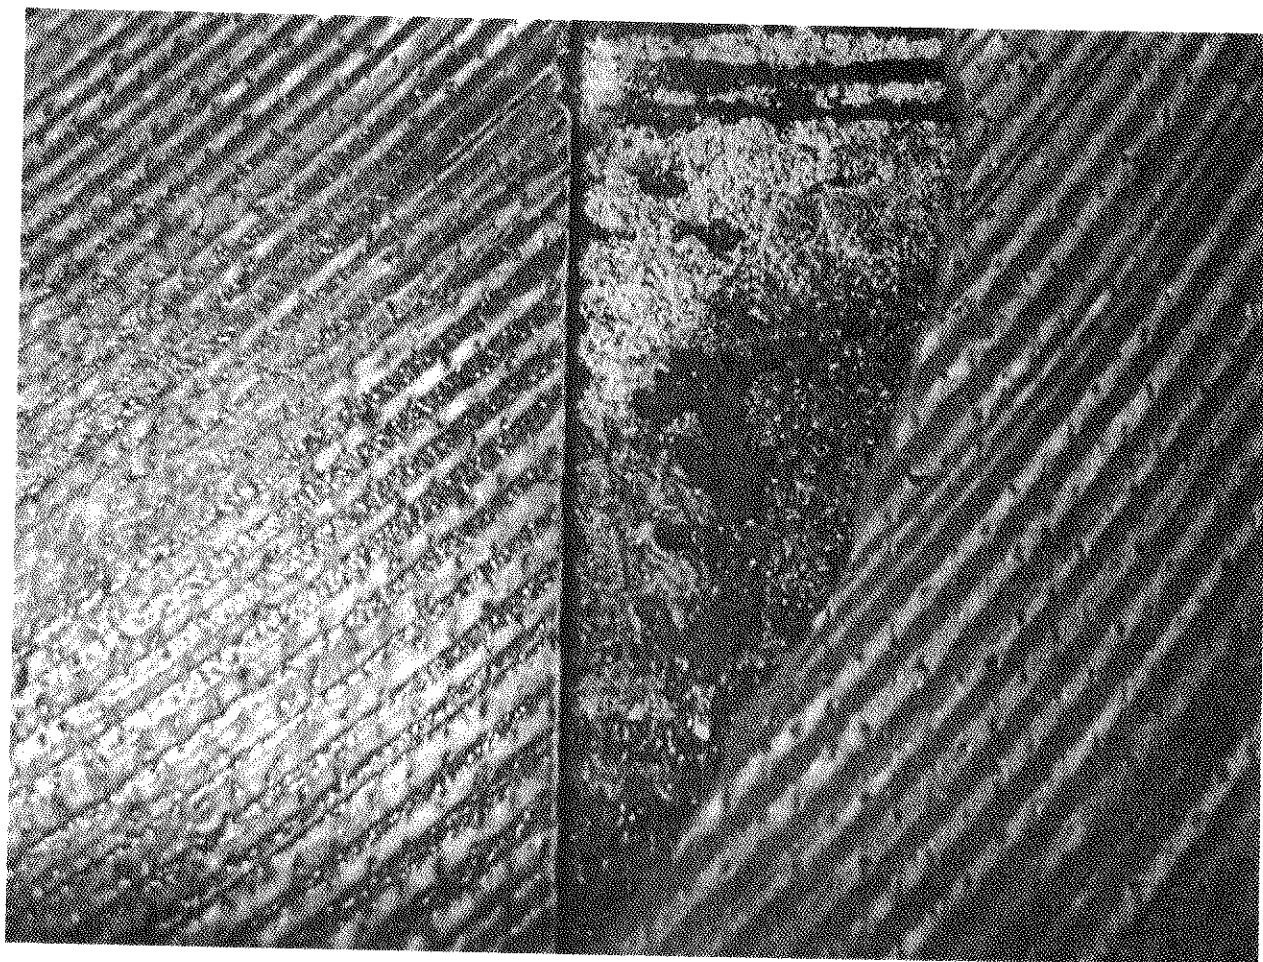
Floor Tile 6" x 12" Red

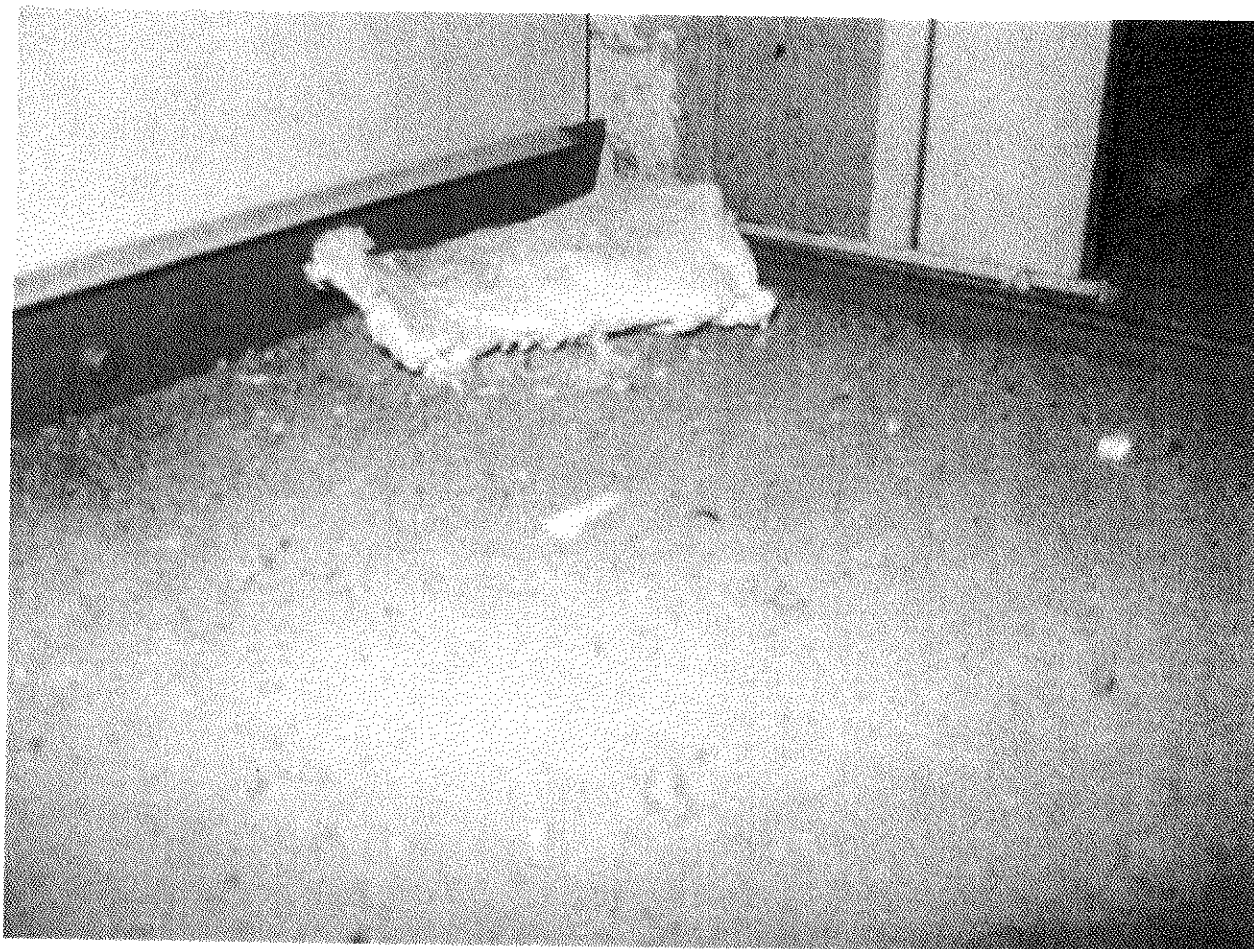
Space #	Homogenous Area	Material Description	Quantity	Condition Response Action
Hallway 17	27	TSI Beige, Gray and White 4" Elbows As Debris on top of ceiling tiles	356 SF	Severly Damaged/Remove/High Priority
Hallway 18	27	TSI Beige, Gray and White 4" Elbows As Debris on top of ceiling tiles	886 SF	Severly Damaged/Remove/High Priority
2	28	TSI 6" Mudded Joint	2 Elbows	Good/Defer Action/None Required
4	28	TSI 6" Mudded Joint	2 Elbows	Good/Defer Action/None Required
4A	28	TSI 6" Mudded Joint	1 Elbow	Good/Defer Action/None Required
5	23	TSI 1" TSI Beige & Gray Pipe Insulation	82 LF	Good/Defer Action/None Required
	24	TSI 1" TSI Beige & White Elbow	8 Elbows	Good/Defer Action/None Required
7	25	TSI TSI Black and Gray 2" Elbows	5 Fittings	Good/Defer Action/None Required
	26	TSI Beige, Brown and Gray 4" Pipe Insulation	40 LF	Good/Defer Action/None Required
	27	TSI Beige, Gray and White 4" Elbows	9 Fittings	Good/Defer Action/None Required

TSI Beige, Gray and White 4" Elbows As Debris on top of ceiling tiles

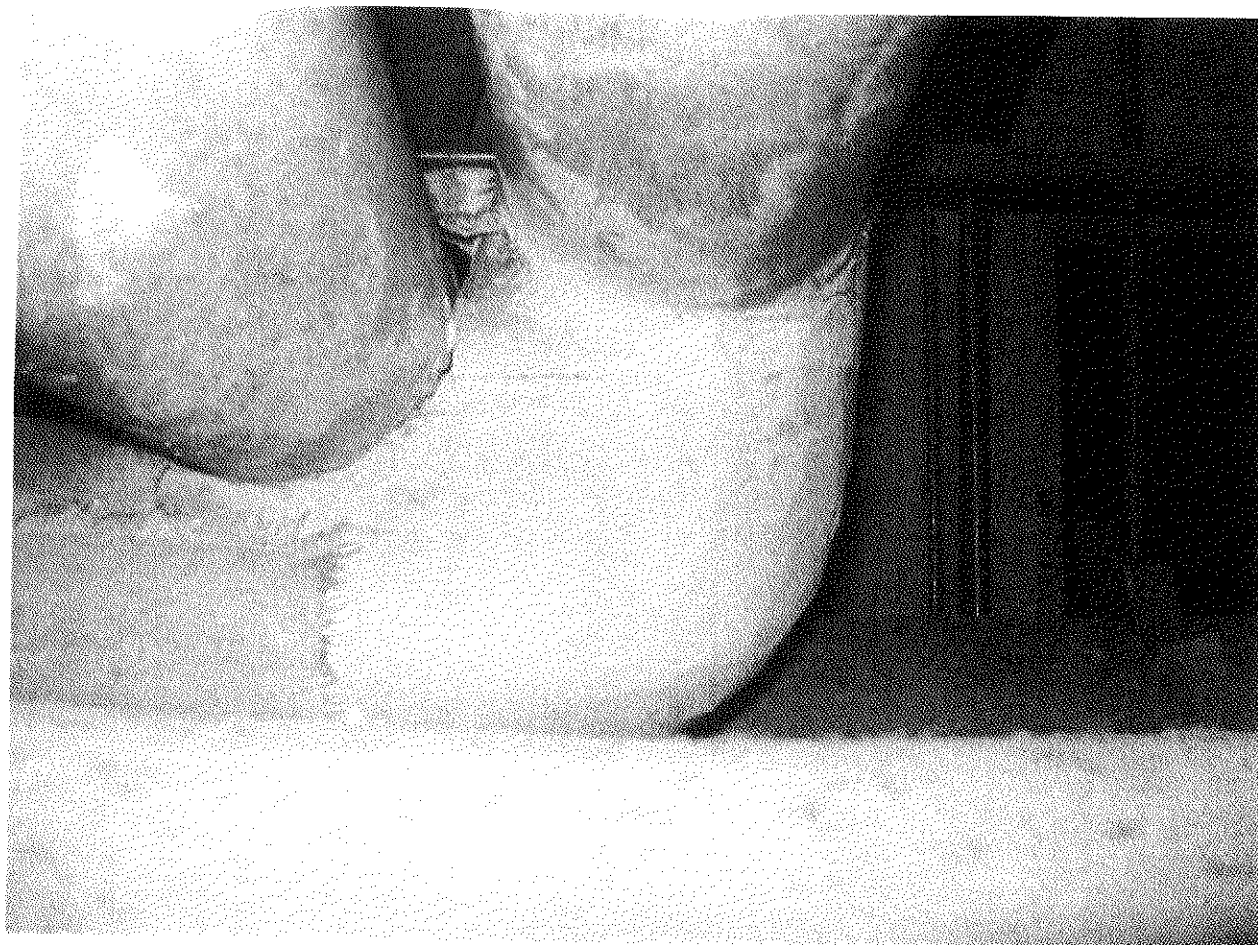
TSI 6" Mudded Joint

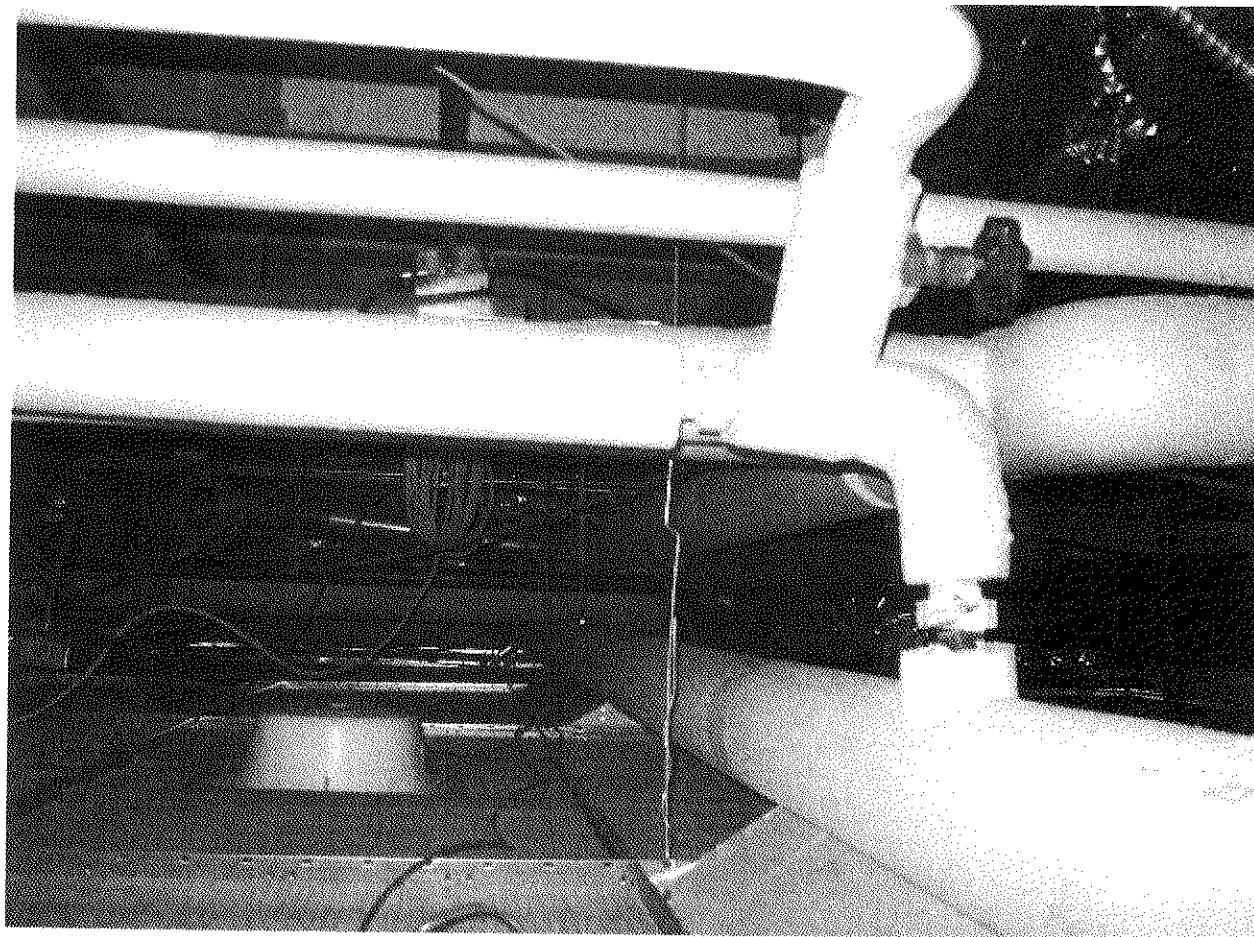
**TSI 1" TSI Beige & Gray Pipe Insulation
&
TSI 1" TSI Beige & White Elbow**

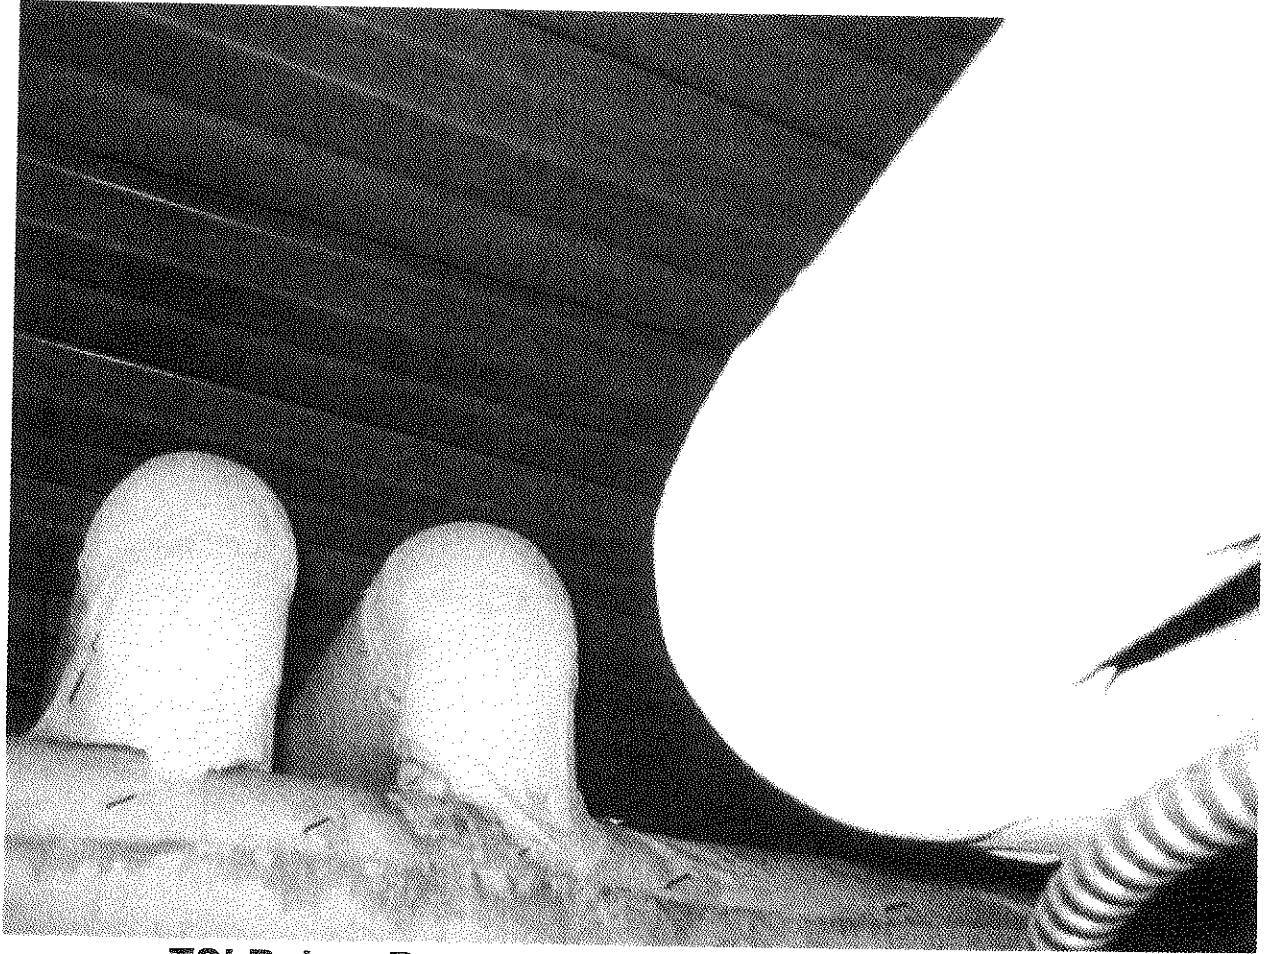
TSI Beige, Brown and Gray 4" Pipe Insulation

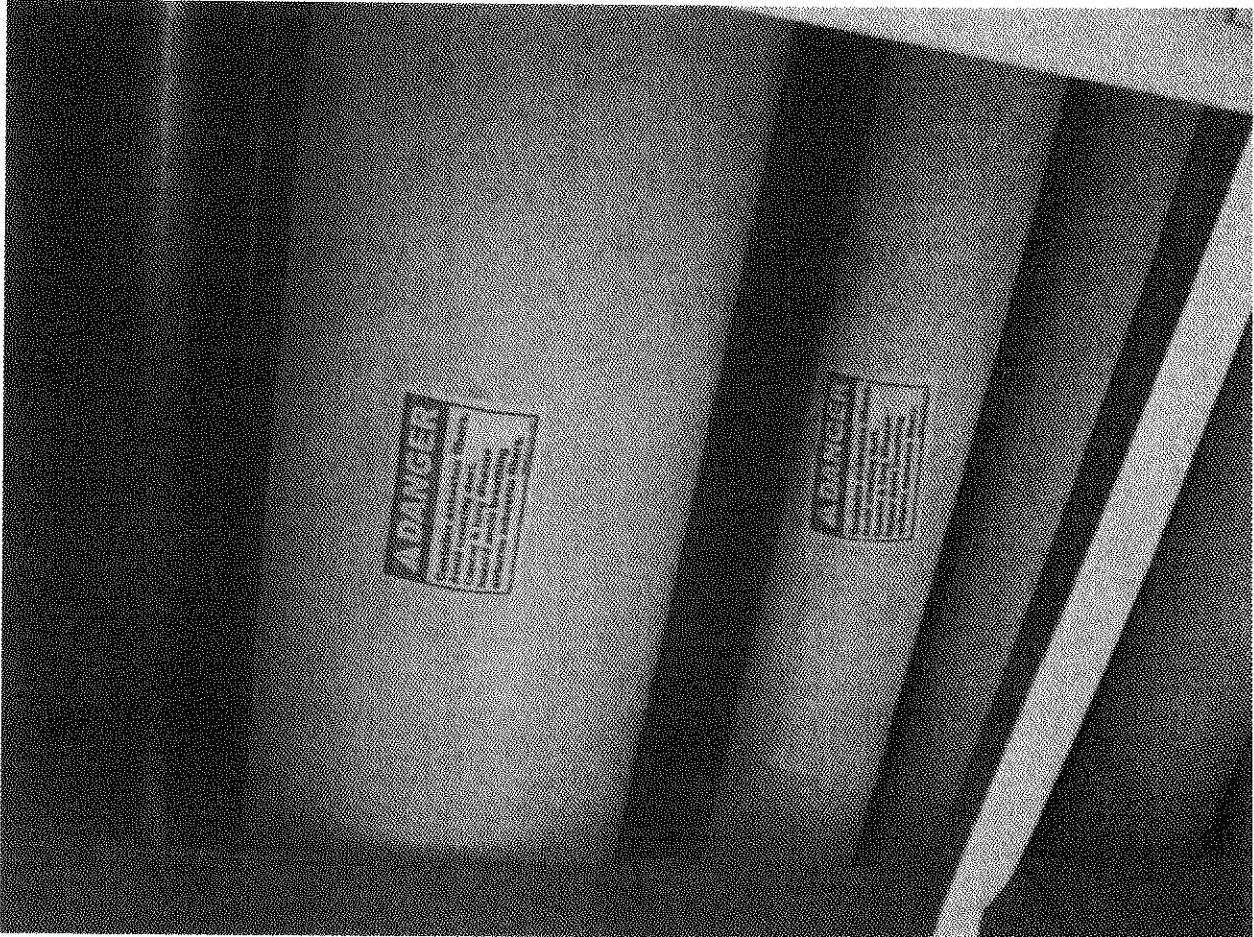
4" TSI Pipe Insulation White
6" TSI Steam Pipe White

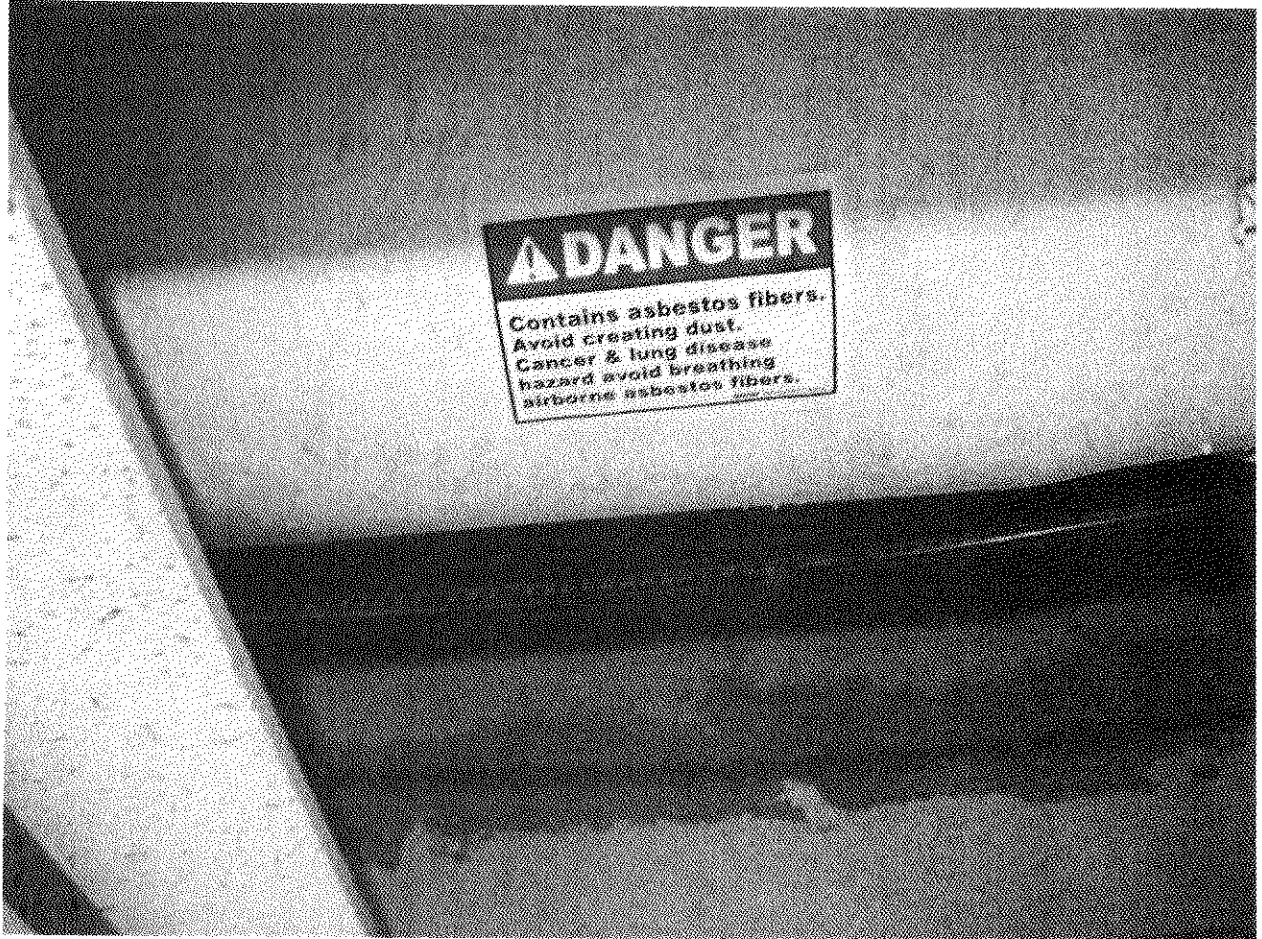
16" TSI Steam Pipe White And Gray
