**COMPREHENSIVE SURVEY FOR ASBESTOS CONTAINING  
MATERIALS**

**Building 77  
Veterans Affairs Medical Center  
1970 Roanoke Blvd  
Salem, Virginia 24153  
Adelaide Project No. VAMC: 10079.00-IN**

**June 28, 2010**

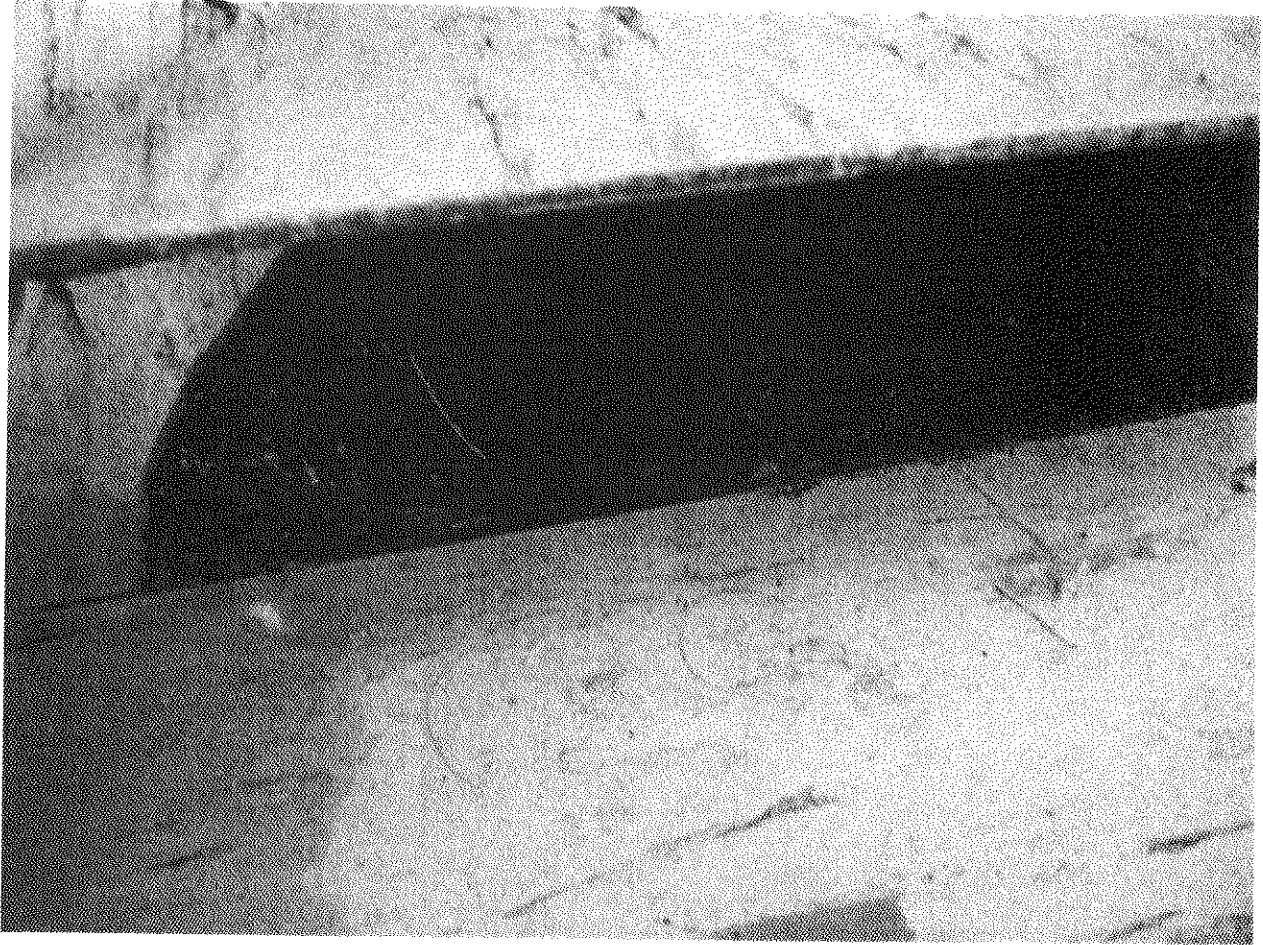
**Mastic Layer Black**

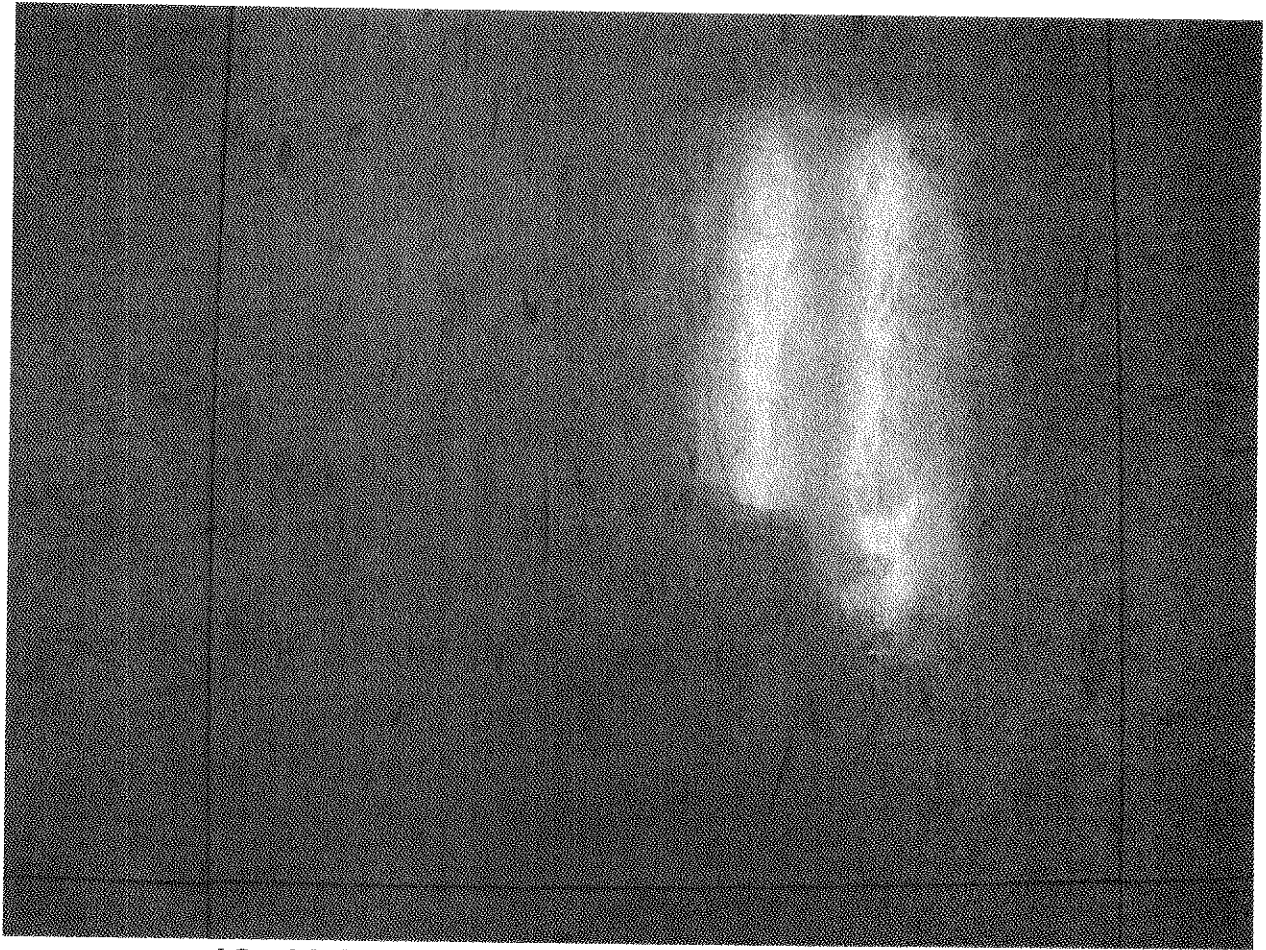
**12x12 Floor Tile Cream with Gray Streaks**

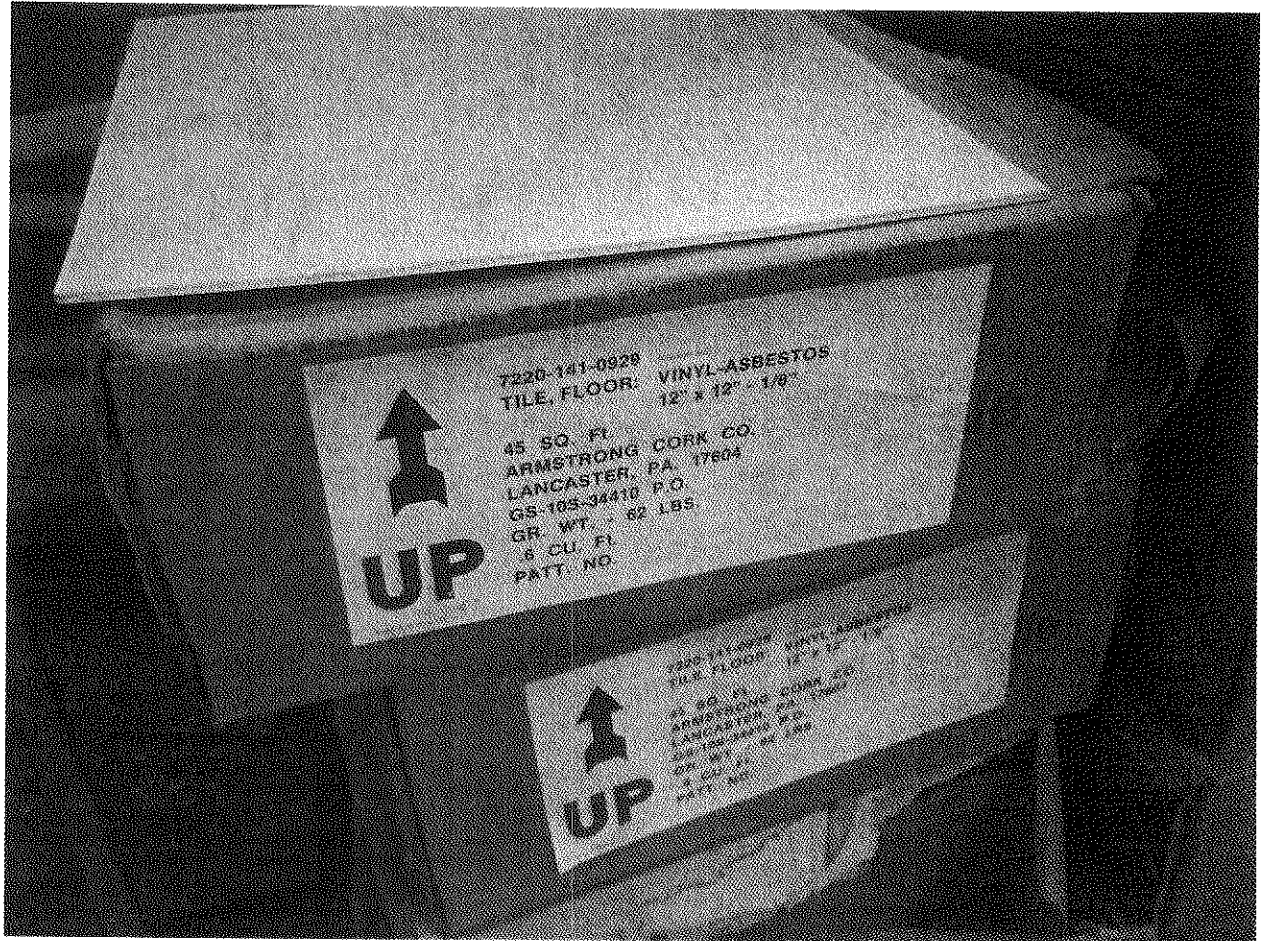
**12X12 Floor Tile Hard White with Thin Light Gray Streaks**

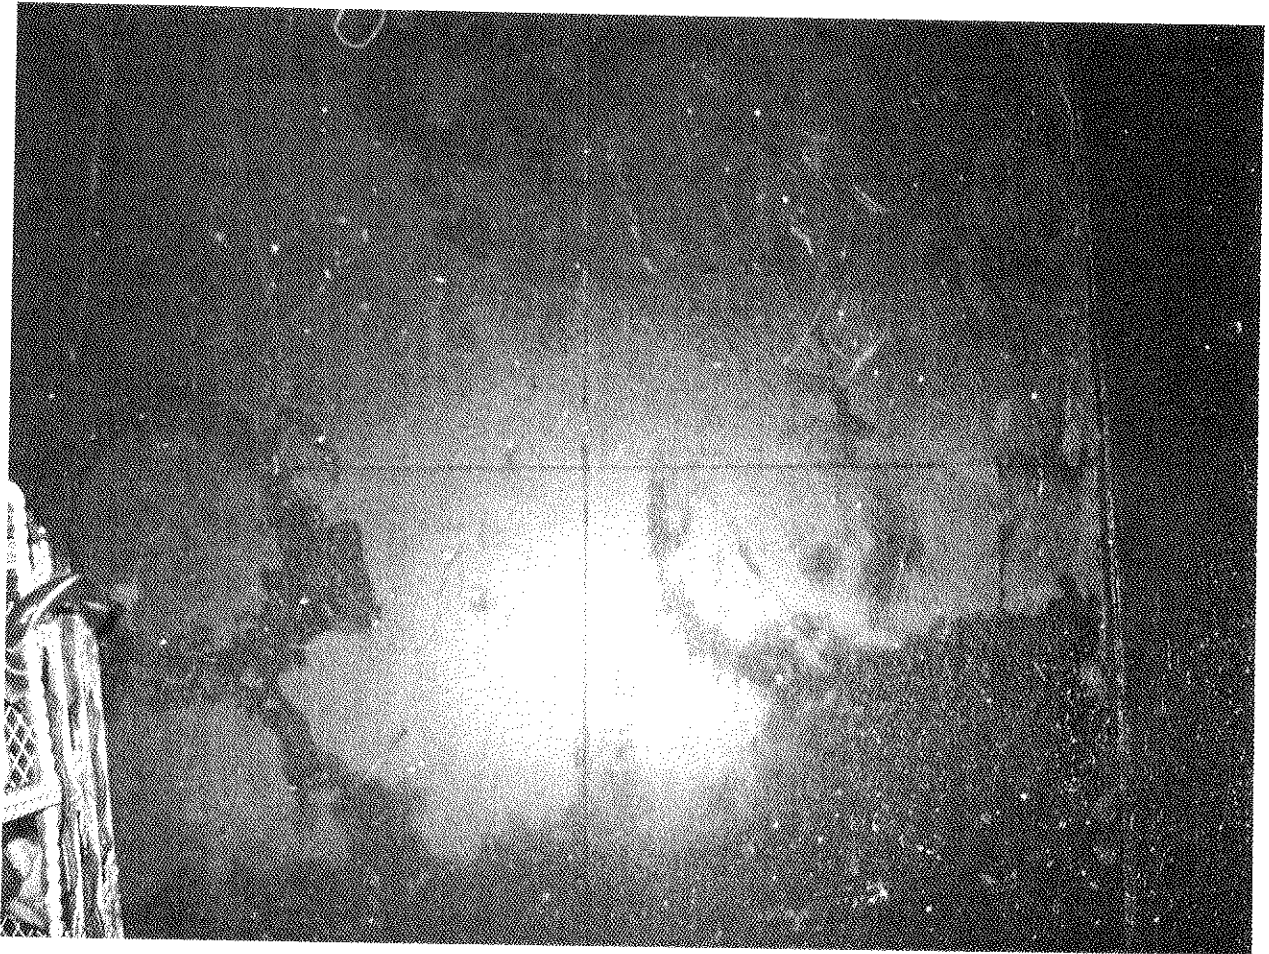
**Floor Tile 9" x 9" Orange**

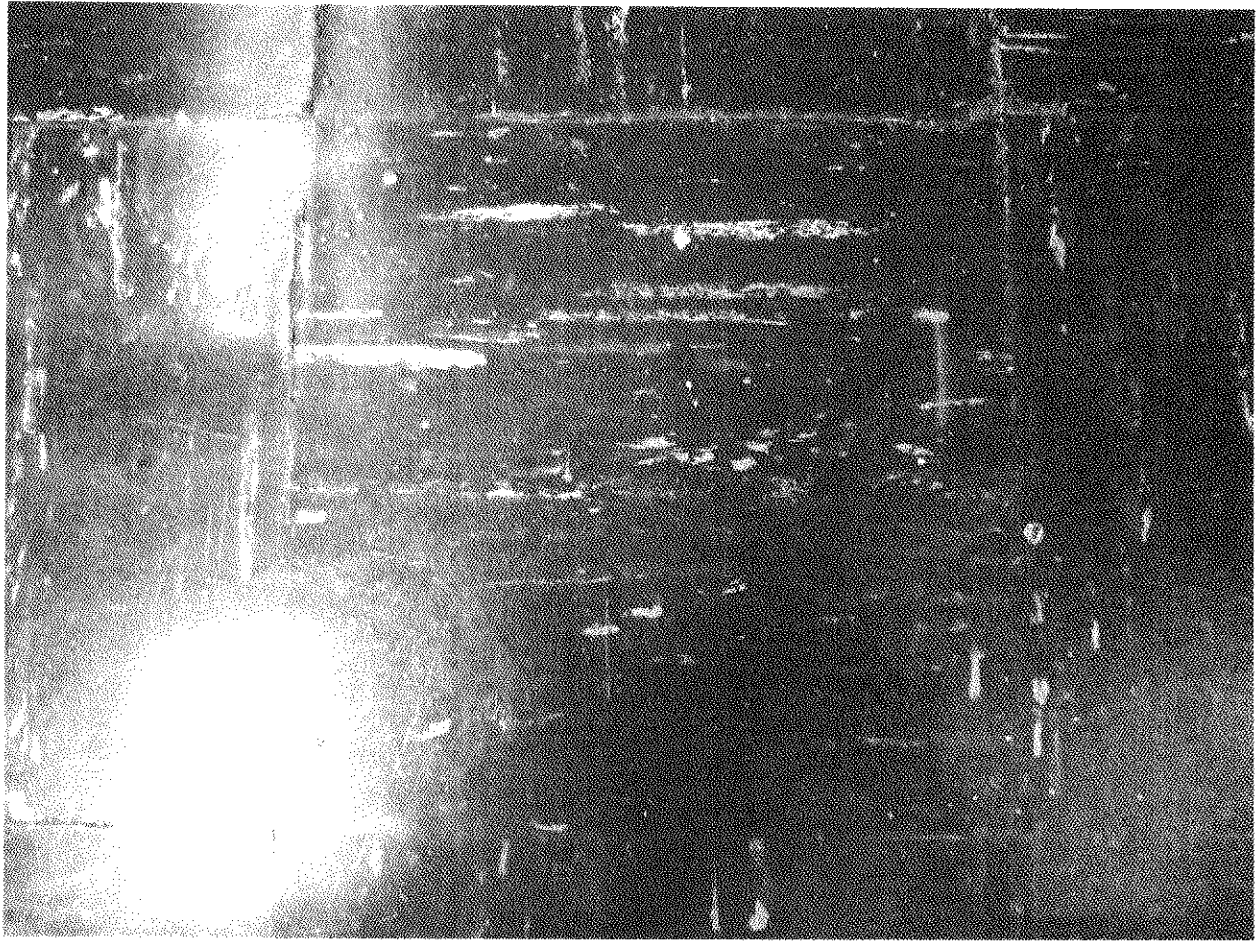
**Floor Tile 9" x 9" Brown**

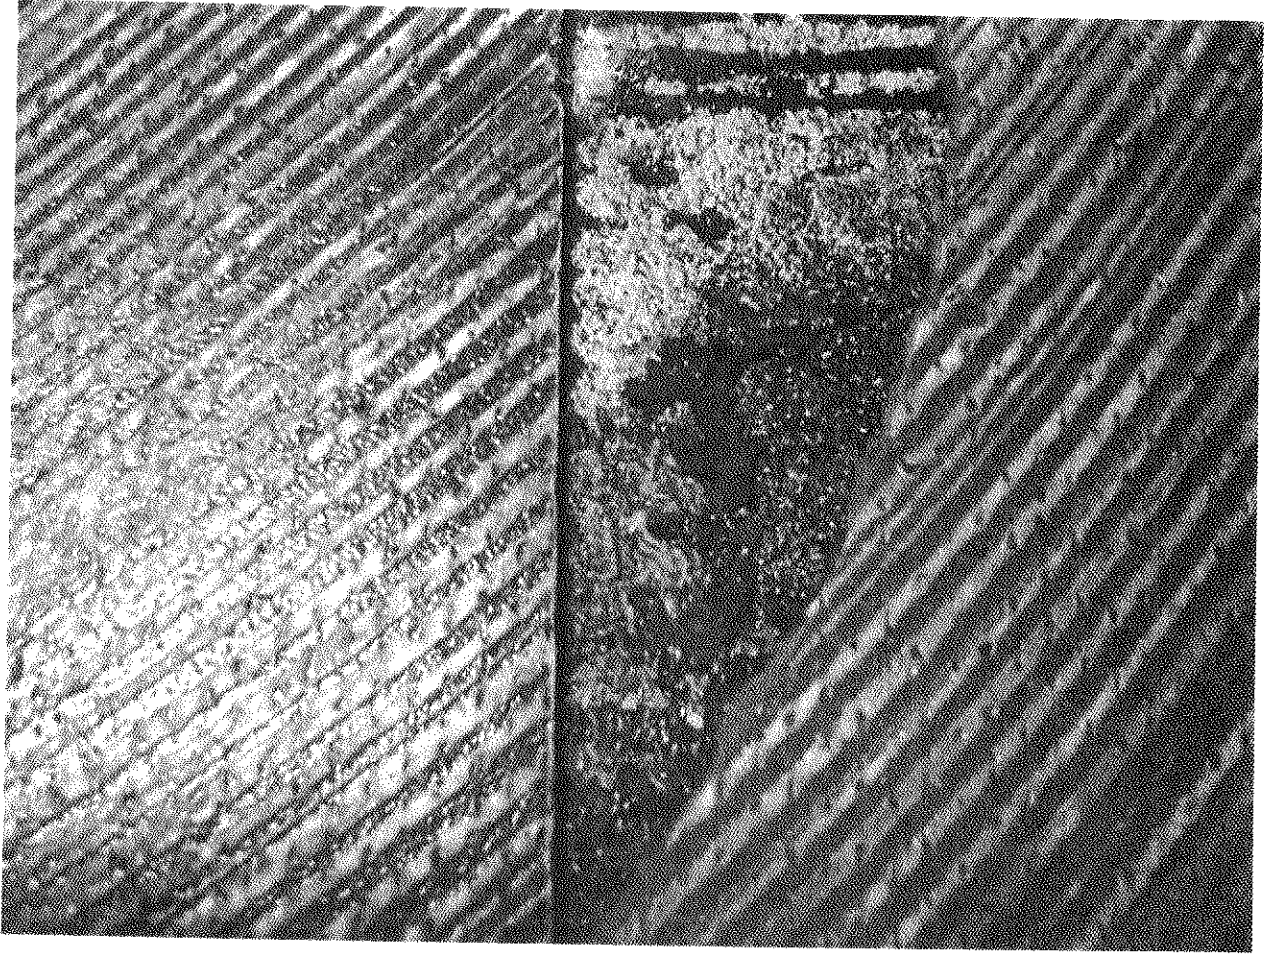
**Floor Tile 6" x 12" Red**

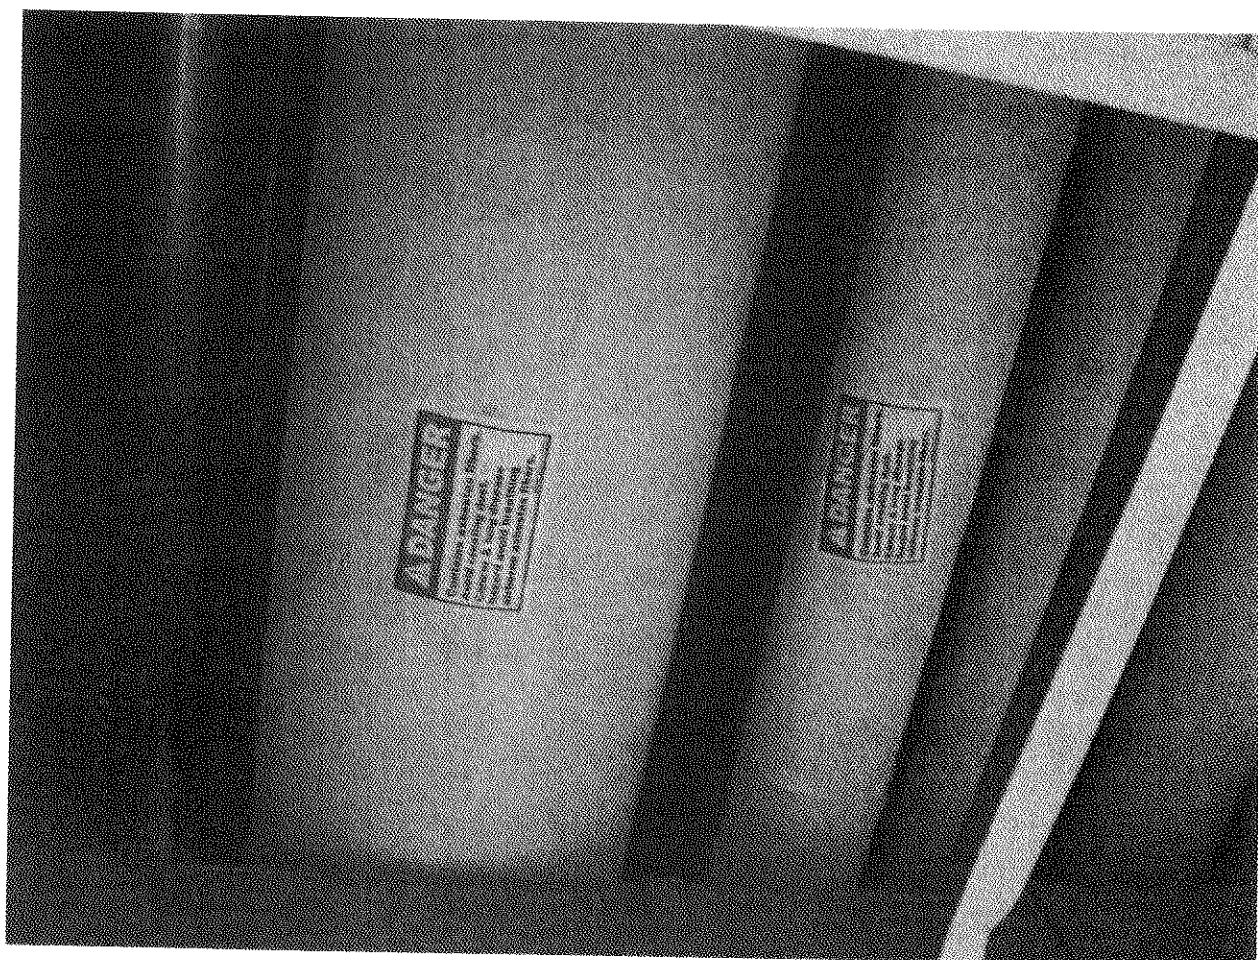
**4" TSI Pipe Insulation White**  
**6" TSI Steam Pipe White**

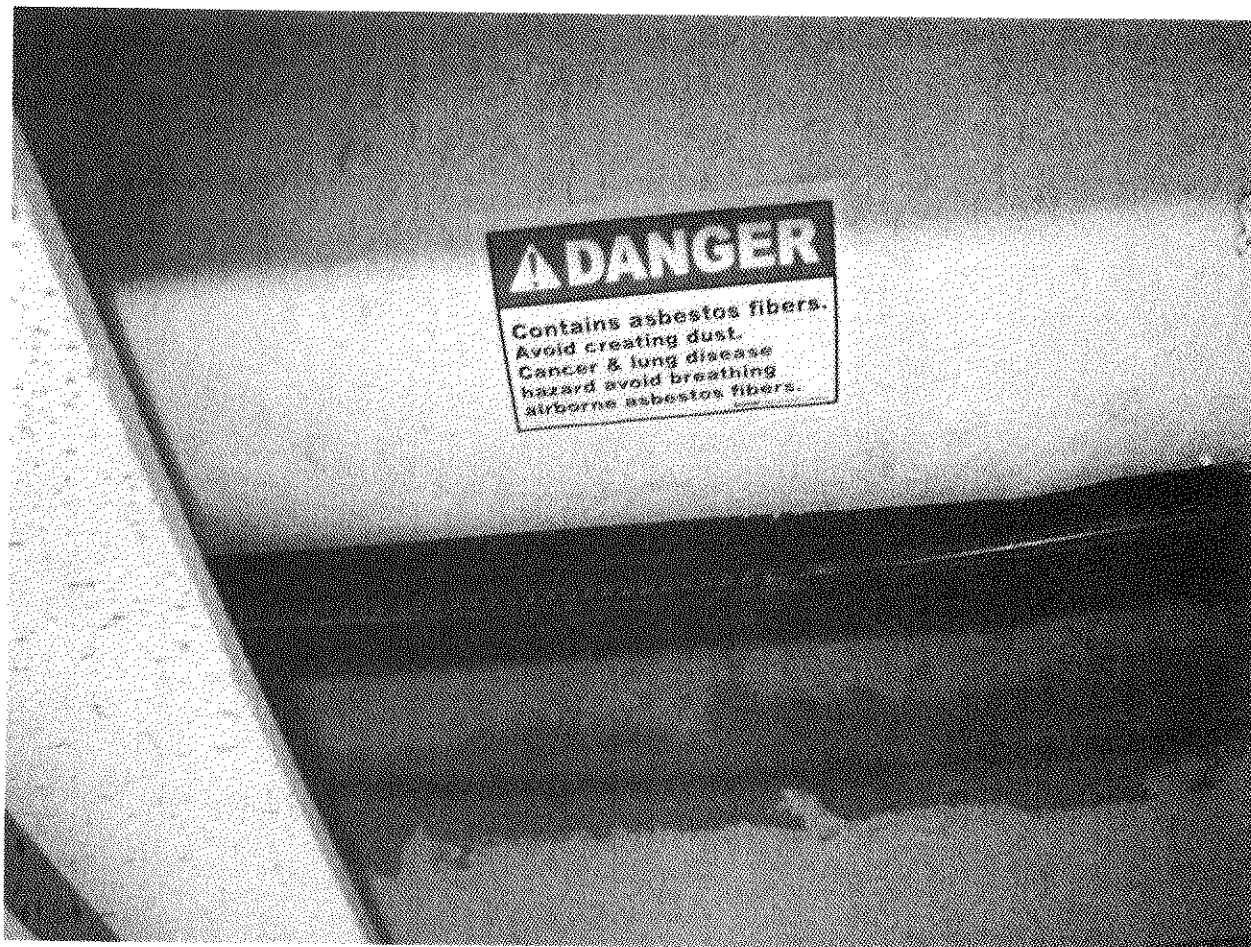
**16" TSI Steam Pipe White And Gray**
