TRIENNIAL ASBESTOS REINSPECTION REPORT
BUILDING 161 –RADIATION THERAPY

Mr. James Bachman & Ms. Olivia Parducho
Department of Veterans Affairs
VA Long Beach Healthcare System
5901 East 7th St.
Long Beach CA 90815
Contract Number: GS-10F-0229U - Order Number: VA262-14-F-7064

Millennium Consulting Associates
401 Roland Way, Suite 250
Oakland, CA 94621

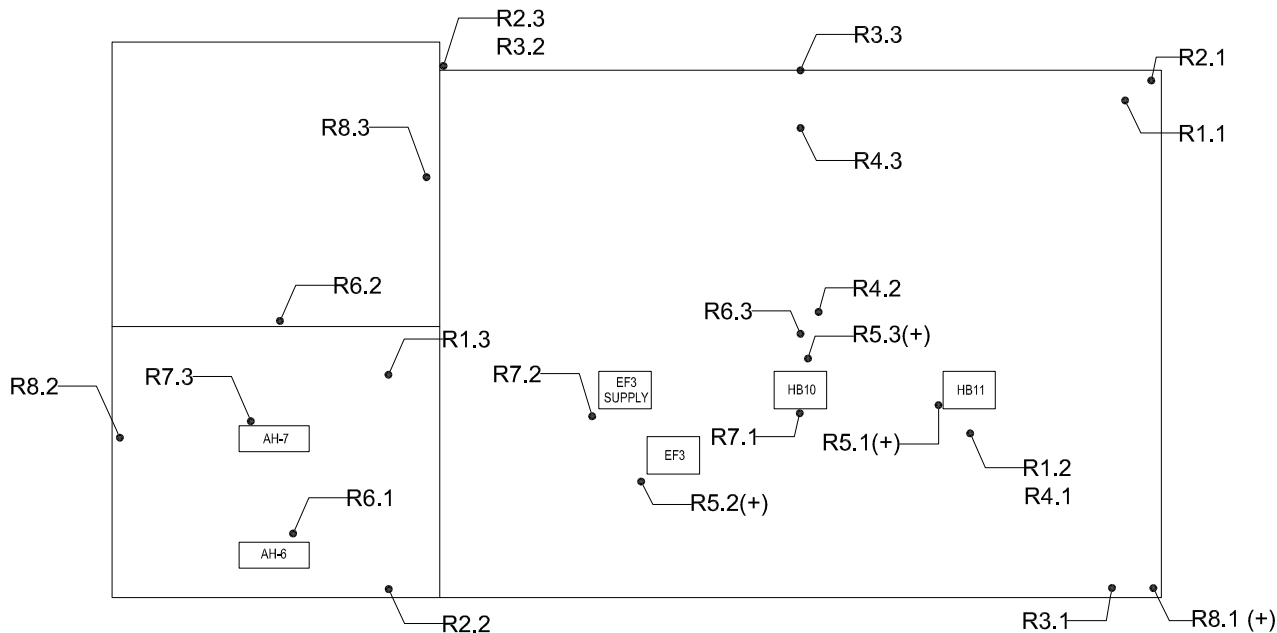
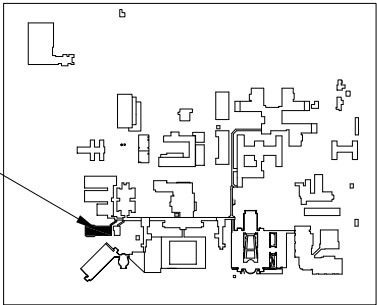
Architects/Engineers/Consultants: MILLENNIUM CONSULTING ASSOCIATES <small>A MECA Consulting, Inc. Company</small>				Drawing Title BUILDING 161 ROOF PLAN ASBESTOS SAMPLE LOCATION MAP		Project Title LONG BEACH ACM SURVEY		Project Number: 22015.2033		Office of Facilities Management

- The walking pad material and flashing mastic on the roof was found to contain asbestos in concentrations less than 1%. For regulatory compliance purposes, this material is considered to be an Asbestos-Containing Material (ACM) unless point count analysis is performed and reported to be <1.0%. This material is in good condition.
