ASBESTOS CONTAINING MATERIALS ASSESSMENT

BROOKLYN VETERAN'S ADMINISTRATION MEDICAL CENTER

BUILDING #1

JUNE 17TH, 2010

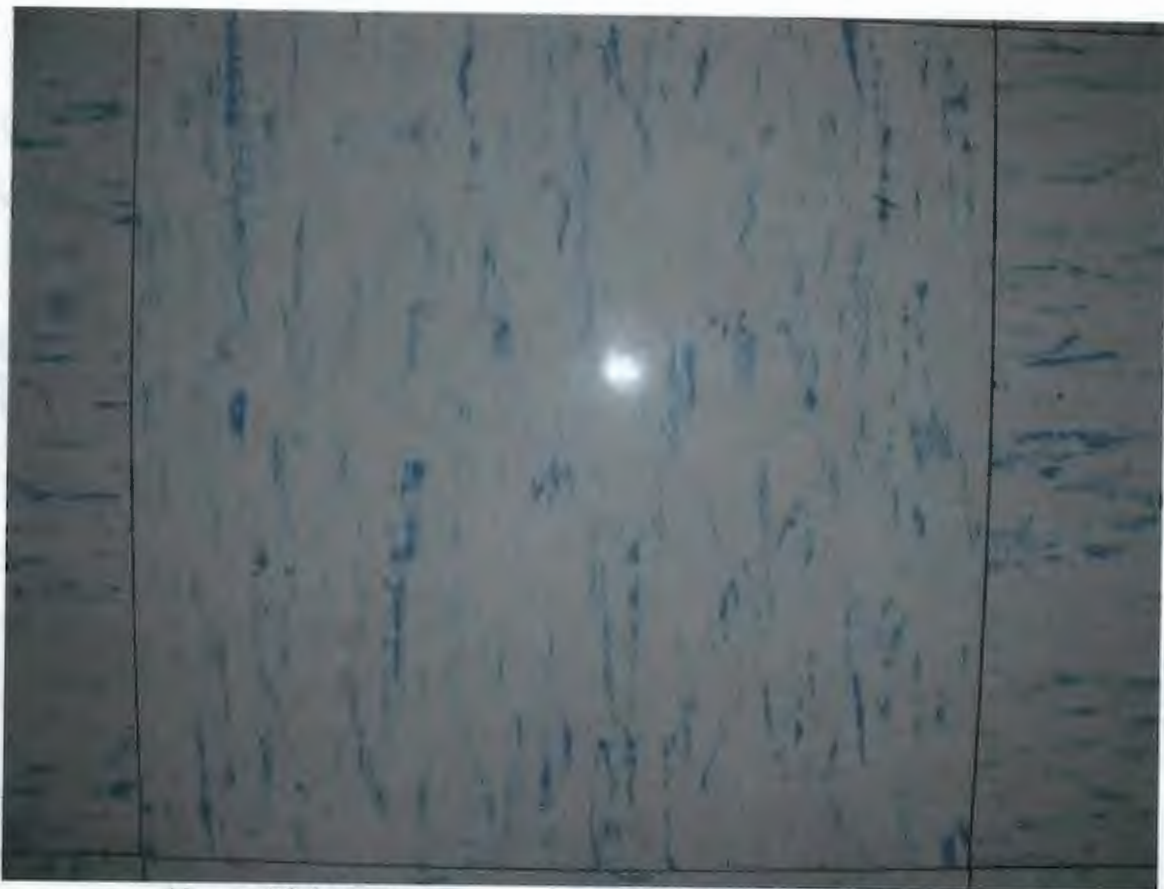
12 x 12 Light Grey Floor Tile with Light Blue Streaks (positive)

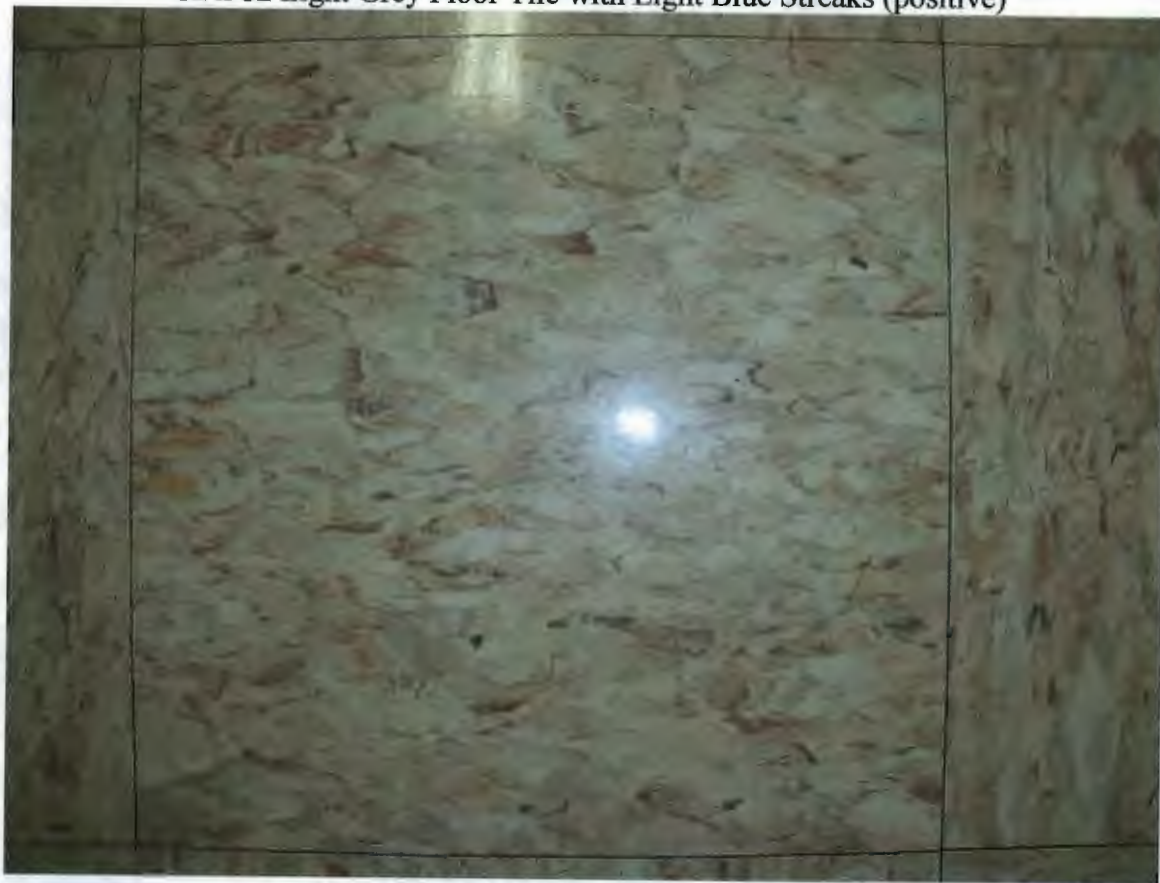
12 x 12 Rust Multi Mottle Tile (negative)

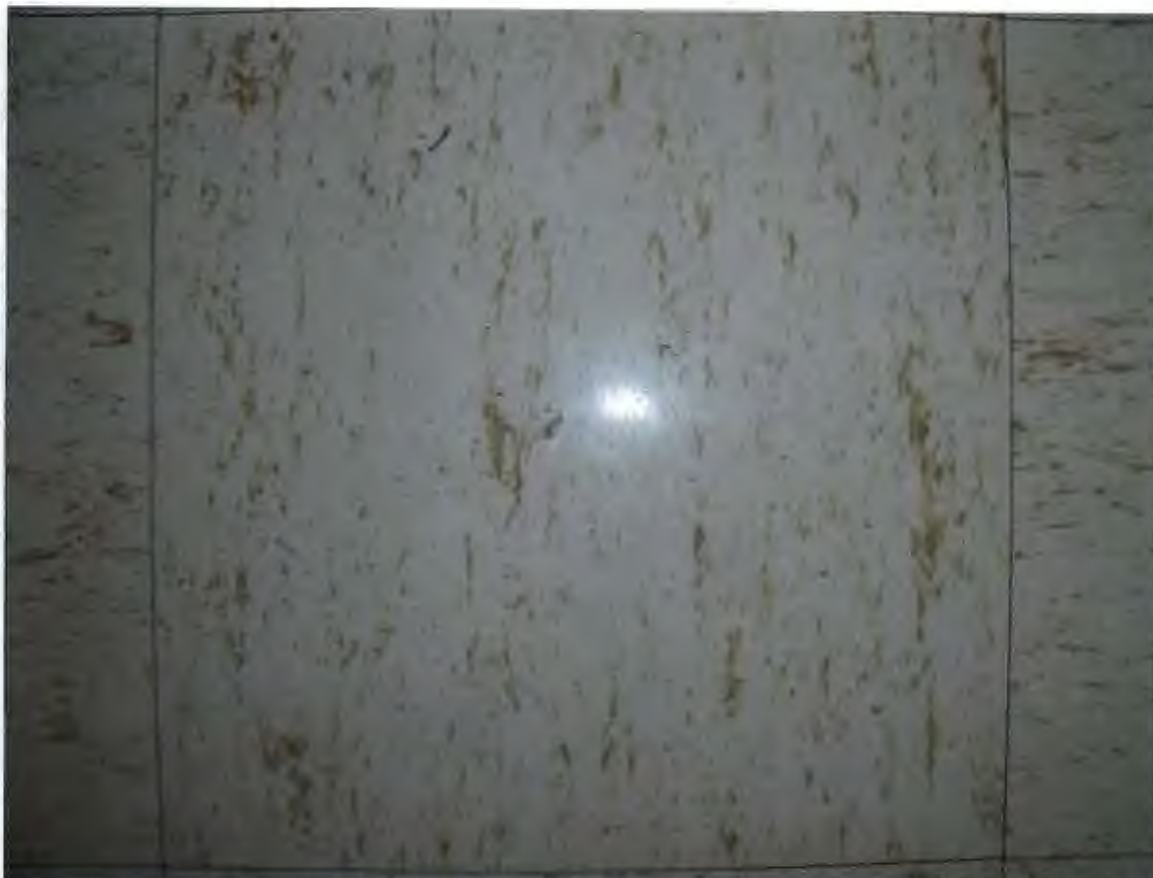
12 x 12 Tile with Brown and Gold Streaks (positive)

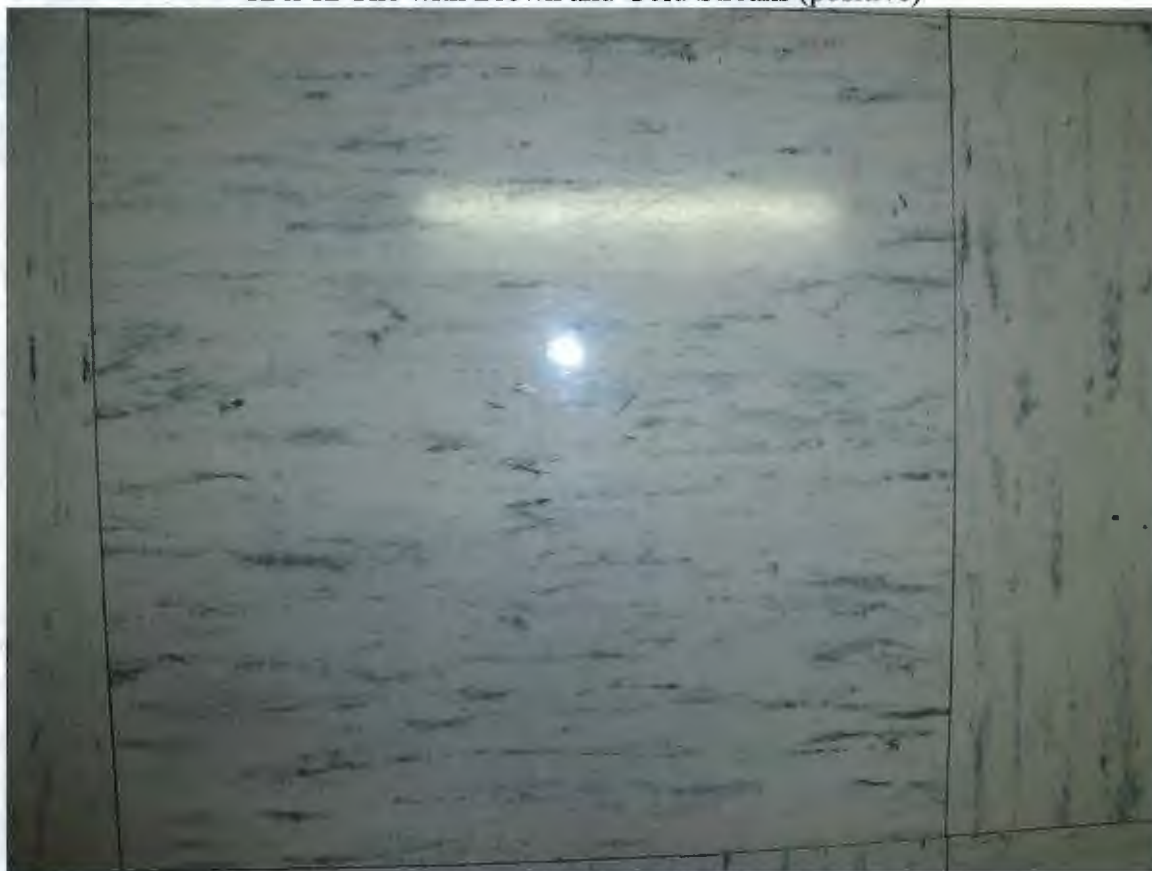
12 x 12 Tile with Green Streaks (positive)

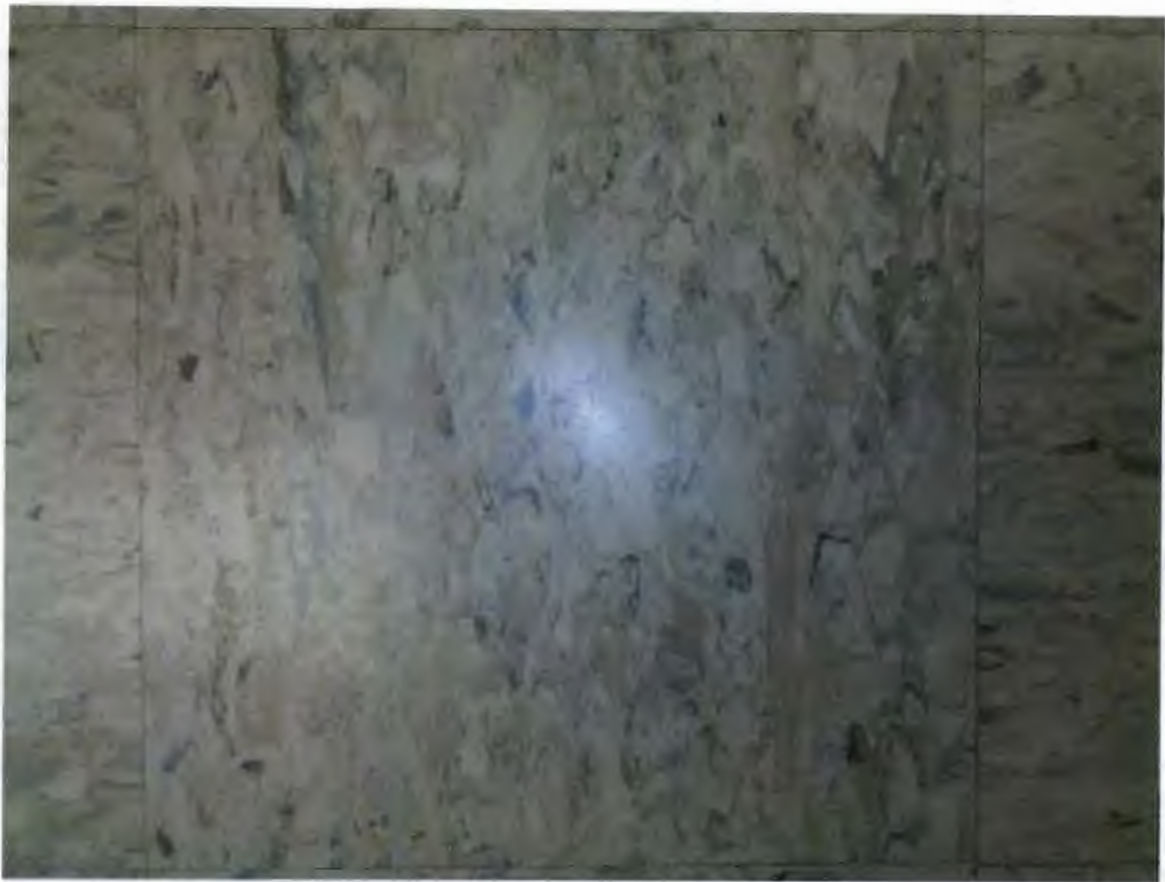
12 x 12 Blue Mottled Tile (positive)

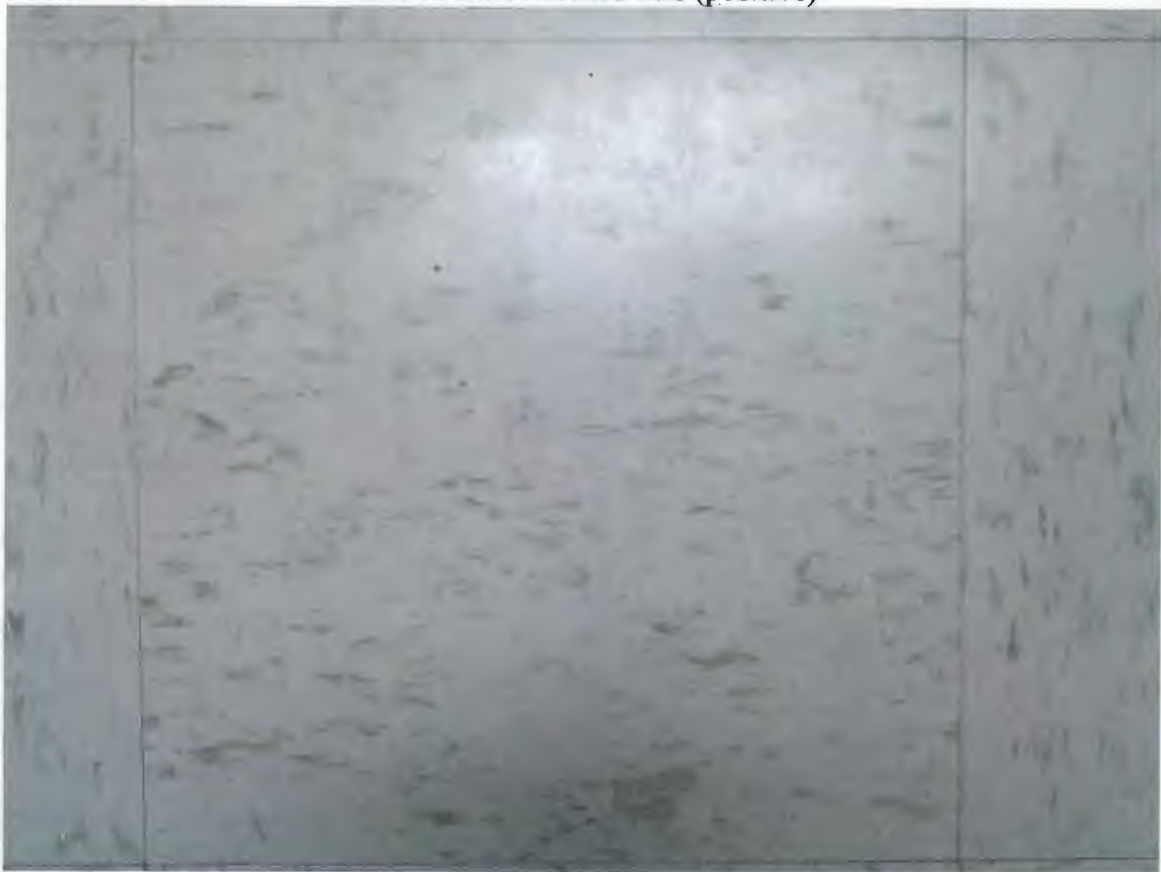
12 x 12 Cream Floor Tile with Olive Streaks (positive)

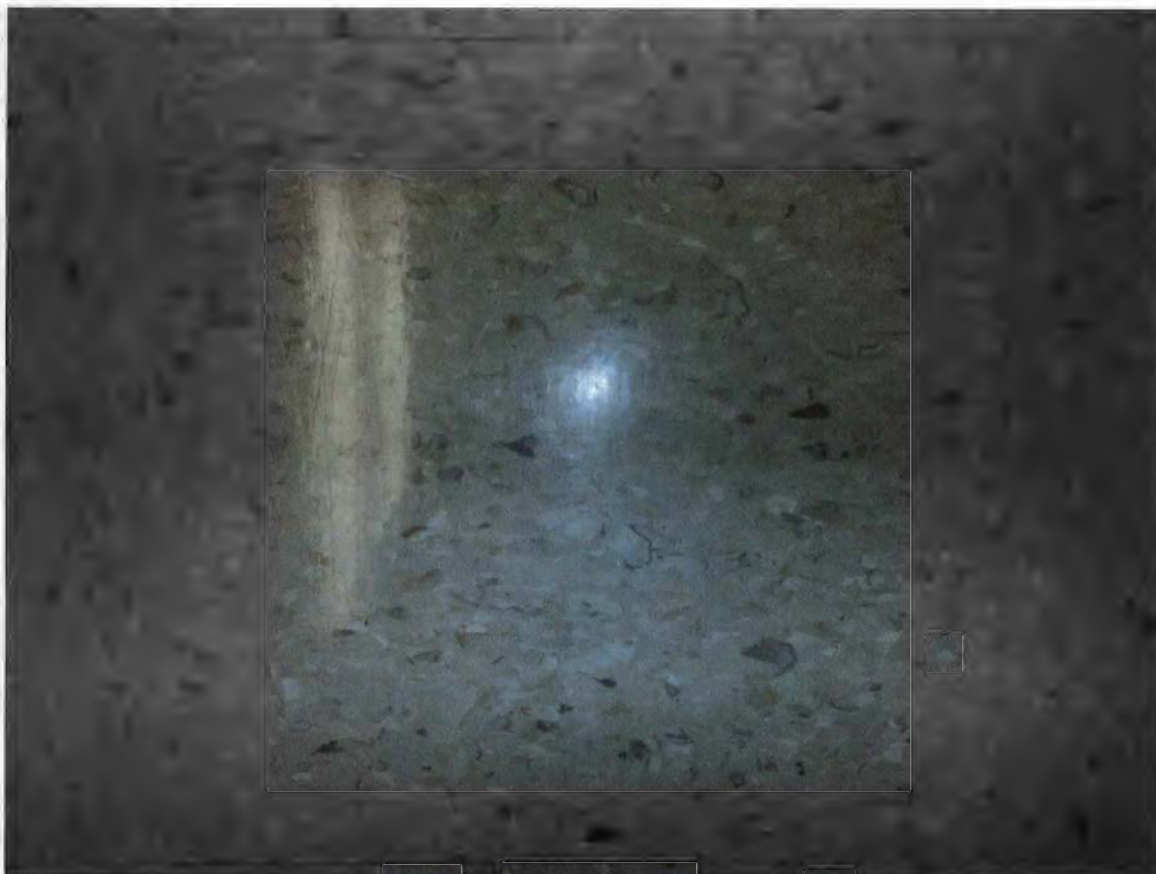
12 x 12 Pebble Style Floor Tile (negative)

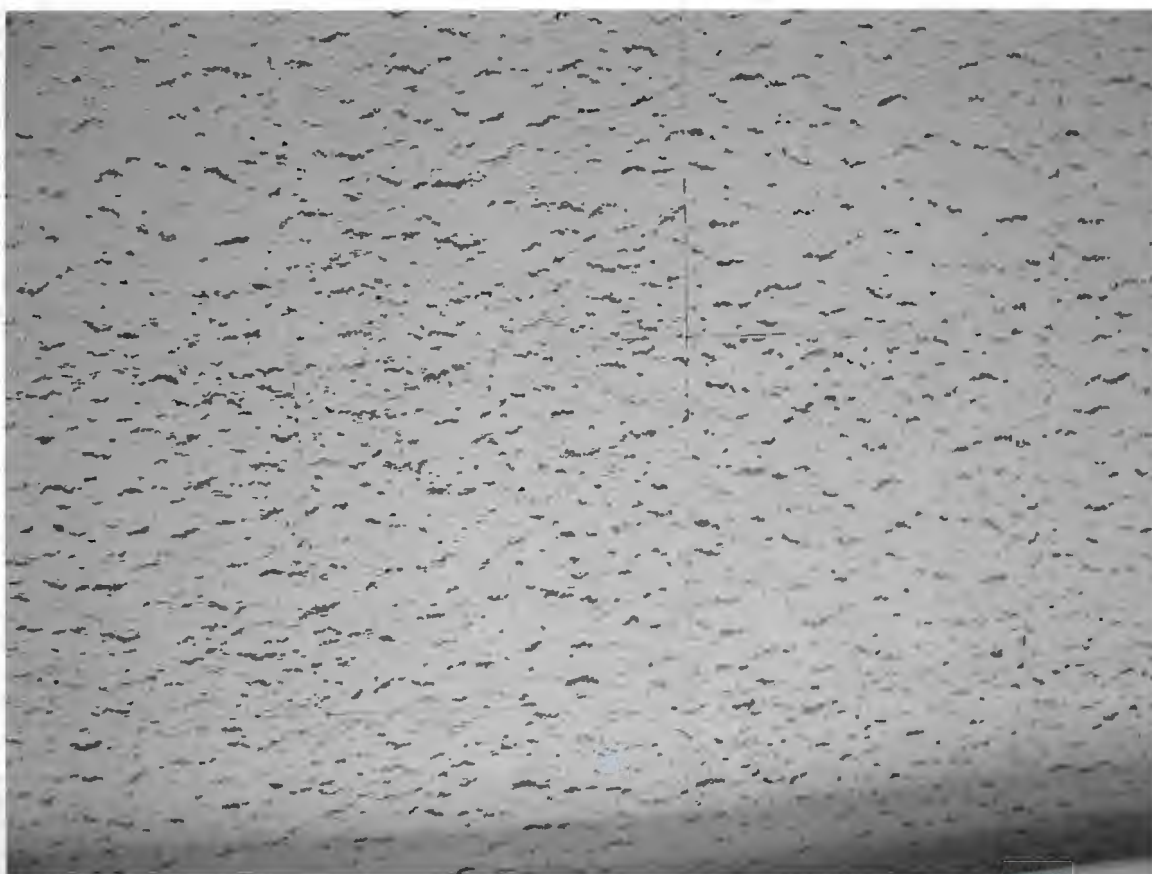
1 x 1 Acoustic Tile (negative)

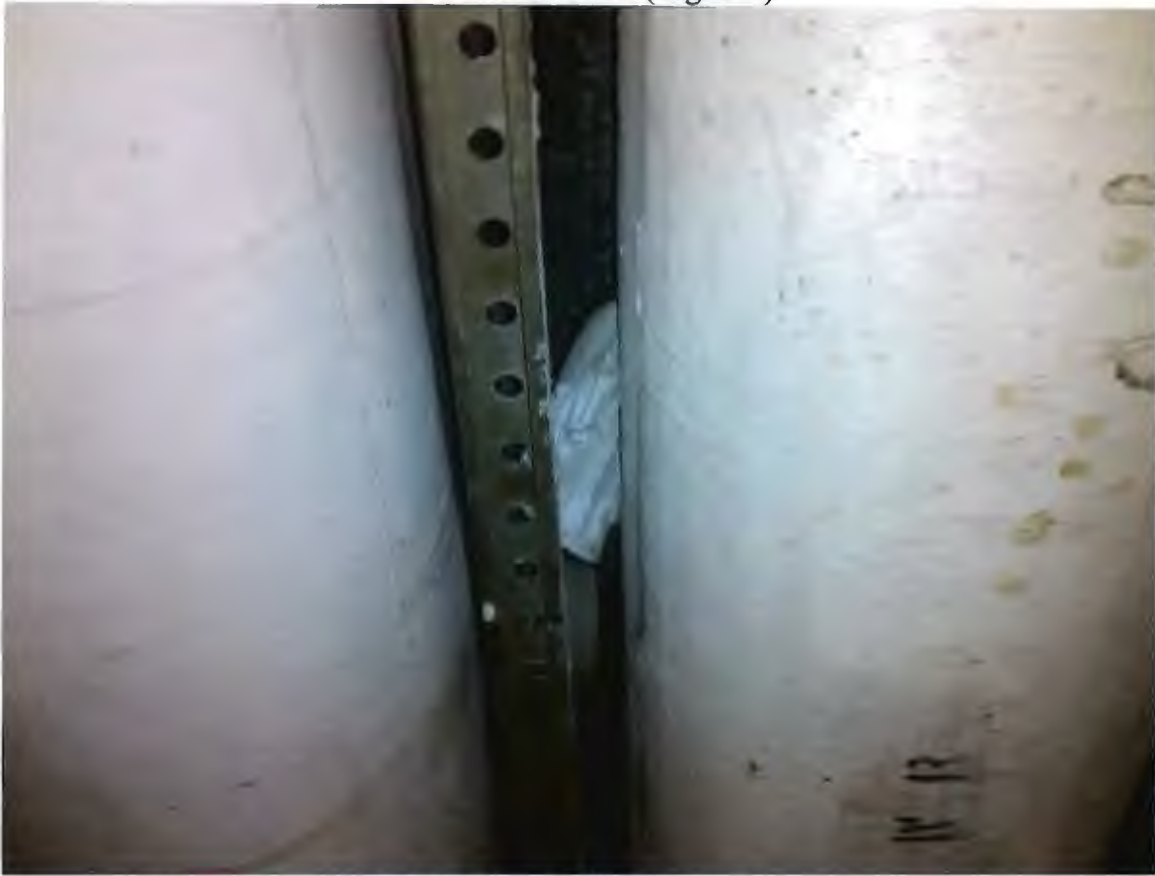
THERMAL SYSTEM INSULATION REMAINING IN PIPE CHASES IS GENERALLY IN POOR CONDITION AND HAS REACHED THE END OF ITS SERVICE LIFE. ASBESTOS CONTAINING PIPE INSULATION AND FITTING INSULATION DEBRIS WAS ALSO NOTED IN THE BOTTOMS OF SEVERAL ACCESSIBLE PIPE CHASES.

Air cell debris above pipes in basement hall

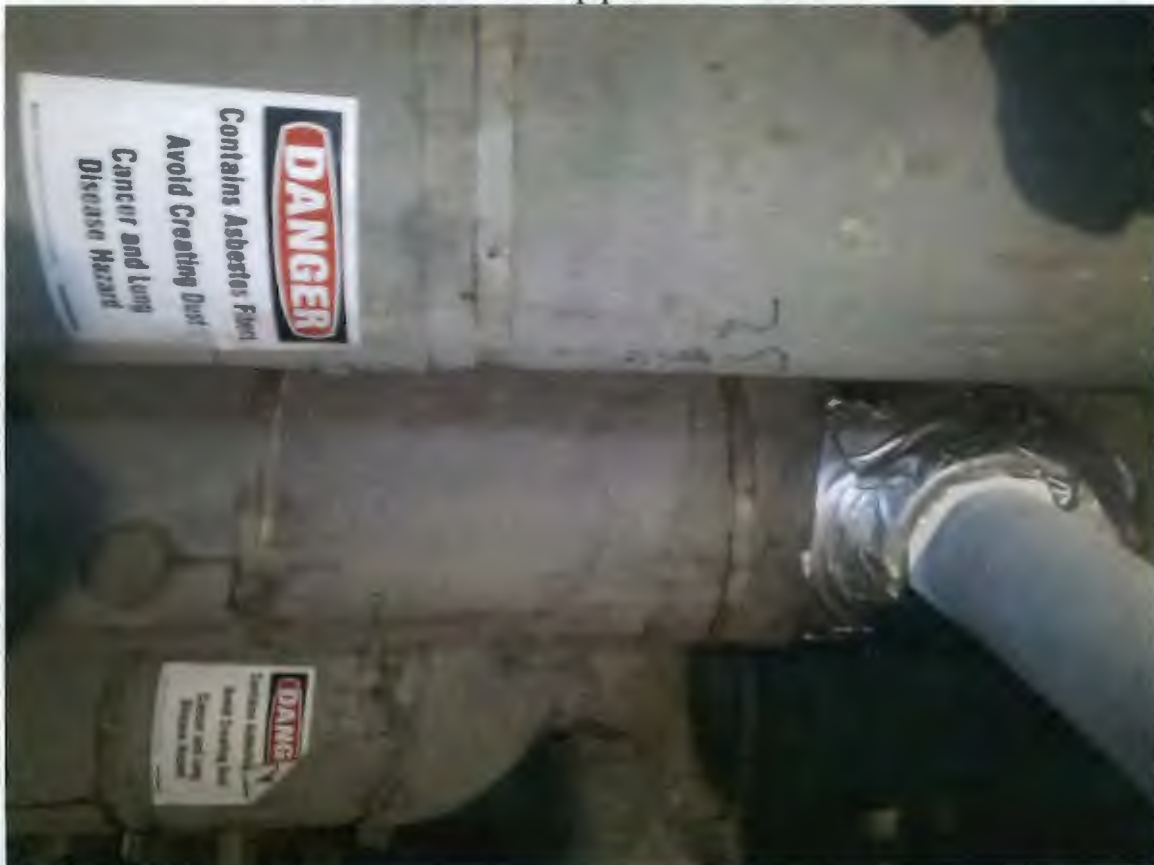
Improperly tied in pipe run in core pipe chase

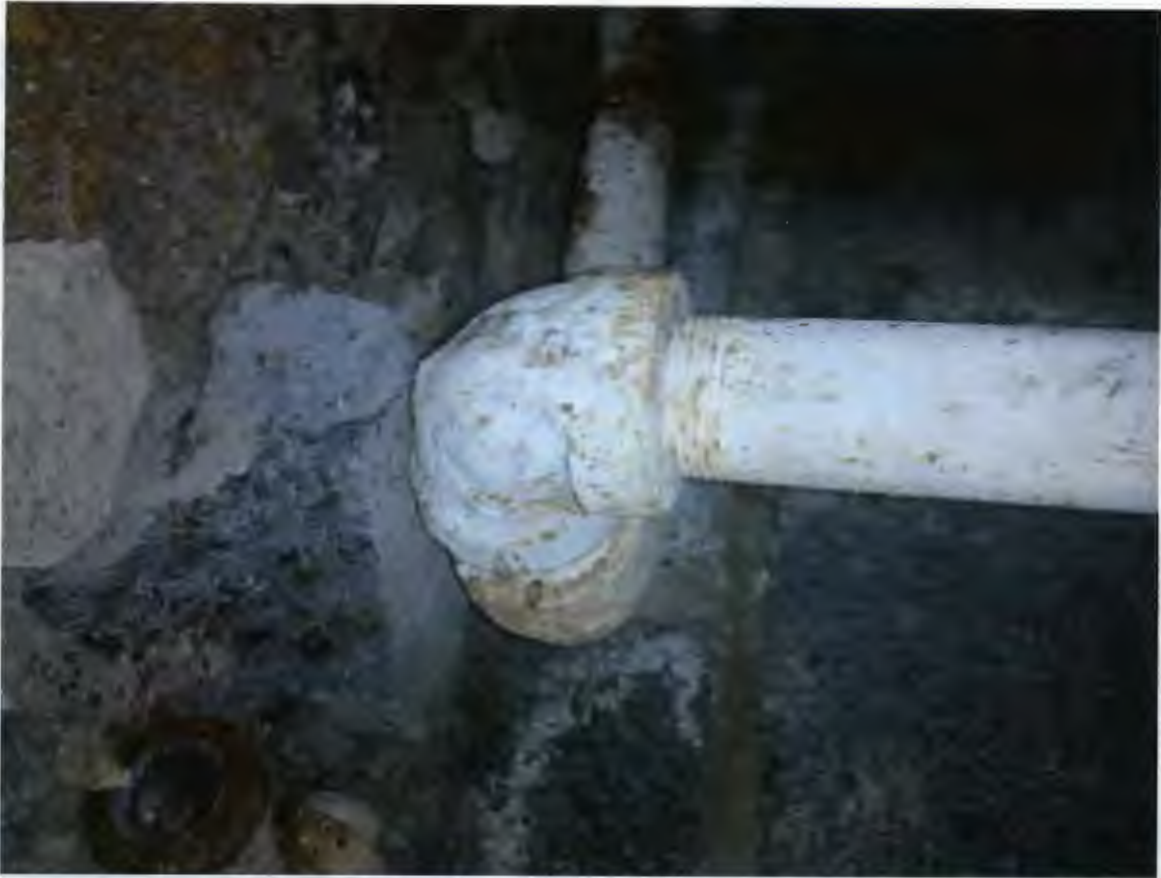
Residual asbestos joint packing on elbow

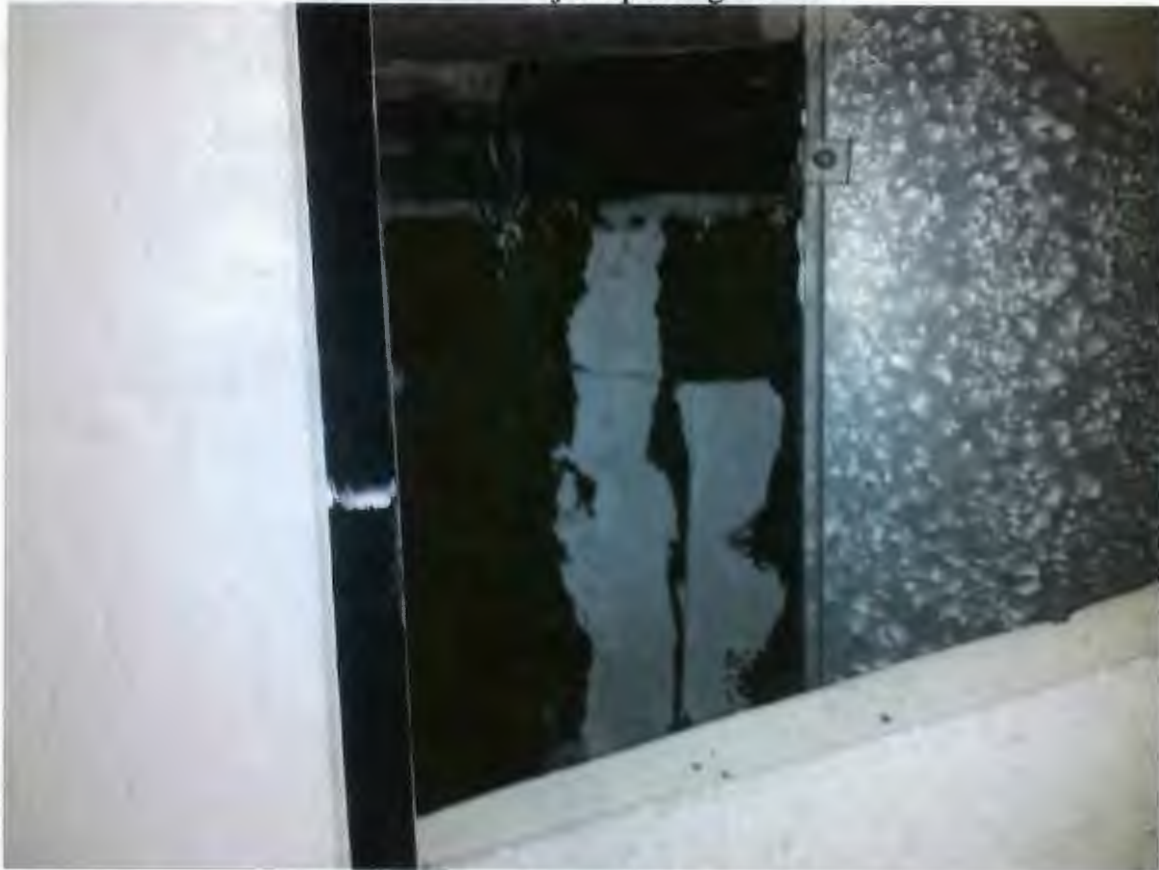
ORIGINAL CORK BOARD INSULATED DUCTWORK REMAINS IN A FEW AREAS OF THE HOSPITAL. THIS DUCTWORK HAS ASBESTOS CONTAINING SEAM CEMENT THAT IS DETERIORATED AND SHOULD BE ABATED IN ALL AREAS IDENTIFIED AS EARLY AS IS PRACTICAL.

Asbestos containing seam patching on cork ductwork

RECOMMENDED IN ALL AREAS THIS MATERIAL REMAINS AS IT IS DAMAGED AND REACHED THE END OF ITS SERVICE LIFE.
