Client: VAMC Providence, Rhode Island
830 Chalkstone Ave
Providence, RI 02908

Report: Fire Barrier Wall - Large Opening
VA 241-15-C-0127
PO 650-C58125

Providence VA Medical Center - Fire Barrier Wall Large Opening (Holes) Report

Providence VA Medical Center - Fire Barrier Wall Large Opening (Joints) Report

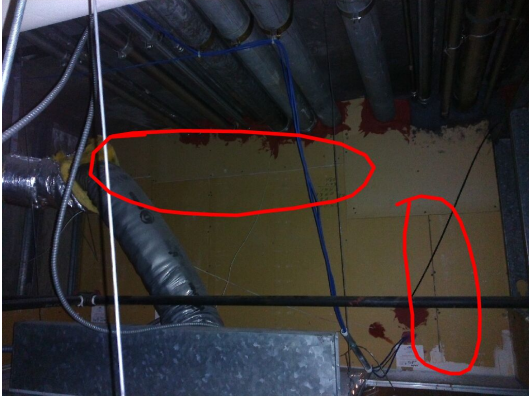
<p>10/27/15 01:36 PM</p>											
10/28/15	268295	116	Spec Pur 21	z-other	Large Opening	Concrete	30min Smoke Barrier	Fiber board is scabbed on wall. Opening behind is undetermined	2	2	1

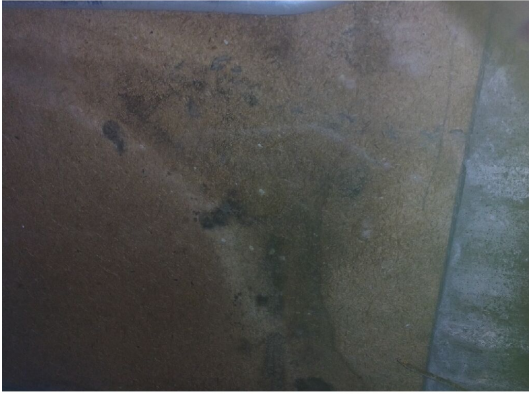
<p>10/28/15 11:35 AM</p>											
10/28/15	268331	116	D009	Large wall with penetrations	Large Opening	Gypsum	1HR Fire Barrier	Stucco needs to be demoed and replaced completely with rated gypsum board.	1	1	1

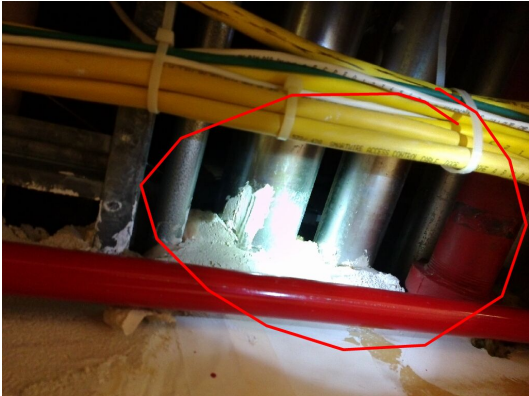
<p>10/28/15 09:59 AM</p>											
10/28/15	268297	117	017A	Large wall with penetrations	Large Opening	Concrete	30min Smoke Barrier	Conduit penetrations can not be accessd due to mechanicals. Bottom side of penetraitons are caulked by others.	1	1	1

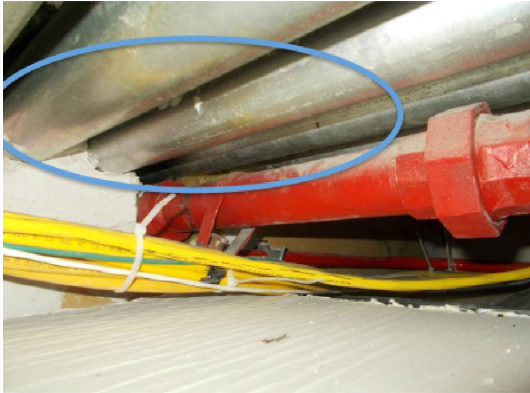
<p>11/6/15 12:32 PM</p>											
4/5/16	307401	218	Mechanical Room D009	z-other	Large Opening	Gypsum	1HR Fire Barrier	12x12 Scab Patch	1	1	1

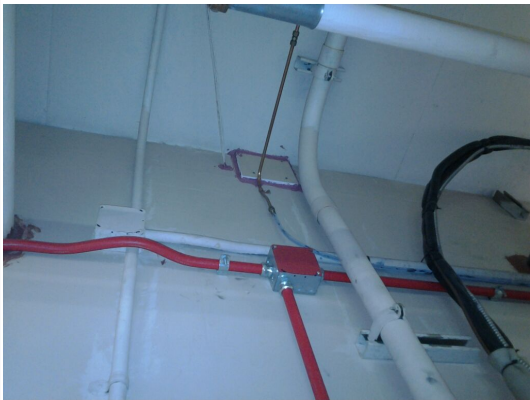
<p>4/5/16 02:45 PM</p>											
4/5/16	307402	219	Mechanical Room D009	z-other	Large Opening	Gypsum	1HR Fire Barrier	1ftx2.5ft Scab Patch	3	1	1

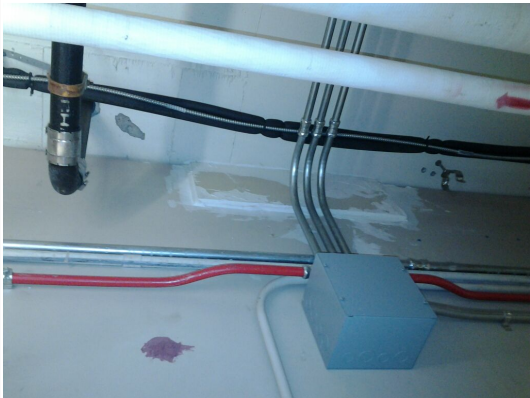
<p>4/5/16 02:47 PM</p>											
4/5/16	307403	220	Mechanical Room D009	z-other	Large Opening	Gypsum	1HR Fire Barrier	12 x 12 Scab Patch	1	1	1

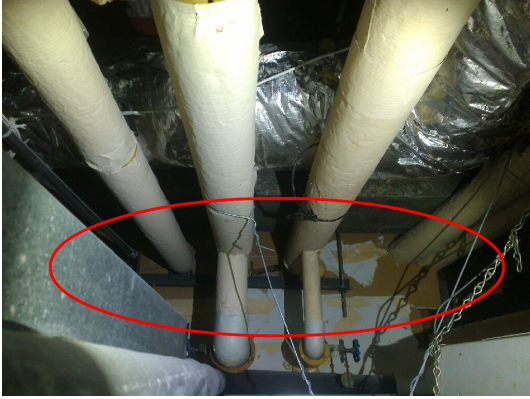
<p>11/2/15 11:50 AM</p>											
11/10/15	271531	182	Corridor D1212-1	Large wall with penetrations	Large Opening	Concrete	30min Smoke Barrier	Room on PFI 1-200. Metal Sleeve with penetration Room D1212-1	2	3	2

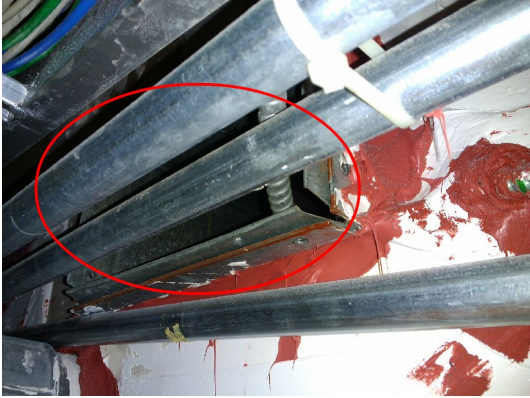
<p>11/10/15 10:22 AM</p>											
11/10/15	271532	183	Electrical Closet 157B	Sections of walls missing	Large Opening	Gypsum	2HR Fire Barrier	Multiple holes	2	2	1

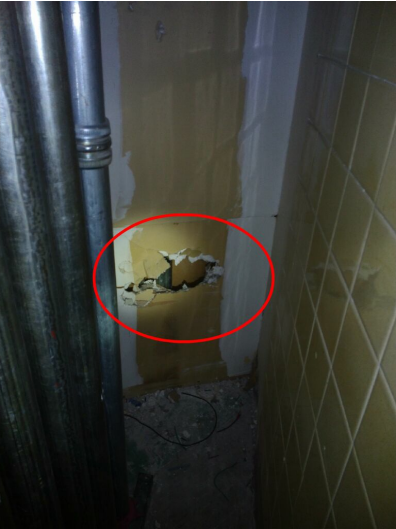
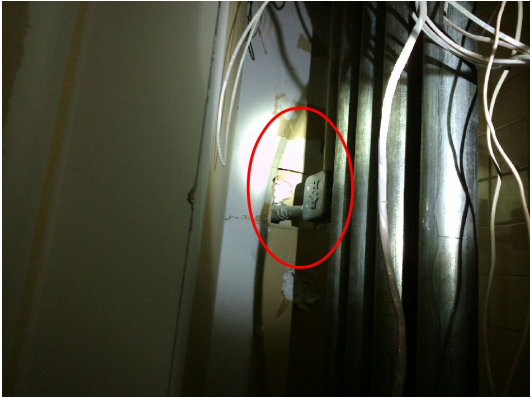
<p>11/10/15 10:36 AM 11/10/15 10:37 AM</p>											
4/6/16	307880	235	Oxygen Storage D144	Sections of walls missing	Large Opening	Concrete	1HR Fire Barrier	Section of block missing with penetration 16in x 16in	2	2	1

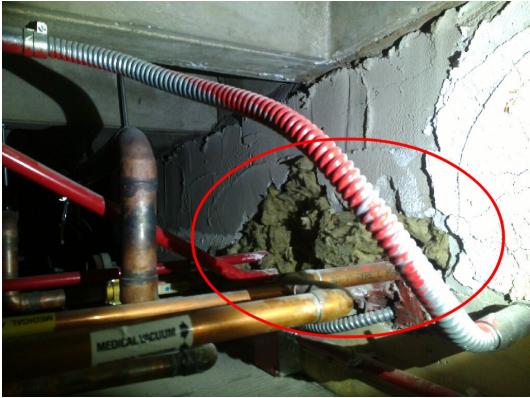
<p>10/30/15 09:38 AM</p>											
10/30/15	268619	149	Radiologist Office 259	Large wall with penetrations	Large Opening	Gypsum	1HR Fire Barrier	Pipe needs protected on both sides.	1	1	2

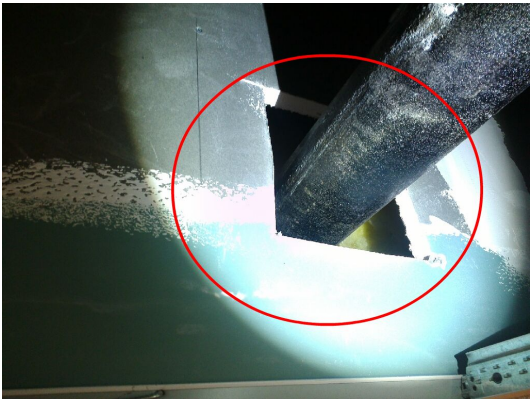
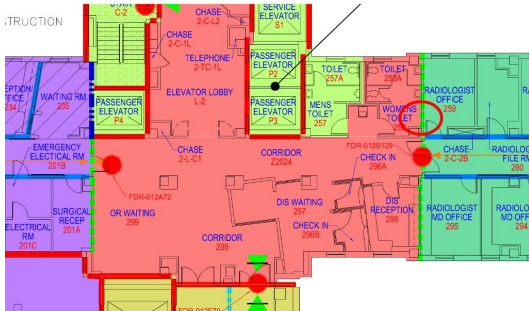
<p>10/30/15 10:39 AM 10/30/15 10:40 AM</p>											
10/30/15	268624	150	Soiled and O2 215B	Sections of walls missing	Large Opening	Gypsum	1HR Fire Barrier	Gypsum board missing. Metal studs in place. Top of wall joint will be needed also.	3	3	1

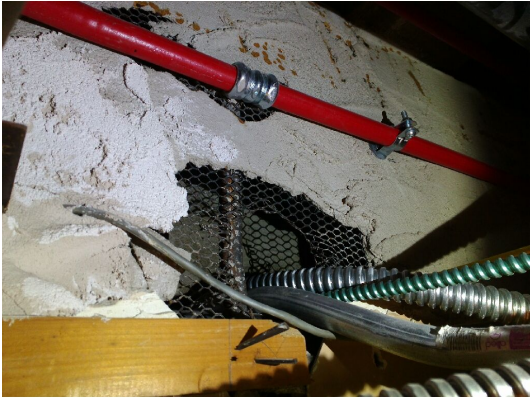
</div> <p>10/30/15 02:09 PM</p>											
11/12/15	271617	209	Office 366	Sections of walls missing	Large Opening	Concrete	2HR Fire Barrier	Room on PFI. No PFI # listed. Part of 3-B renovation. General Contractor responsibility. Room 366	1	1	1

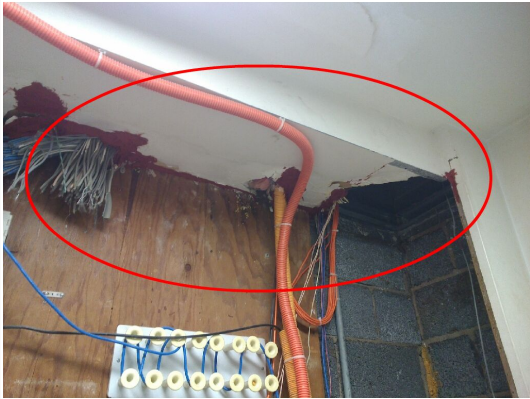
</div> <p>11/10/15 01:01 PM</p>											
11/10/15	271548	195	Corridor 5CA-2	Sections of walls missing	Large Opening	Gypsum	2HR Fire Barrier	Room on PF11-093. Cable Tray needs protected. Room 5CA-2	2	1	2

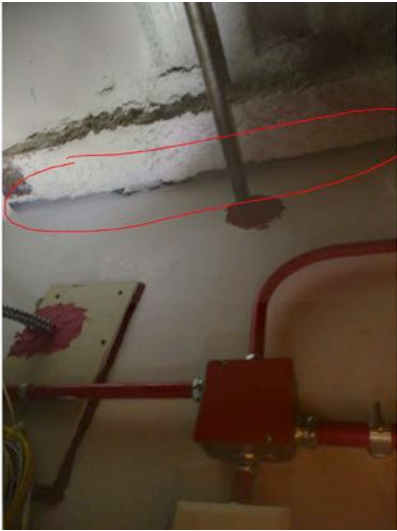
<p>10/27/15 11:50 AM</p>										
10/27/15	266837	107	D009	Joints	Large Opening	Gypsum	1HR Fire Barrier	Joint is tight.	.5	100

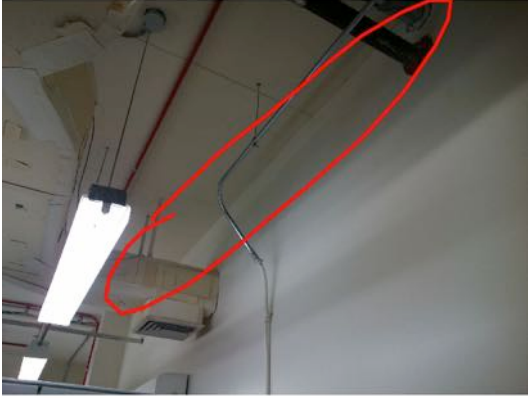
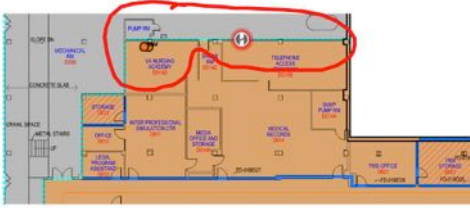
</div> <div> <div>10/27/15 01:02 PM</div> <div>10/27/15 01:05 PM</div> </div>										
10/27/15	266845	115	D012	Joints	Large Opening	Gypsum	1HR Fire Barrier	Head of wall and wall to wall joint needs to be protected.	.5	13
<div>

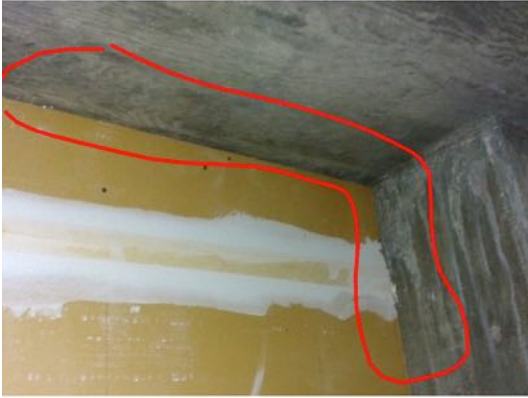
</div> <div>10/27/15 02:15 PM</div>										
10/28/15	268303	121	Stair S01	Joints	Large Opening	Gypsum	2HR Fire Barrier	Head of wall joint needs protected	.5	20
<div>

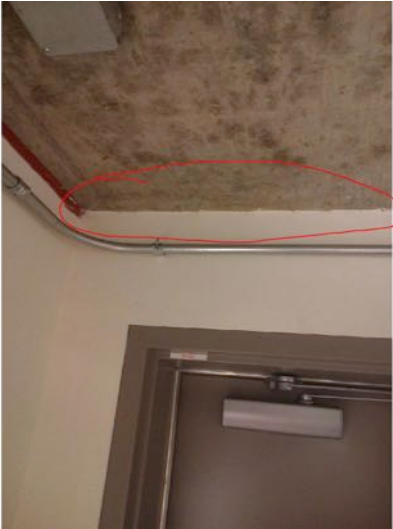
</div> <div>10/28/15 02:15 PM</div>										
11/16/15	272253	210	D009	Joints	Large Opening	Concrete	1HR Fire Barrier	Room on PFI. No PFI # listed. No access due to mechanicals. Room D009	.5	1
