EOC-Providence VAMC Fire and Fire/Smoke Damper Failed Report

EOC-PROVIDENCE VAMC FIRE AND FIRE/SMOKE DAMPER FAILED REPORT

03/04/15

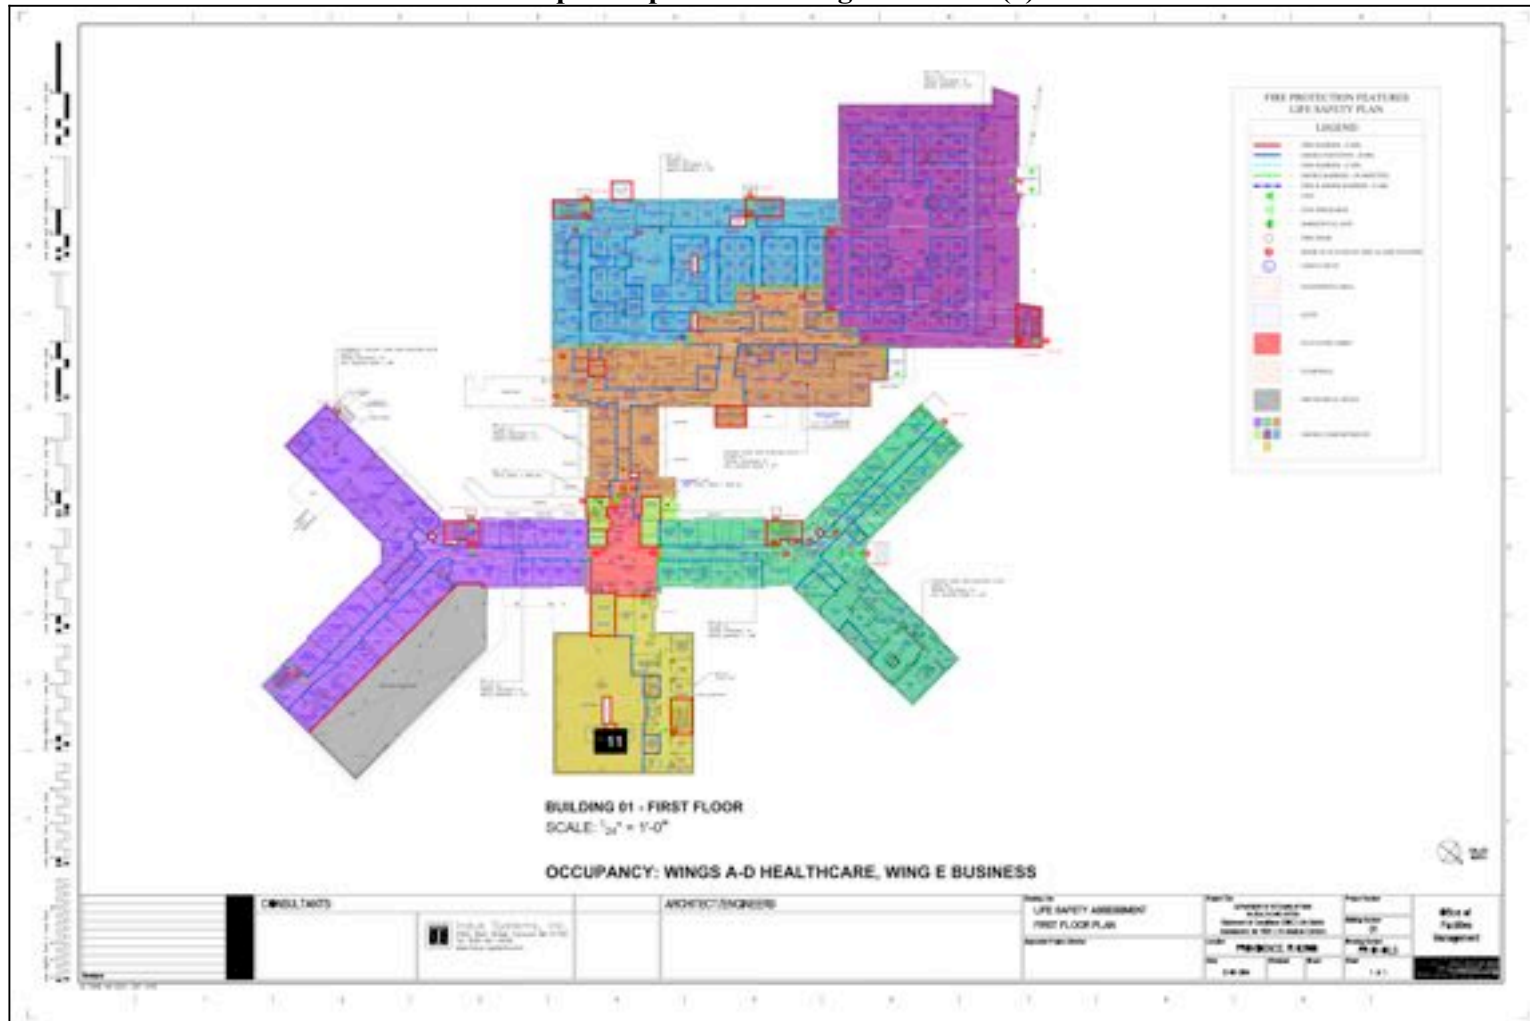
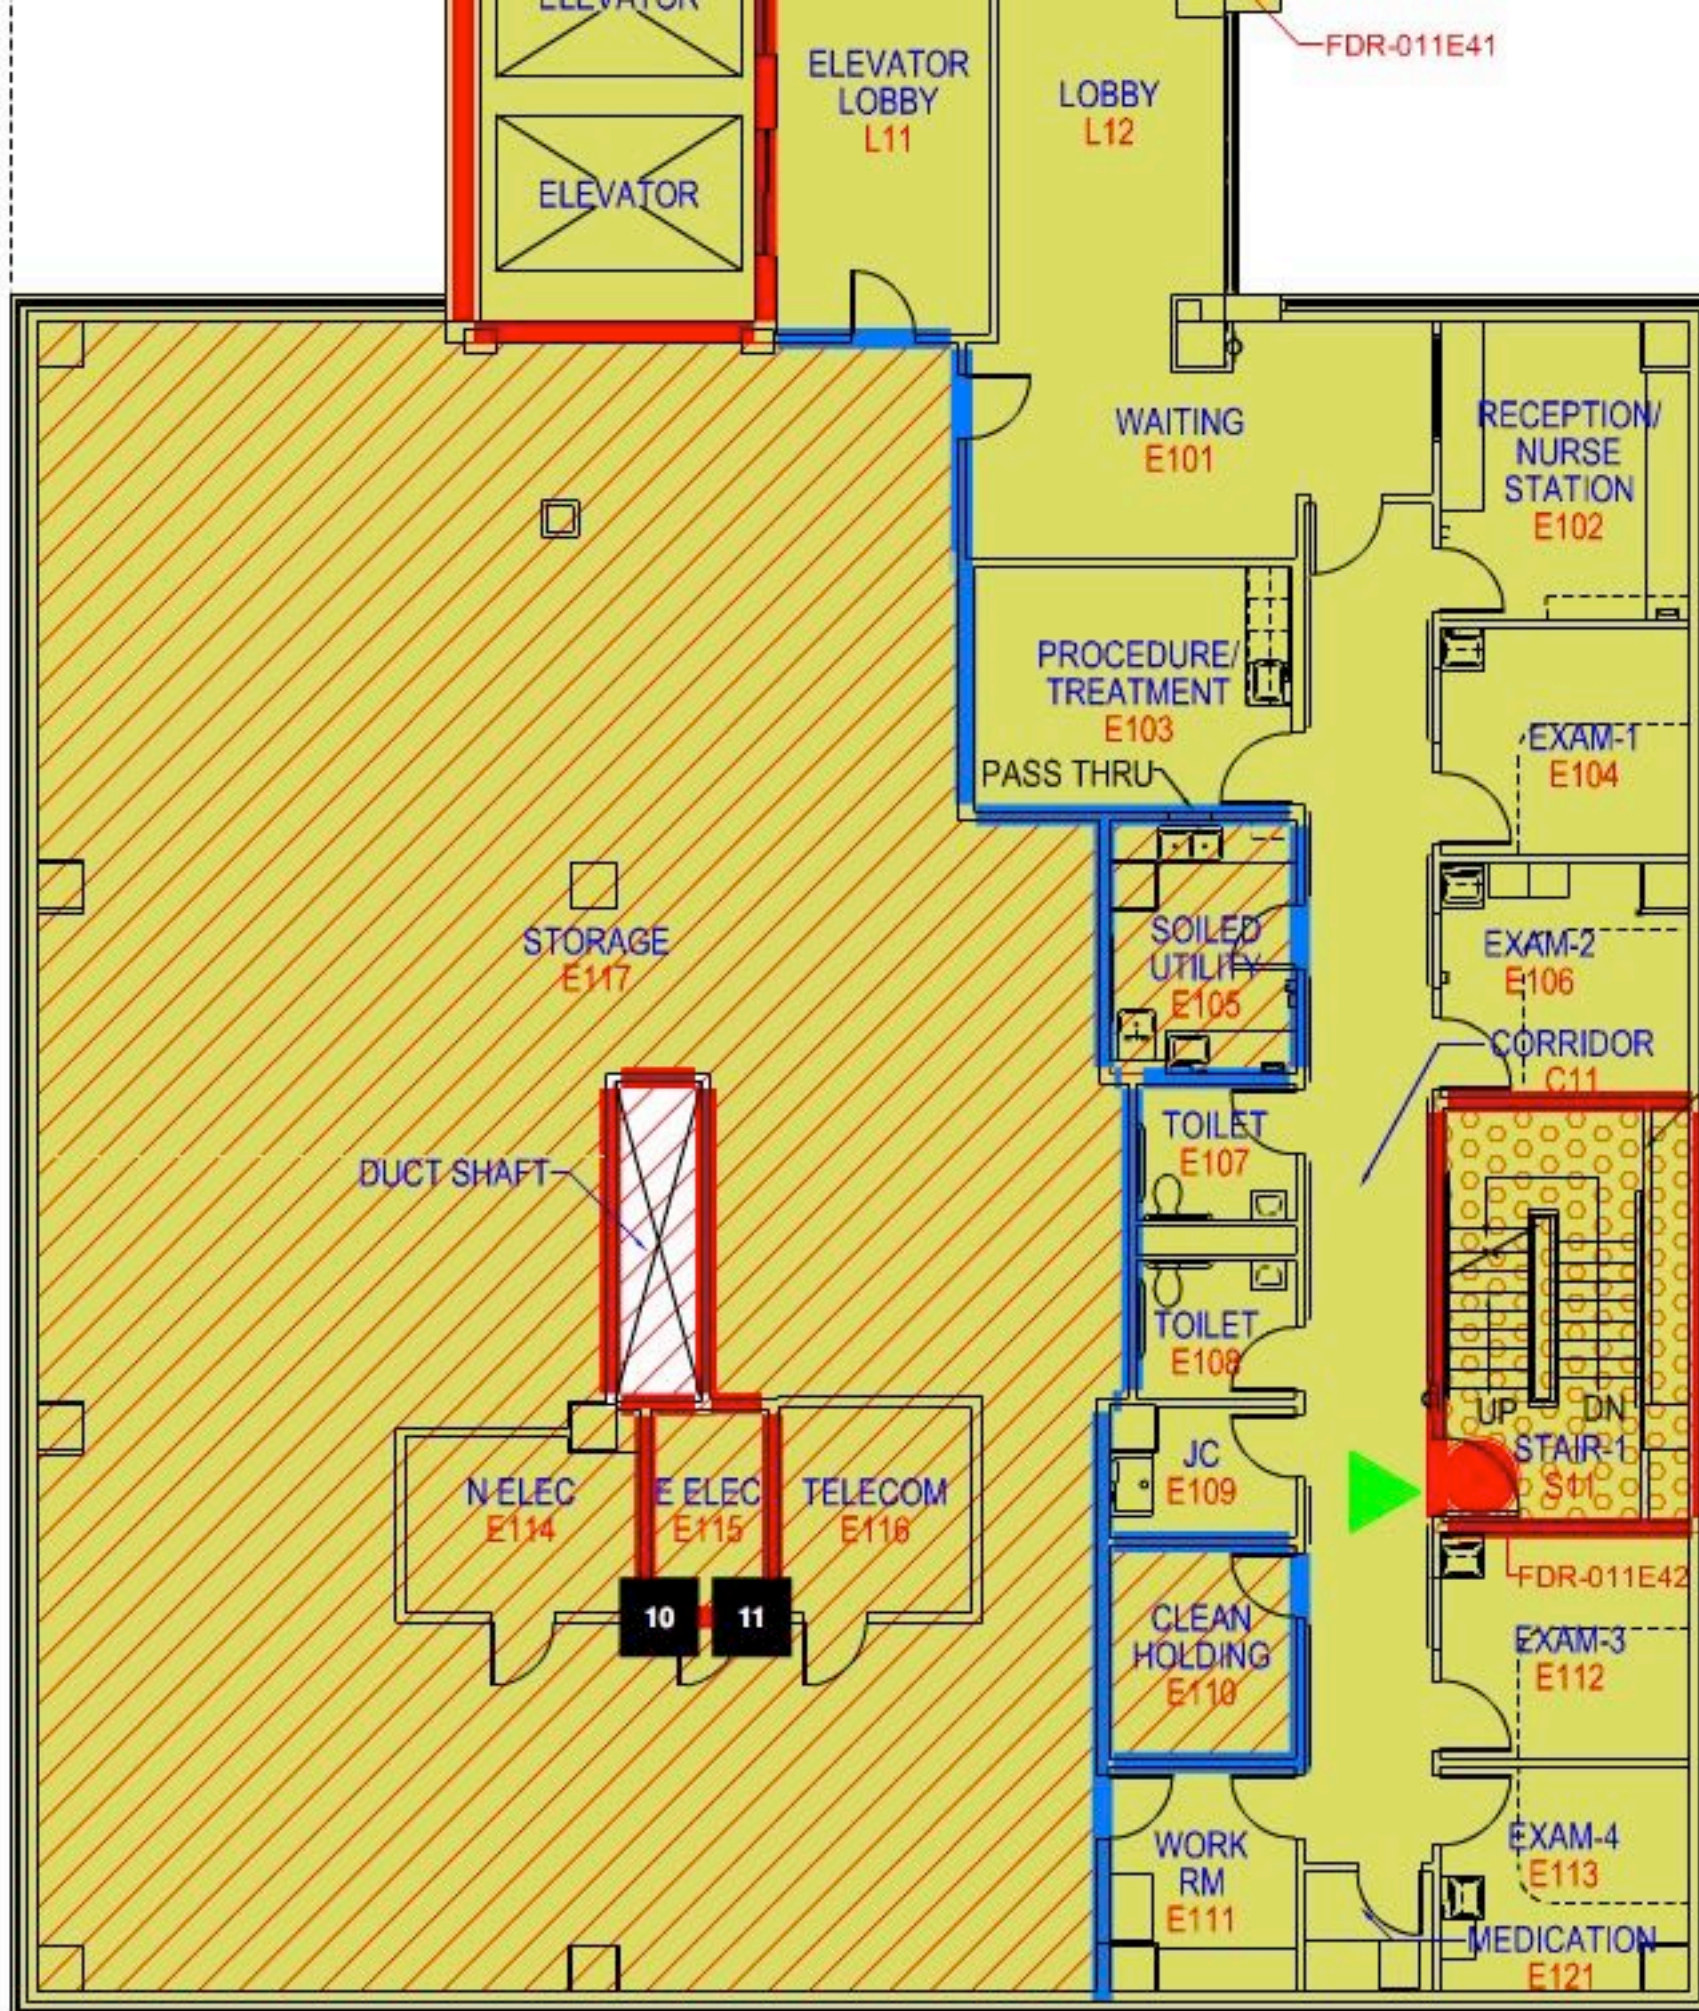
Damper Inspection E-Wing / 1st Floor (1) -

Date Created	Damper Asset Tag #	Damper Size	EOC ID #	Punch #	Type	Floor	Comments
1/13/15	FD-011E165	8x6	211811	10	Fire Damper	1st Floor	Damper Failed. Damper was damaged during installation and was not installed in the plane of the barrier. Reference: NFPA 80 2013 Section 19.2.1.1.1 A damper installed in a fire resistance-rated assembly shall be located (in its sleeve) within the plane of the fire resistance-rated assembly, unless listed otherwise and installed in accordance with the manufacturer's installation instructions and the listing.
  <p>1/13/15 11:15 AM</p>

Date Created	Damper Asset Tag #	Damper Size	EOC ID #	Punch #	Type	Floor	Comments
1/13/15	FD-011E164	6x6	211812	11	Fire Damper	1st Floor	Damper Failed. Damper was damaged during installation and was not installed in the plane of the barrier. Reference: NFPA 80 2013 Section 19.2.1.1.1 A damper installed in a fire resistance-rated assembly shall be located (in its sleeve) within the plane of the fire resistance-rated assembly, unless listed otherwise and installed in accordance with the manufacturer's installation instructions and the listing.
  <p>1/13/15 11:19 AM</p>

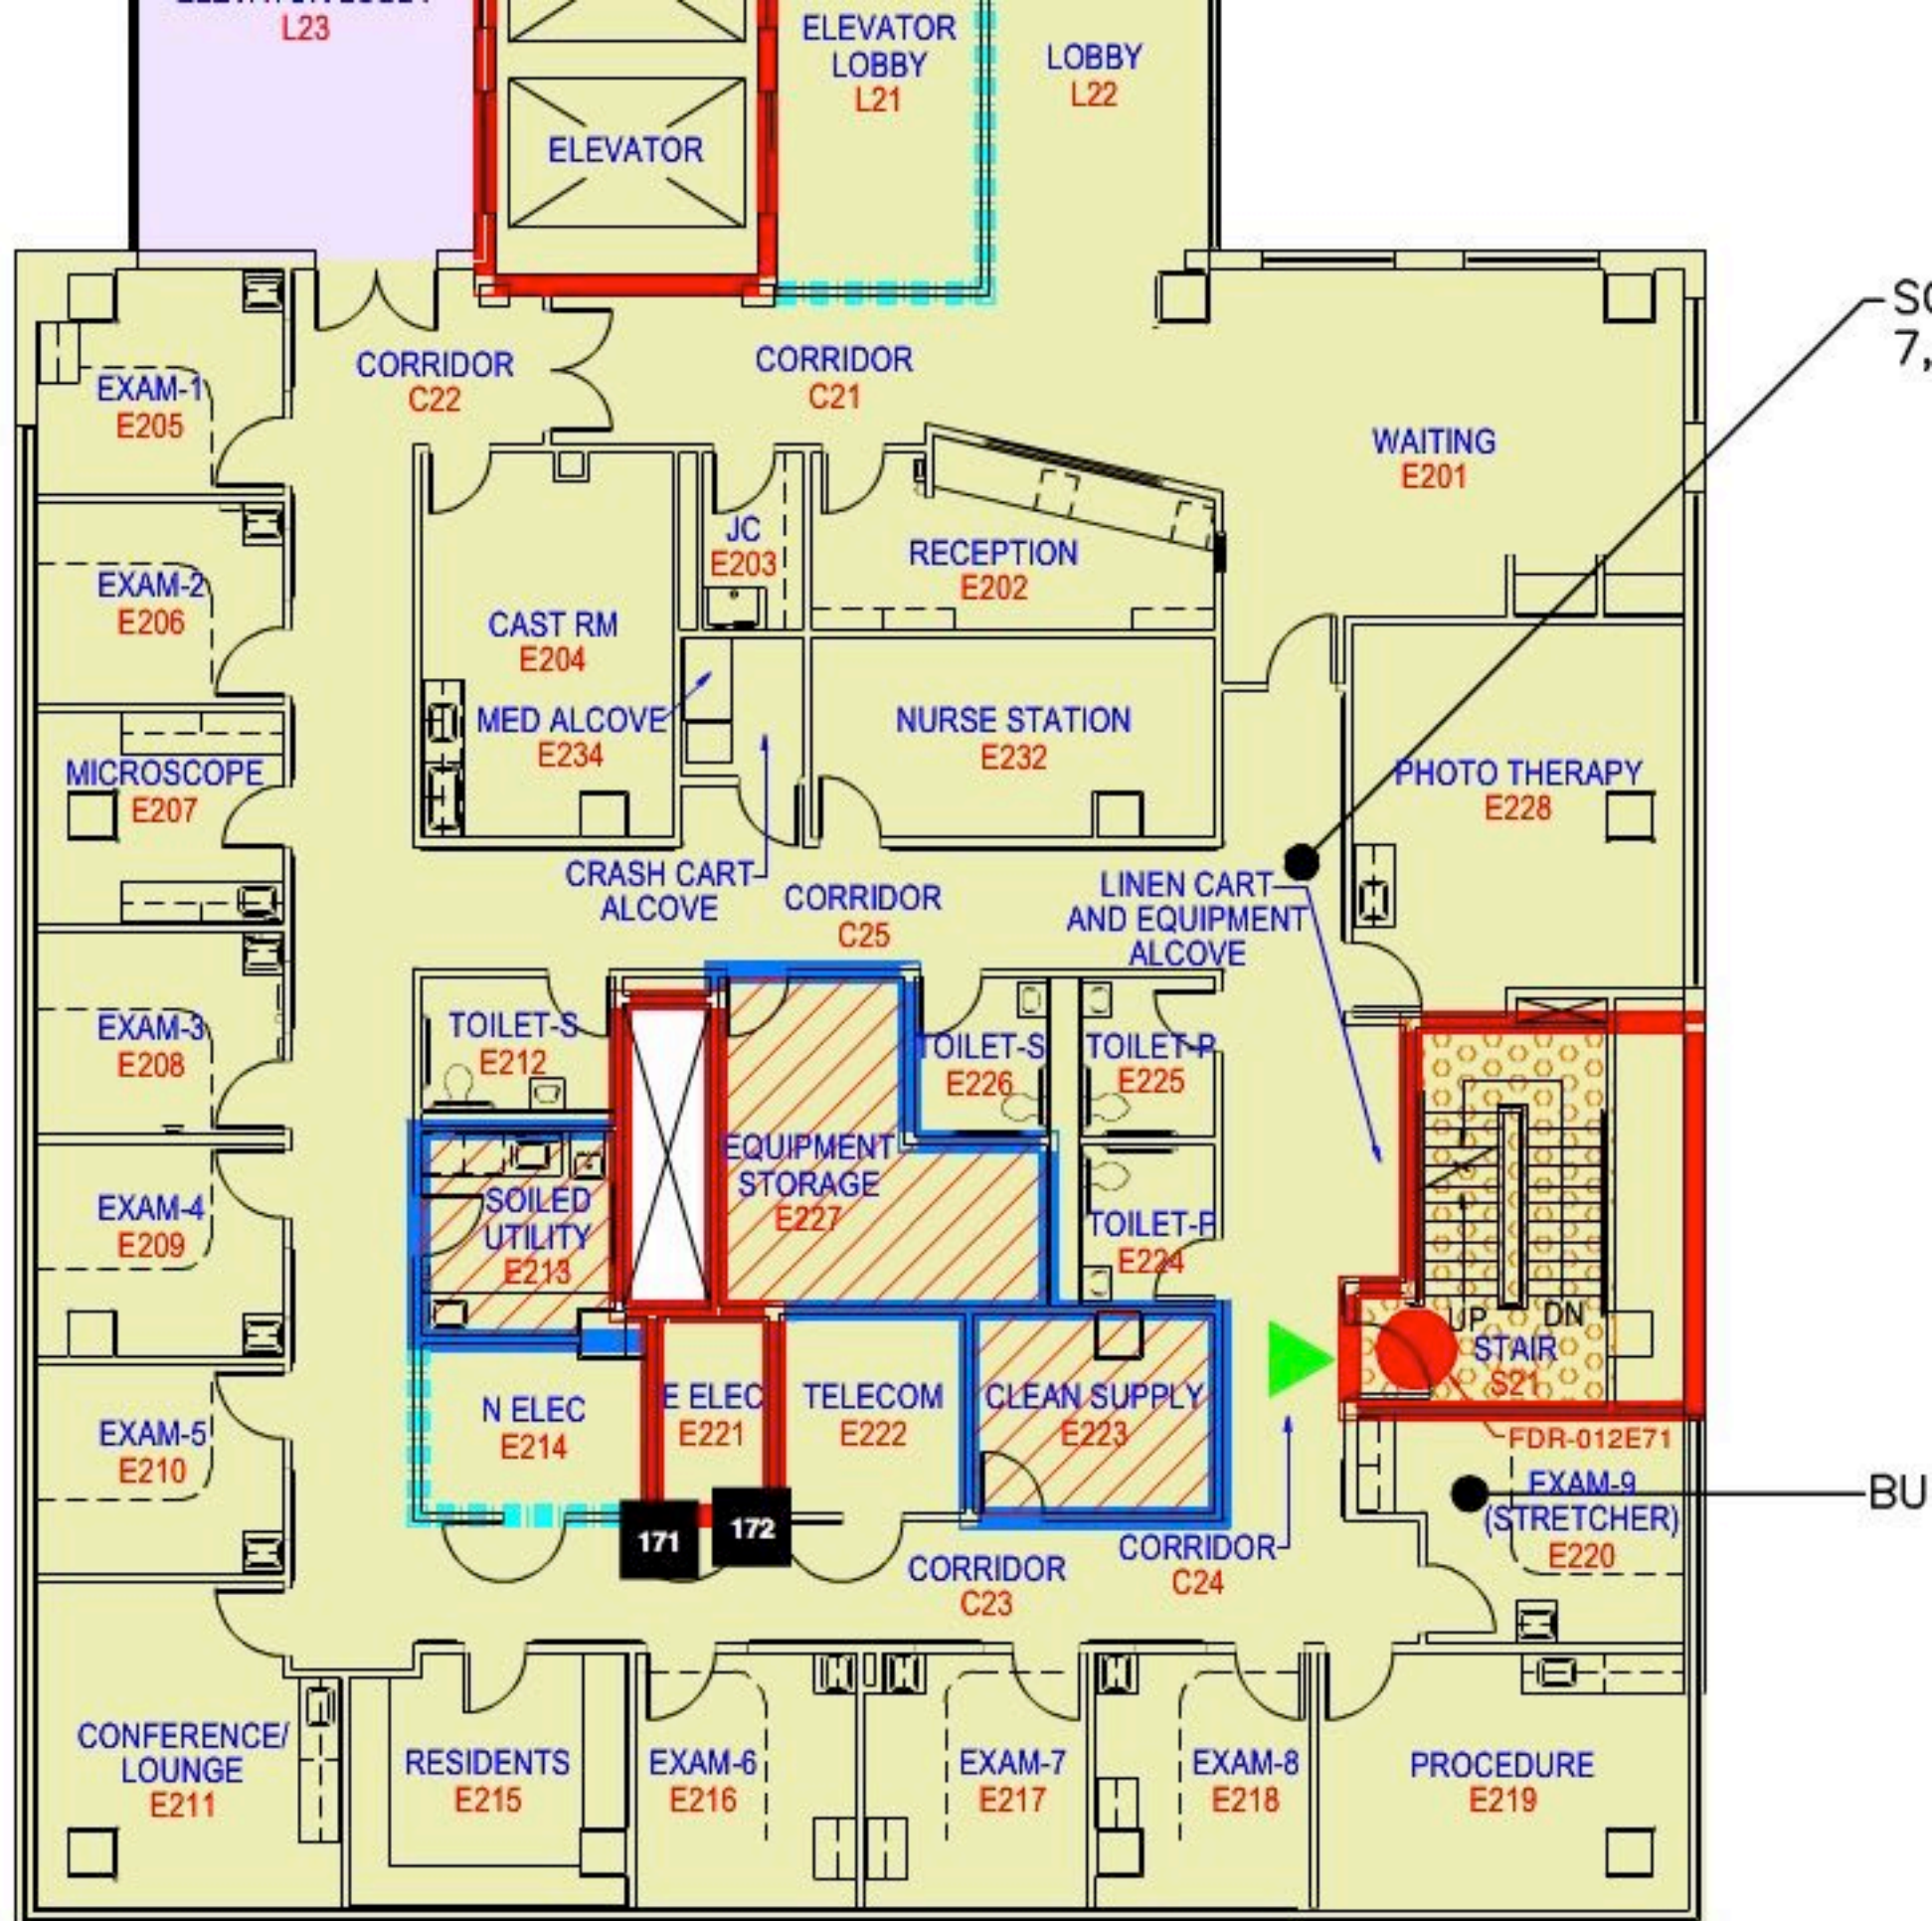
Date Created	Damper Asset Tag #	Damper Size	EOC ID #	Punch #	Type	Floor	Comments
1/13/15	FD-012E167	8x6	211813	171	Fire Damper	2nd Floor	Damper Failed. Damper was damaged during installation and was not installed in the plane of the barrier. Reference: NFPA 80 2013 Section 19.2.1.1.1 A damper installed in a fire resistance-rated assembly shall be located (in its sleeve) within the plane of the fire resistance-rated assembly, unless listed otherwise and installed in accordance with the manufacturer's installation instructions and the listing.
  <p>1/13/15 11:33 AM</p>

Date Created	Damper Asset Tag #	Damper Size	EOC ID #	Punch #	Type	Floor	Comments
1/13/15	FD-012E166	6x6	211814	172	Fire Damper	2nd Floor	Damper Failed. Damper was damaged during installation and was not installed in the plane of the barrier. Reference: NFPA 80 2013 Section 19.2.1.1.1 A damper installed in a fire resistance-rated assembly shall be located (in its sleeve) within the plane of the fire resistance-rated assembly, unless listed otherwise and installed in accordance with the manufacturer's installation instructions and the listing.

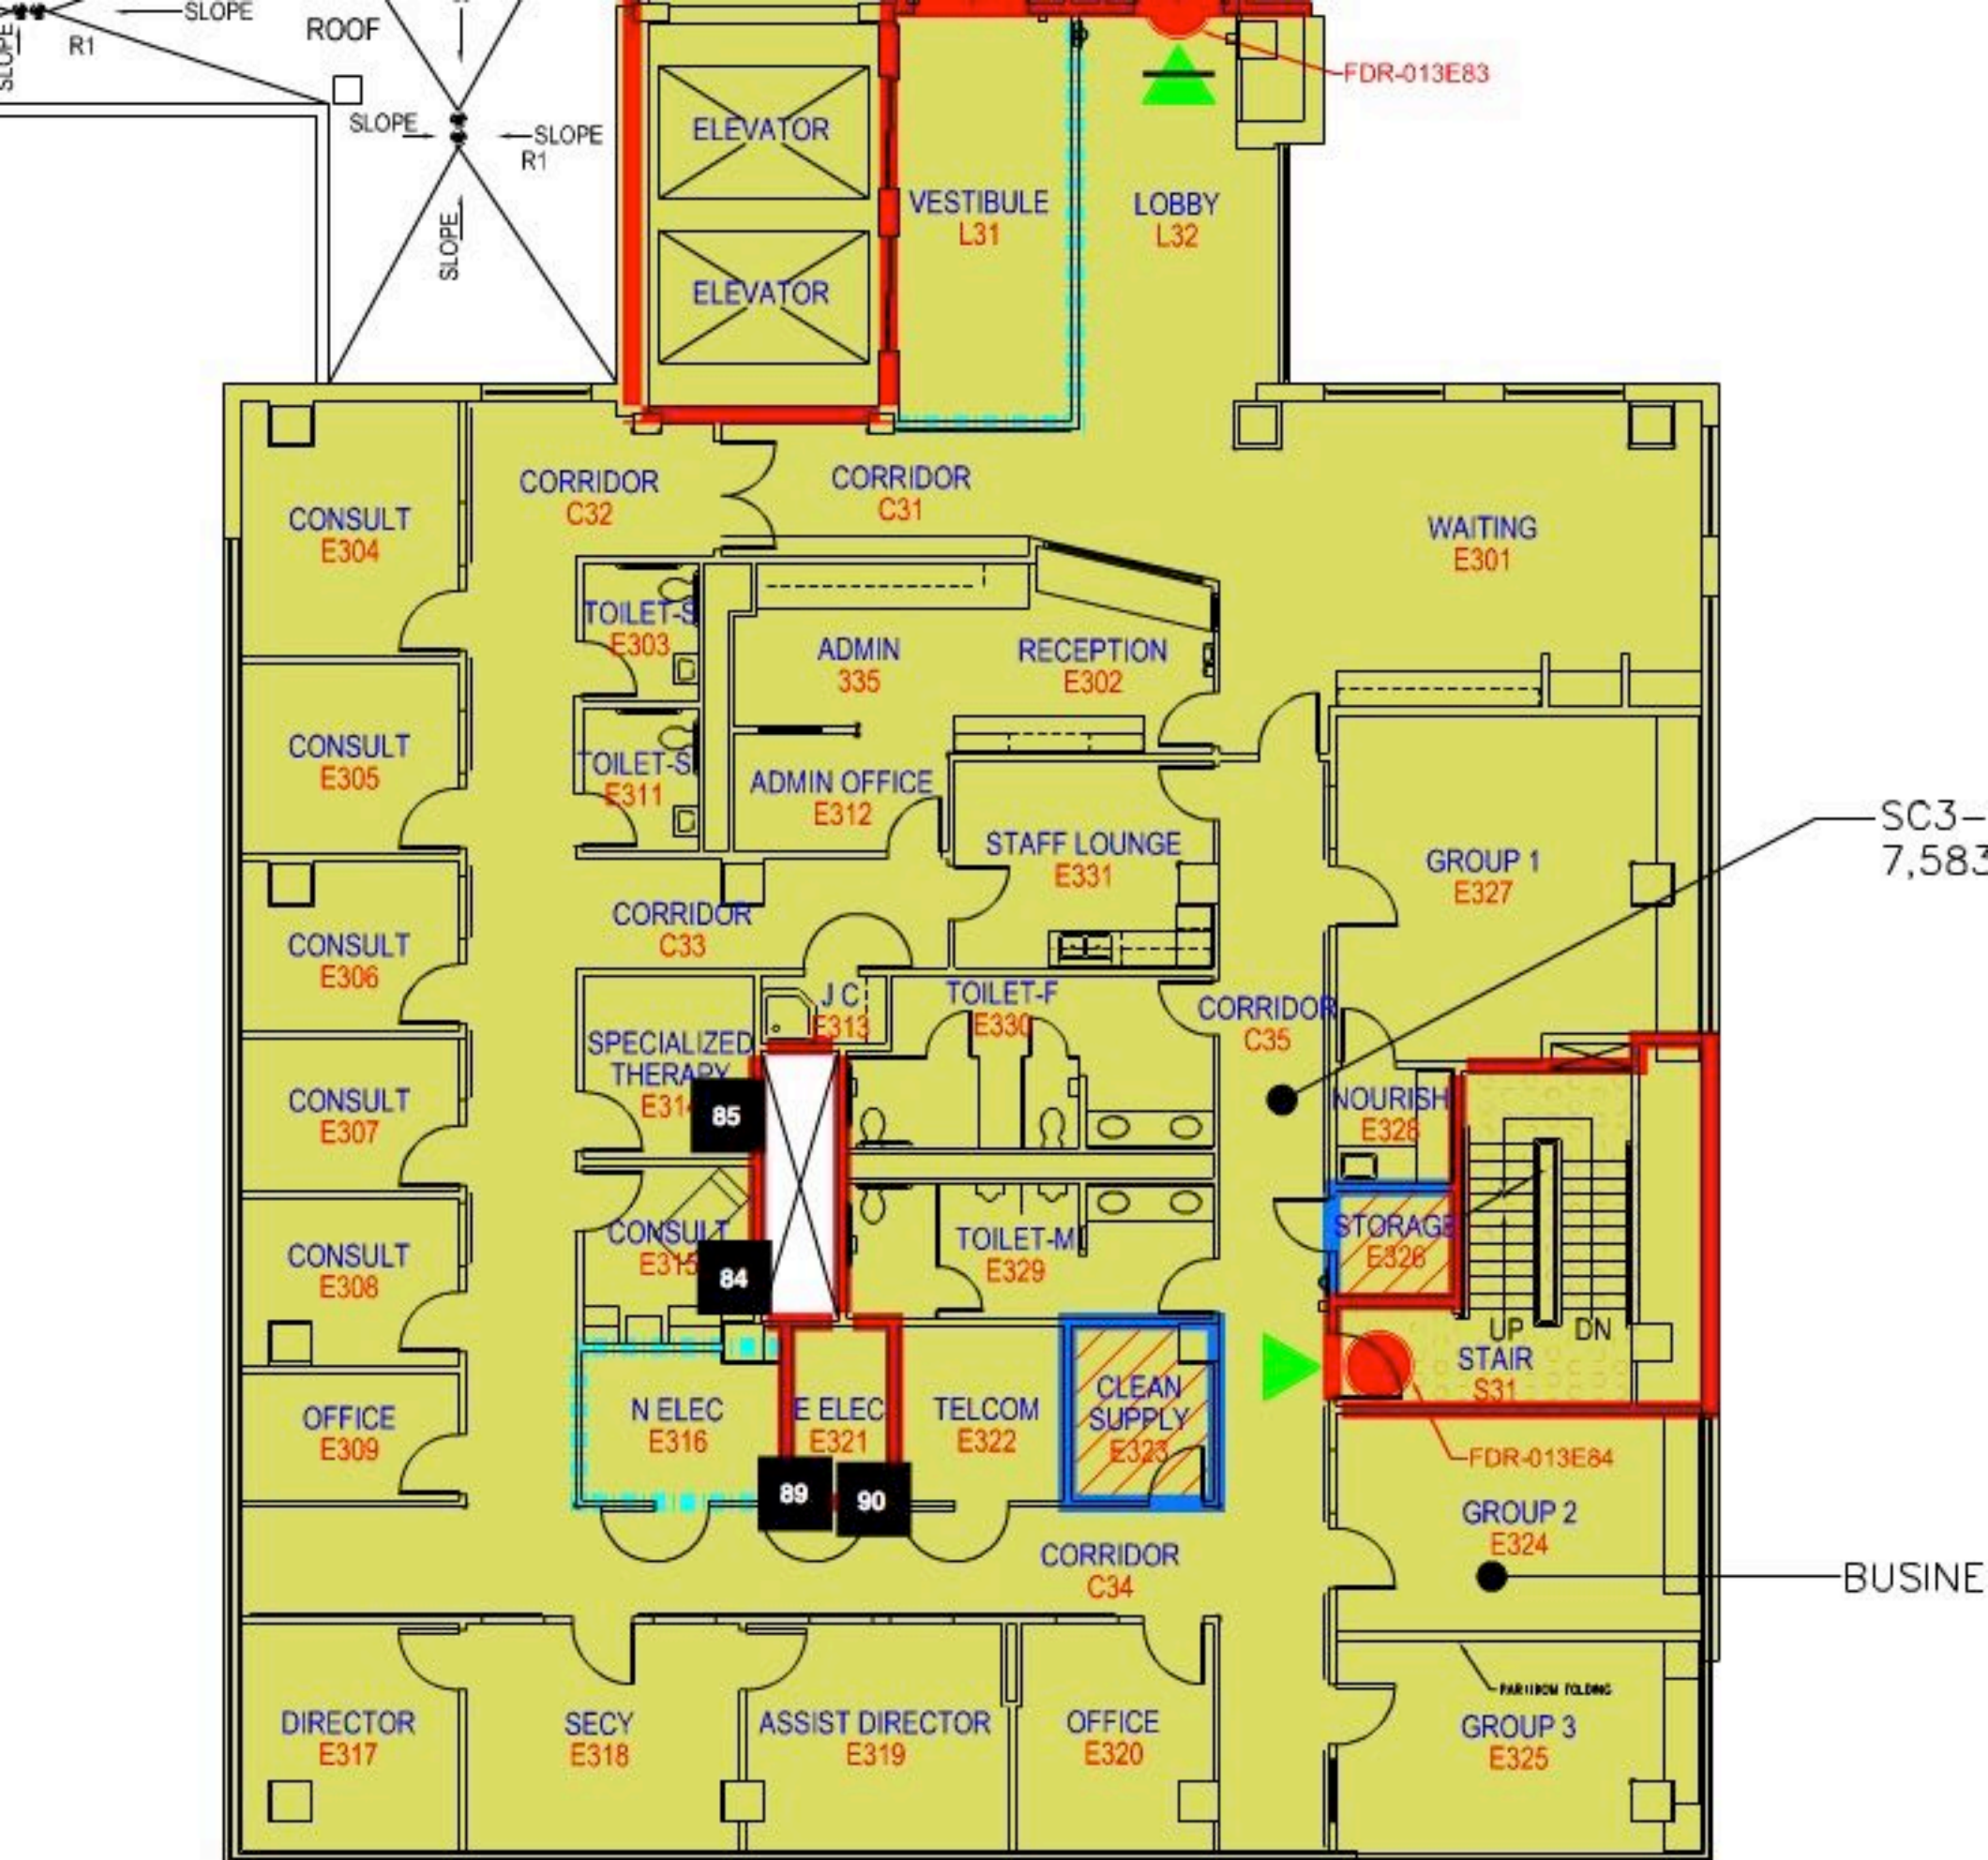
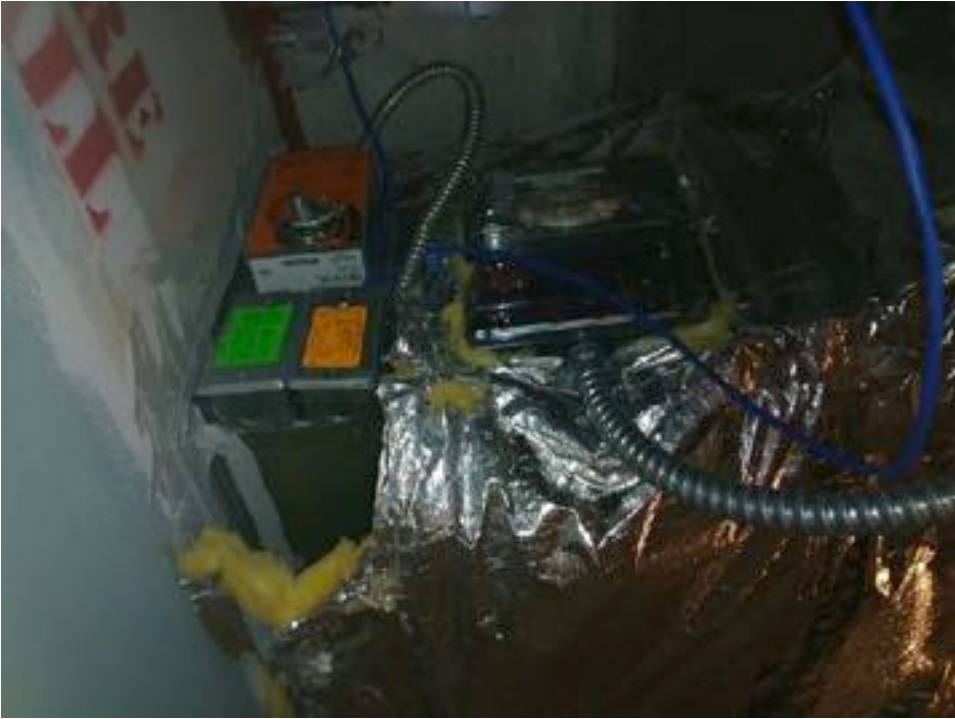
Date Created	Damper Asset Tag #	Damper Size	EOC ID #	Punch #	Type	Floor	Comments
1/13/15	FSD-013E48	30x14	211820	84	Smoke/Fire damper	3rd Floor	Damper Failed. Actuator is functioning properly. No access door was installed to visually test damper.
<div>

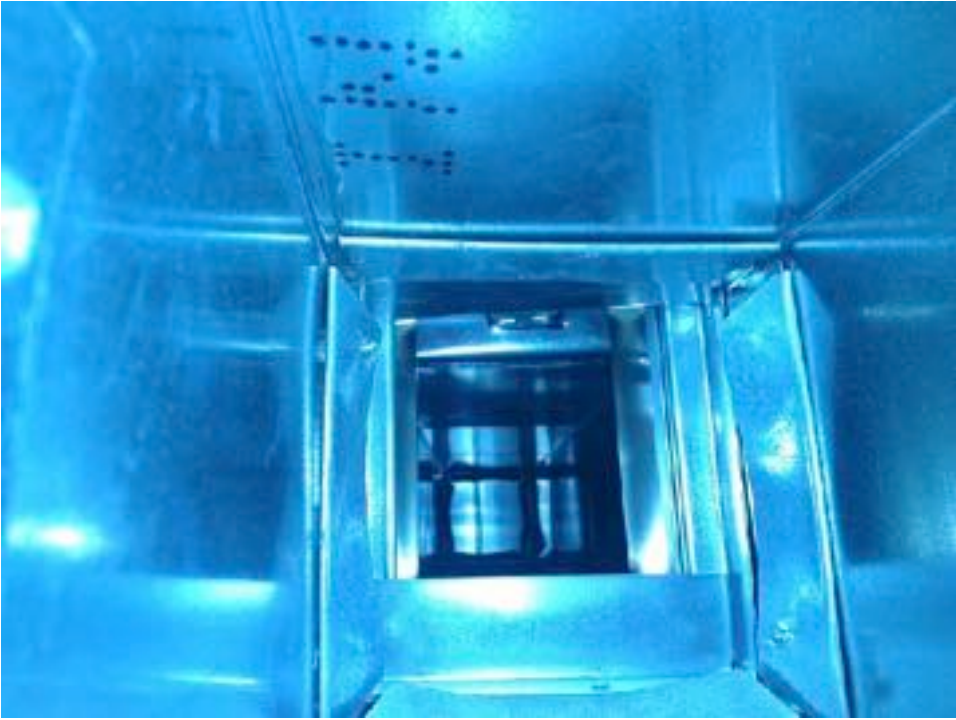
Date Created	Damper Asset Tag #	Damper Size	EOC ID #	Punch #	Type	Floor	Comments
1/13/15	FD-013E169	8x6	211825	39	Fire Damper	3rd Floor	Damper Failed. Damper was damaged during installation and was not installed in the plane of the barrier. Reference: NFPA 80 2013 Section 19.2.1.1.1 A damper installed in a fire resistance-rated assembly shall be located (in its sleeve) within the plane of the fire resistance-rated assembly, unless listed otherwise and installed in accordance with the manufacturer's installation instructions and the listing.
  <p>1/13/15 05:25 AM</p>

Date Created	Damper Asset Tag #	Damper Size	EOC ID #	Punch #	Type	Floor	Comments
1/13/15	FD-013E168	6x6	211826	90	Fire Damper	3rd Floor	Damper Failed. Damper was damaged during installation and was not installed in the plane of the barrier. Reference: NFPA 80 2013 Section 19.2.1.1.1 A damper installed in a fire resistance-rated assembly shall be located (in its sleeve) within the plane of the fire resistance-rated assembly, unless listed otherwise and installed in accordance with the manufacturer's installation instructions and the listing.

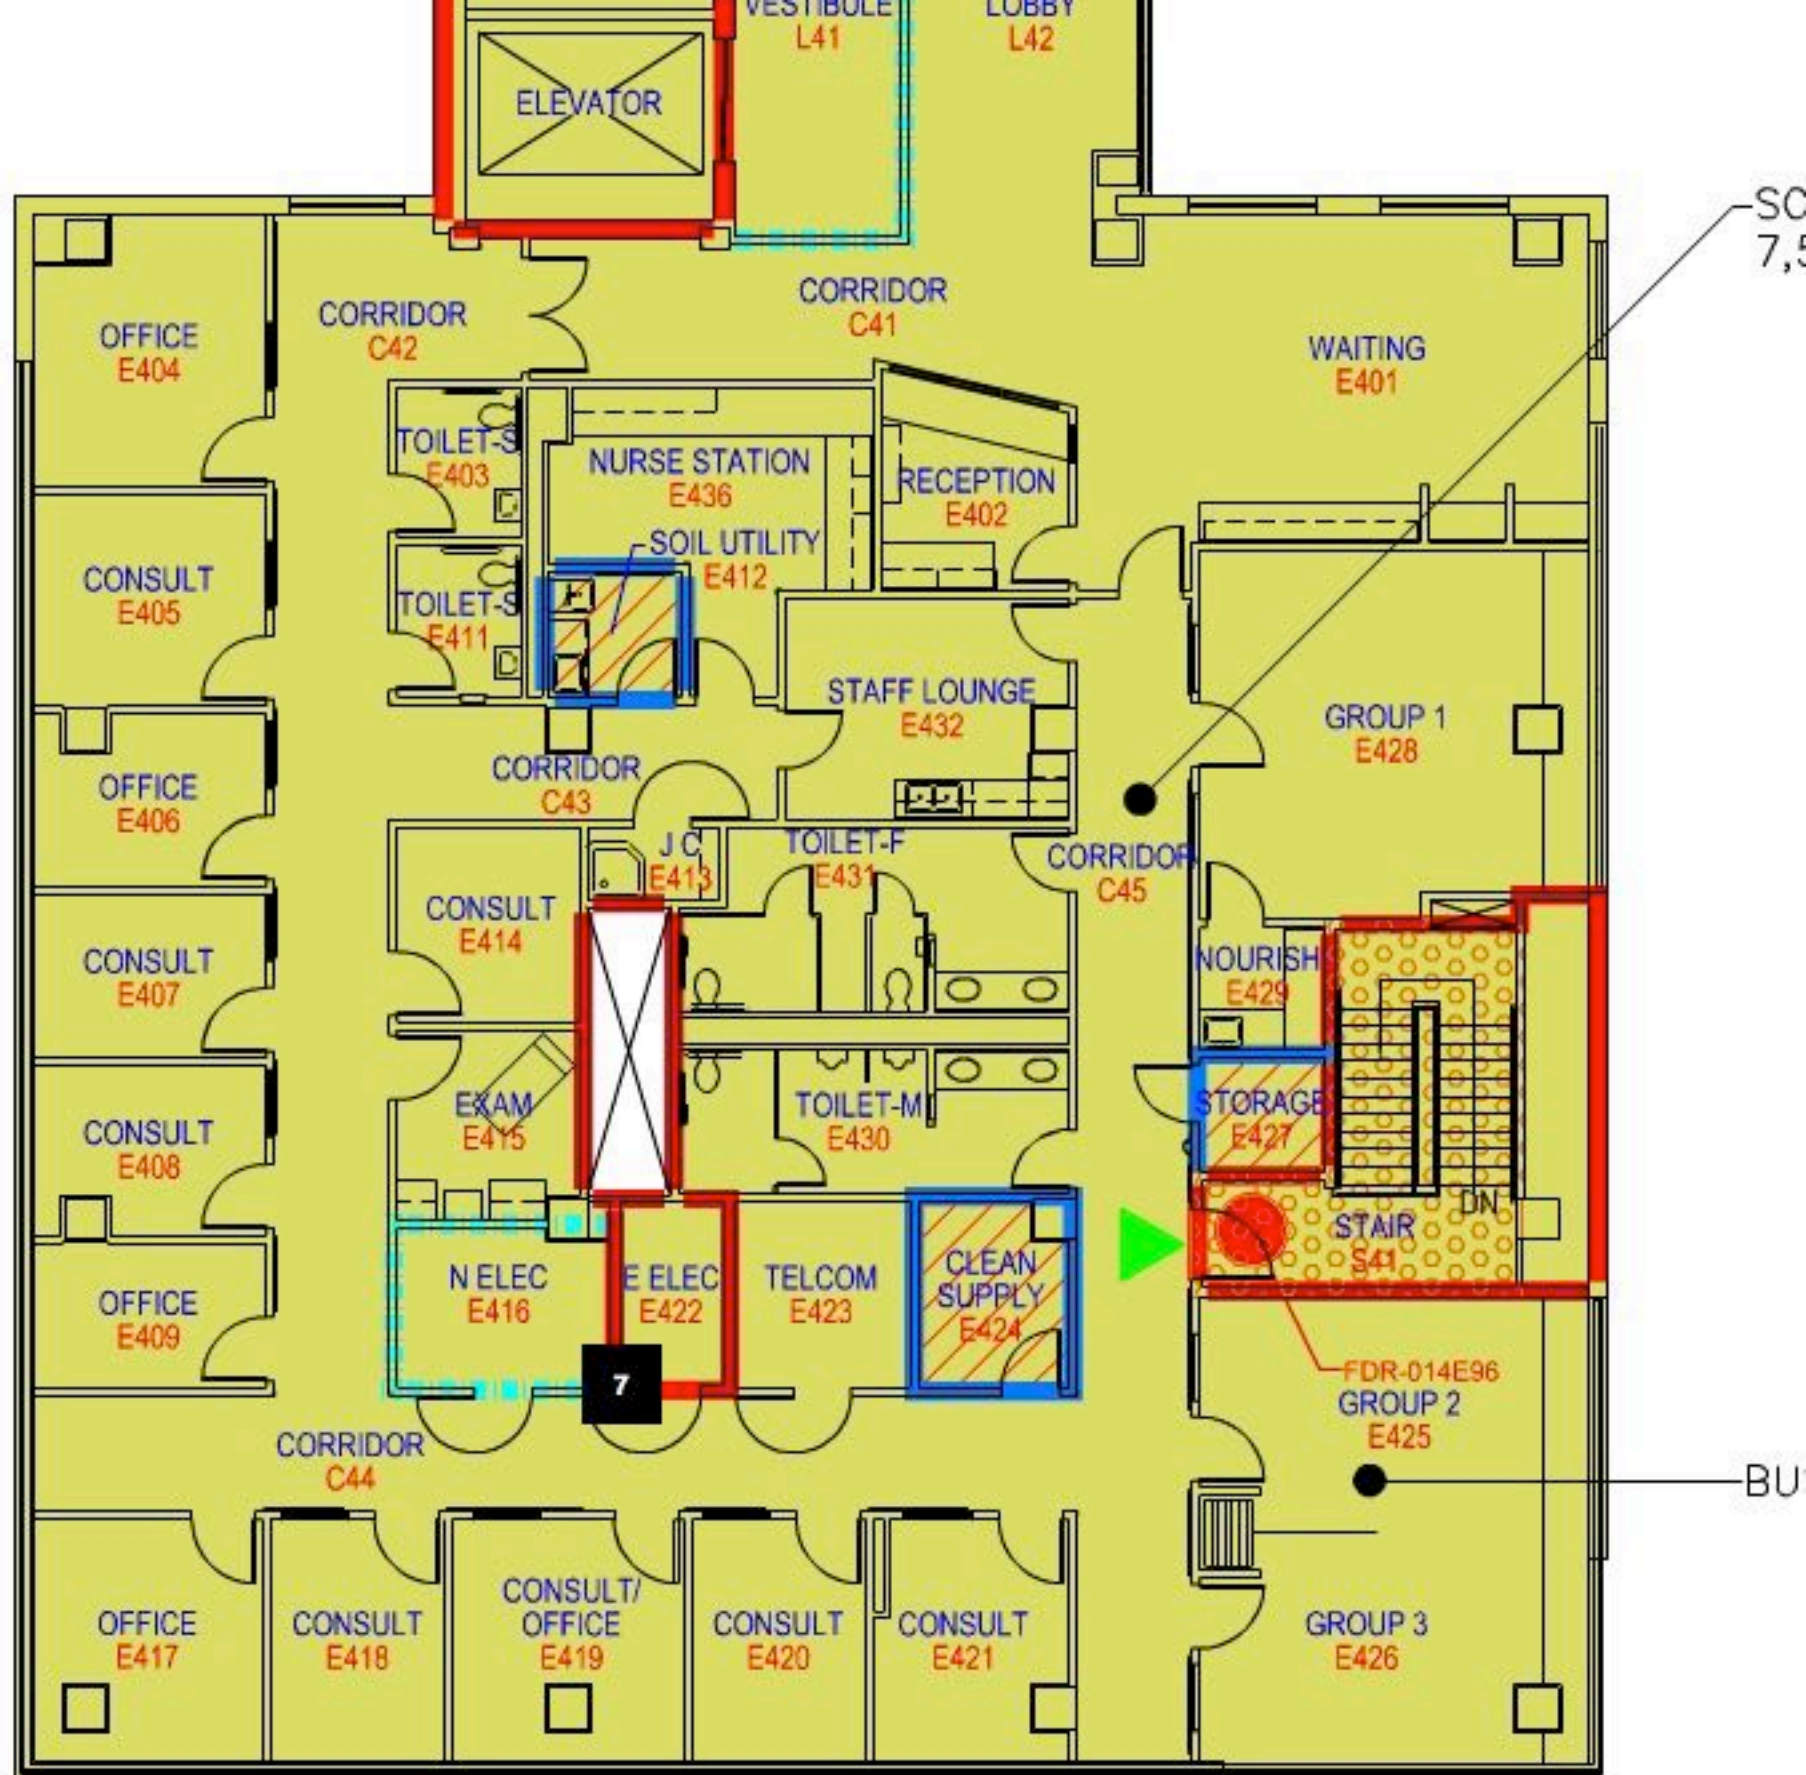
Date Created	Damper Asset Tag #	Damper Size	EOC ID #	Punch #	Type	Floor	Comments
1/13/15	FD-014E171	8x6	211832	7	Fire Damper	4th Floor	Damper Failed. Damper was damaged during installation and was not installed in the plane of the barrier. Reference: NFPA 80 2013 Section 19.2.1.1.1 A damper installed in a fire resistance-rated assembly shall be located (in its sleeve) within the plane of the fire resistance-rated assembly, unless listed otherwise and installed in accordance with the manufacturer's installation instructions and the listing.
