EOC-Providence VAMC Fire and Fire/Smoke Damper Failed Report

EOC-PROVIDENCE VAMC FIRE AND FIRE/SMOKE DAMPER FAILED REPORT

03/04/15

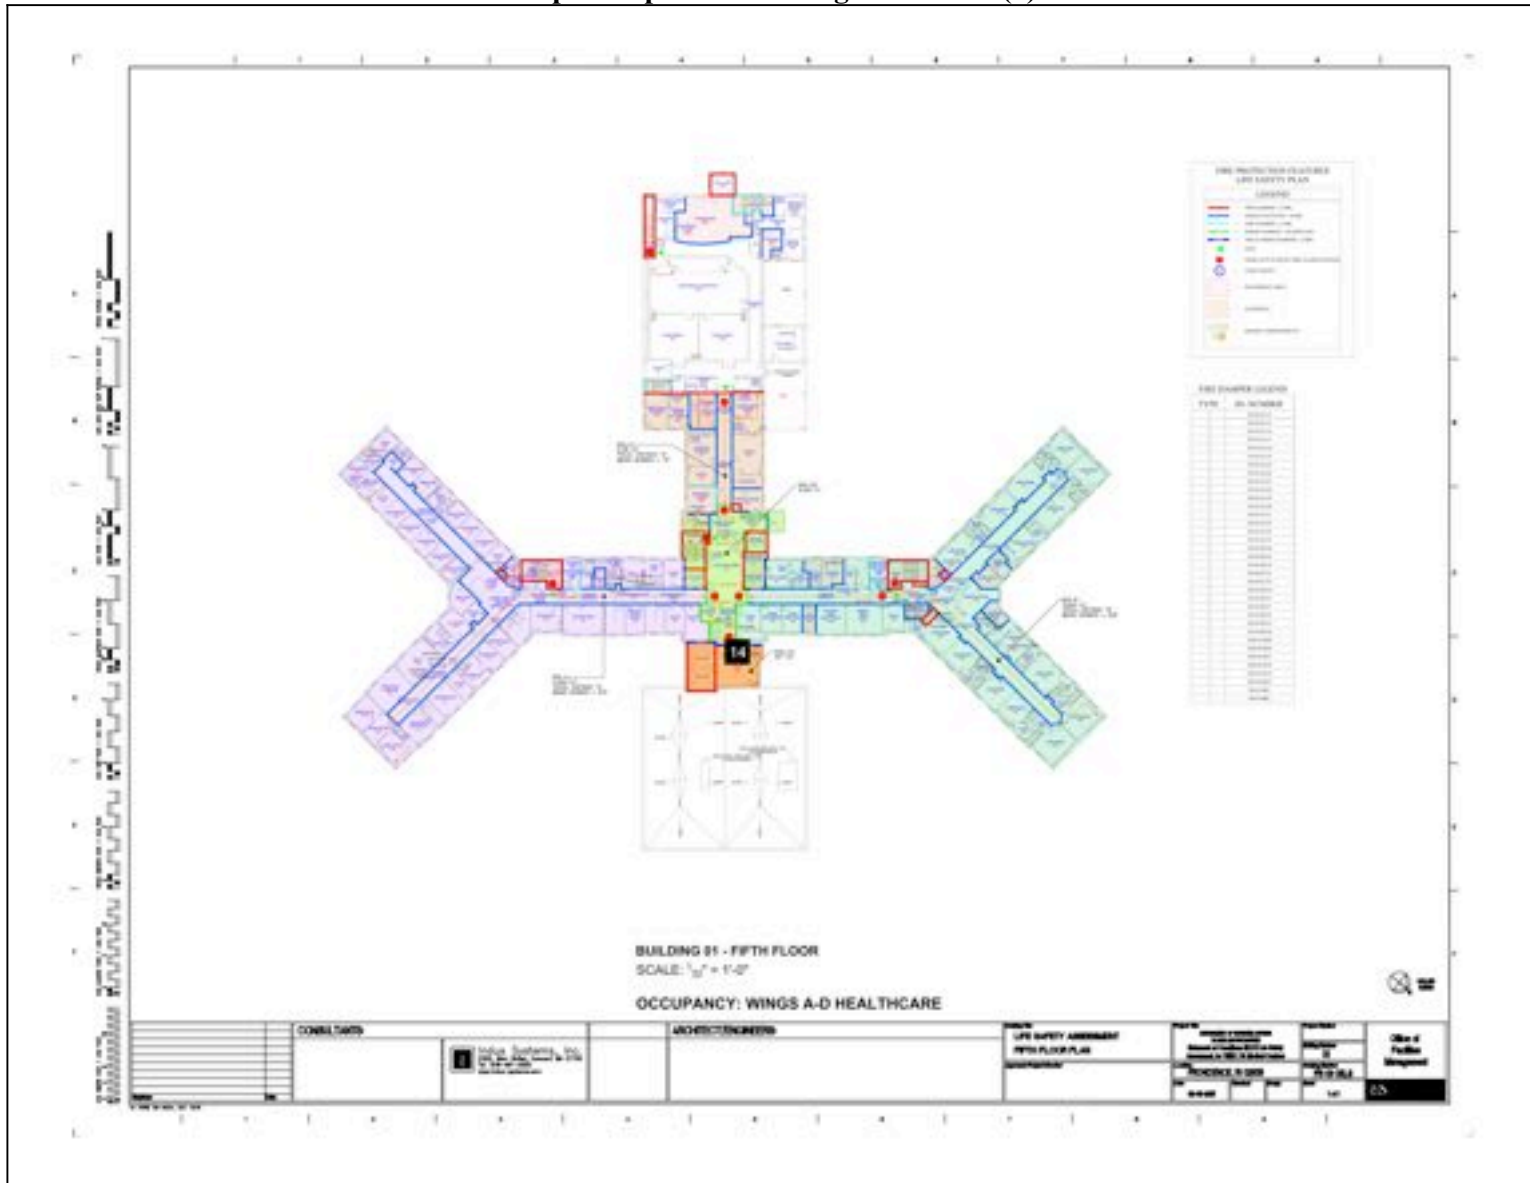
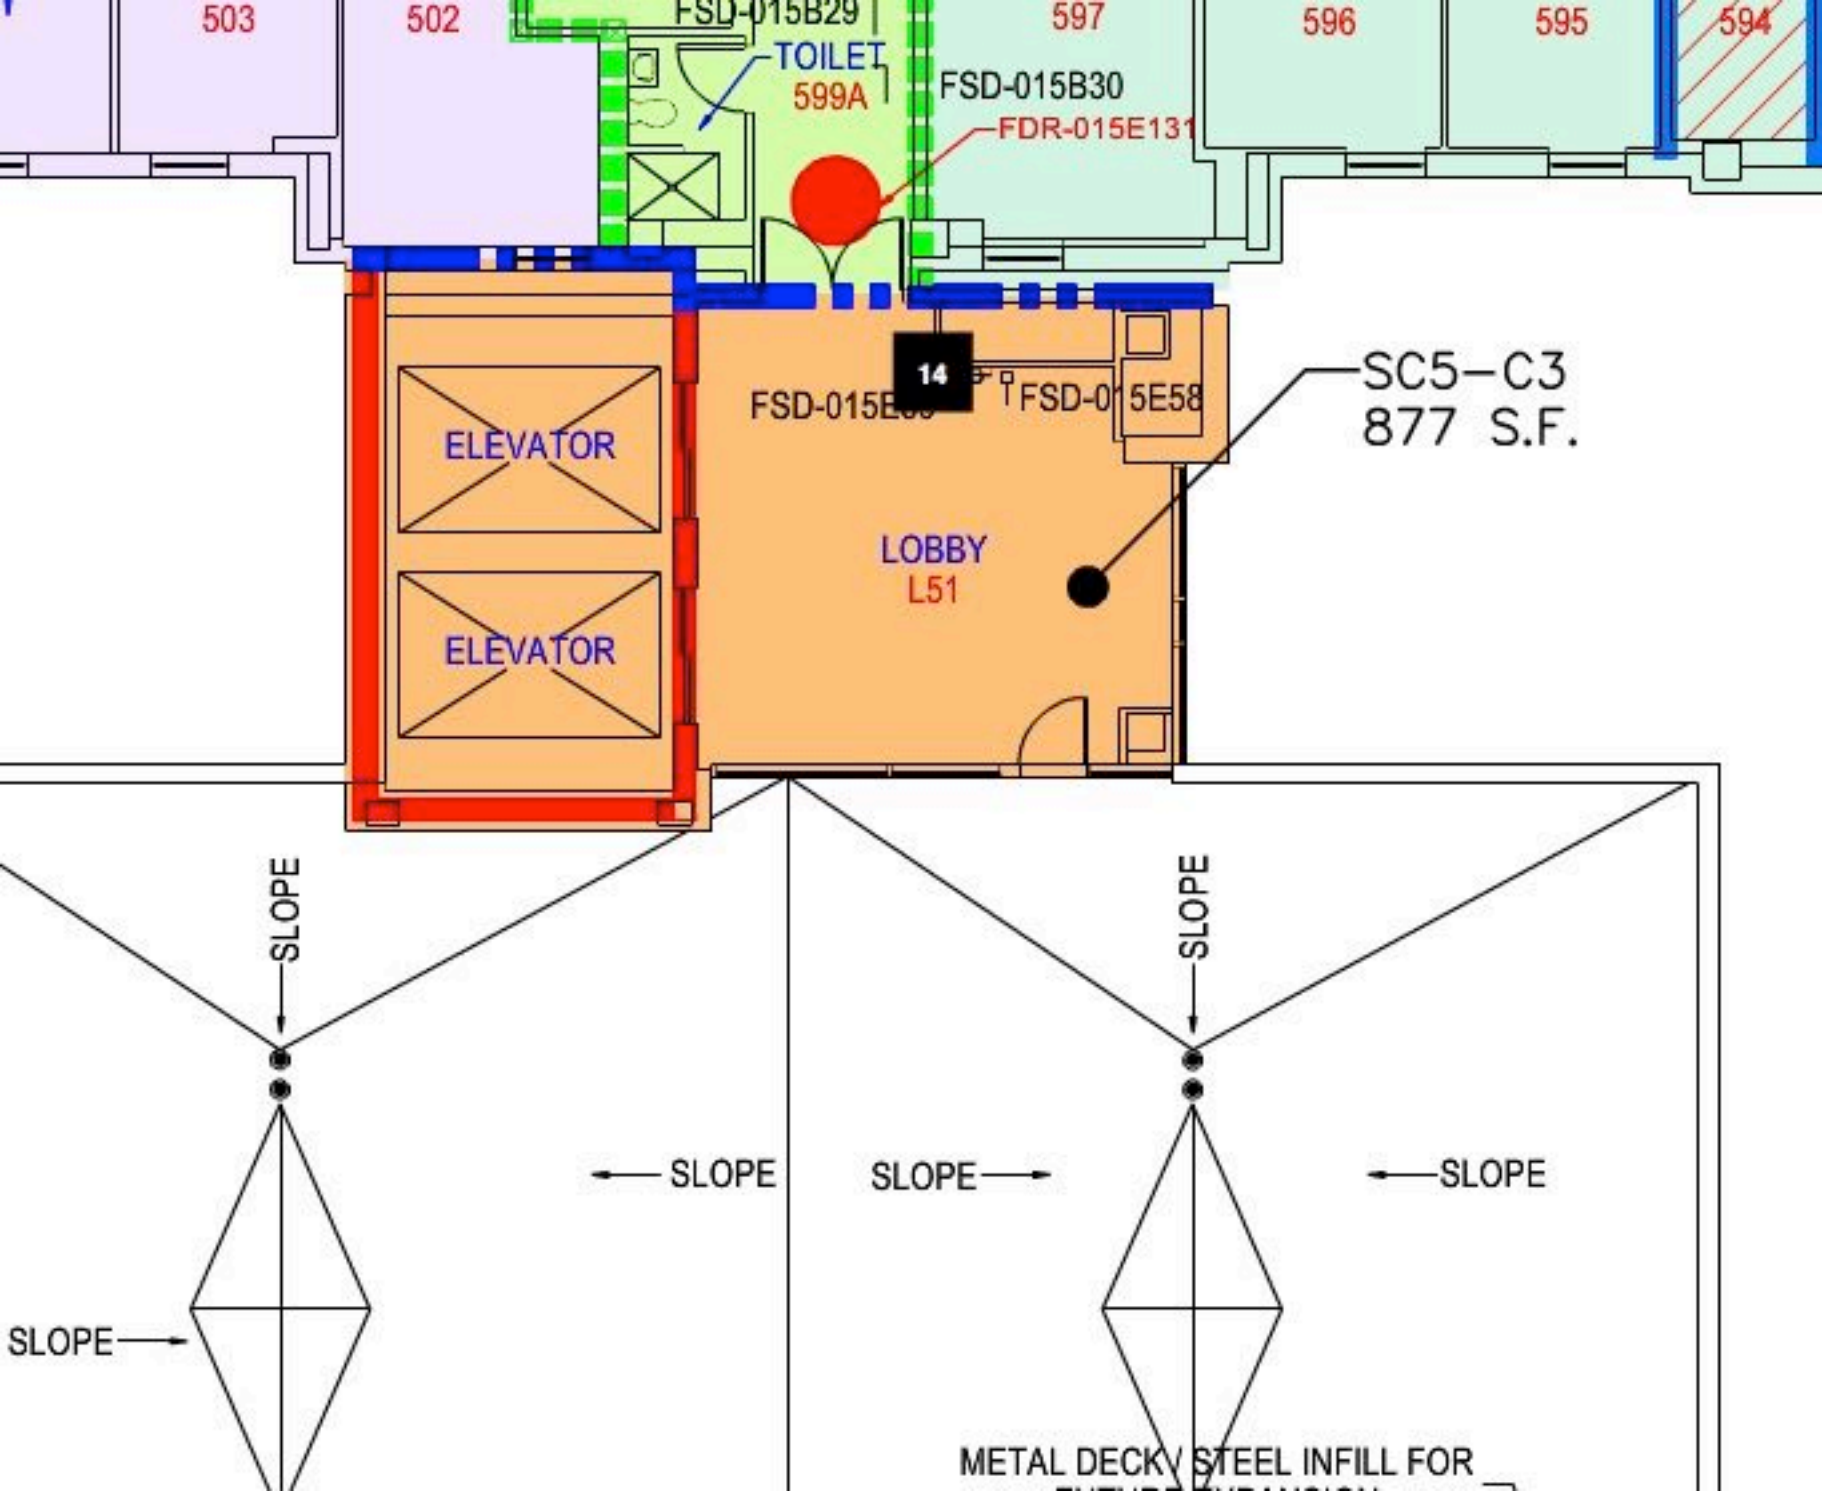
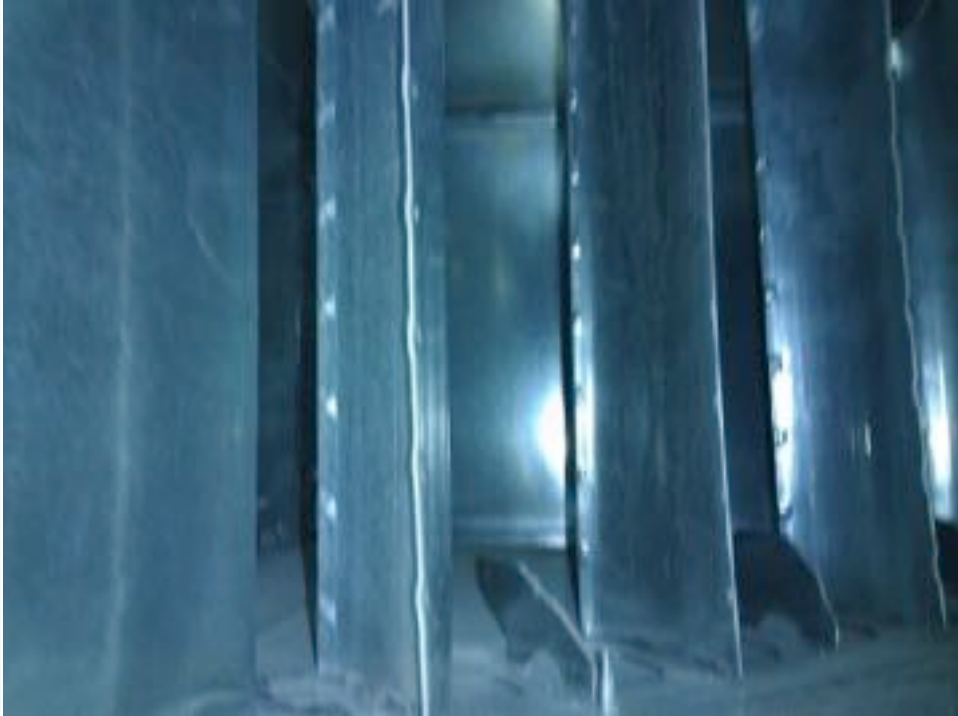
Damper Inspection E-Wing / 5th Floor (5) -

Date Created	Damper Asset Tag #	Damper Size	EOC ID #	Punch #	Type	Floor	Comments
1/13/15	FSD-015E59	14x12	211834	14	Smoke/Fire damper	5th Floor	Damper Failed. No visible access. Actuator appears to be functioning properly, air flow stops which indicates that the damper is closing, but no visible access. Access door needs to be moved to gain visible access.

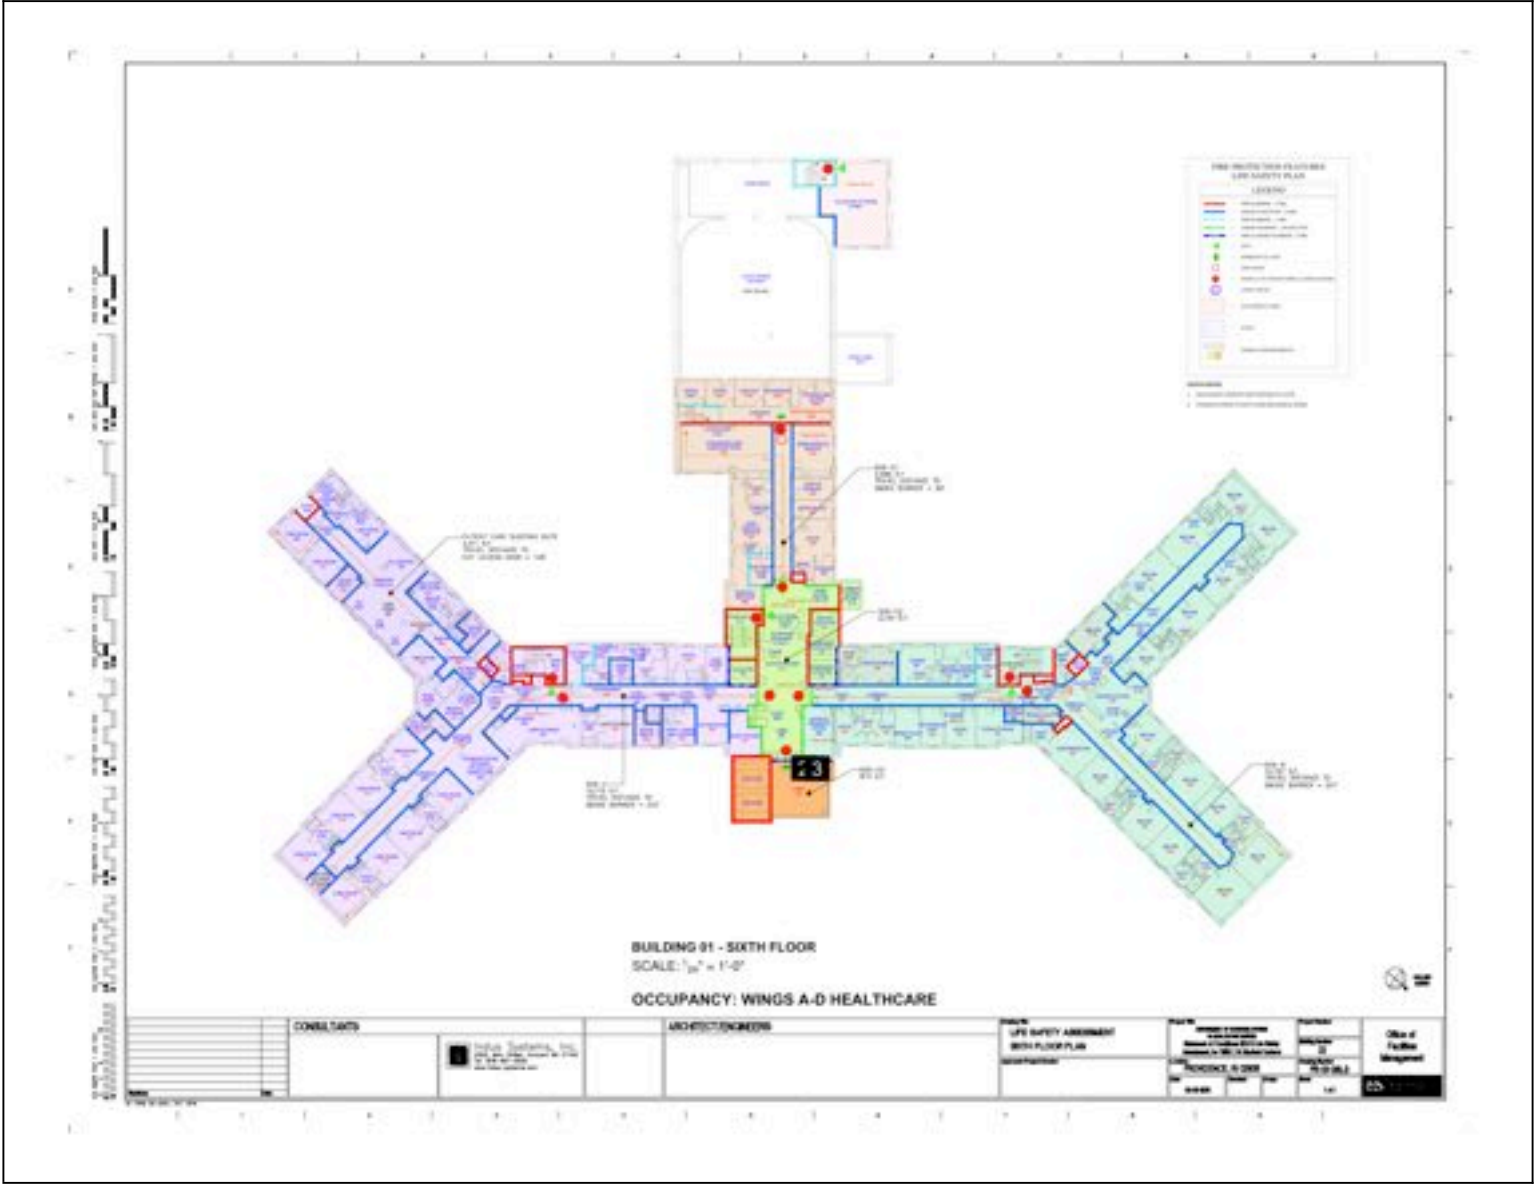
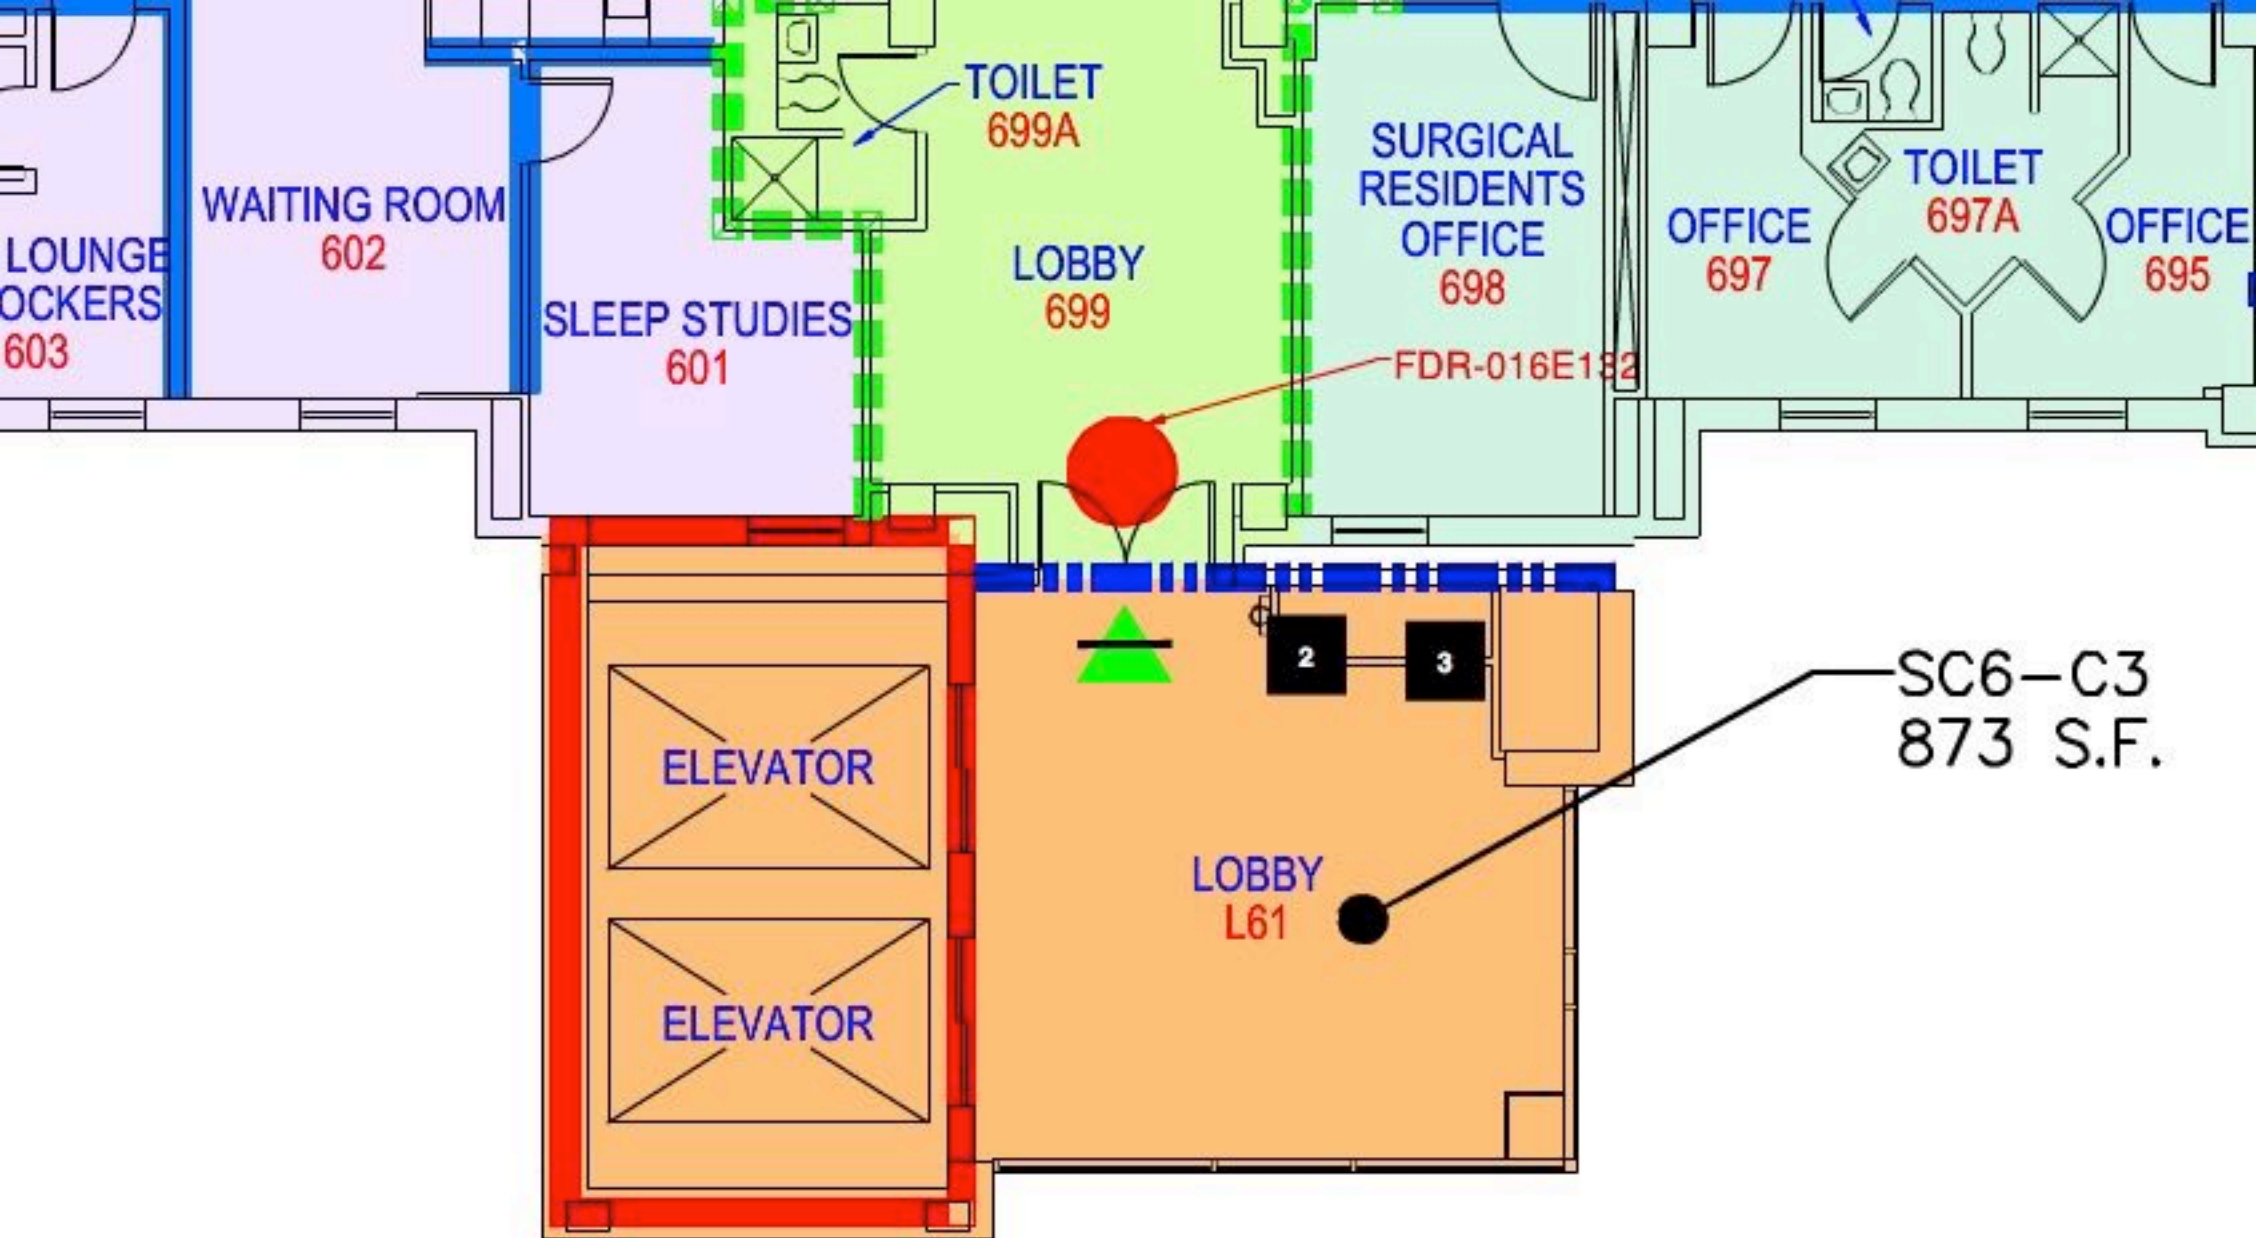
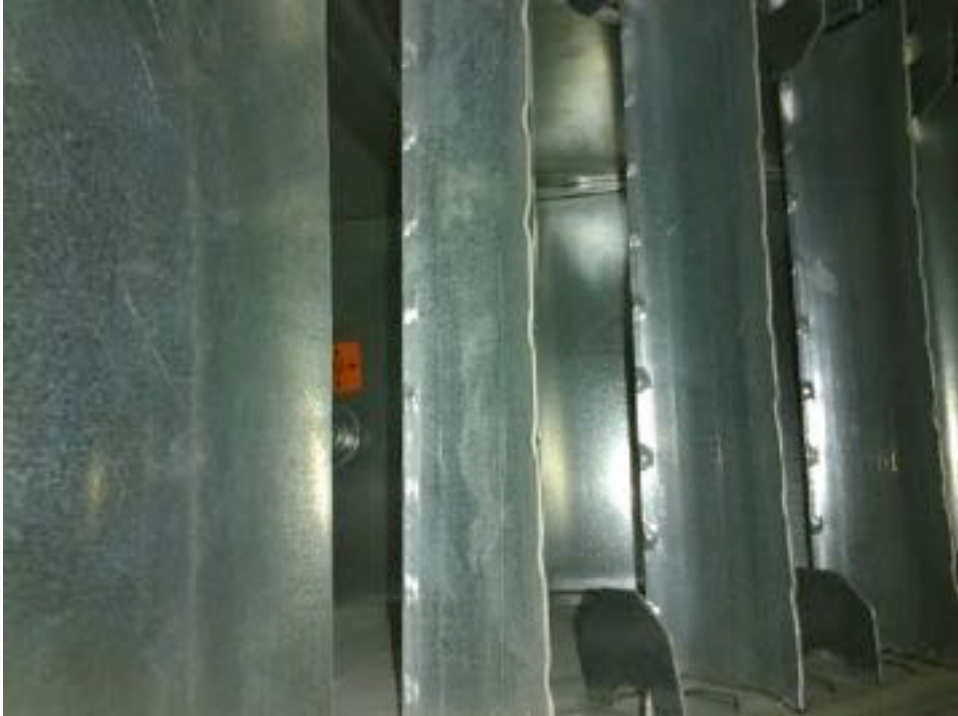
Damper Inspection E-Wing / 6th Floor (6) -

Date Created	Damper Asset Tag #	Damper Size	EOC ID #	Punch #	Type	Floor	Comments
1/13/15	FSD-016E61	14x12	211836	2	Smoke/Fire damper	6th Floor	Damper Failed. No visible access. Actuator appears to be functioning properly, air flow stops which indicates that the damper is closing, but no visible access. Access door needs to be moved to gain visible access.

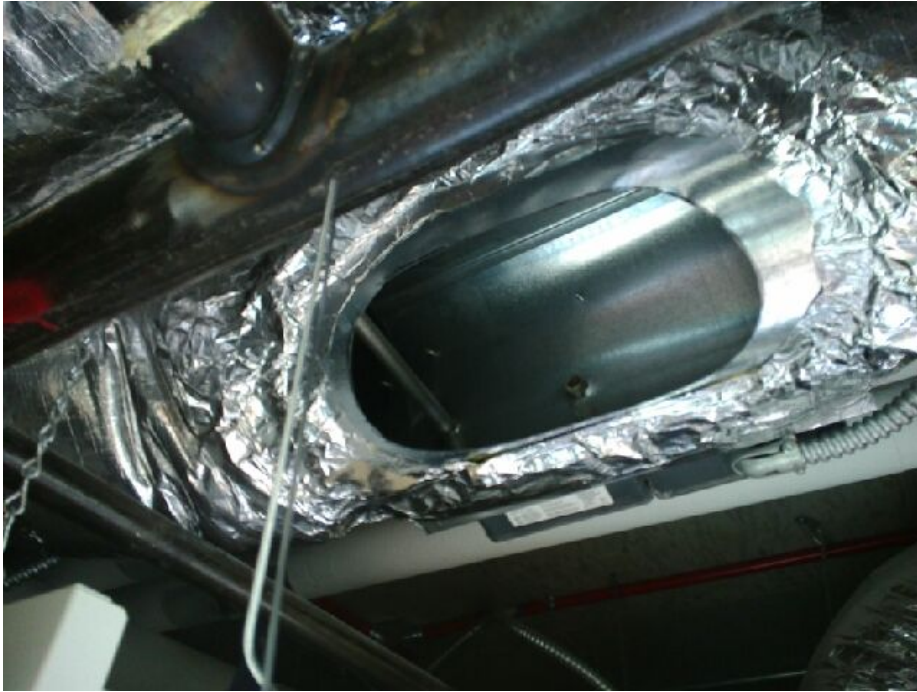
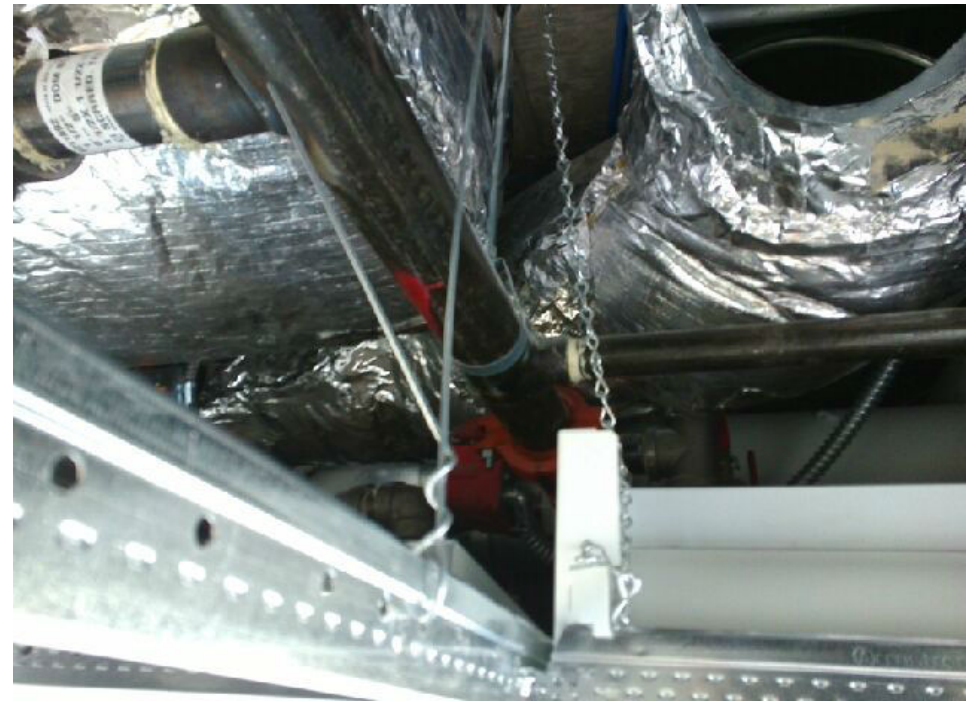
Date Created	Damper Asset Tag #	Damper Size	EOC ID #	Punch #	Type	Floor	Comments
1/13/15	FSD-016E60	16x8	211837	3	Smoke/Fire damper	6th Floor	Damper Failed. No visible access. Actuator appears to be functioning properly, air flow stops which indicates that the damper is closing, but no visible access. Access door needs to be moved to gain visible access.
