R.F.I.

Project #:	691-15-114WL	RFI #:	1
Project Name:	IMPROVE Steam Distribution System	Date Requested:	12/13/2016
Solicitation No.:	VA262-17-B-0019	Reference:	Site Visit
Drawing:		Specification Section:

LIMITED ASBESTOS INSPECTION REPORT

VA West Los Angeles- Building 256
11301 Wilshire Boulevard
Los Angeles, CA 90073

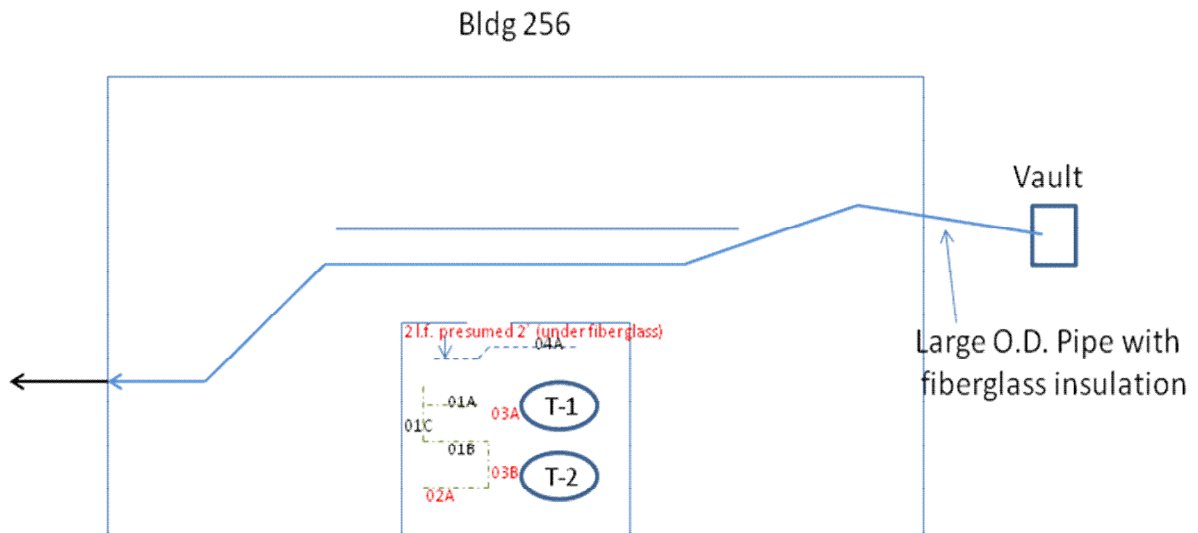
Appendix A – Site Diagram

01A- Non-ACM sample location – Valve Mud
01B- Non-ACM sample location – Valve Mud
01C- Non-ACM sample location – Valve Mud
02A- ACM Insulation – 4" (~21.f.)
03A/B – ACM tank insulation – under fiberglass (~400 s.f.)
04A – Non-ACM 2" mudded elbow(1 each)

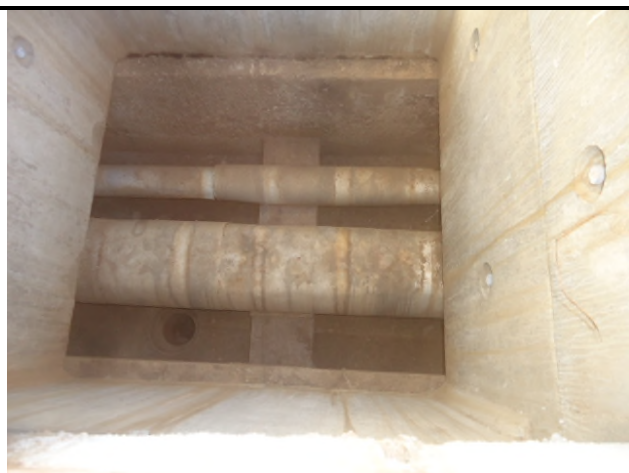
Photo 2: This is a view of the vault on the east side of the building, next to the parking lot.

5. The large diameter pipes that enter into the building via a vault on the east exterior and through the base level and office adjacent to the Boiler Room and exit through the south side of the building are insulated with fiberglass. The piping must be presumed to be insulated with ACM where it runs underground, west of the building. AES recommends testing the insulation when the underground piping is exposed. Photos 2 through 6.

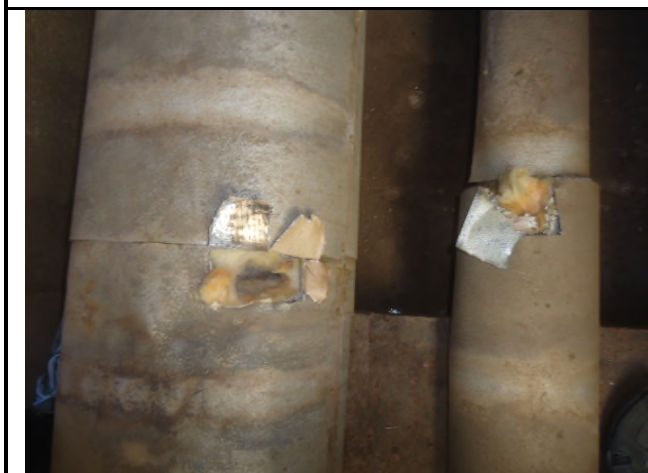
Photo 3: This is a view of the fiberglass insulation on the large diameter piping.

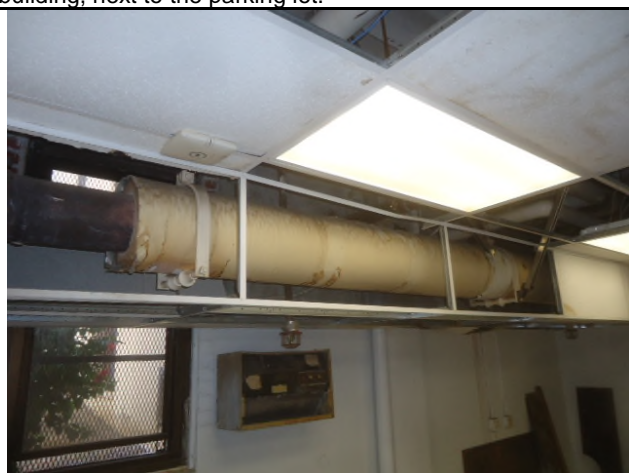
Photo 4: This is a view inside the building, of the same fiberglass insulated pipe.

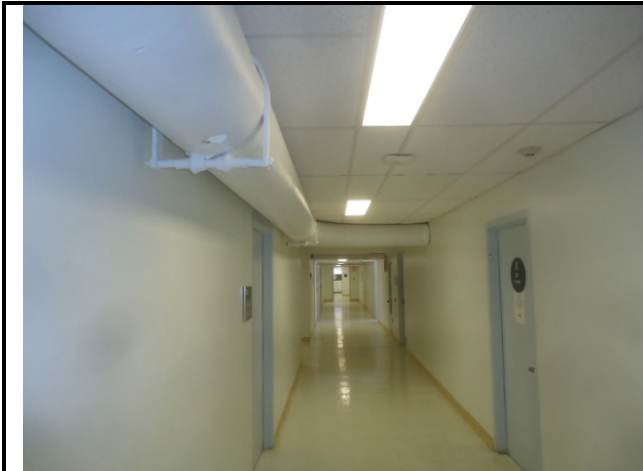
Photo 5: This is a view inside the building, of the same fiberglass insulated pipe.

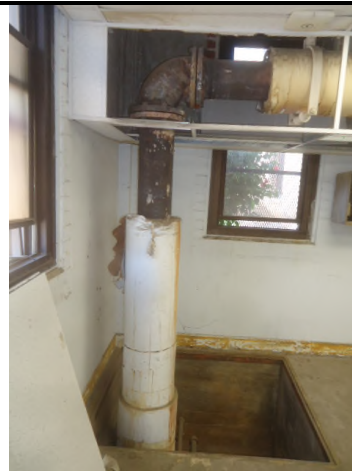
Photo 6: This is a view of the west side, where the piping again runs below grade. Outside the building, the piping must be presumed ACM and tested when exposed.

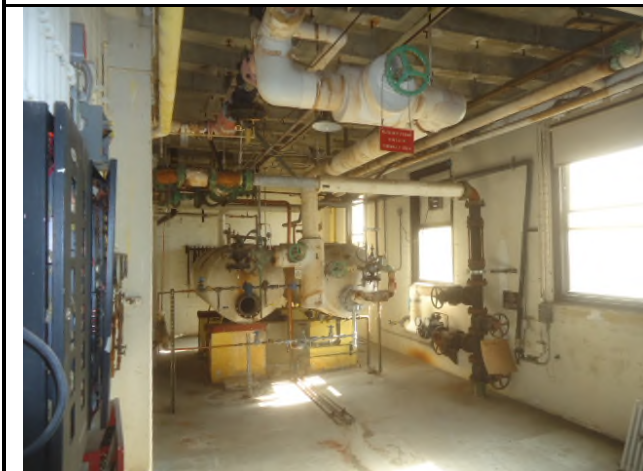
Photo 7: This is an overview of the affected boiler room area.

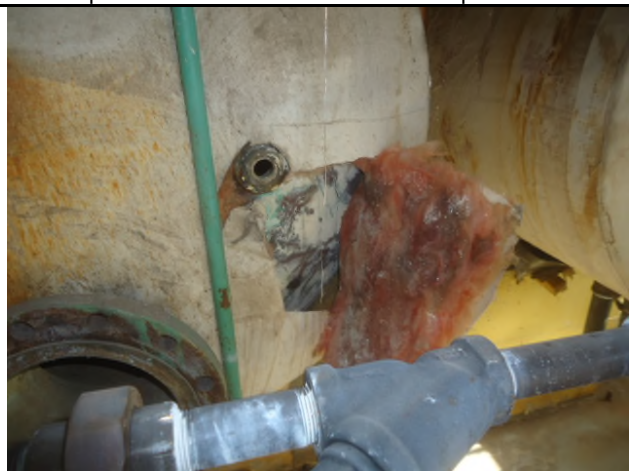
- 1) **(02A) 4" Pipe Insulation - Pipe west of Tank 2 = 45% Chrysotile. (~2 l.f.)**
- 2) **(03A) Old white tank insulation (under fiberglass) - Tanks 1 and 2 = 20% Chrysotile. (~400 s.f.)**

Photo 8: This is a view of the ACM insulation remnants, under the fiberglass over-lay on Tank 1. (200 s.f. per tank estimate)

1. The ACM tank insulation and fiber glass overlay will require abatement on Tanks 1 and 2. Photos 8 and 9.
2. The 4" pipe insulation will require abatement. See plot plan and photo 10 for exact location.

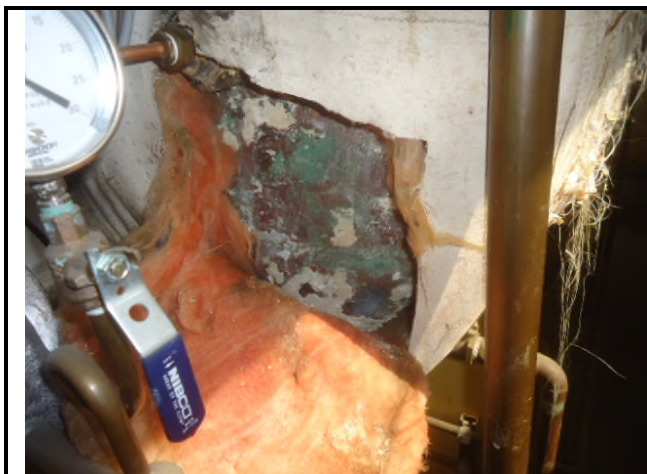
Photo 9: This is a view of the ACM insulation remnants, under the fiberglass over-lay on Tank 2.

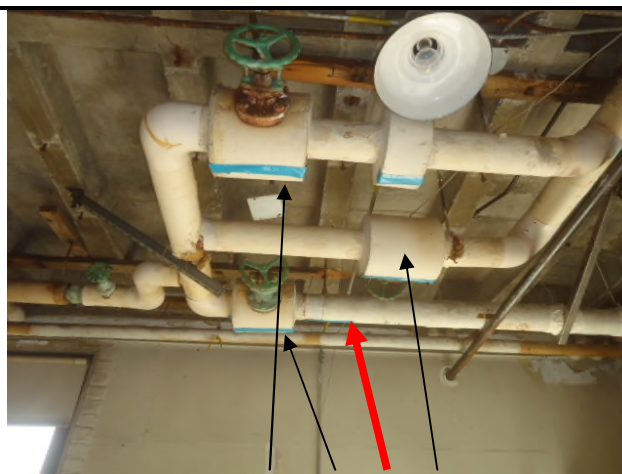
Photo 10: This is a view of the mudded valves with blue tape. The mudded valve insulation is non-ACM. The red arrow indicated the 4" O.D ACM insulation (2 l.f. estimate).

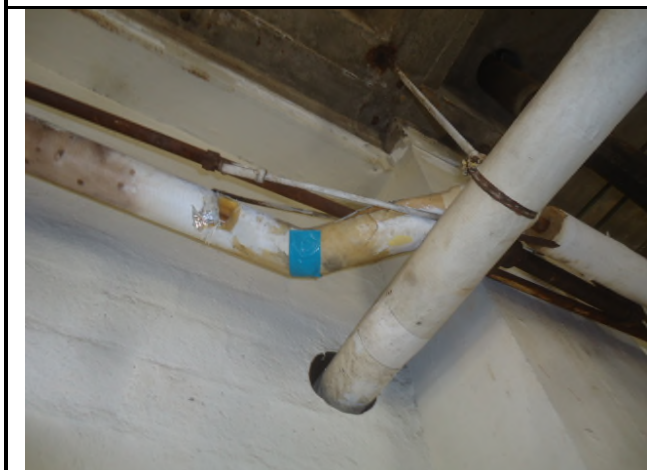
Photo 11: This is a view of the non-ACM 2" mudded elbow (just north of T-1).

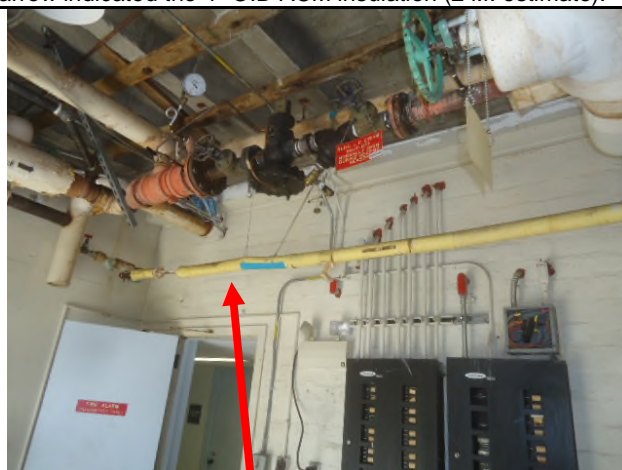
- 1) **2" pipe insulation - same line as the non-ACM 2" elbow.** Not sampled due to the amount, condition and being under fiberglass. (~1-2 l.f.). Sampling may have created a P5 clean-up.

Photo 12: This is a view of the presumed 2" old pipe insulation location. The material was in bad shape and merely moving the fiberglass to expose it may have caused an asbestos clean-up. Therefore, the material is presumed ACM. (~2 l.f. estimate).

3. The 2" pipe insulation (under fiberglass) will require abatement. Photo 12.
4. Other piping in the boiler room covered with fiberglass, should be stripped by an abatement contractor in the vent that there is more old suspect ACM insulation underneath. If found, then abate.
