Asbestos and Lead Based Paint Site Investigation Report

**VA Medical Center
Building #3
Omaha, NE**

AMIE # 14-00391

March 3, 2015

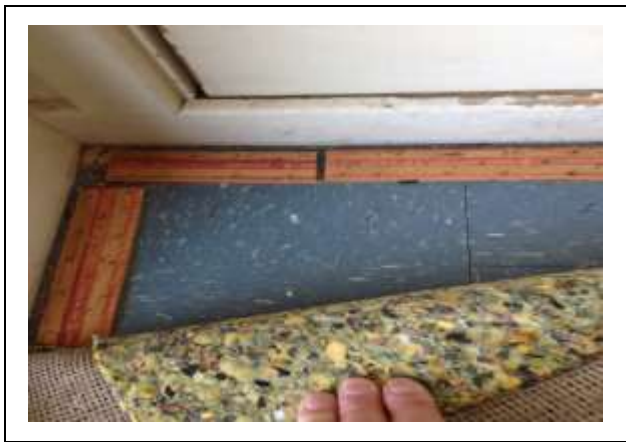
PHOTO 3	Asbestos-Containing Black mastic under 12" x 12" blue vinyl tile

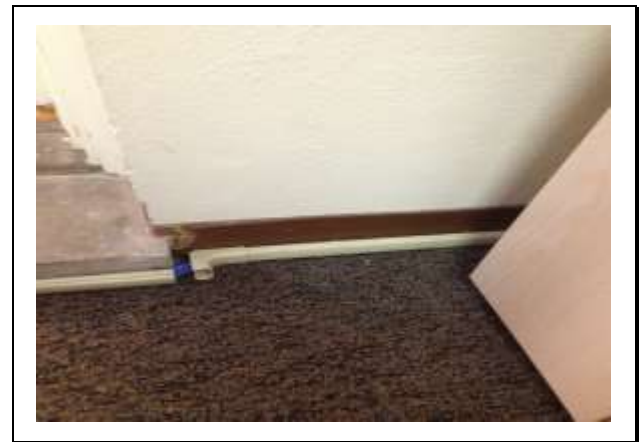
PHOTO 4	Asbestos-Containing Brown mastic behind 4" brown vinyl wall base

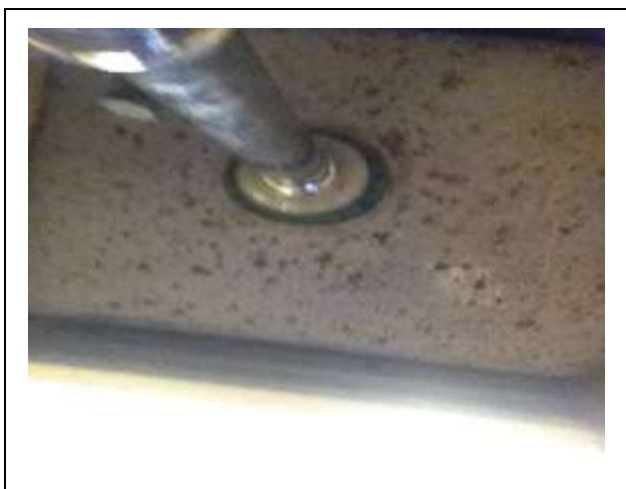
PHOTO 5	Asbestos-Containing sink undercoating

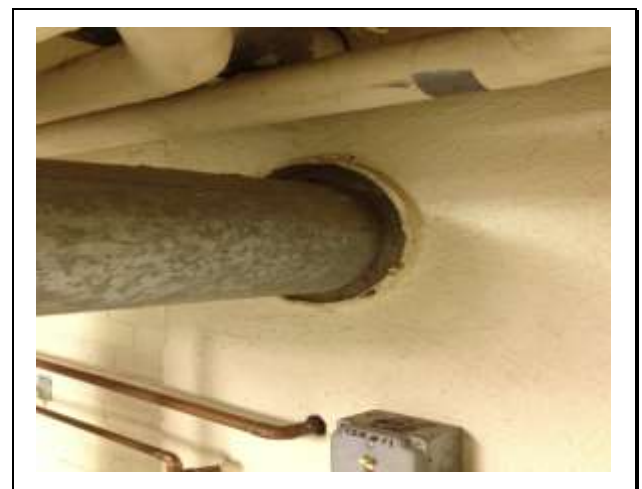
PHOTO 6	Asbestos-Containing mortar at vent pipe penetration

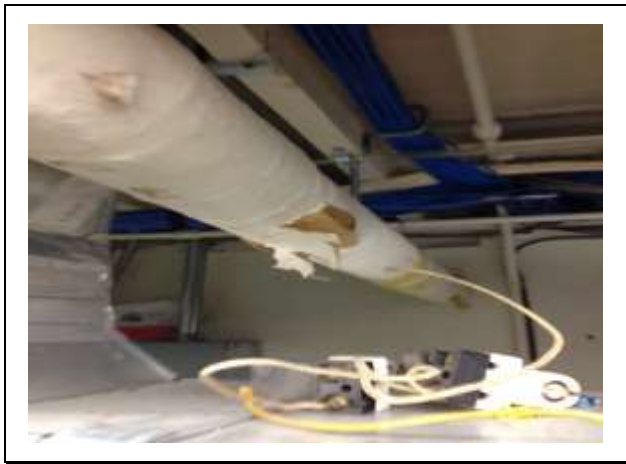
PHOTO 7	Asbestos-Containing Mechanical fitting insulation associated with fiberglass pipe runs

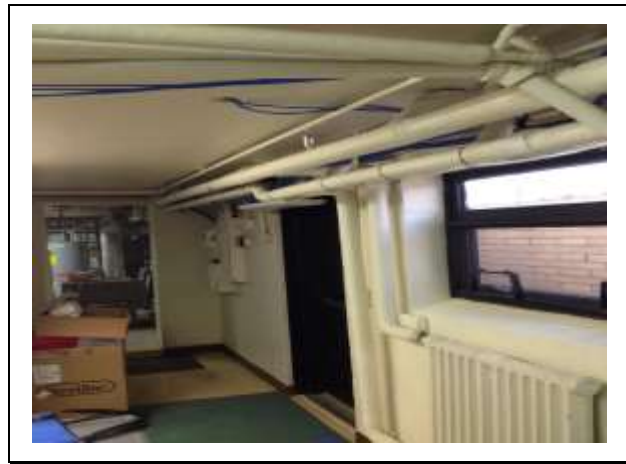
PHOTO 8	Asbestos-Containing Pipe Insulation – air cell type

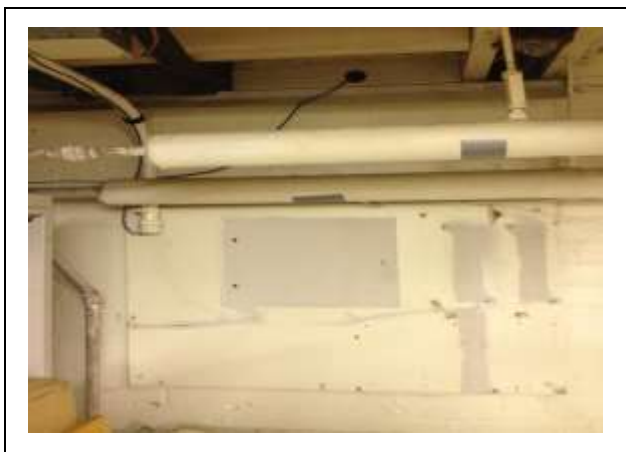
PHOTO 9	Asbestos-Containing Pipe Insulation – mag type

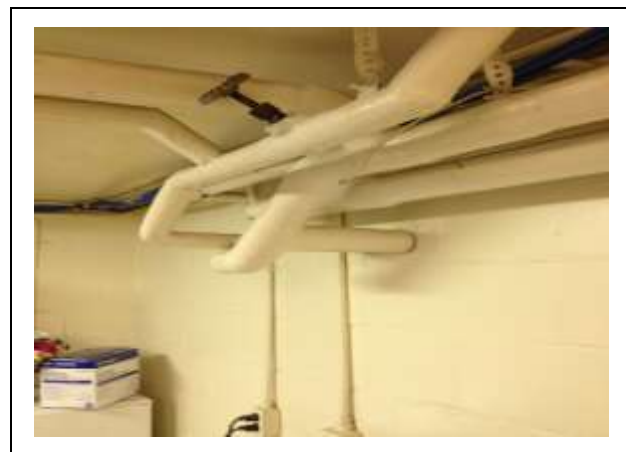
PHOTO 10	Asbestos-Containing Mechanical fitting insulation associated with air cell and mag pipe runs

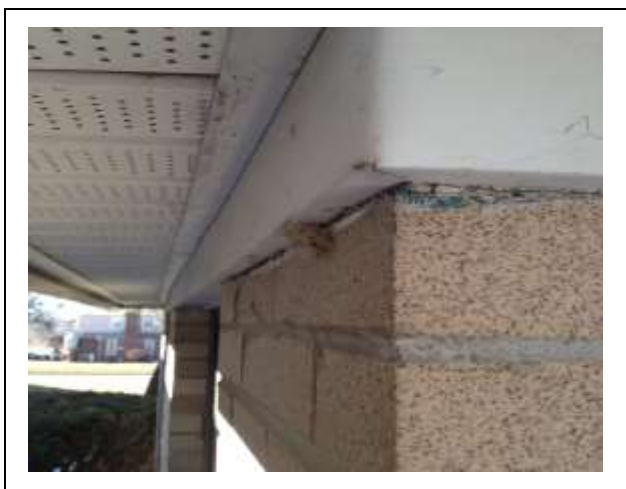
PHOTO 11	Asbestos-Containing Soffit/Roof edge sealant

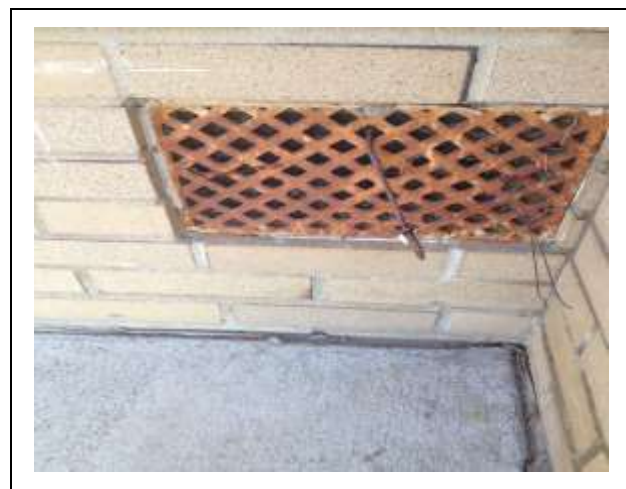
PHOTO 12	Asbestos-Containing Exterior exhaust vent sealant
