## **Asbestos Inspection Report- Supplemental Fire Proofing Testing**

**Denver VA Hospital, Building 21**  
**1055 Clermont Street**  
**Denver, Colorado 80220**

August 26, 2015

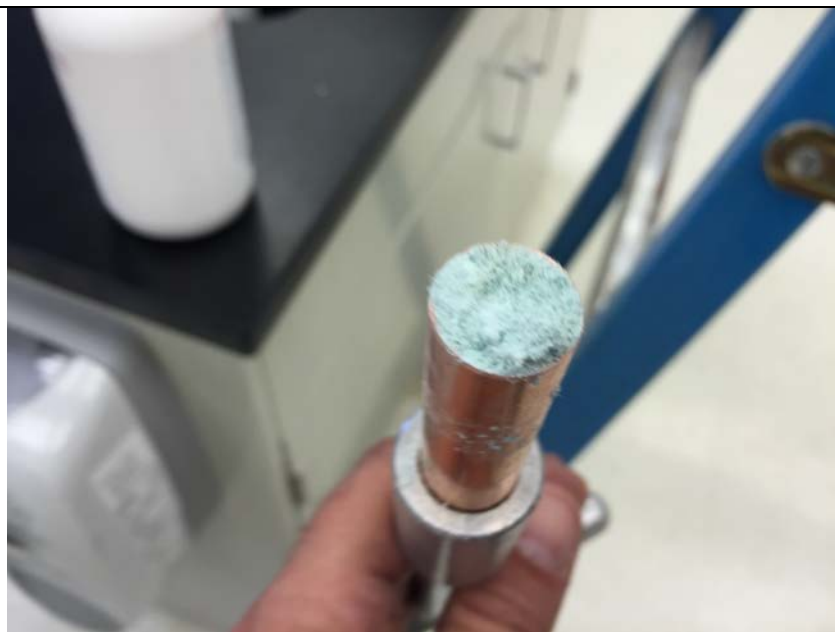
**FP2- Mint Green Fire Proofing Material- ND**

No further action is recommended with respect to the mint green and tan fire proofing.

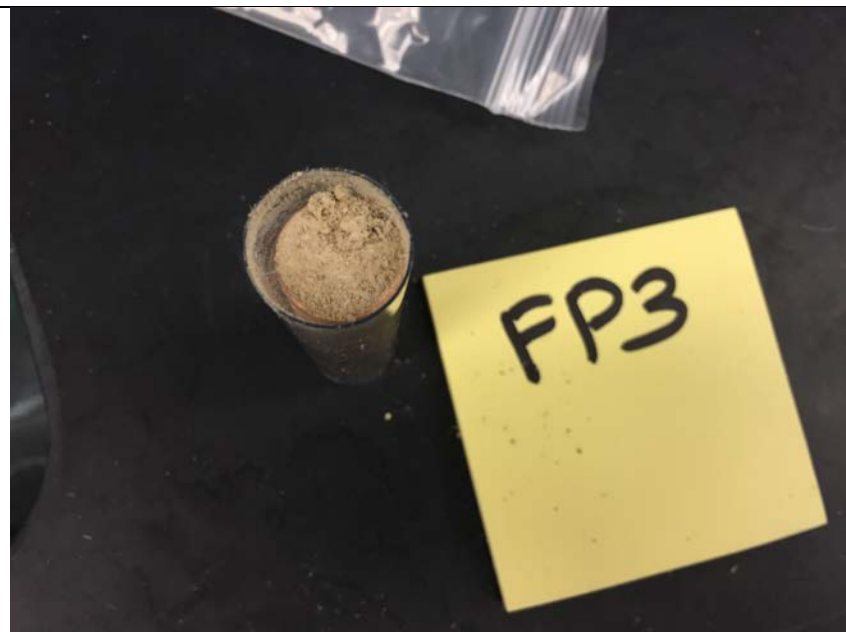
**FP3- Tan/Brownish Fire Proofing Material-ND**
