## **Limited Asbestos Inspection Report**

**Denver VA Hospital, Building 21**  
**1055 Clermont Street**  
**Denver, Colorado 80220**

August 10, 2015

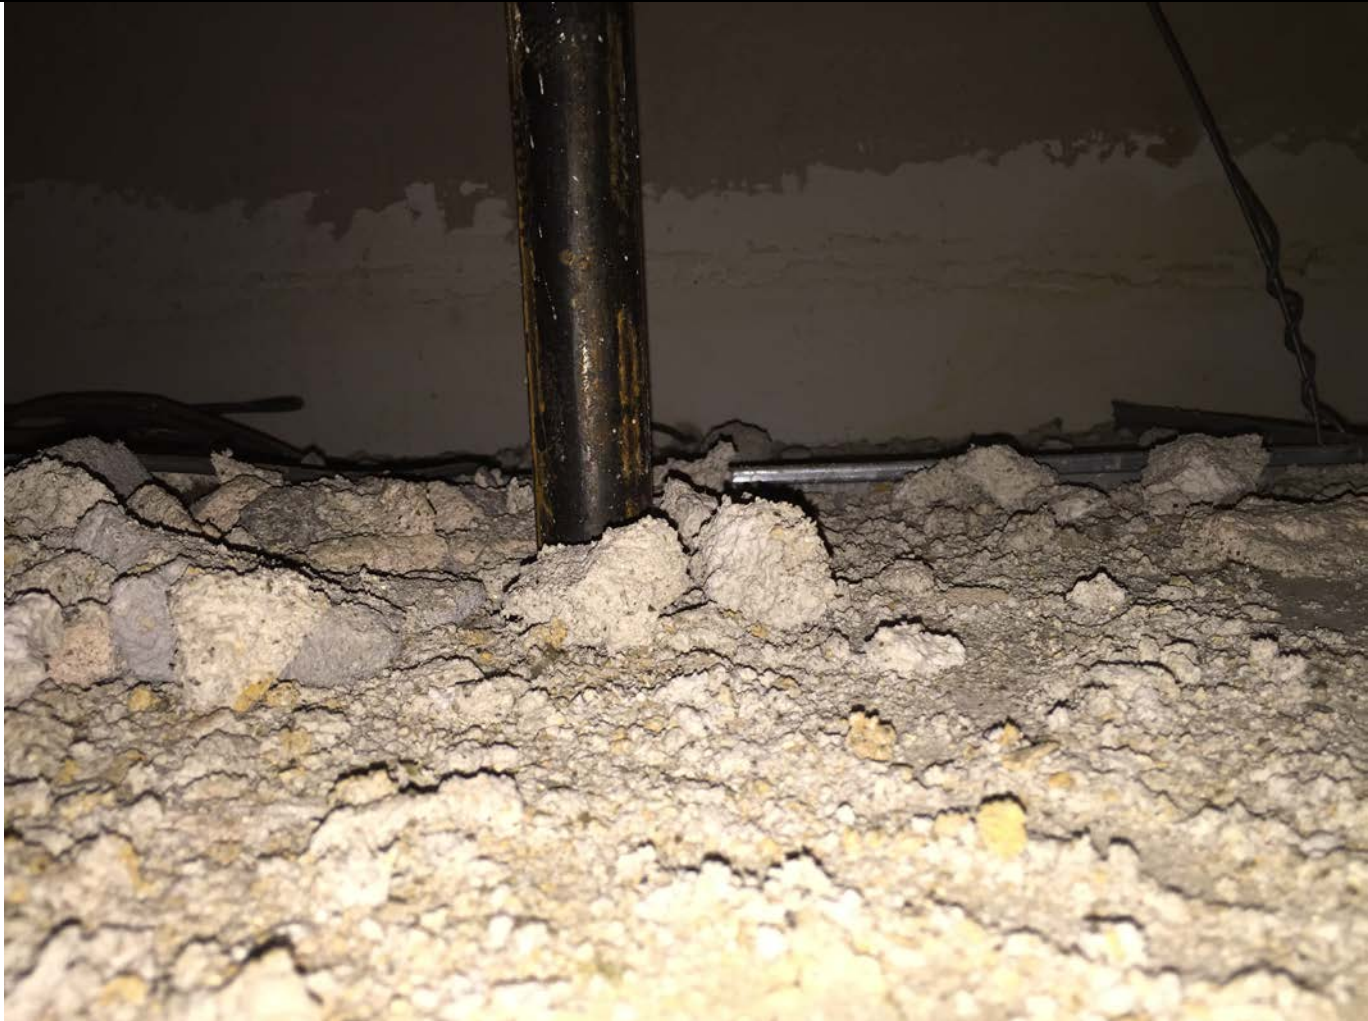
SAMPLE ID	Debris-1
LOCATION	Building 21, above east closet of room 110
MATERIAL	Fire proofing debris
FUNCTIONAL SPACE #	Above east closet of room 110
FRIABLE / NON FRIABLE	Friable

QUANTITY ESTIMATE	Less than a 55-gallon drum
RESULTS	<b>15% Chrysotile</b>
HAZARDOUS ASSESSMENT	This material should be removed as it is loose and is considered a minor spill. The material should be removed by a Colorado-Certified General Abatement Contractor.
MATERIAL DESCRIPTION: gray, white and tan fire proofing.

Please contact a Colorado-Certified to remove the debris above the closet in Room 110. This work should be conducted in accordance with Colorado Regulation No. 8. During removal, a Colorado-Certified Air Monitoring Specialist (AMS), should monitor the area since the building is occupied. Please keep re-inspecting the areas that contain FP1. This material is friable and susceptible to air movement.

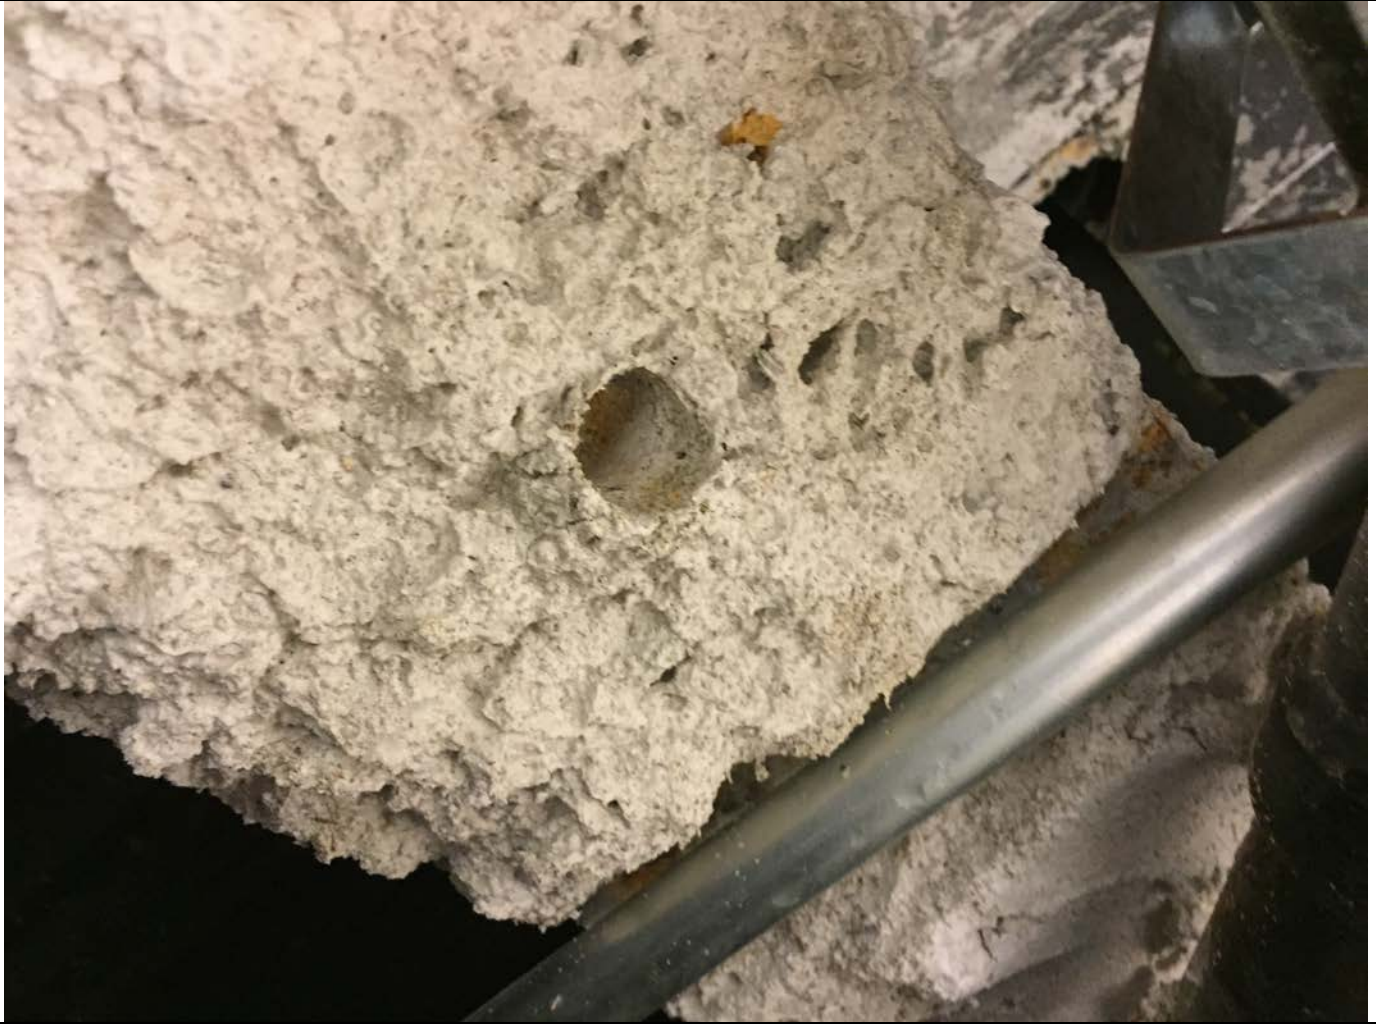
SAMPLE ID	FP1
LOCATION	Building 21, Rooms 110 and 101, stairwells (needs to be delineated/quantified)
MATERIAL	Fire proofing, white, gray and tan
FUNCTIONAL SPACE #	Needs to be delineated
FRIABLE / NON FRIABLE	Friable

QUANTITY ESTIMATE	Not quantified
RESULTS	<b>10 to 15% Chrysotile</b>
HAZARDOUS ASSESSMENT	Recommend removal due to air movement in plenum
MATERIAL DESCRIPTION: fibrous, white/gray and tan color

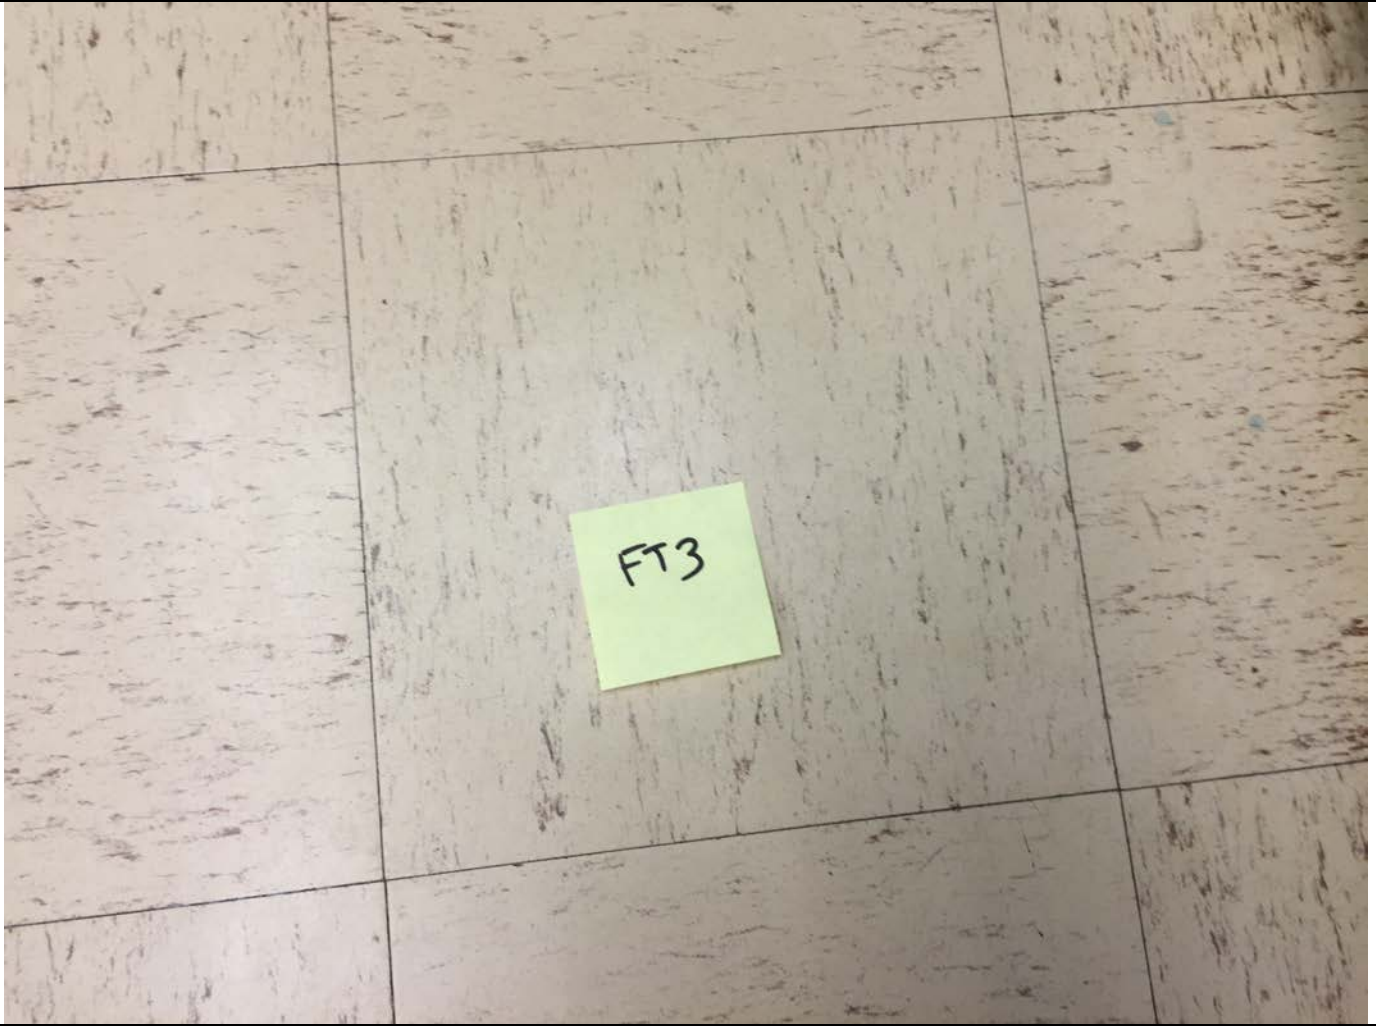
SAMPLE ID	FT3
LOCATION	Building 21, rooms (101)
MATERIAL	Black Mastic
FUNCTIONAL SPACE #	Presumed throughout floor
FRIABLE / NON FRIABLE	Non-friable

QUANTITY ESTIMATE	Not quantified; presumed throughout floor
RESULTS	<b>2% Chrysotile</b>
HAZARDOUS ASSESSMENT	Non-friable; appears in good condition-covered with floor tile
MATERIAL DESCRIPTION: 12x12 tan and brown floor tile, associated with black mastic.

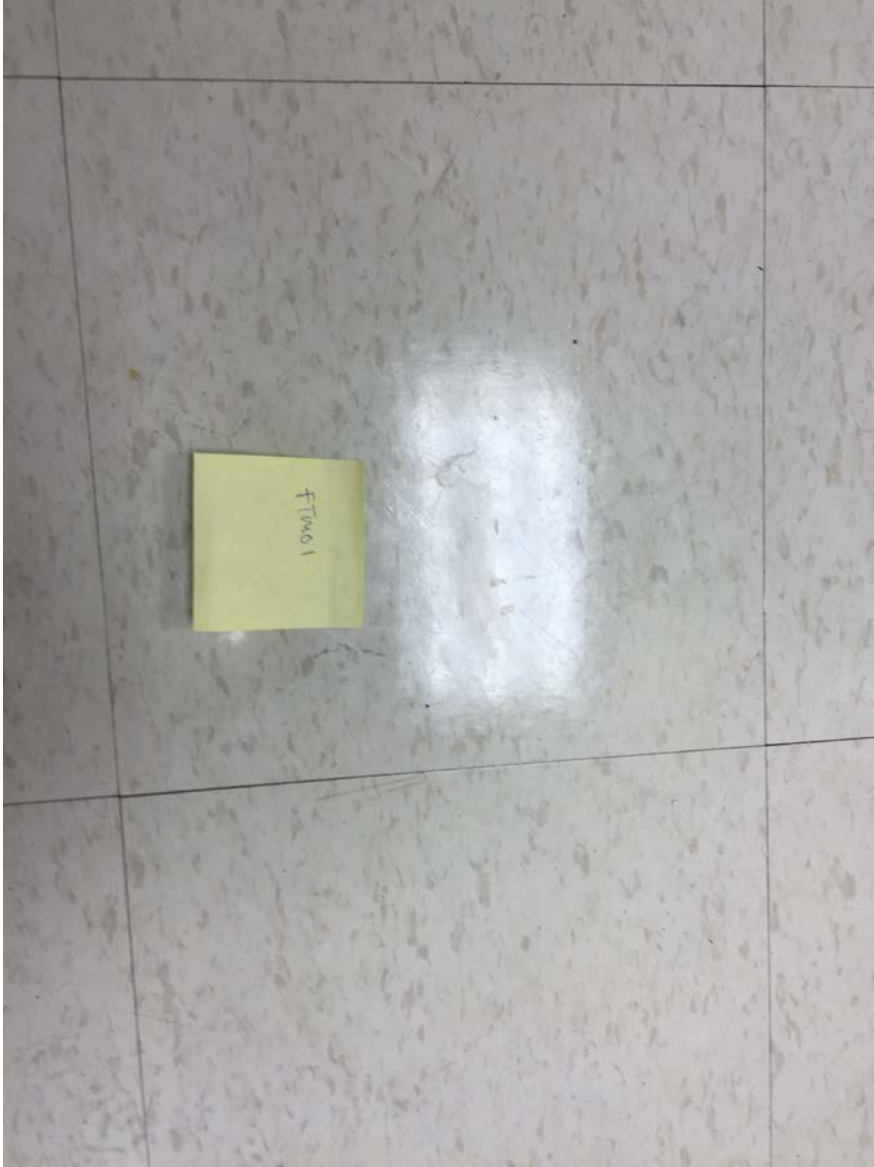
SAMPLE ID	FTM1
LOCATION	Building 21, rooms on first and second floors
MATERIAL	Black Mastic
FUNCTIONAL SPACE #	Presumed throughout floor
FRIABLE / NON FRIABLE	Non-friable

QUANTITY ESTIMATE	Not quantified; presumed throughout floor
RESULTS	<b>Trace to 2% Chrysotile</b>
HAZARDOUS ASSESSMENT	Non-friable; appears in good condition
MATERIAL DESCRIPTION: 12x12 light greenish tint floor tile, associated with black mastic.
