Report of Findings Asbestos Survey

Building 212
VA Medical Center
Chillicothe, Ohio

HSA Report

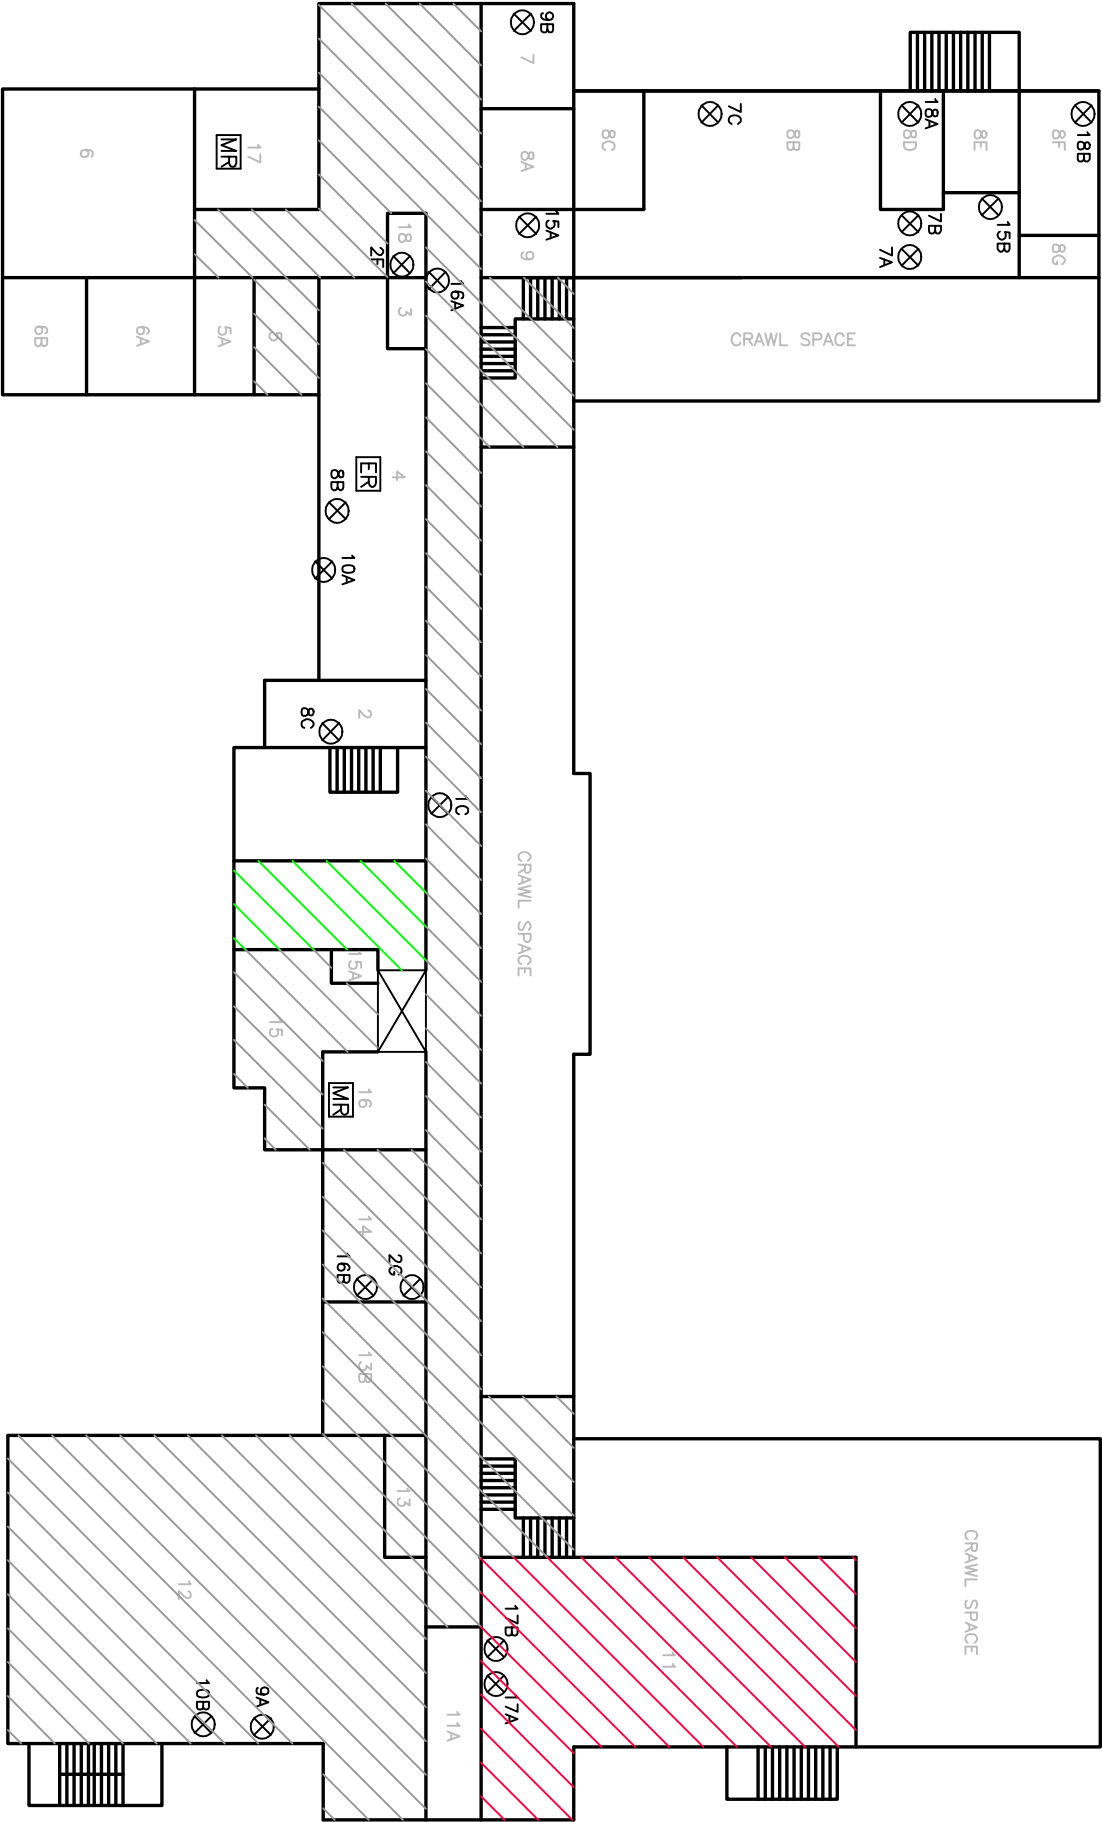
FIGURE 18.0

09	212	Grey Exterior Window Caulk	NF-II	1108	l.f.	Basement	Exterior Windows	Positive	Medium
09	212	Grey Exterior Window Caulk	NF-II	2008	l.f.	First Floor	Exterior Windows	Positive	Medium
09	212	Grey Exterior Window Caulk	NF-II	2128	l.f.	Second Floor	Exterior Windows	Positive	Medium
10	212	Grey Exterior Window Glazing	NF-II	9624	l.f.	First Floor	Exterior Windows	Negative	Medium

16	212	12" x 12" Off-White Floor Tile with Brown Streaks and associated Mastic	NF-I	170	s.f.	Basement	South Stairwell	Positive	Medium
16	212	12" x 12" Off-White Floor Tile with Brown Streaks and associated Mastic	NF-I	210	s.f.	Basement	13B	Positive	Medium

17	212	12" x 12" White Floor Tile with Dark Streaks and associated Mastic	NF-I	1215	s.f.	Basement	11	Positive	Medium
18	212	Yellow and Black Carpet Mastic	NF-I	220	s.f.	Basement	8F	Negative	Low
18	212	Yellow and Black Carpet Mastic	NF-I	135	s.f.	Basement	8D	Negative	Low
19	212	9" x 9" Green and White (Checker Pattern) Floor Tile and associated Mastic	NF-I	235	s.f.	Basement	Hallway	Positive	Medium

HSA-09: GREY EXTERIOR WINDOW CAULK
-

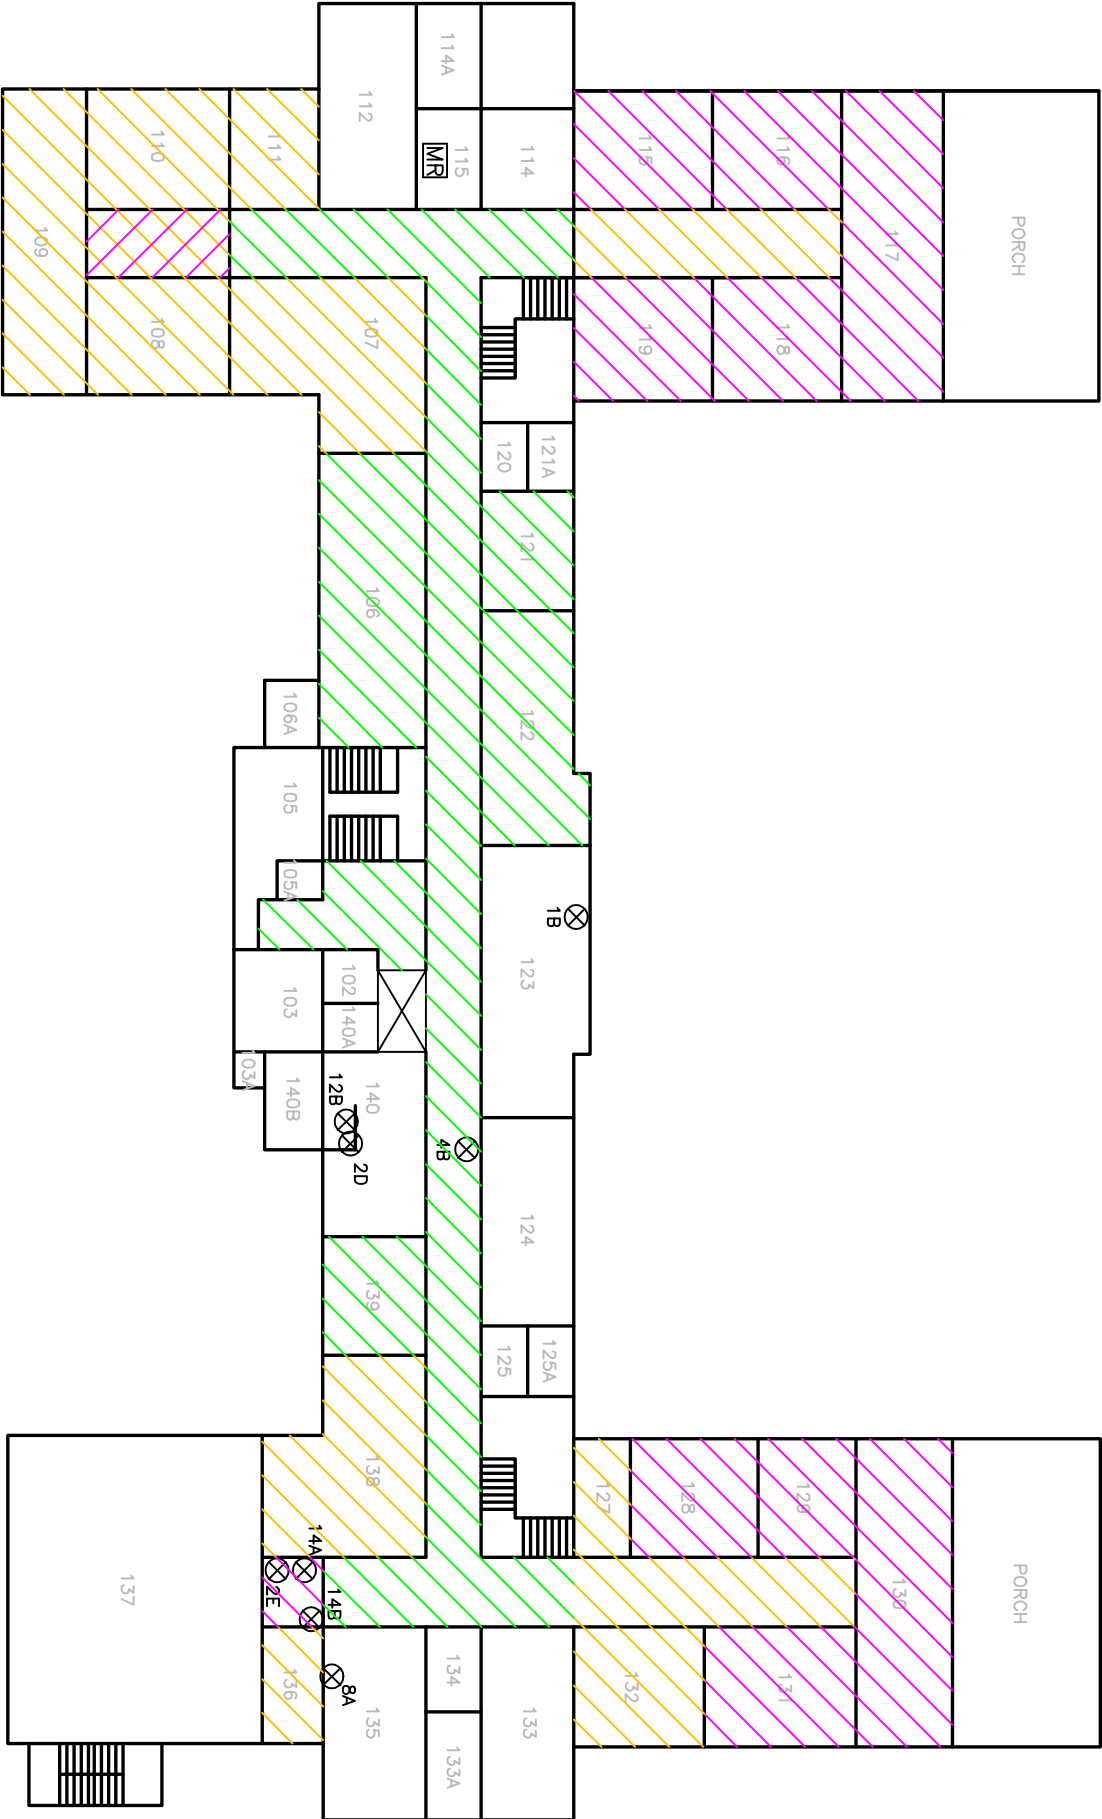
FIGURE 18.1

ALL EXTERIOR WINDOWS HAVE ACM CAULK

HSA-19: 9"x9" GREEN AND WHITE CHECKER PATTERN FLOOR TILE AND ASSOCIATED MASTIC

HSA-21: 9"x9" WHITE WITH GREEN SMUDGES FLOOR TILE AND ASSOCIATED MASTIC

HSA-23: 9"x9" GREEN FLOOR TILE AND ASSOCIATED MASTIC
