Roth Environmental Consultants, Incorporated
a Division of Roth Industries, Inc. ®

September 30, 2015

Re: Limited Lead-Based Paint Testing
John Cochran VA Medical Center
915 North Grand Blvd. St. Louis, MO 63106

Limited Lead-Based Paint Testing

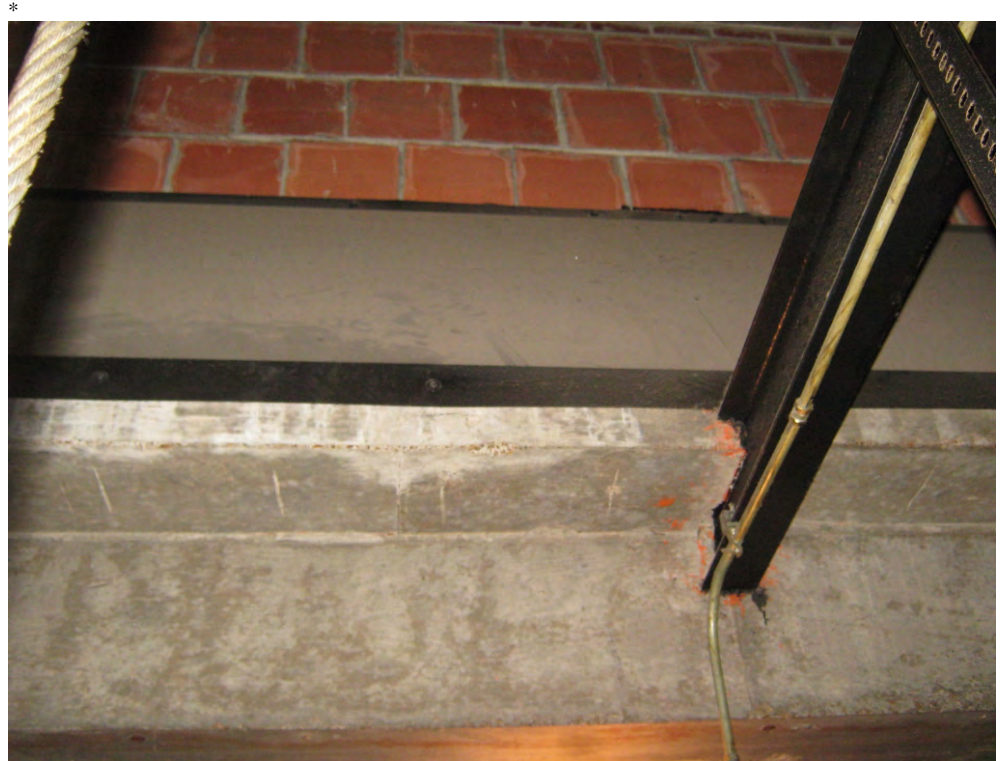
Photographer: M Liechti
Date: 9/17/15
Direction:
Comments: Passenger
Elevator Bank
A Cars 1-6

Black Metal Divider Beam: 528 LF
Black Metal Car Rail: 1,800 LF
Black Metal Counterweight Rail: 1,800 LF
Black Metal Counterweight Spreader Beam: 360 LF
Black Metal Counterweight Frame: 6 Each measuring 4'x3'
Black Metal Ladder: 4 Each at 15' Tall

Black Metal
Divider Beam
(Right Side of
Photo)

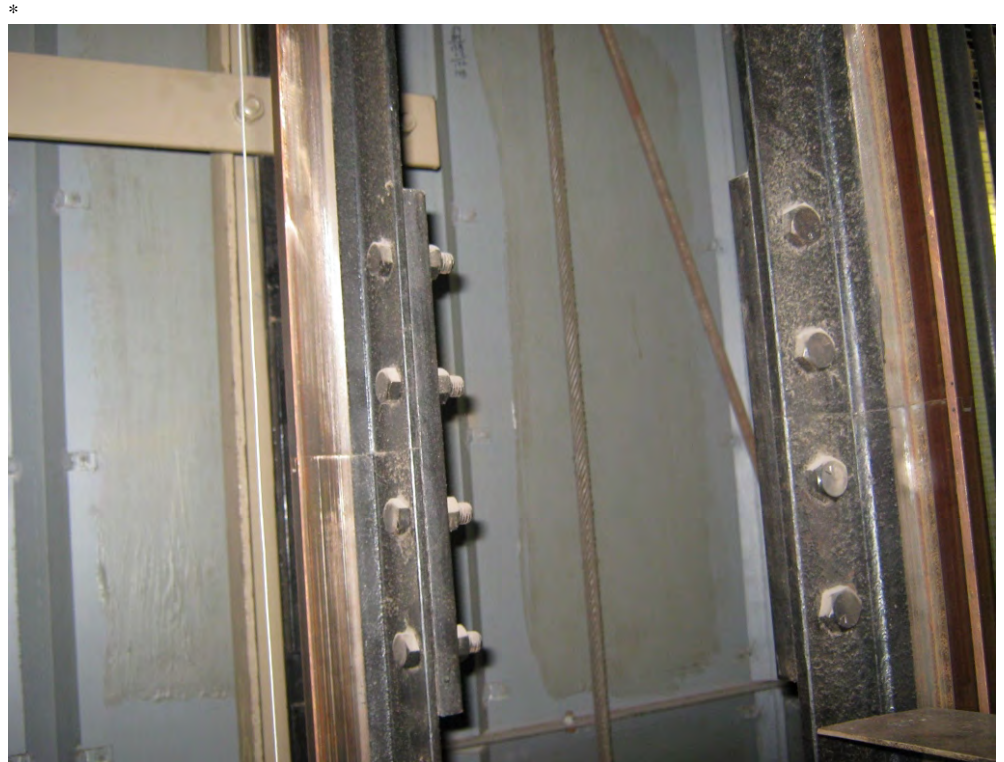
Photographer: M Liechti
Date: 9/17/15
Direction:
Comments: Passenger
Elevator Bank
A Cars 1-6

Black Metal
Car Rail

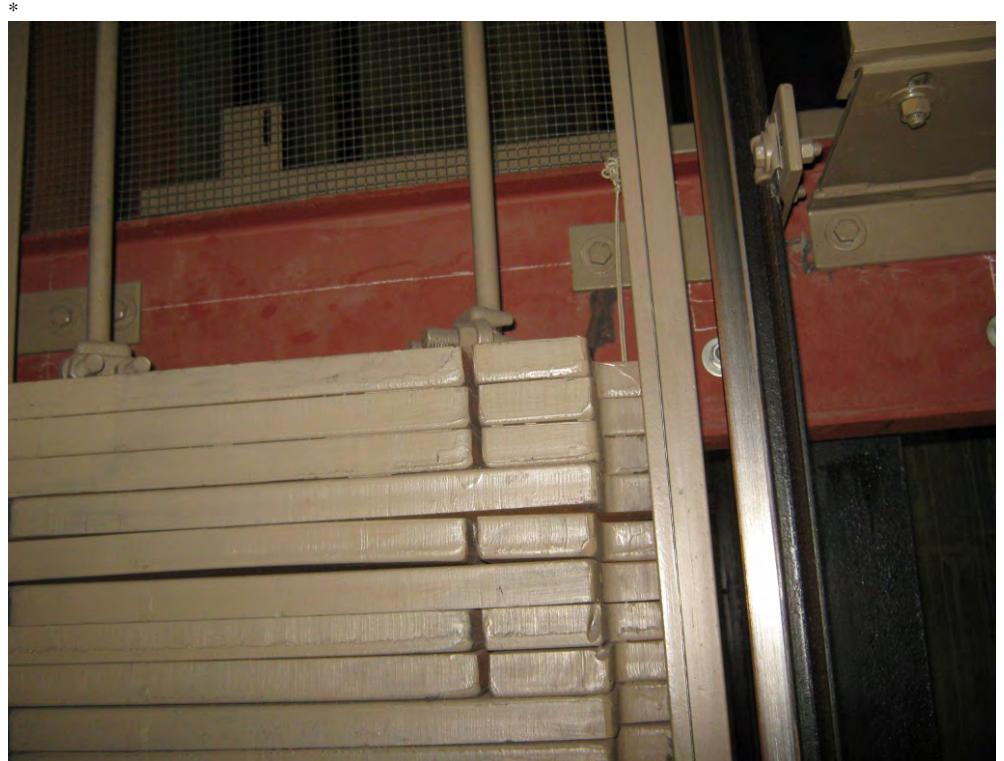
Photographer: M Liechti
Date: 9/17/15
Direction:
Comments: Passenger
Elevator Bank
A Cars 1-6

Black Metal
Counterweight
Rail
(Right Side of
Photo)

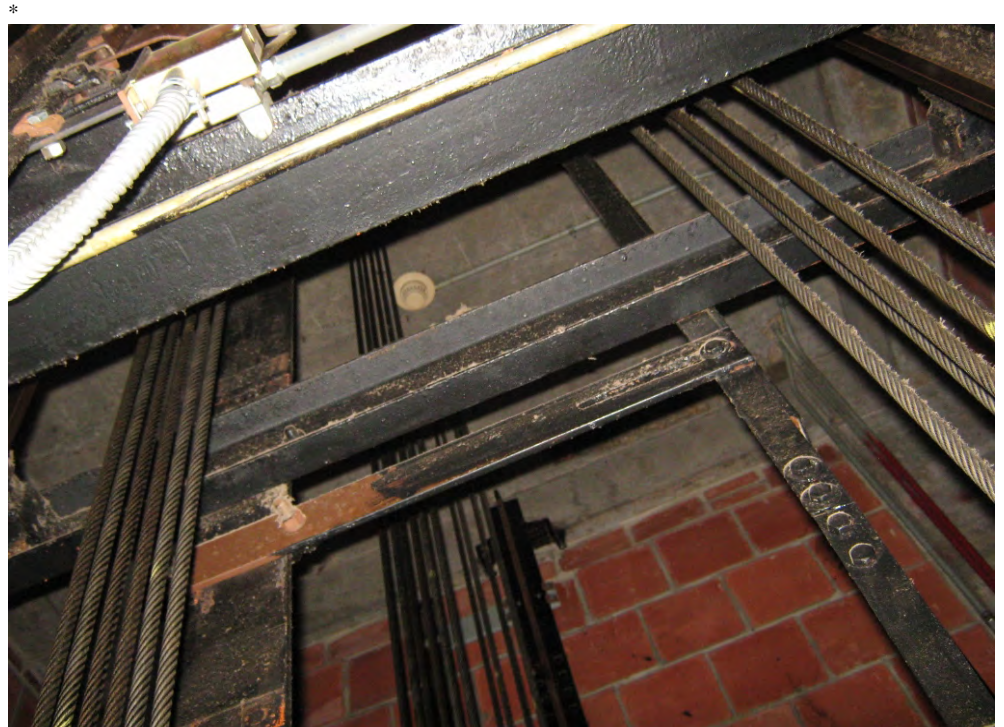
Photographer: M Liechti
Date: 9/17/15
Direction:
Comments: Passenger
Elevator Bank
A Cars 1-6

Black Metal
Counterweight
Spreader Beam
(Center of
Photo)

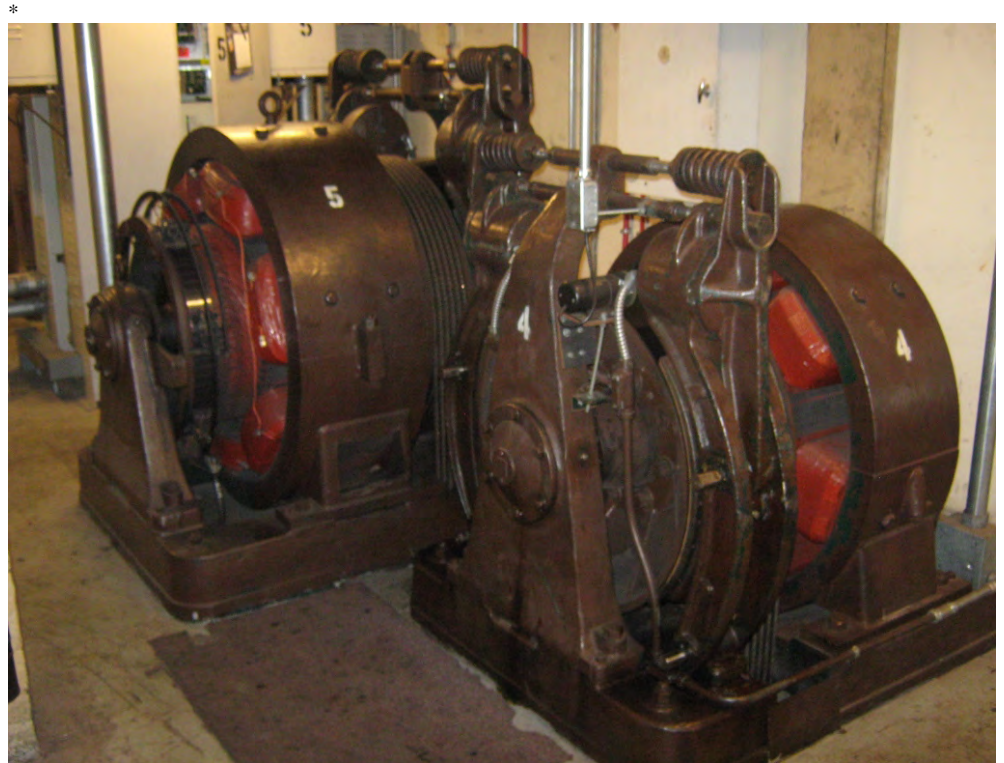
Photographer: M Liechti
Date: 9/17/15
Direction:
Comments: Elevator
Machine Room
Penthouse Cars
1-6

Brown Metal Elevator Machine Housing: 6 Each measuring 6' x 6.5'
Brown Metal Bed Plate: 6 Each measuring 5'x5'
Brown Metal Brakes: 6 Each
Beige Metal Ceiling Beam: 120 LF
Gray Wood Window Trim: 3 Each measuring 4'x3'
Beige Wood Window Trim: 2 Each measuring 4'x3'

Brown Metal
Elevator
Machine
Housing
(Cylindrical
housing)

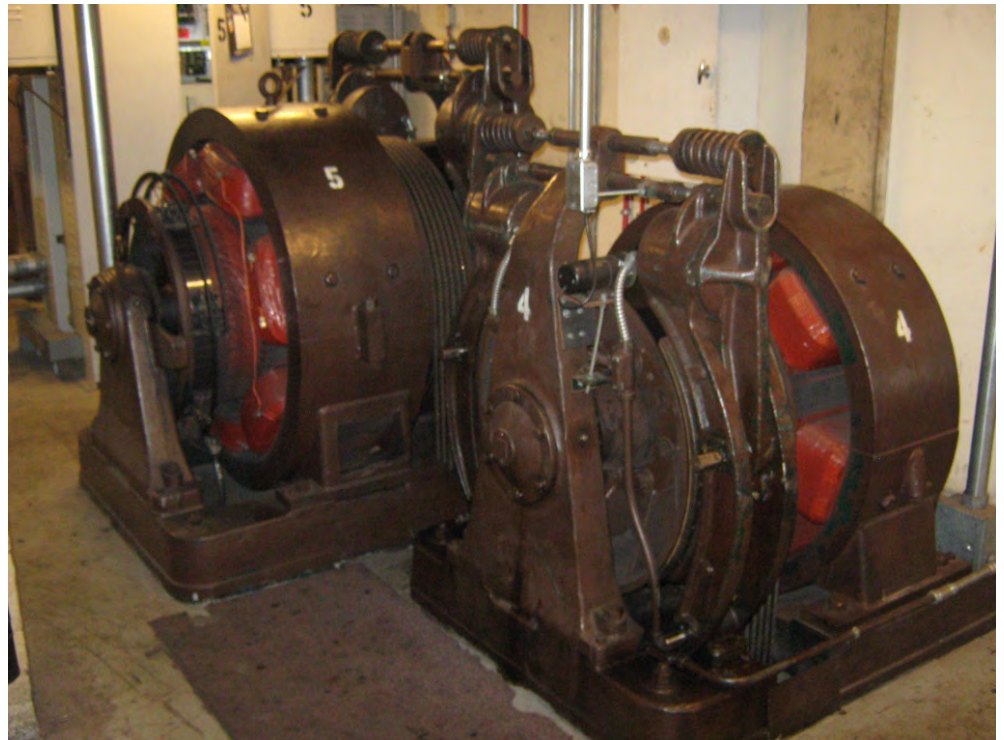
Photographer: M Liechti
Date: 9/17/15
Direction:
Comments: Elevator
Machine Room
Penthouse Cars
1-6

Brown Metal
Bed Plate
(Bottom Plate)

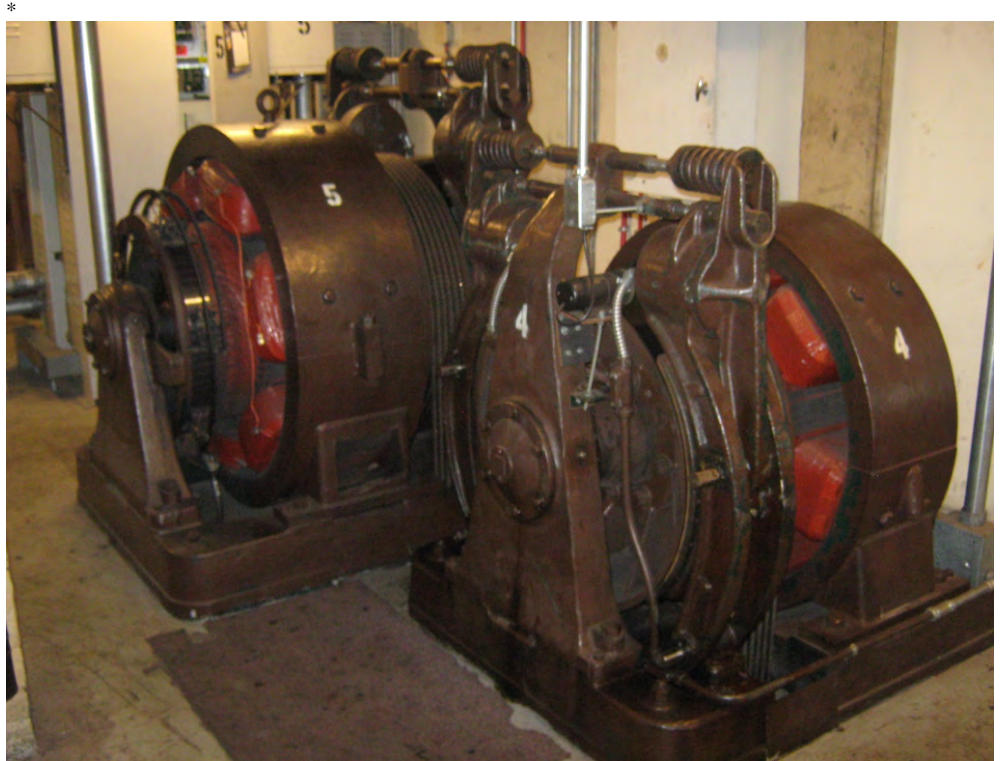
Photographer: M Liechti
Date: 9/17/15
Direction:
Comments: Elevator
Machine Room
Penthouse Cars
1-6

Brown Metal
Brakes
(Brakes
pictured on the
left side of Car
4)

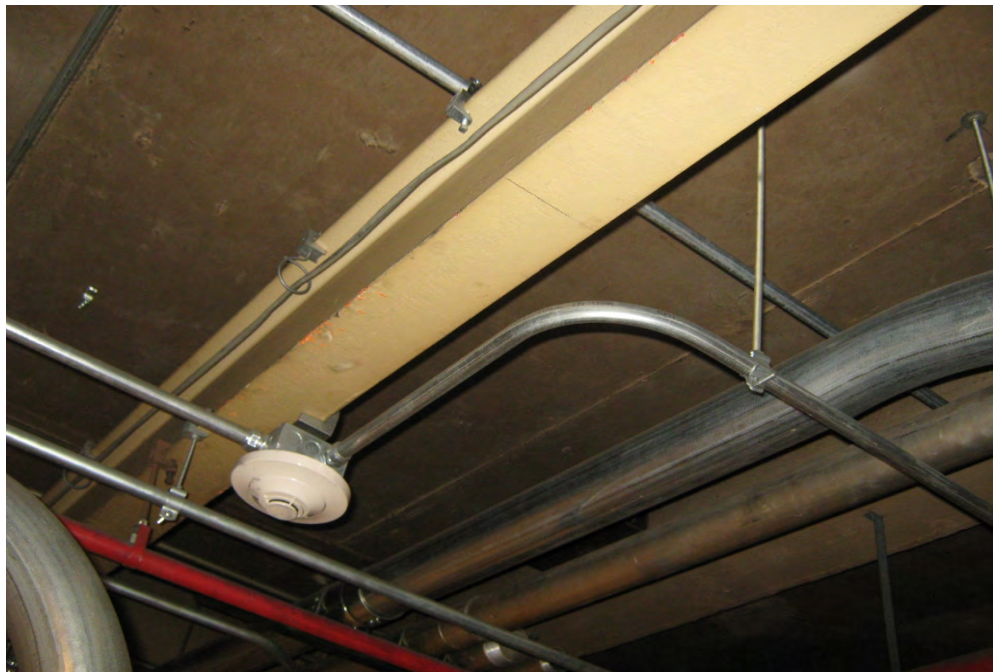
Photographer: M Liechti
Date: 9/17/15
Direction:
Comments: Elevator
Machine Room
Penthouse Cars
1-6

Beige Metal
Ceiling Beam

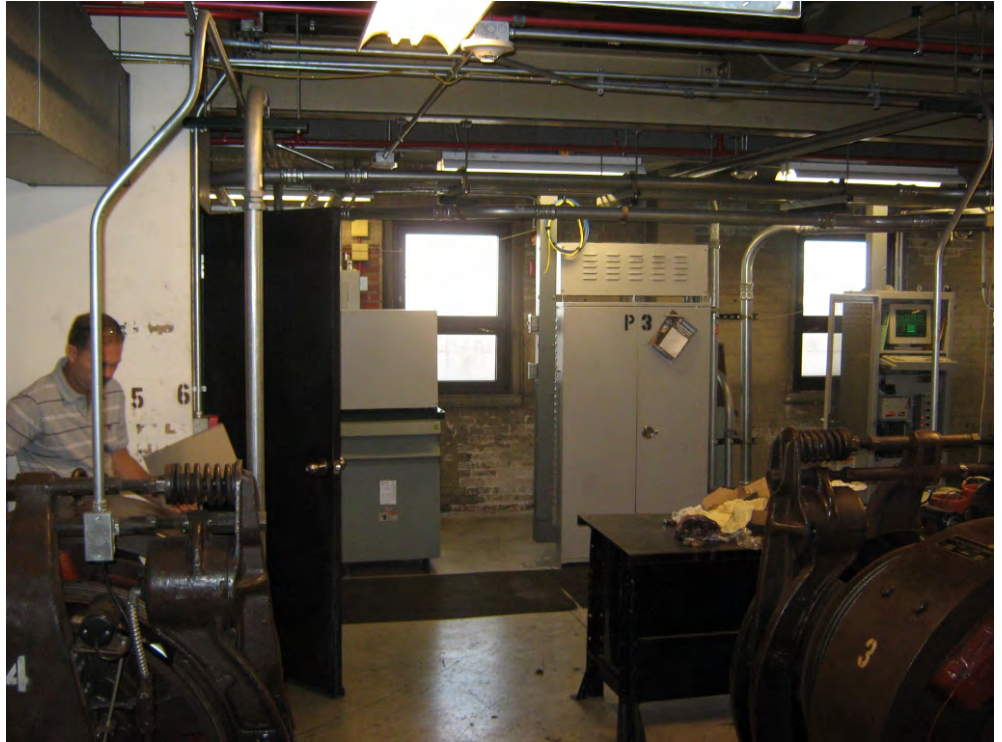
Photographer: M Liechti
Date: 9/17/15
Direction:
Comments: Elevator
Machine Room
Penthouse Cars
1-6

Gray & Beige
Wood Window
Trim
(Shown in rear
of photo)

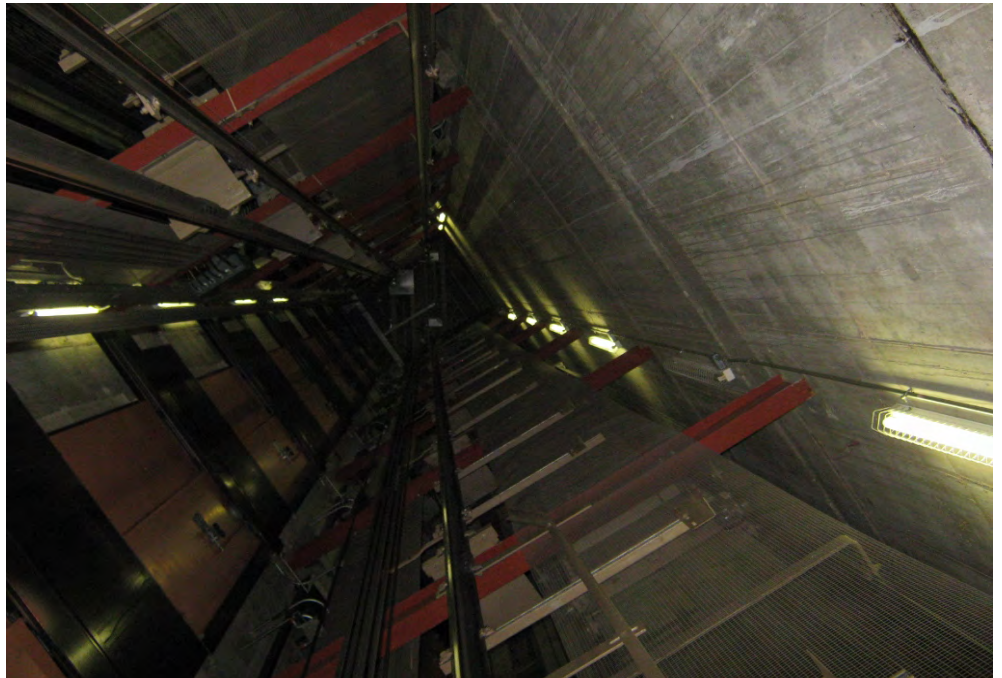
Photographer: M Liechti
Date: 9/17/15
Direction:
Comments: Passenger
Elevator Bank
B Cars 7-9

Orange Metal Divider Beam: 264 LF

Orange Metal
Divider Beam

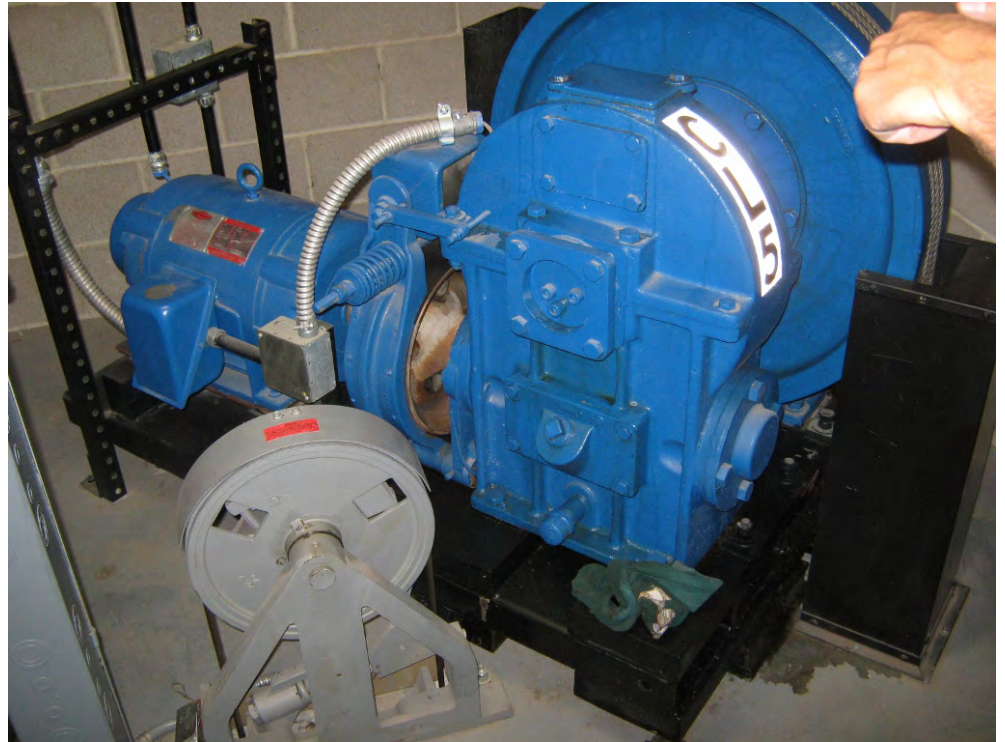
Photographer: M Liechti
Date: 9/17/15
Direction:
Comments: Cart Lift 5 and
6 Equipment
Room
Penthouse

Blue Metal Motor Housing: 2 Each

Blue Metal
Motor Housing
