**ATTACHMENT 1
PICTURES**

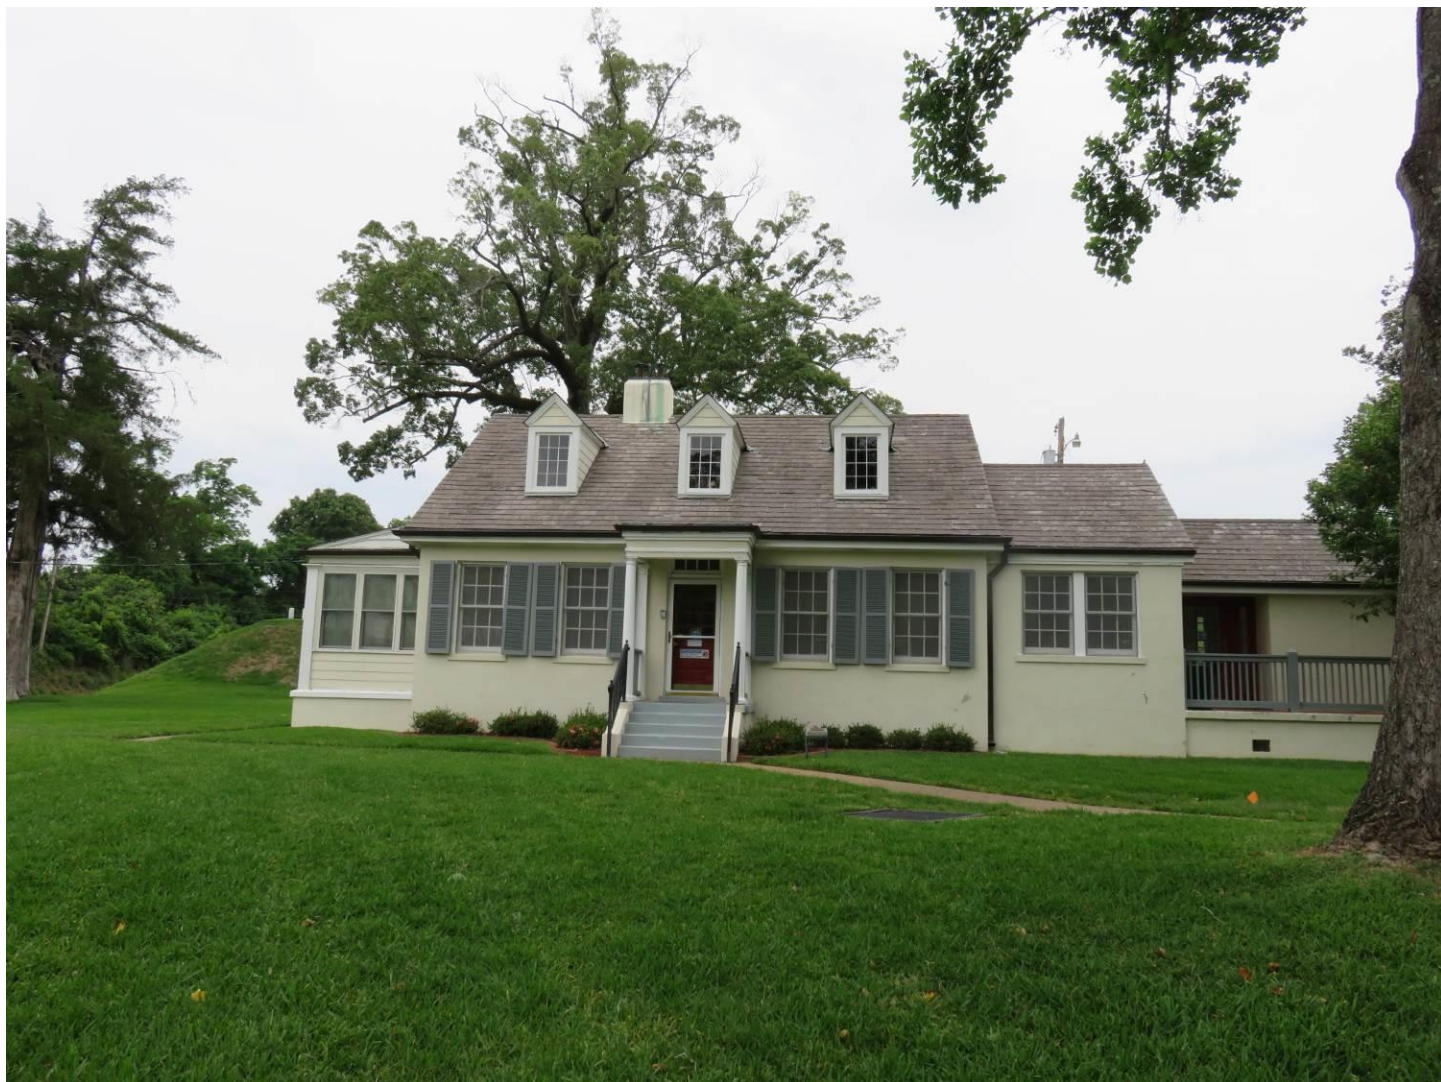
Figure 1: Front of building (South side), entrance; public restrooms on right

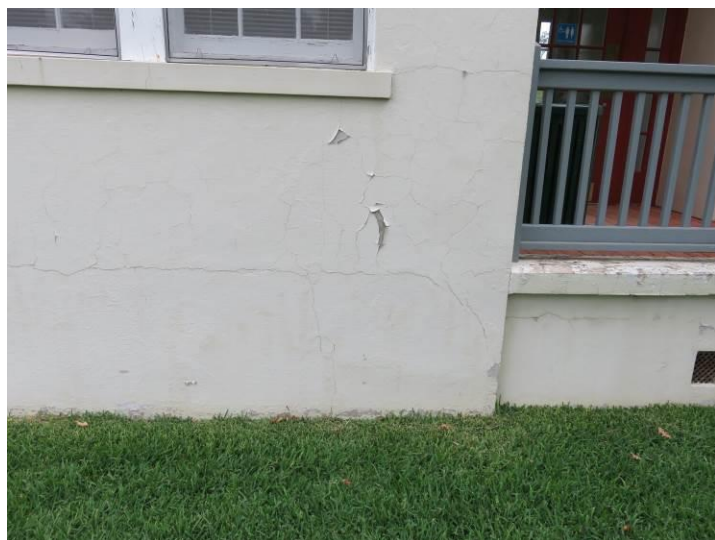
Figure 2: Condition of stucco (typical)

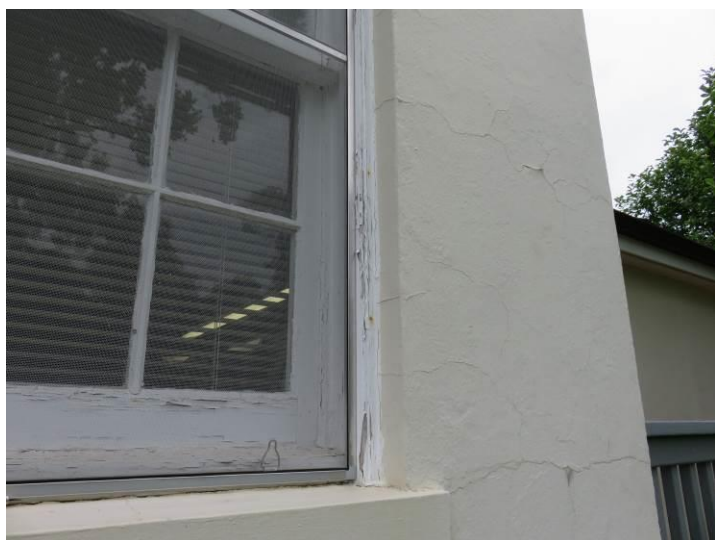
Figure 3: Condition of window frame, sash, and muntin (typ.)

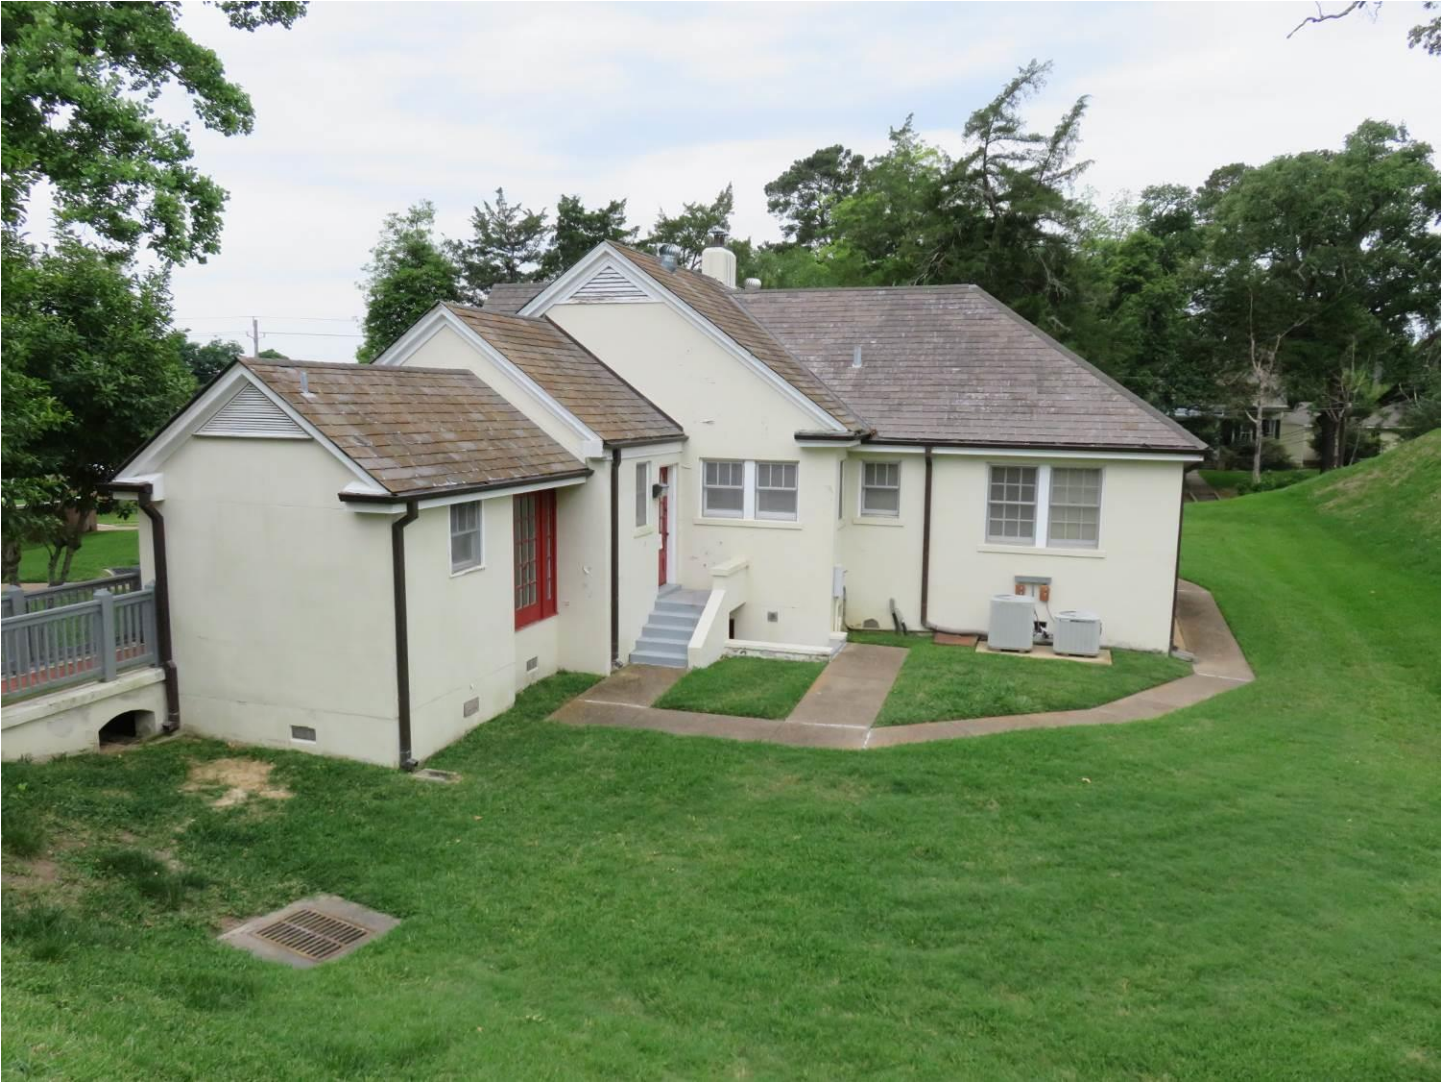
Figure 4: East side of building, rear entrance; public restrooms in foreground

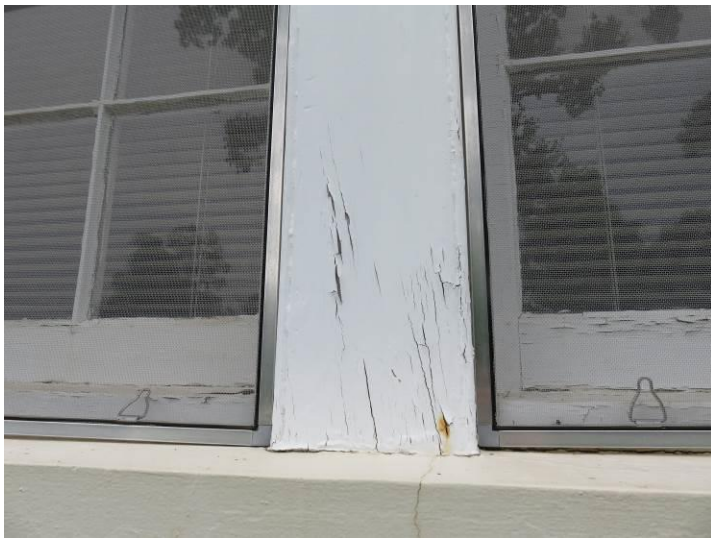
Figure 5: Condition of window divider (typ.)

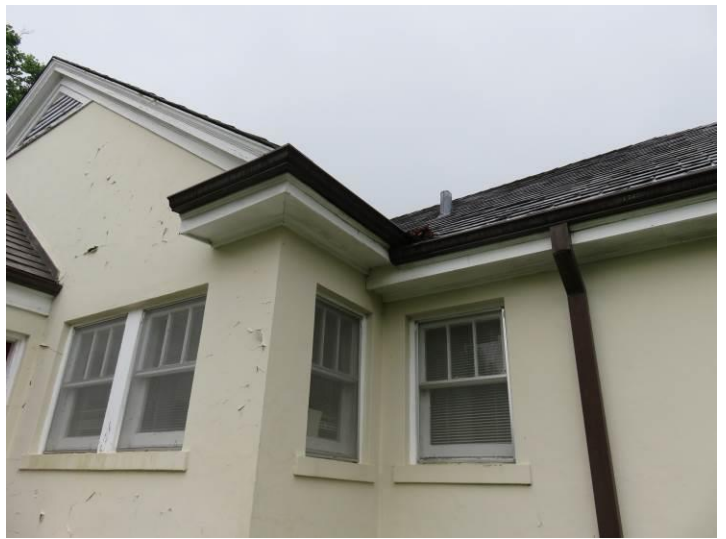
Figure 6: Close up of East side

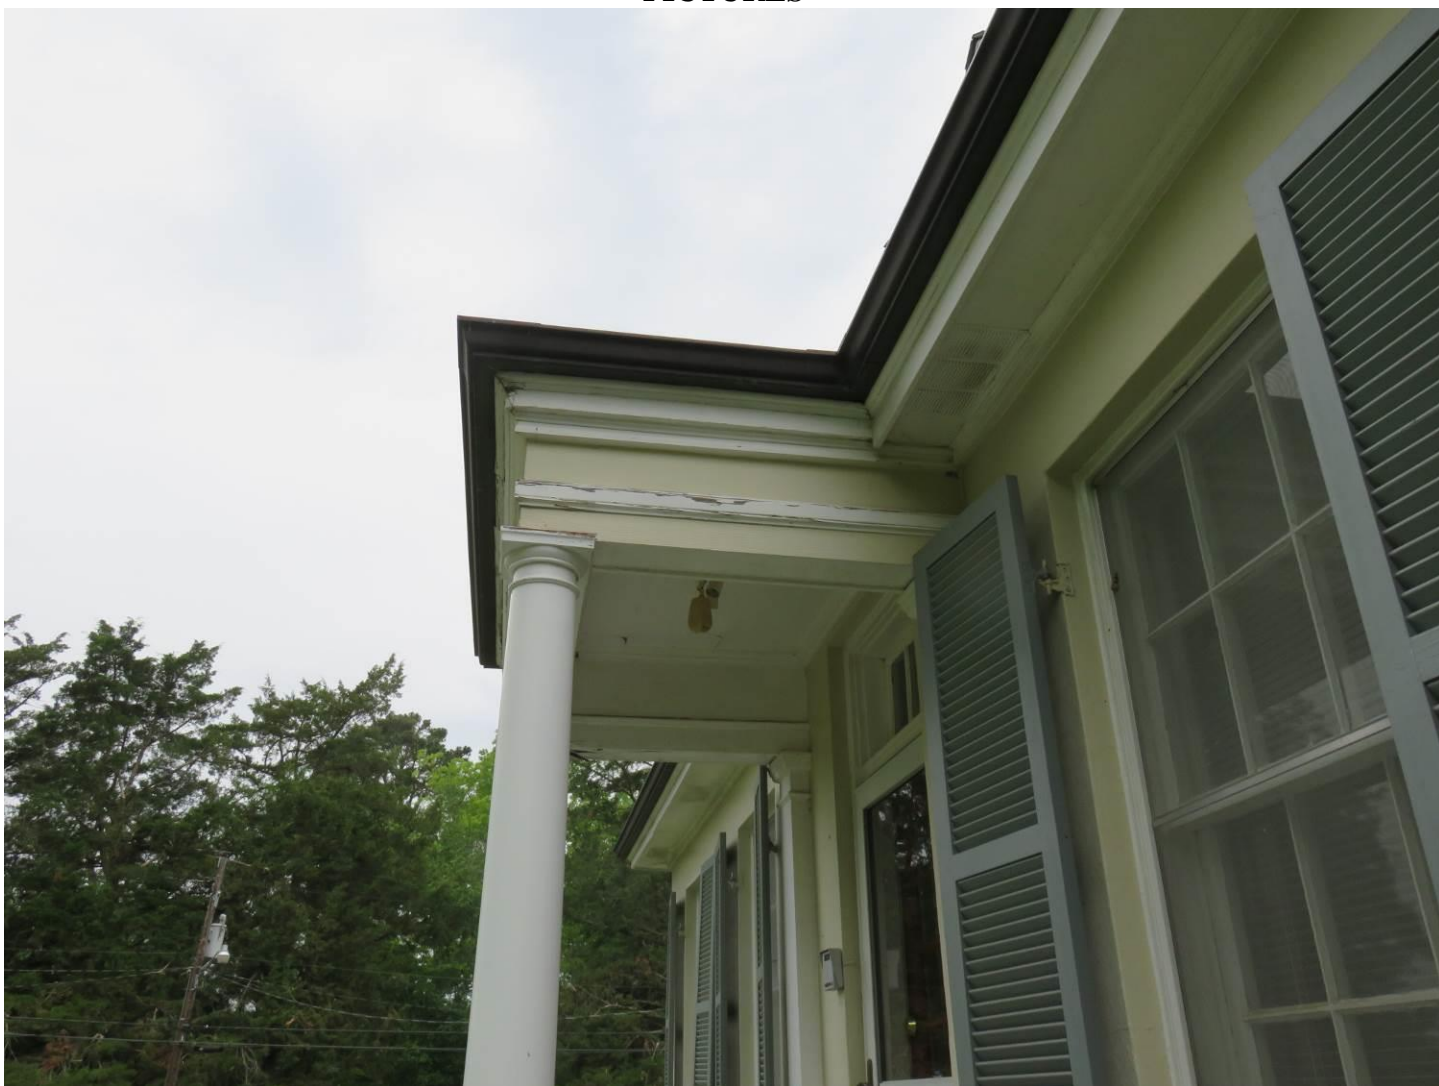
Figure 7: Front entrance overhang

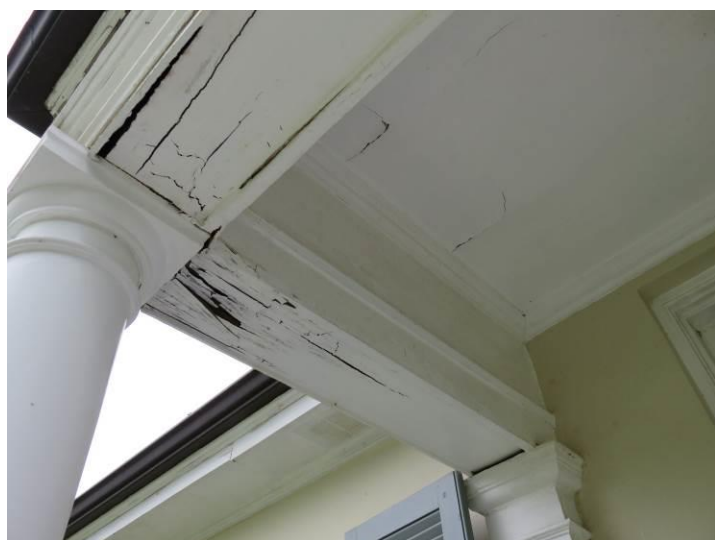
Figure 8: Casing to be replaced

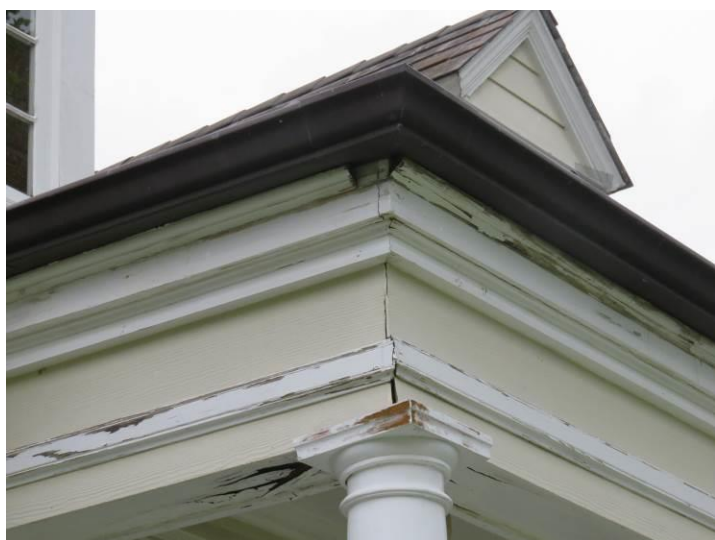
Figure 9: Detail of overhang moulding (typ.)

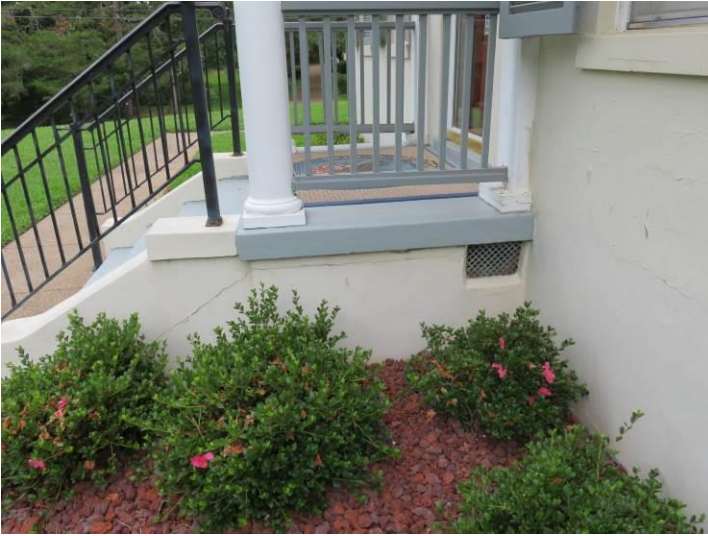
Figure 10: Side of entrance steps

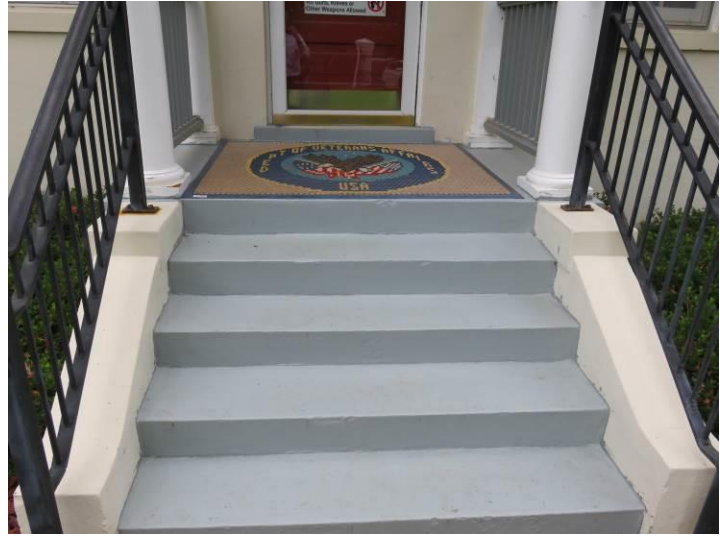
Figure 11: Front of steps

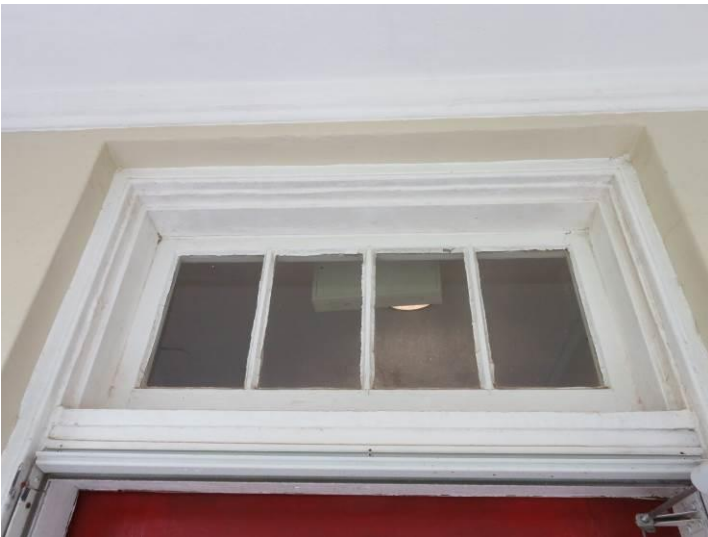
Figure 12: Over-door light

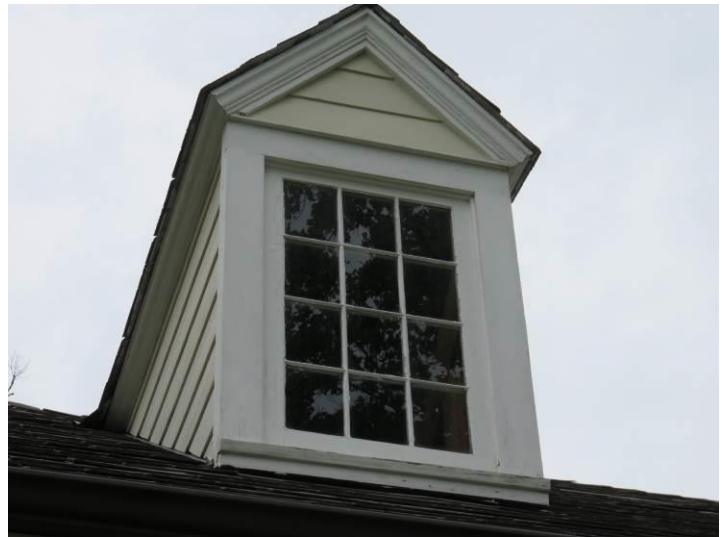
Figure 13: Dormer (typical of three)

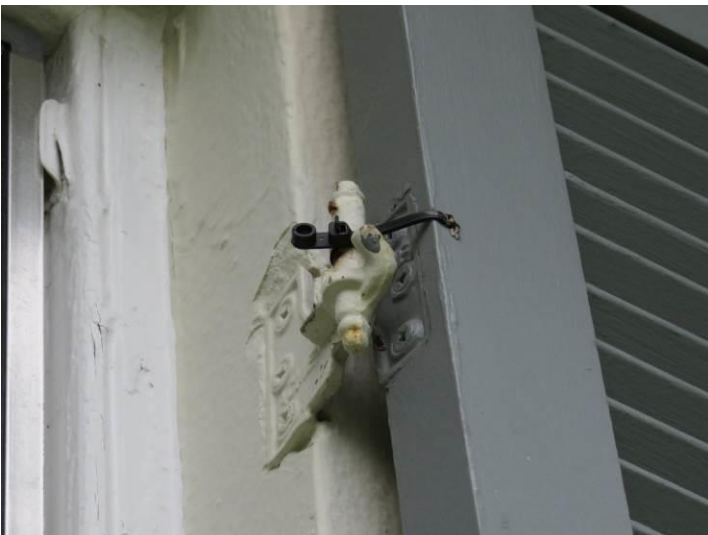
Figure 14: Shutter hardware to be replaced (typ.)

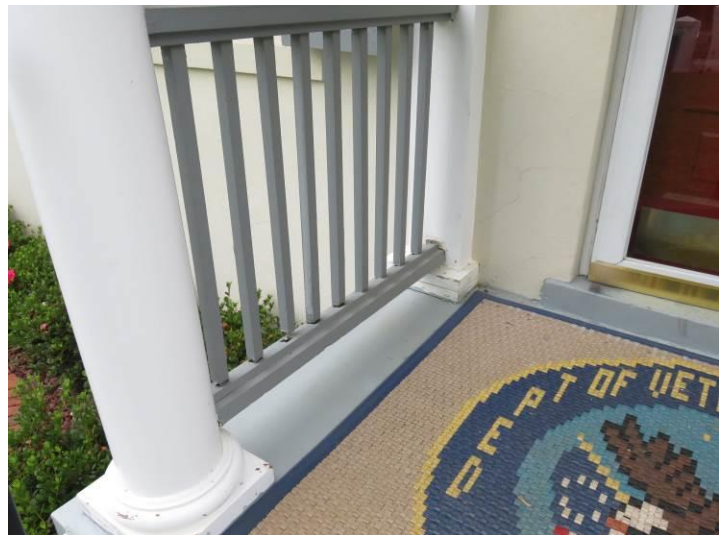
Figure 15: Entrance railing to be replaced

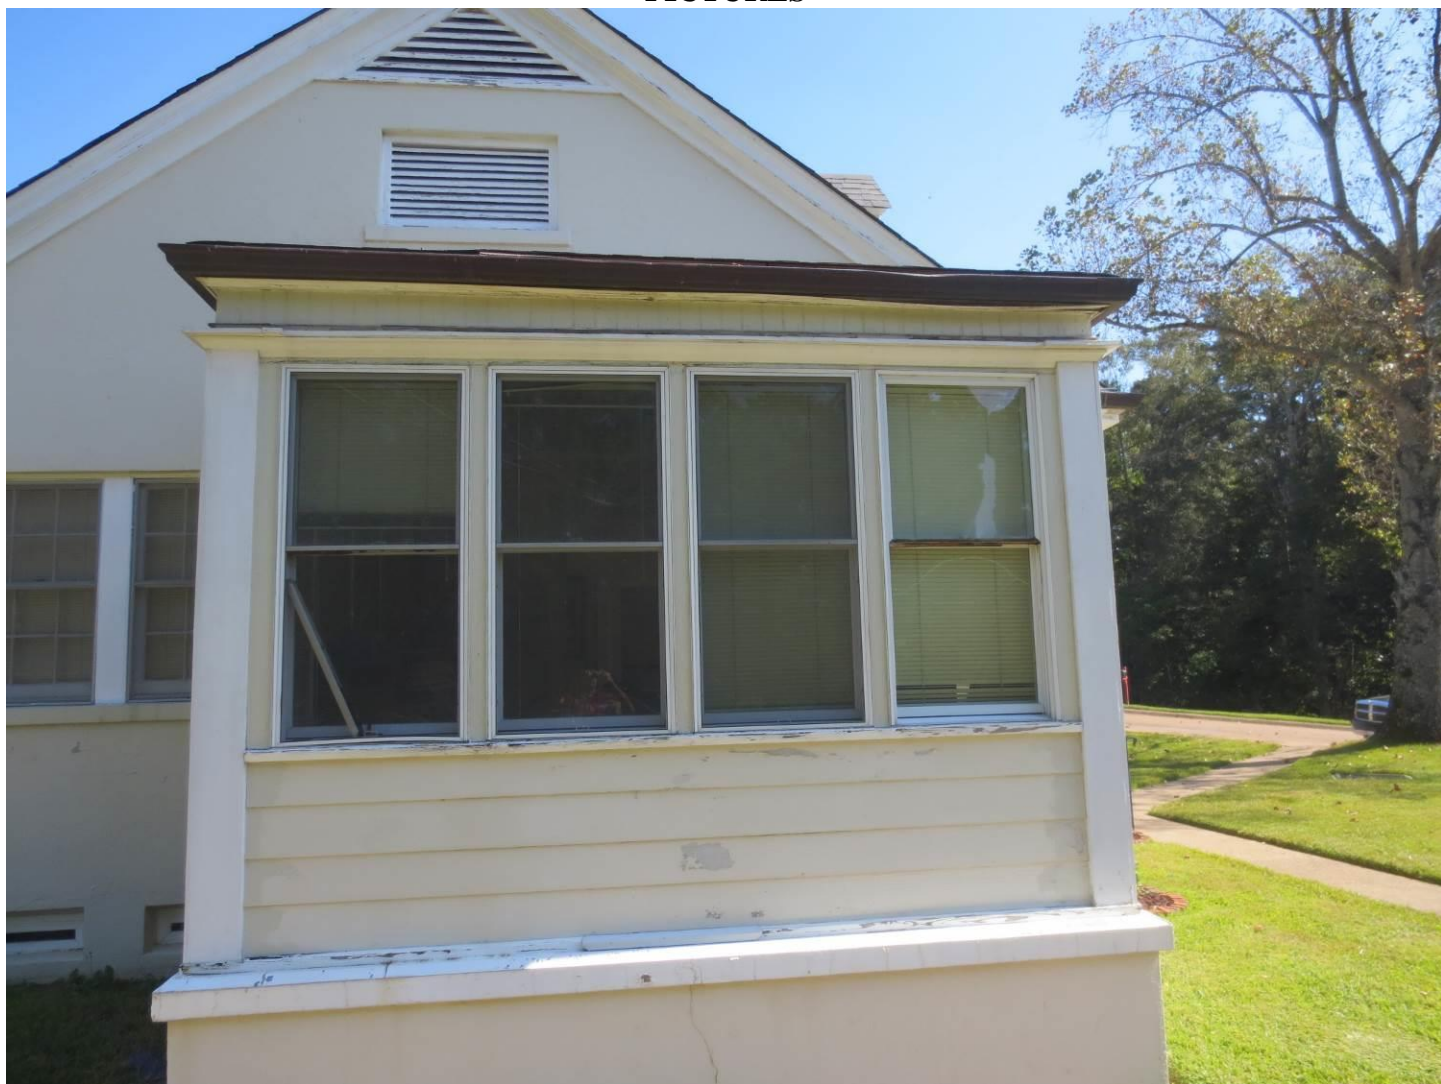
Figure 16: West side of porch enclosure; repair upper sash, outer two windows

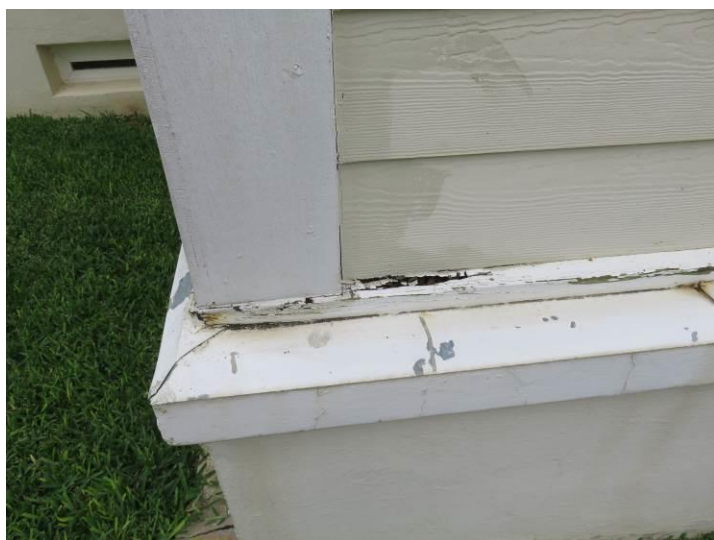
Figure 17: Rotten enclosed porch sill plate

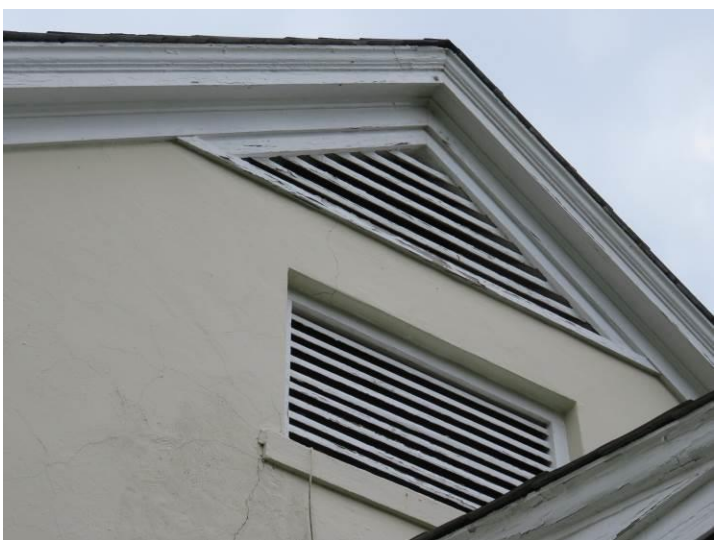
Figure 18: Gable vent (typ.)

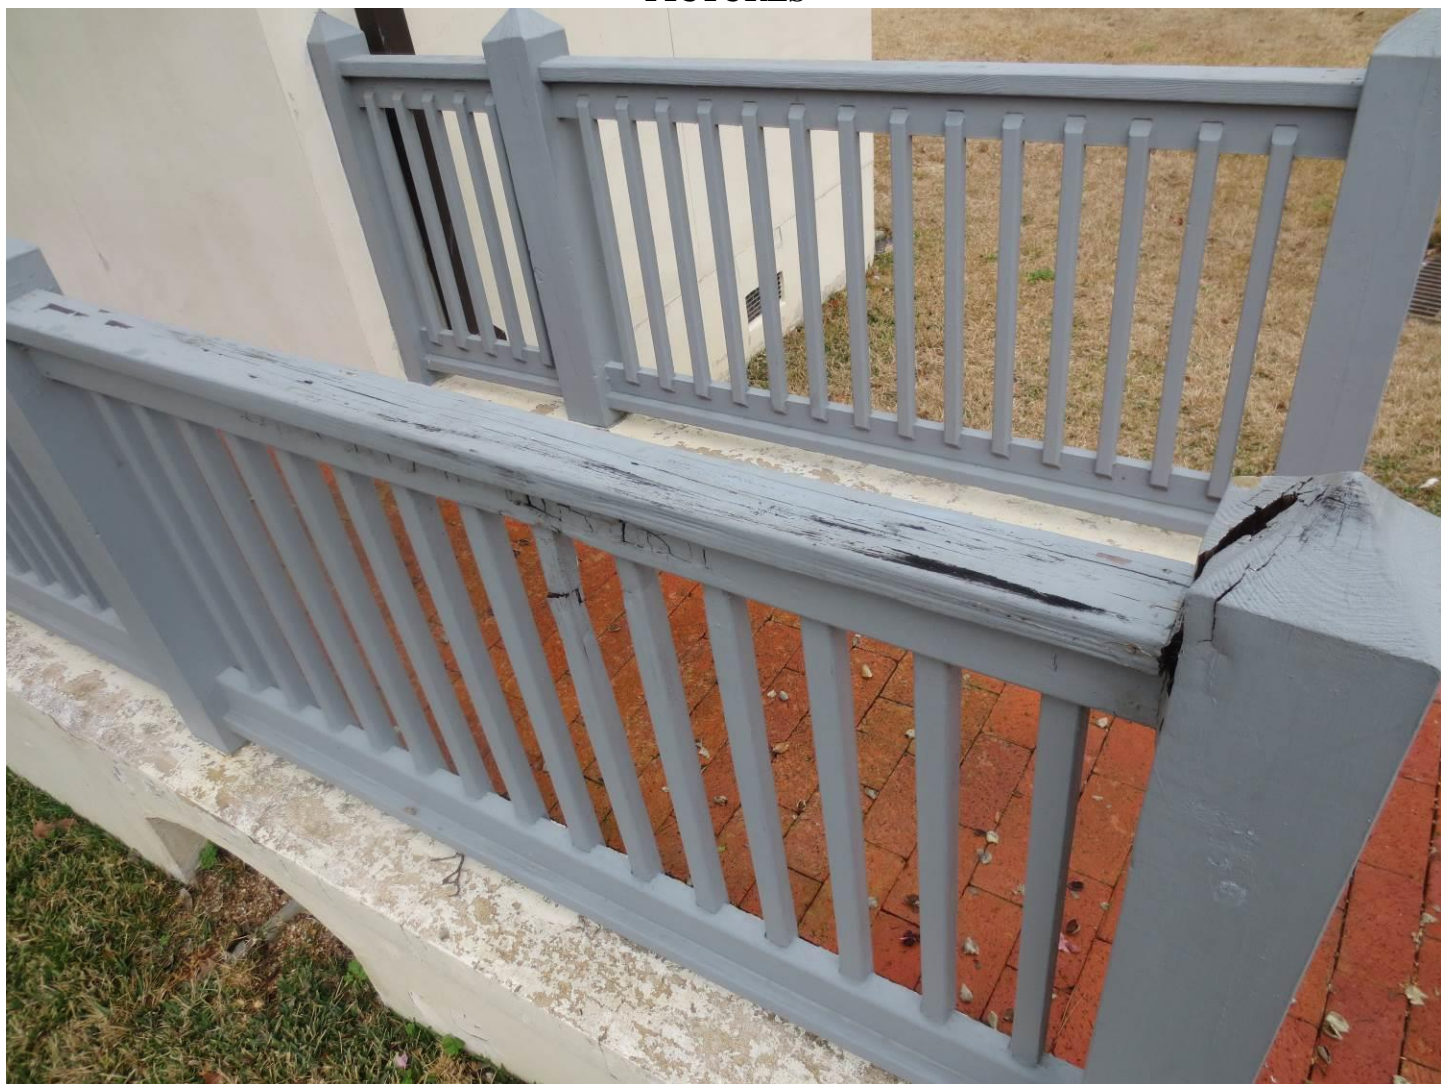
Figure 19: Public restroom railing to be replaced

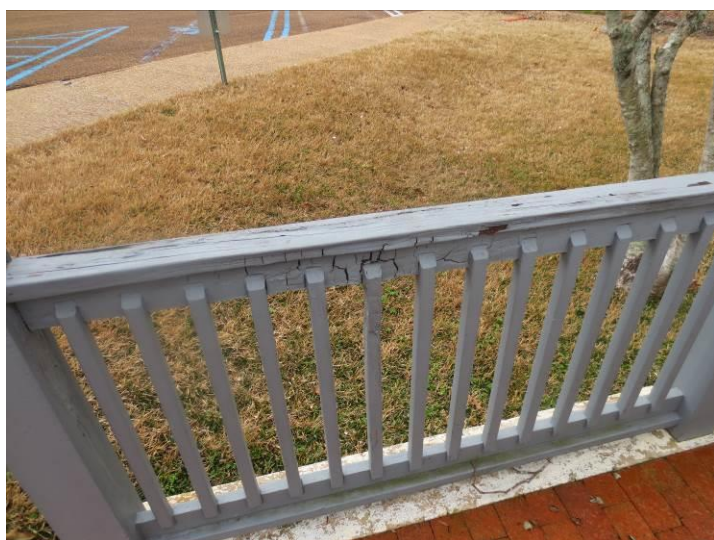
Figure 20: Public restroom railing to be replaced

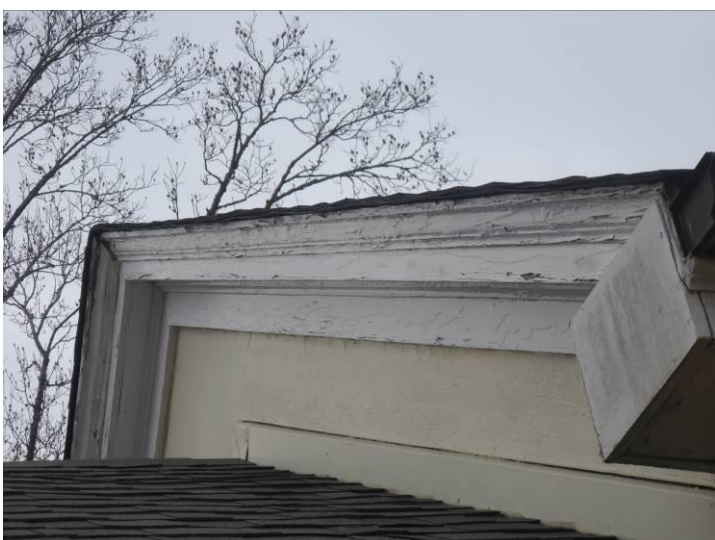
Figure 21: Condition of gable trim and moulding (typ.)
